Safety Alert

Duct Bracket Failure

6 August 2021

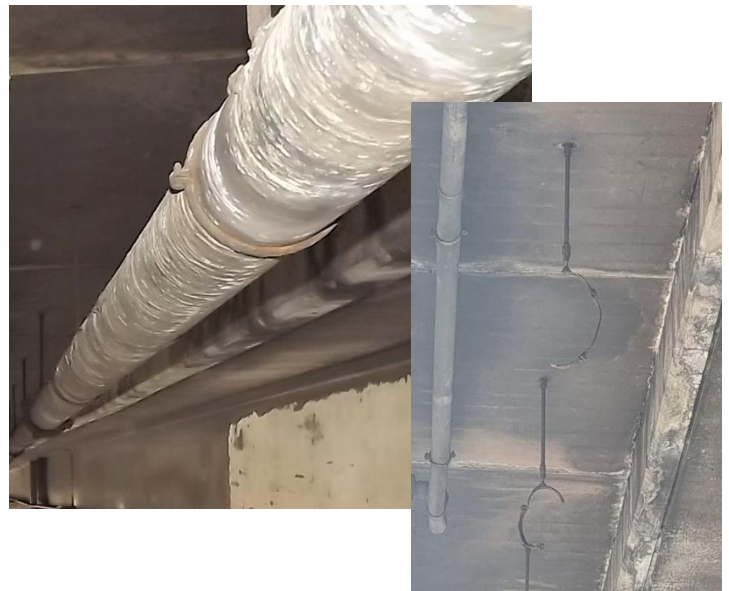
- Failure was identified in the pipe clamps at the majority of locations, including 'pull-through' of the clamping bolts. Additionally, a failure was also identified in a coupler connection to one hanger.

- Corrosion to the brackets was identified to all components.
