HRE major work review template

Proforma for SAF consideration

Structure name	Asset ID	NH Priority Rank
Limekiln Road, Newton on Ayr	AYH/1	P3

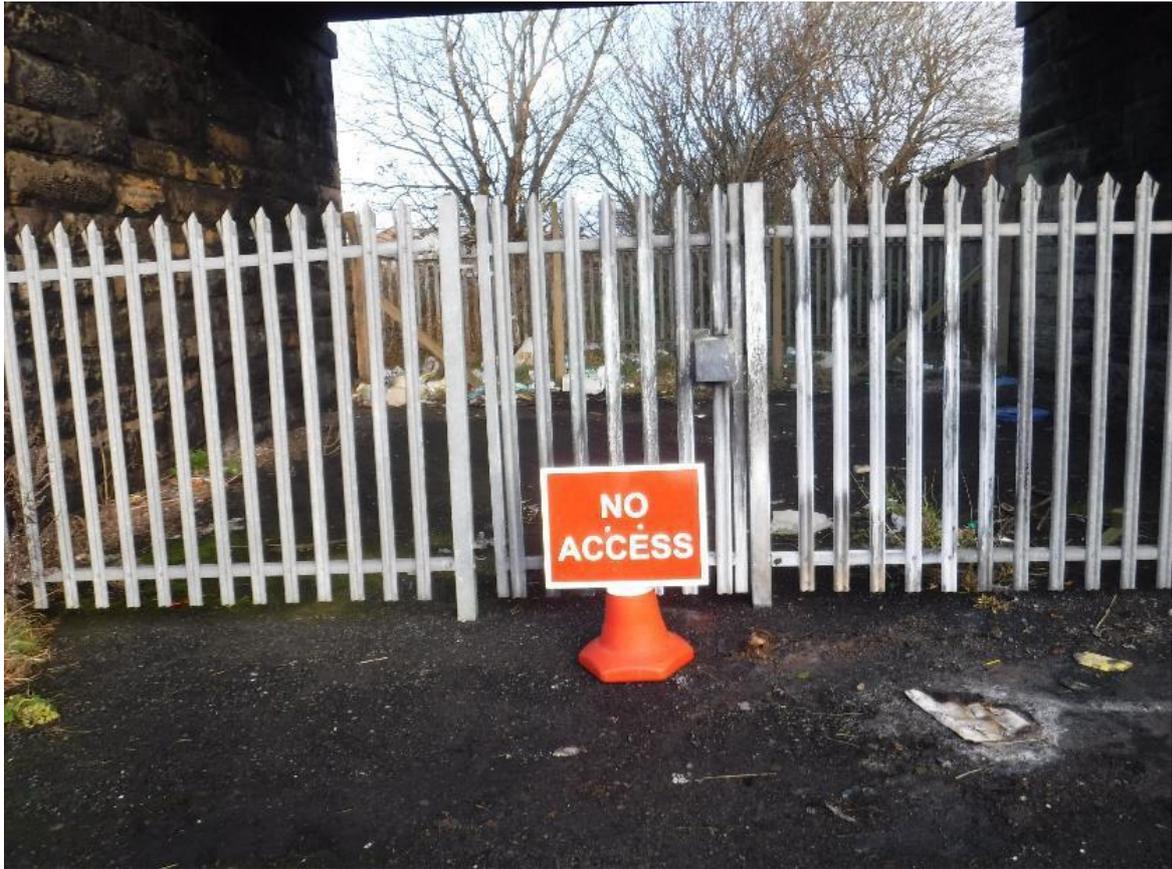
The site suffers from anti-social behaviour problems. Although the solum is fenced it is frequently used by fly-tippers and the accumulated waste set on fire. Exposed cast iron elements can lose strength quickly when subjected to temperatures exceeding 300°C and the sudden cooling from firefighter's hoses can lead to failure from thermal shock.

Figure 5 – Fire Damage to fence and gate

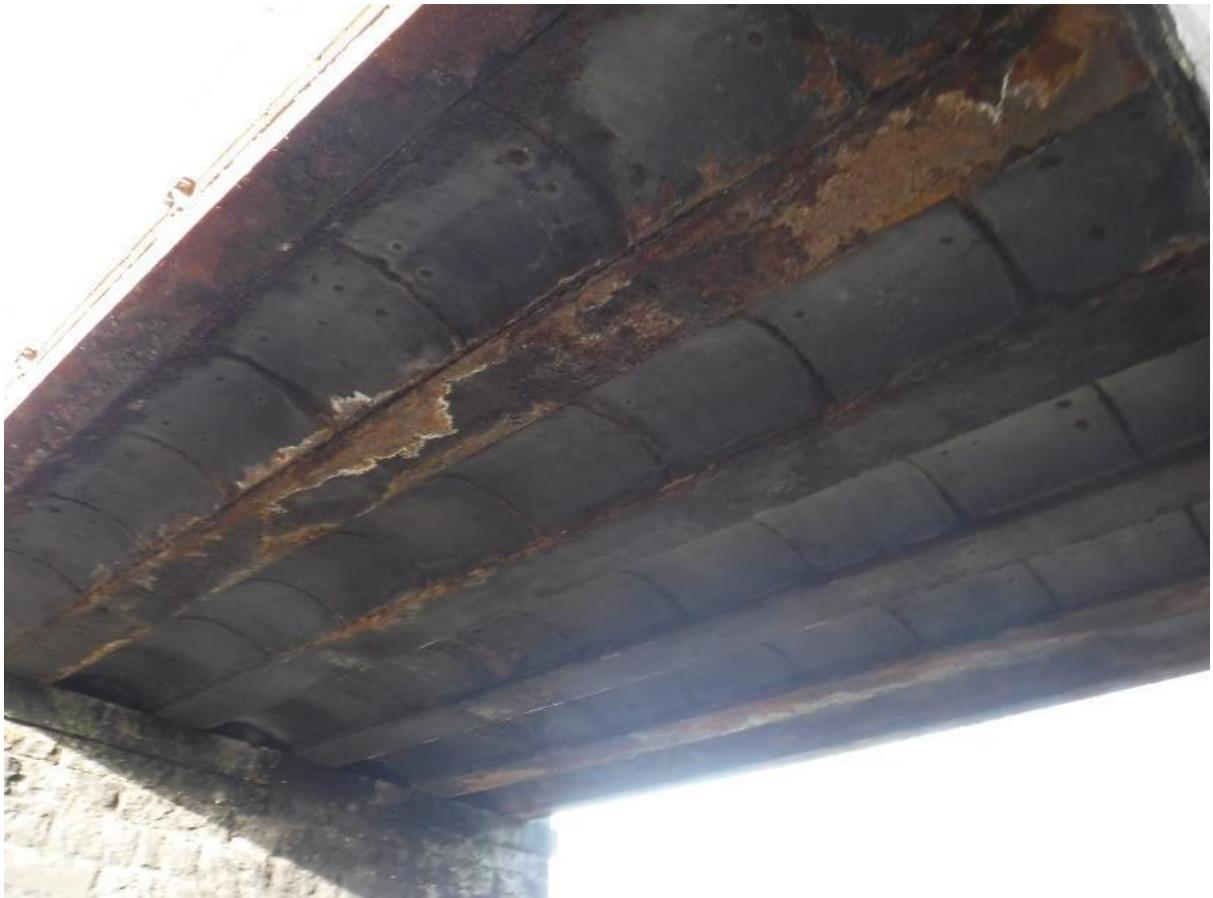
Figure 6 – Soffit view looking west

The bridge comprises four cast iron internal girders and two cast iron edge girders. Cast iron hogging plates span transversely between the girders. The bridge has span of 8.03m. The abutments and wingwalls are of coursed stone ashlar.

Visual examinations confirm that the structure is still in 'Fair' condition. However, it's assessed capacity is lower than that for both BE4 and BD21 (CS454).

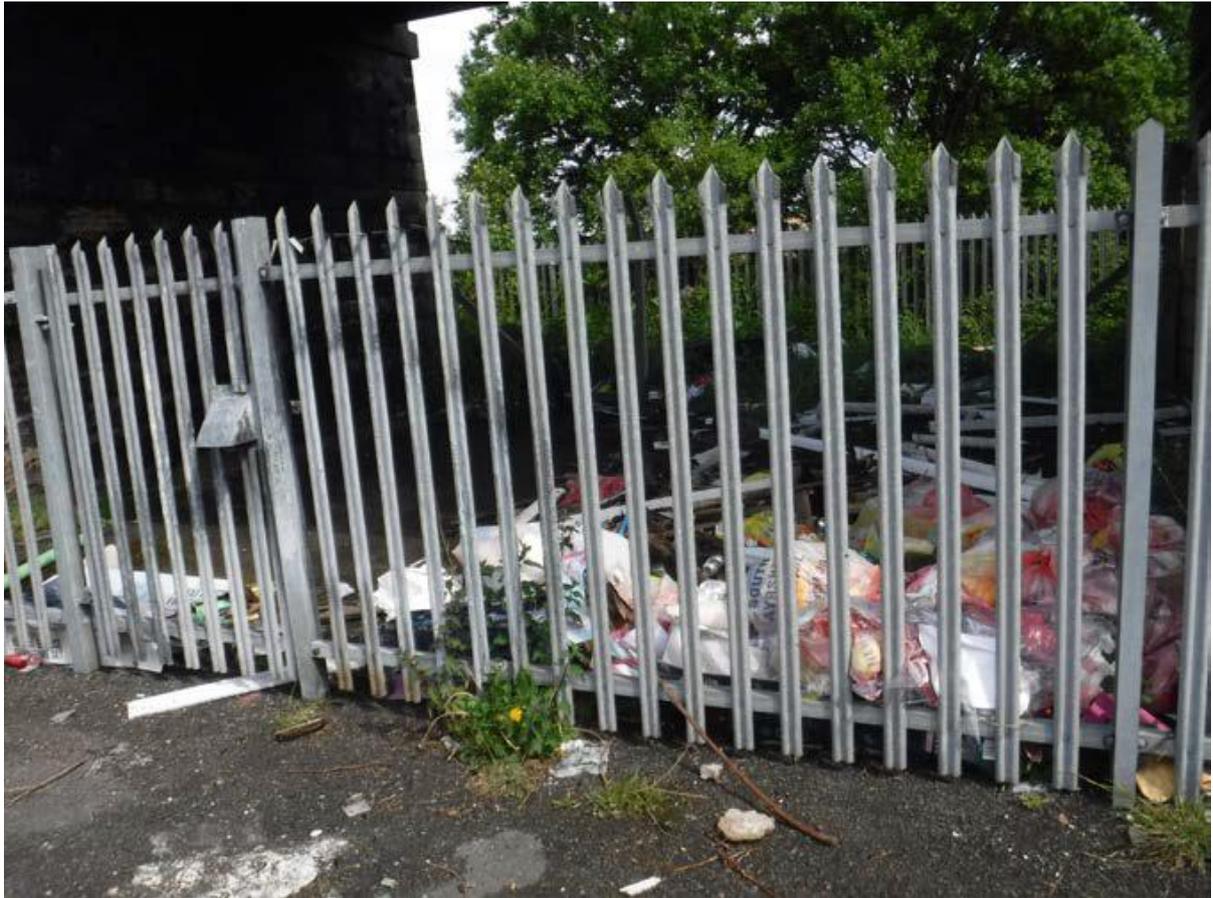
Figure 7 – Fly tipping below bridge

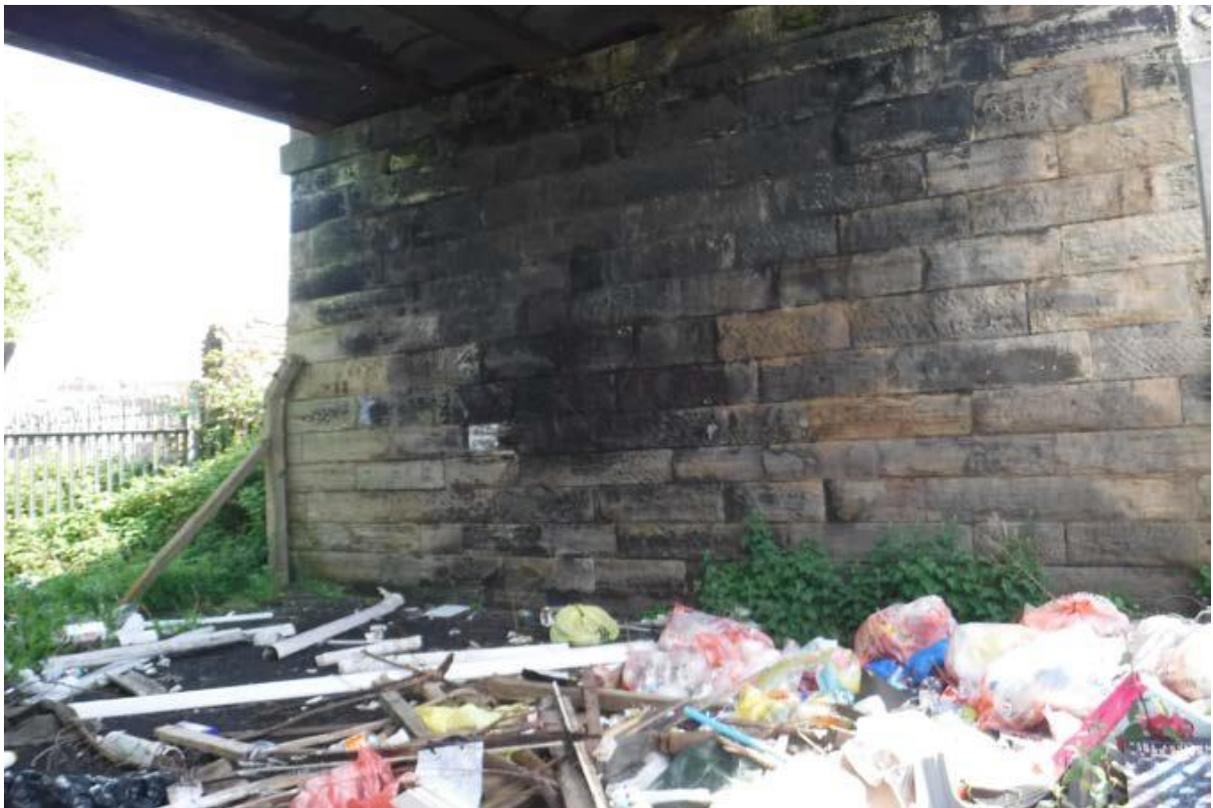
Figure 8 -Fly tipping below bridge.
