## HRE major work review template

### Proforma for SAF consideration

Structure name	Asset ID	NH Priority Rank
Paisley Road West, Glasgow	GTB/78	P3

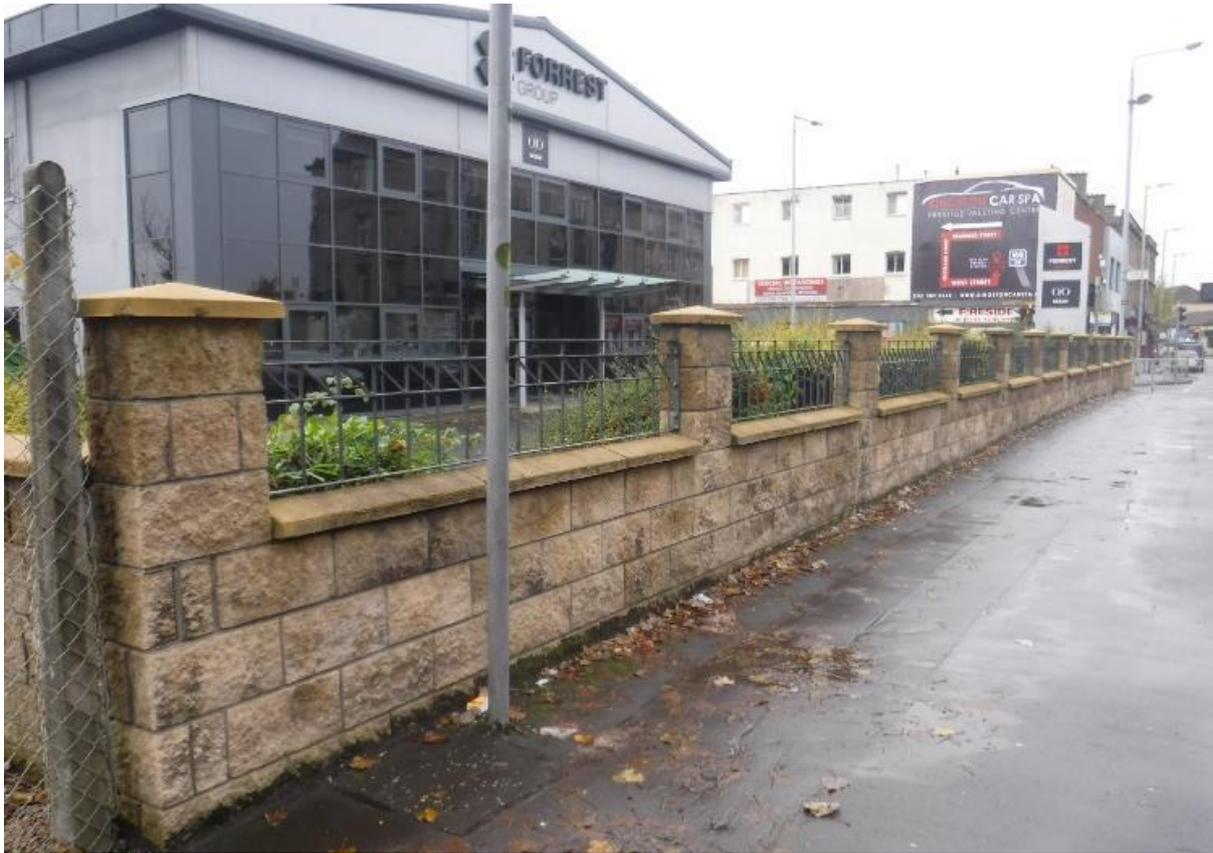
*Figure 6 – South parapet – demolished. Cutting filled and redeveloped*

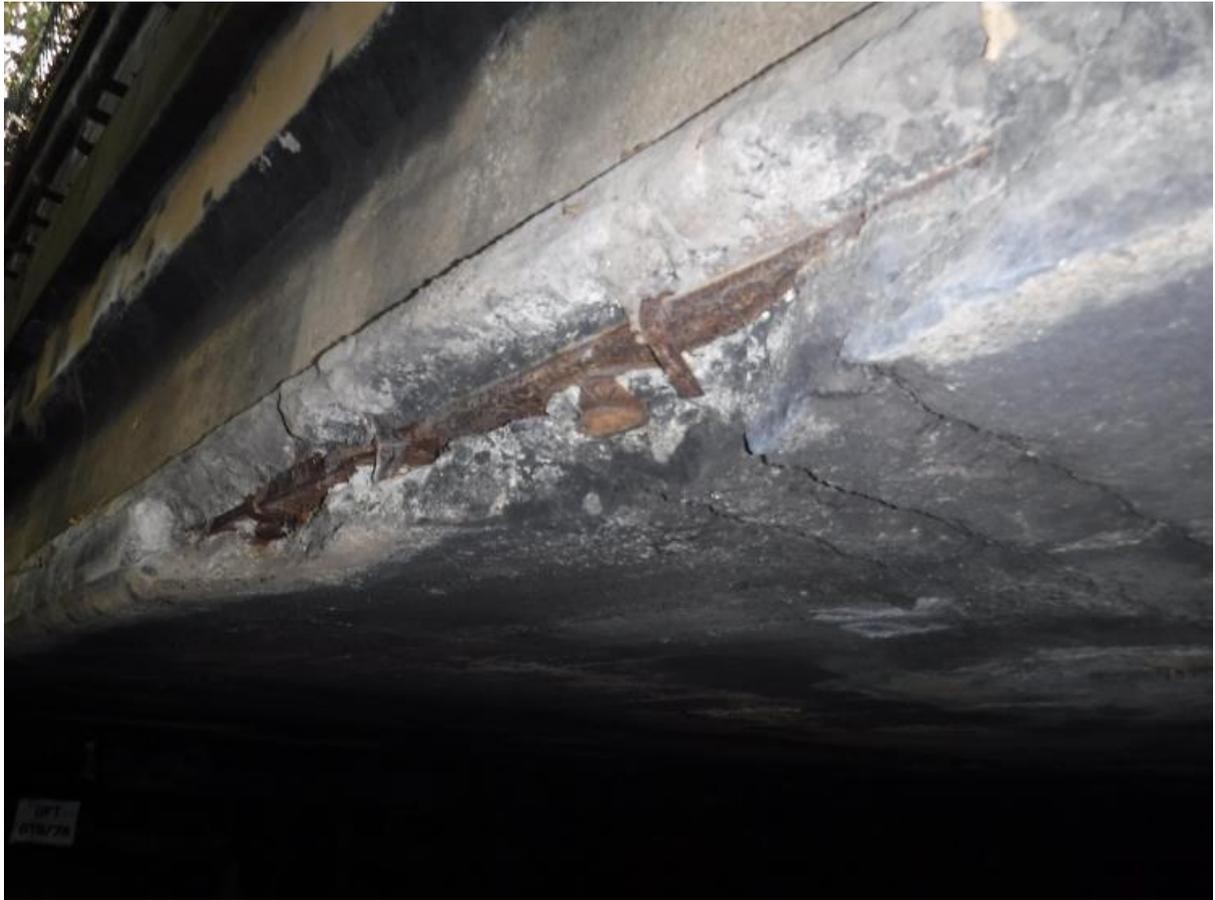
Detailed examination in October 2020 confirmed that the main girders and concrete deck are in 'Poor' condition.

*Figure 8 – Typical defects span 1*

Engineering options	Pro's	Con's	Estimated cost of remedy
Do Nothing	No cost	The bridge's visible current condition is <i>Poor</i> and it will continue to deteriorate without intervention.	£0
Concrete repairs to encased girders and deck.  Install full height security fences.	Preserves the current capacity of the bridge and will retard further deterioration.	Does not deal with the anti-social behaviour and the ongoing cost of clearing sharps from the voids.  Leaves a residual risk for examiners entering the spans from litter, hypodermics, and other waste.  Future intervention will be required to maintain the girders and concrete encasement.	£300k*
Complete infill the three remaining voids.	Removes the need to examine the structure and the long-term risk of its unknown condition and capacity.  Removes the risk of continued deterioration of the concrete encasement to the girders.  Negligible future or whole life cost issues.  Works can be completed without significant disruption to traffic using the bridge.  Retains the full width of the bridge deck for mixed road and active travel.	Ongoing reduced maintenance liability for embankment and parapets.	£260k*

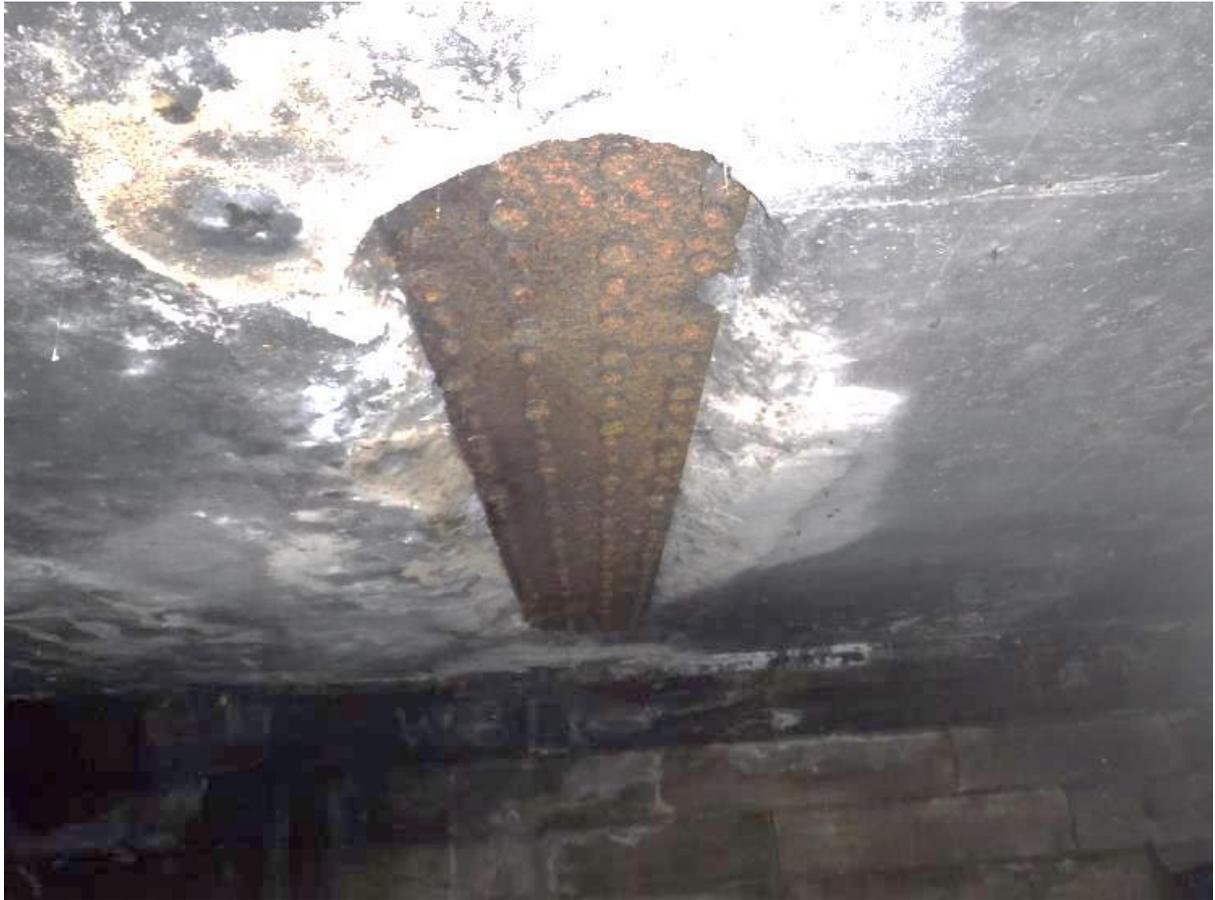
Figure 9 – Typical spalling to encased girder – span 3

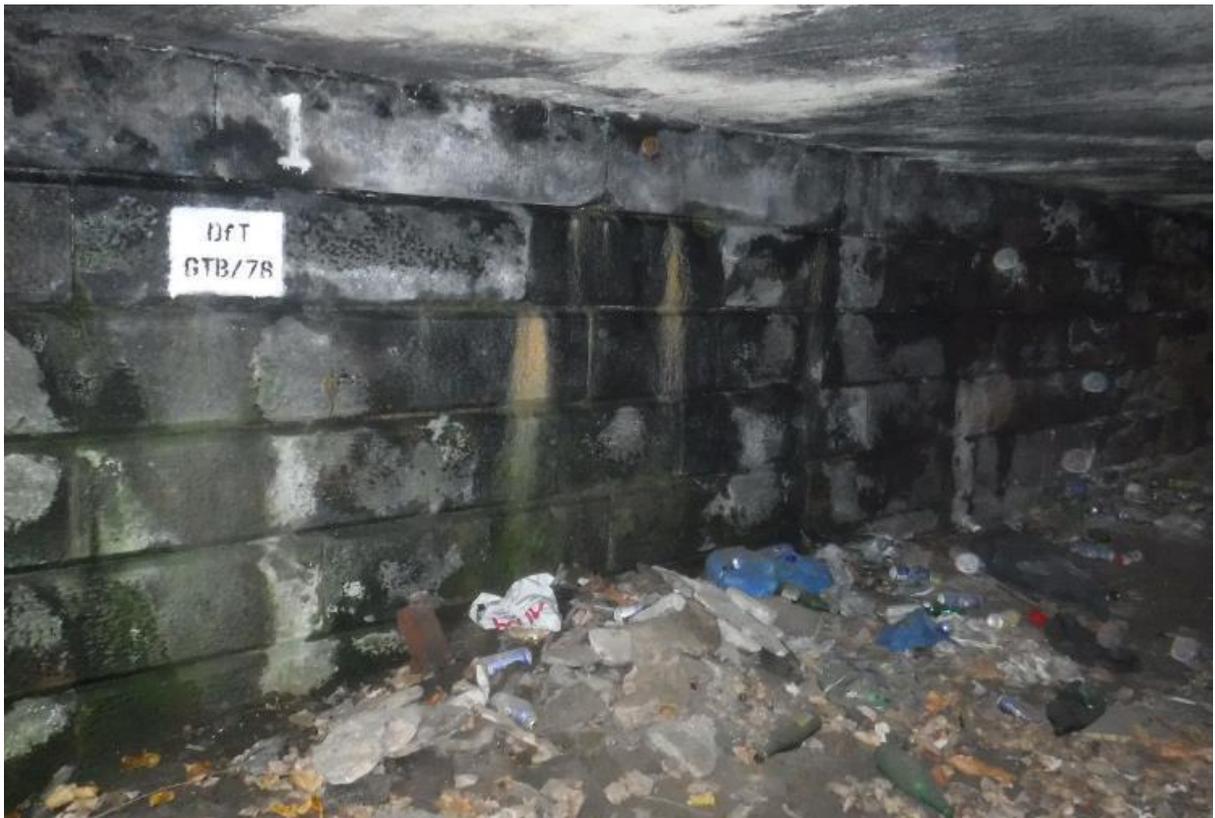
The needles and waste left in the spans presents a risk to our examiners and owners of the property to the north of the structure.

Figure 10 -Litter and waste left in span 1.

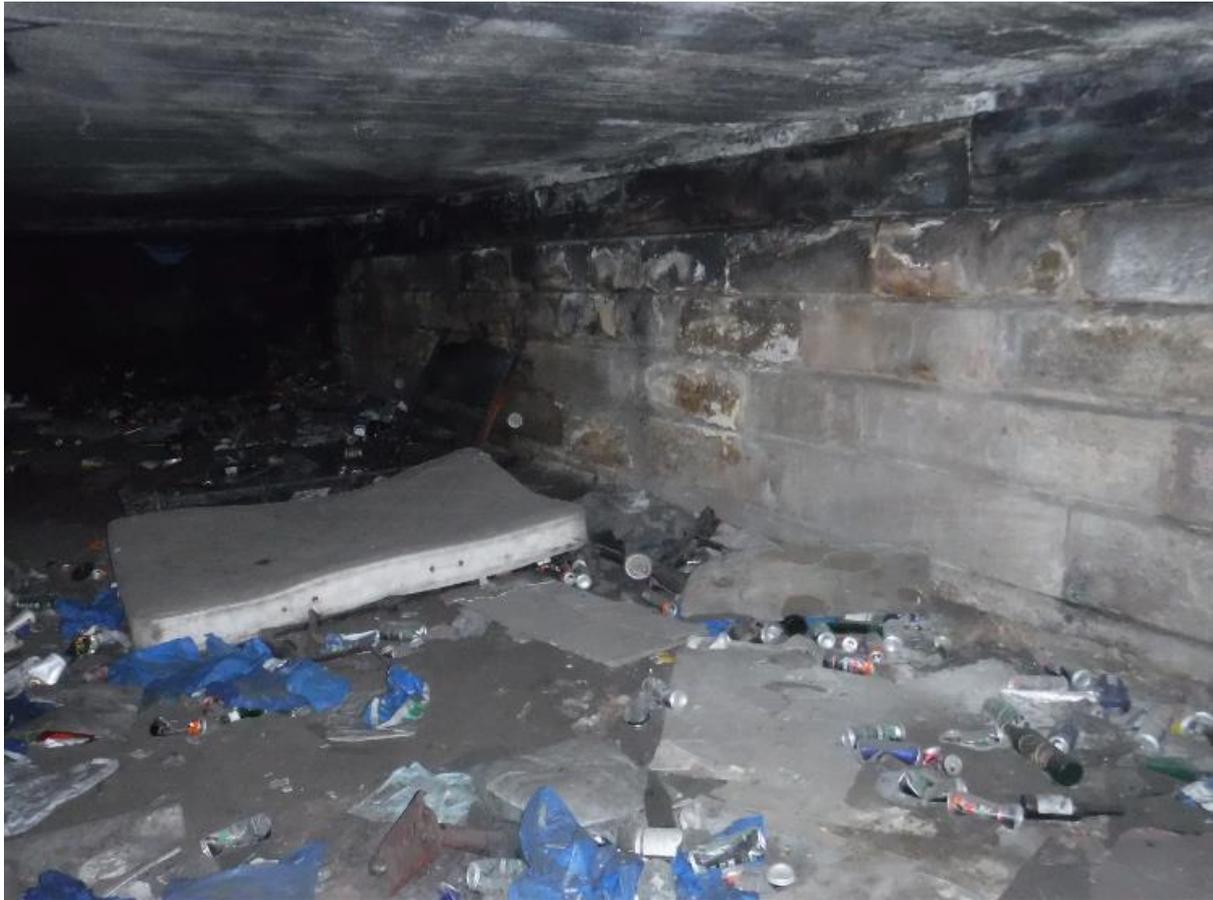
Figure 11 -Litter and waste left in span 3.

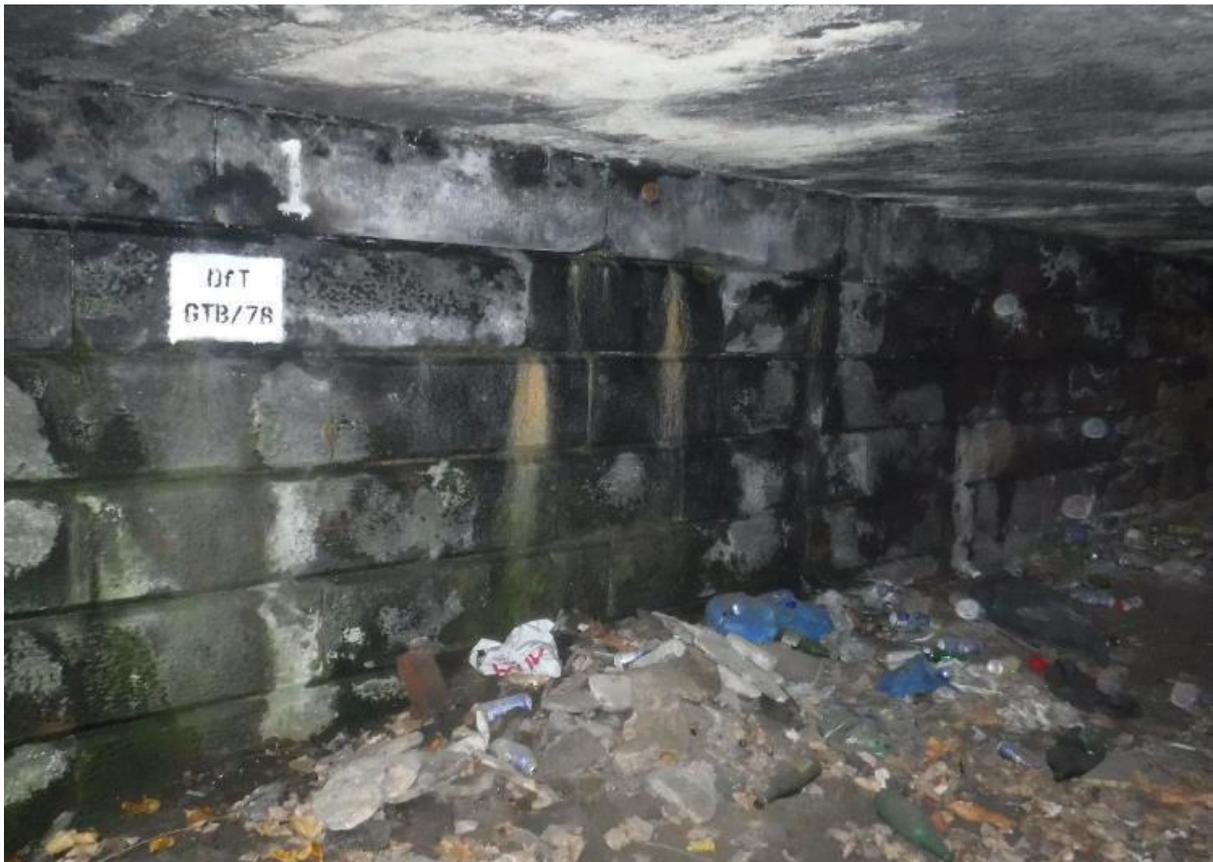
Figure 12 -Litter and waste left in span 1.
