CASE STUDY AECOM | 1.1b) – Apr23'- Jun3' A63 Castle St – Diaphragm Wall Cable Break

Title:	Failed Wire Sling Incident (HS8130 Chisel Tool)		
Project Name:	A63 Castle Street Improvement Scheme	iSMS Ref No:	679672
Project Number:	MHC1005	Date of Incident:	17.03.2023

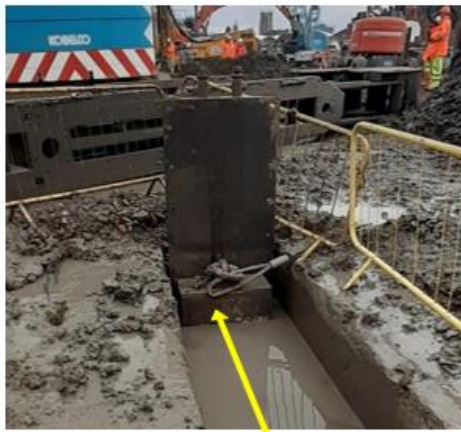
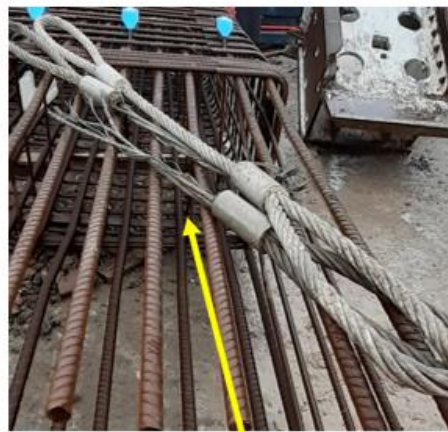
AECOM were made aware that during a D-Wall excavation shift there was a cable break on a sling that was being used to support the chisel attachment. It was reported that an operative not directly involved in the operation reported being struck on the shoulder by a piece of wire rope approximately 20 meters from the point of failure (outside of the exclusion zone). The injured party was checked out by a first aider and returned to work.

The sling that failed was supporting the chisel attachment. As part of the Diaphragm wall construction a Liebherr HS8130 Duty Cycle Crane utilising a 7 meter long chisel attachment was in the process of removing excess concrete that was encasing a stop end at a depth of circa 6 meters. The operator experienced some resistance when lifting the chisel out of the excavation and seconds after the crane's load alarm had sounded and the 12 tonne wire rope sling connecting the chain block to the chisel failed. The chisel remained 'wedged' near the base of the 10 meter excavation (it had not been suspended at height at the moment of failure).

Chisel attachment (left in-situ)

Damaged 12 tonne wire rope sling

Figure 1- Cable break location and broken cable highlighted

- Statement taken from the crane operator 18.03.23 and photographs taken of the incident
- Failed wire rope sling quarantined and later removed from site for analysis
- Liebherr engineer visited site 21.03.22 to download load data from the crane and confirm whether the crane was unaffected by any potential shock loading
- Early replacement of crane wire rope
- Review of Diaphragm Wall work package plan and development of a plan for retrieval of the chisel

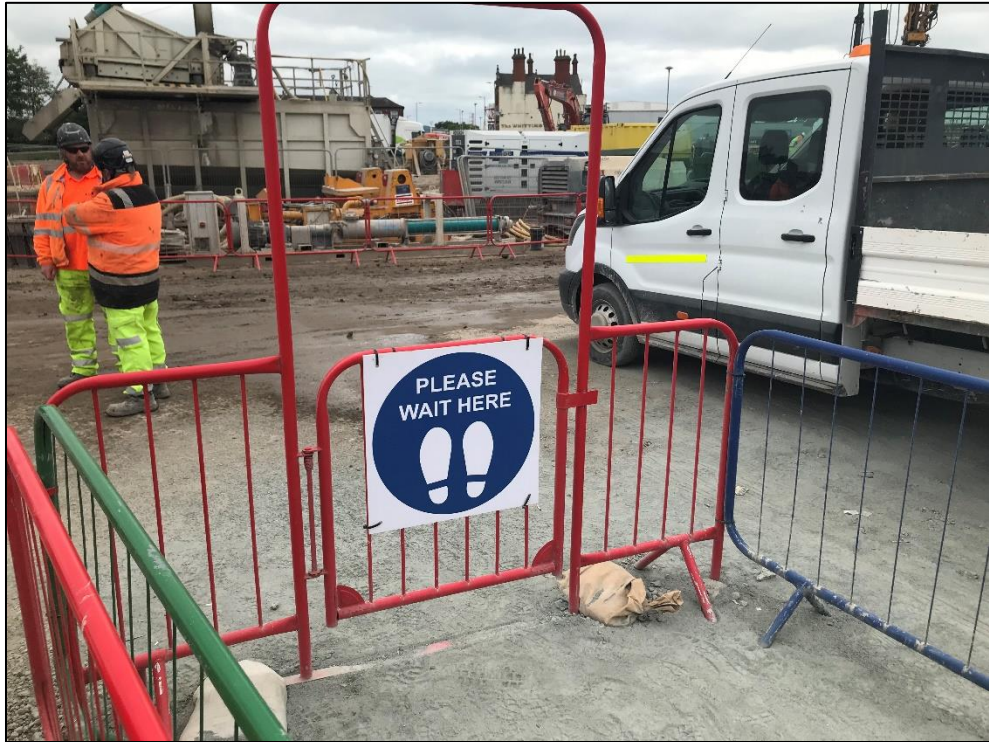
Figure 3 – Site visitor waiting area (pre-brief)

- A 'Waiting Zone' on site, where AECOM Staff can wait on site in a safe location before being accurately briefed about the site activities and where it is safe to be. (Photo example – Figure 2)
- Paper briefing sheets that AECOM can read and sign to ensure all activities and H&S points are understood properly before entering site. (Photo example – Figure 3)

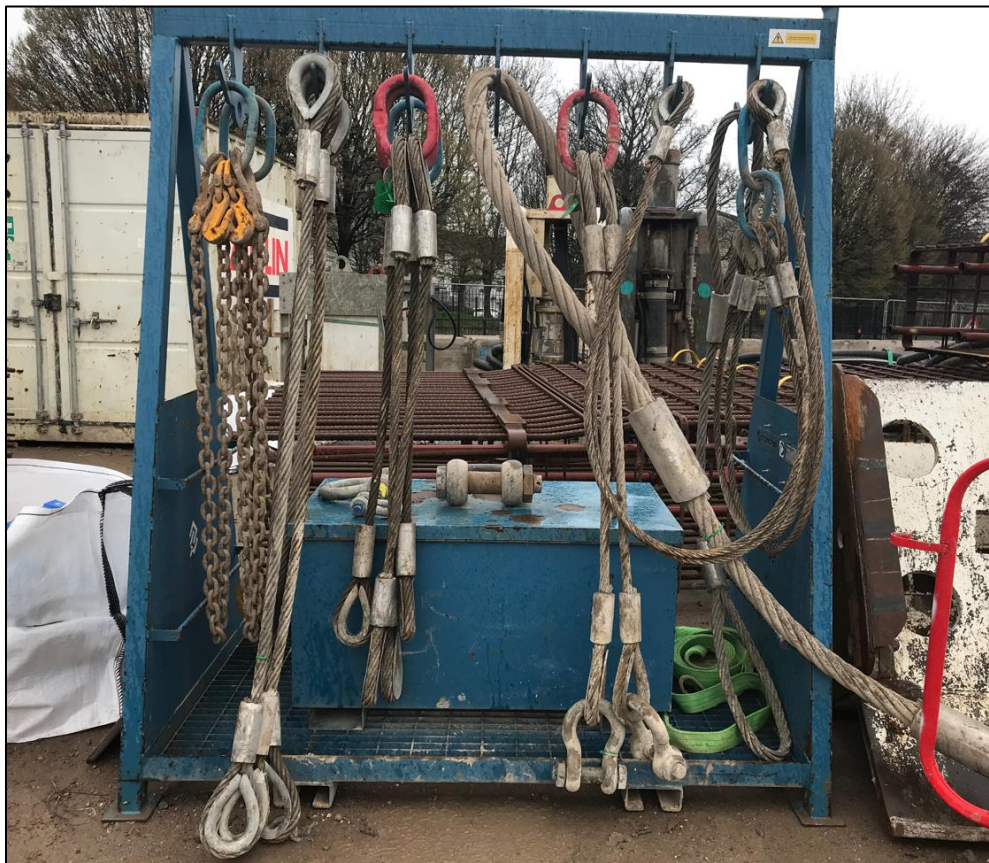
Figure 4 – New sling storage to ease of use and understanding

Following the above actions, the 'Waiting Zone' and the Briefing sheets on site were implemented to ensure the safety of all the AECOM site staff and other staff witnessing works. Also, the Contractor and Sub-Contractor implemented new sling storage on site, that made it very clear which slings were available to ensure the correct sling class was being used for the correct lift. It was concluded that the 12T sling was not the correct sling to be using with the 10T chisel, as it may have been under too much stress when attempting to remove the 'stuck' chisel. The D-Wall operations were put on hold for 2 weeks during the completion of the principal investigation into this sling failure, and all the site operatives were re-briefed in detail about the lifting works on this operation. More details lifting plans were implemented to ensure the correct slings were always being used and maintained.
