CASE STUDY AECOM | 1.1b) – Oct 23' - Dec 23'

A63 Castle St – Mytongate Bridge Pier to Deck Connection (Safety in Design)

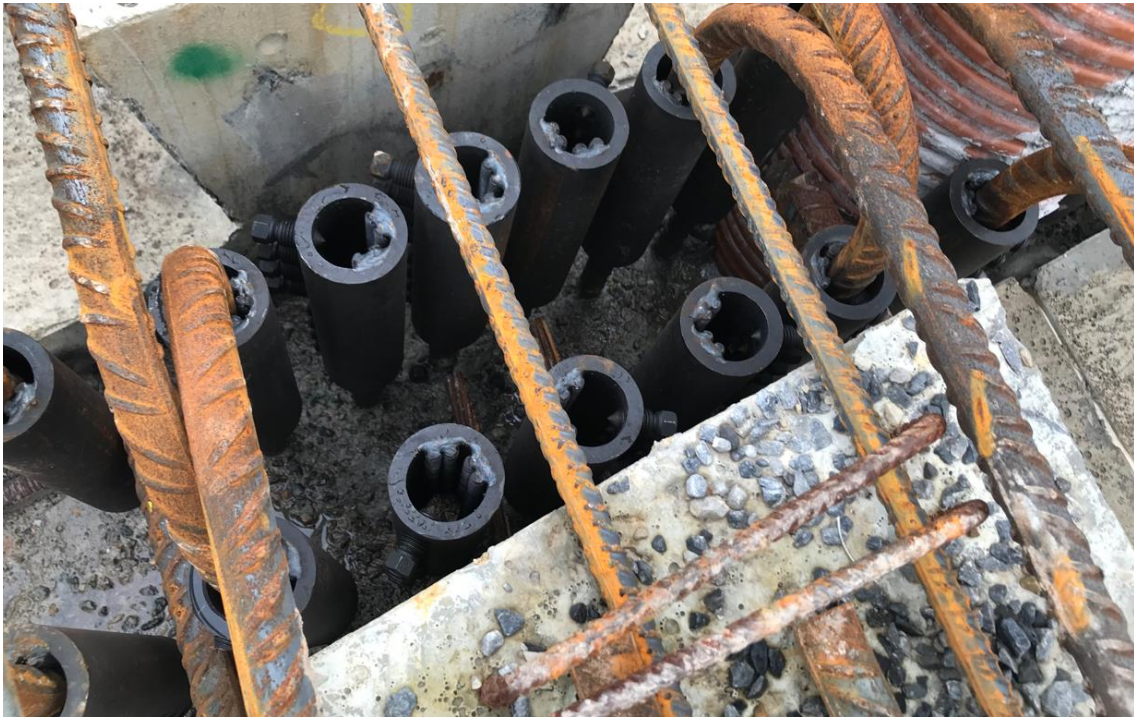
AECOM were asked to complete an inspection of the steel reinforcement connection between the bridge pier and the bridge deck steel. L-Bars have been included within the Design to tie the pier into the deck steel, however, to install the beams these L-Bars were cut and then reconnected with couplers (See figure 1) after the beams were landed.

During the inspection it was identified that about 20% of the L-Bars could not be fully installed with the coupler method as per the Contractors plan. AECOM identified this as a significant issue and ensured that both an NCR & Defect were raised, and that the Designer was engaged to check what remedial works would be required to ensure the As Built per & deck connection would be sufficient and therefore safe for use by the public.

Figure 1 – Example of couplers and L-Bar locations that could not be installed.

The Contractor engaged the Designer and the CAT3 checker, it was initially believed to have failed the CAT3 check, however, after numerous iterations of analysis, it was concluded that the as built design, with 20% of the L-Bars omitted, is ok and safe for construction and use by the public.

- The Contractor followed the advice of AECOM and ensured that once the Designer had completed their analysis, concluding that missing 20% of the L-Bars would be OK, that a CAT3 check would be completed on this resolution.

- The CAT3 check initially concluded that this connection would fail under fatigue and be an unsafe connection for public use once opened to traffic. However, after a more detailed analysis it was concluded to be acceptable and safe.
