Seagreen Offshore Wind Farm

Post-construction Over Trawl Survey - Inter Array Cable Protection

Undertaken by
Brown & May Marine Limited

Ref	Rev.	Date	Author	Checked	Approved
BMM-SWEL-CRR-OTS-IAC	01	24/07/2024	ML	SX	JW

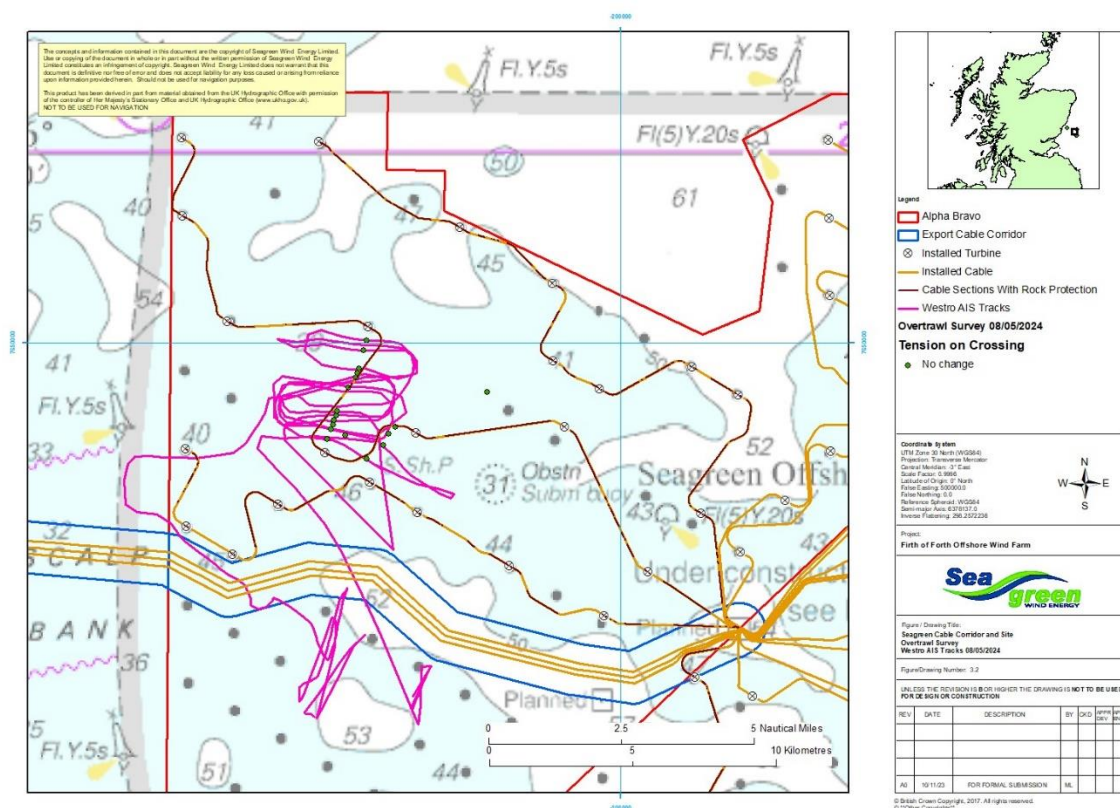
Figure 3-3: Westro over trawl tracks 8th May 2024

At 10:00, the over trawl gear was recovered, and two damaged floats were reported on the headline of the net. Following discussion with the skipper, damage was thought to have occurred during gear recovery and not during the over trawl works. Floats were replaced and gear was redeployed at 10:10 in area J07-K08. No further snagging events or gear damage were recorded.

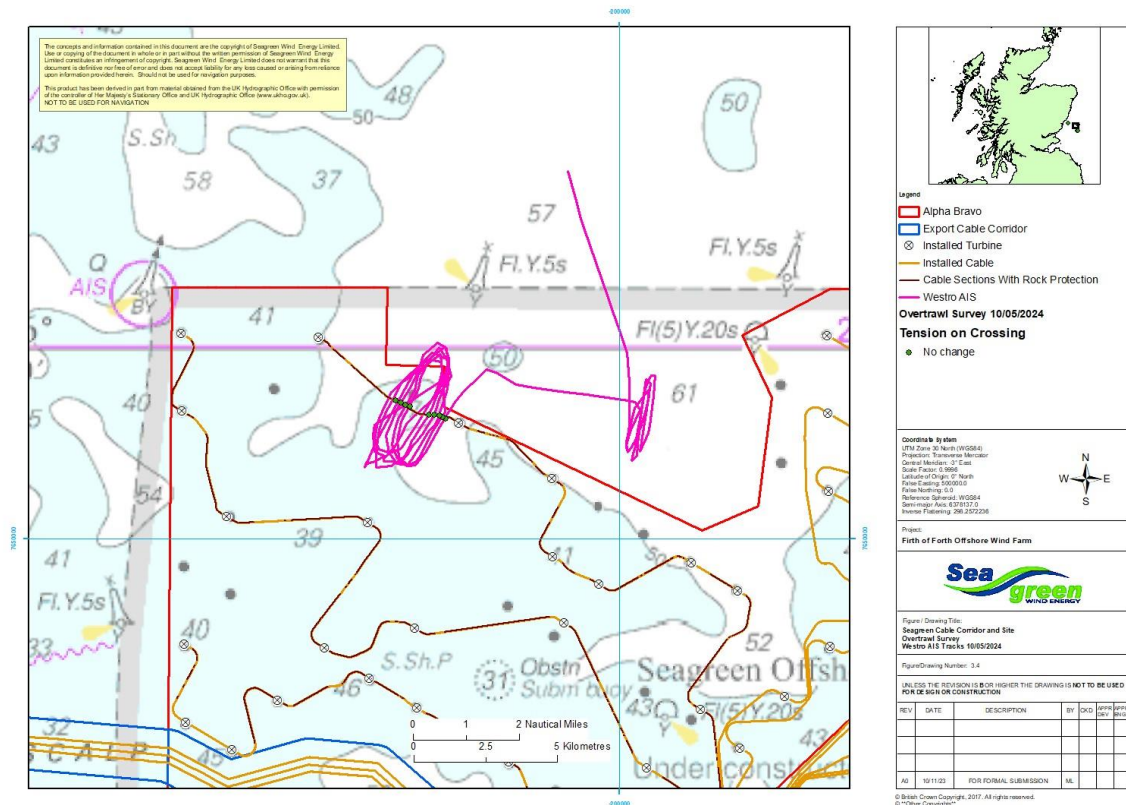
Figure 3-5: Westro over trawl tracks 10th May 2024

At 11:10, a slight reduction in speed was reported along with a slight increase in tension on the trawl gear. The gear was recovered for an inspection at 11:35, but no damage was observed. No further snagging events or gear damage was observed.

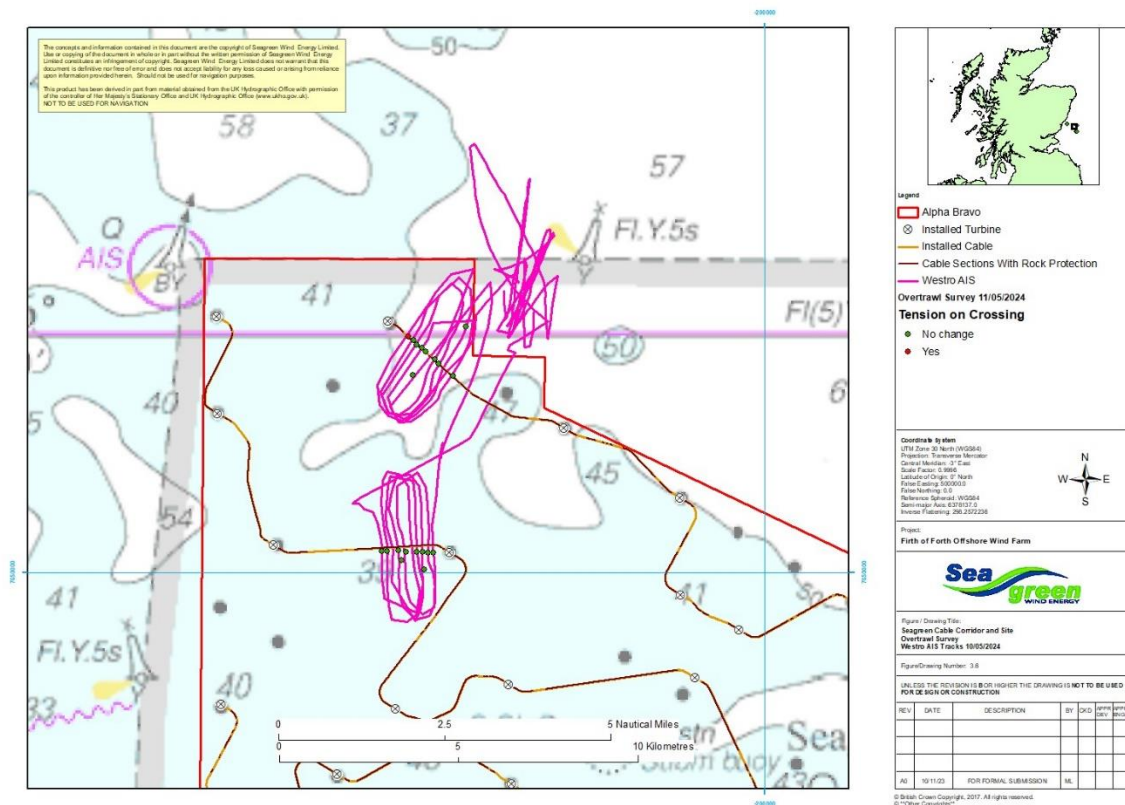
Figure 3-6: Westro over trawl tracks 11th May 2024

At 07:40, 200m beyond the second crossing of area N06-N03, a significant reduction in speed occurred. Speed reduced down from 2.5 kts to 0.1 kts along with a significant increase in tension and reduced trawl door spread. Gear was recovered for damage inspection, but no damage was observed. No further snagging events or gear damage observed.

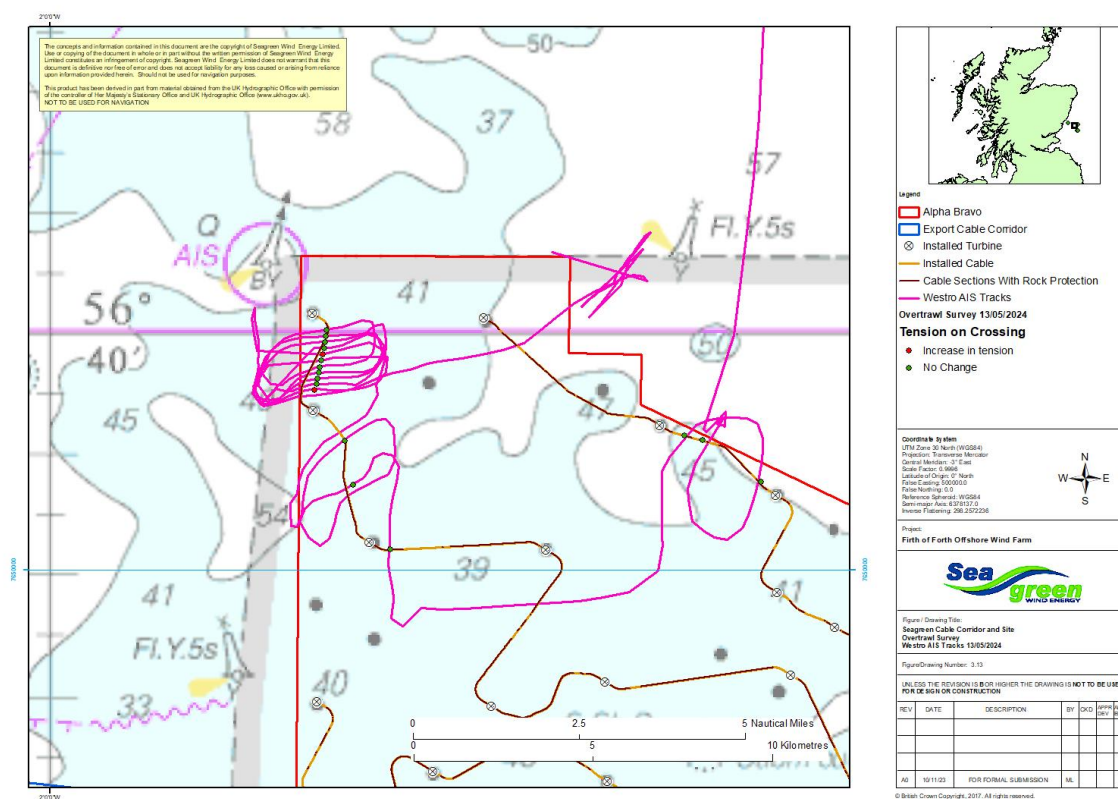
Figure 3-8: Westro over trawl tracks 13th May 2024

At 08:15, 900m beyond the third crossing point, the trawl gear snagged on the seabed. The over trawl gear was recovered, and it was found that a towing extension section and a towing shackle was broken (Figure 3-9 and Figure 3-10). The fishing gear was able to be repaired and was redeployed at 09:00.

At 09:06, after crossing the cable, there was a brief change in engine noise due to increased load on the trawl gear. This additional load caused the towing bridle (dyneema rope) to part (Figure 3-11). A brief reduction in speed was observed and recorded, however, the skipper of the vessel deemed it acceptable given the seabed conditions in the area and decided not to recover the gear for inspection as it was most likely the trawl door as opposed to the trawl net that caused the reduction in speed.

After area L02-M01, the skipper continued to trawl 800m away from the cable crossing, however, it was noted that the trawl door spread had not recovered to the pre-crossing distance. The trawl gear was recovered for inspection, however, no damage was observed, and the trawl gear was redeployed at 09:55.

Following redeployment of gear after an inspection at 16:24, the over trawl gear came fast on the seabed 270m north of the fourth cable crossing at N06-N08 when turning to undertake the next transect. The trawl gear was recovered for inspection at 18:15, however, no damage was observed, and the trawl gear was stowed for transit back to port.

It is, however, recommended that the relevant fishing channels, such as fishing industry representatives (FIR's) and the SFF, are provided with the coordinates of the unrelated snagging incidents which occurred during the survey so they can be avoided by other fishers in the area.

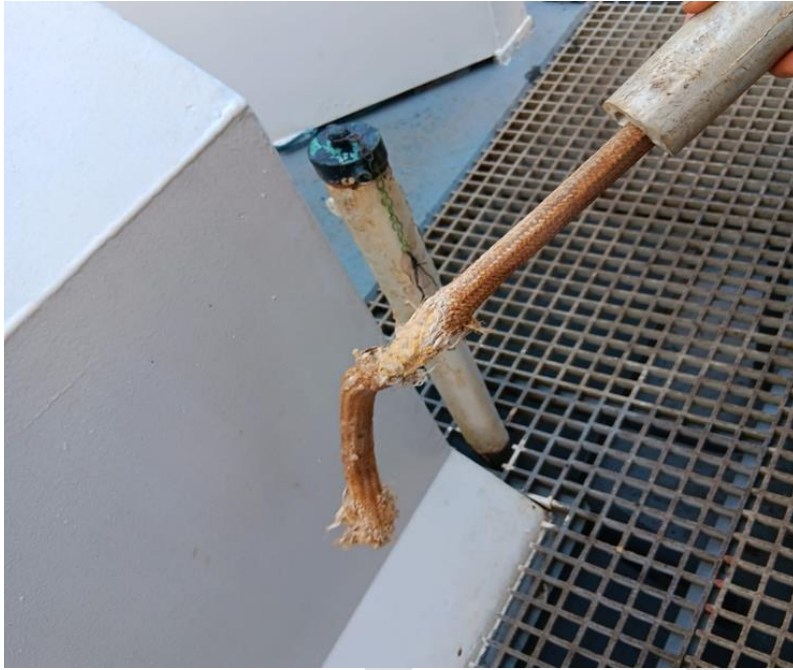
Figure 3-9: Broken towing extension piece

During trawl operations on 13th May 2024 at 08:15, during the third cable crossing of the day, the fishing gear snagged on seabed at a position 900m beyond the crossing point at area L02-M01 (56° 39'.709N, 001° 56'.860W). The fishing gear was recovered to find a broken towing extension piece along with a broken towing shackle (Figure 3-9 and Figure 3-10 respectively). The fishing gear was able to be quickly repaired by the crew, and the vessel continued with the remaining crossings in the area.

06:35 TBT on bridge with skipper, BMM surveyors and mate.
06:40 Over trawl gear deployed and commenced running lines.
08:15 Over trawl gear snagged on seabed 900 m beyond cable crossing. Gear recovered for inspection. Broken towing extension piece and broken shackle on back-strop observed. Gear repaired.

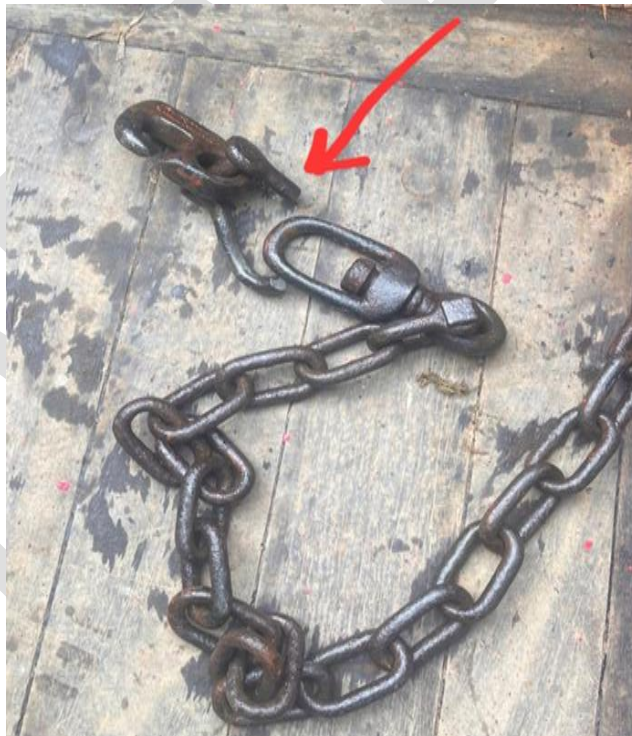
Figure 3-10: Broken towing shackle

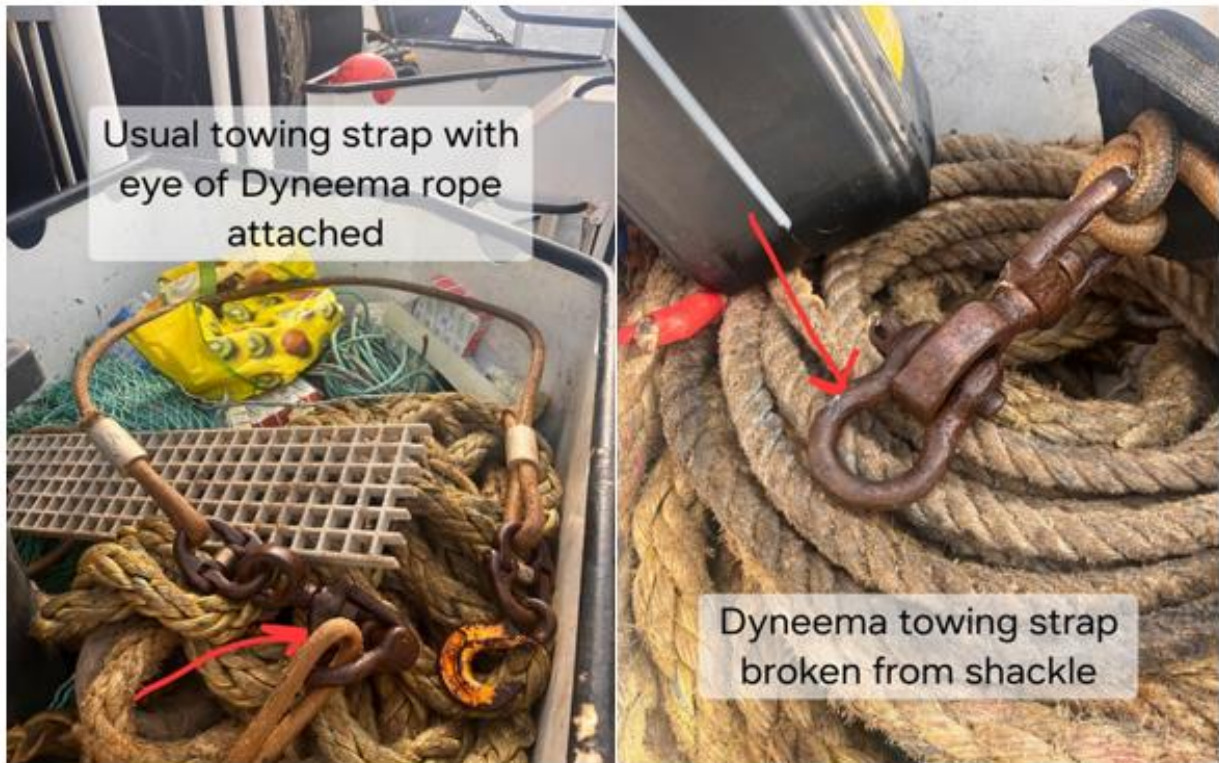
Figure 3-11: Dyneema rope

During trawl operations on 13th May 2024, following the first snag, the fishing gear was then re-deployed at 09:00. At 09:06 when making the fourth cable crossing of the day, the fishing gear caught briefly on the seabed when crossing over the berm (56° 39.836 N, 001° 55.897W) resulting in a broken dyneema rope towing bridle (Figure 3-11). The snag was only momentary, and the gear came free from the seabed without any intervention and the vessel continued towing. The incident was deemed as acceptable by the vessel skipper given the seabed conditions in and around the crossing location.

09:00 Over trawl gear re-deployed and continued running lines.
09:06 Over trawl gear stuck briefly on seabed when crossing over berm, resulting in broken towing bridle. Snag came free from seabed and vessel continued towing.
