Notes from the DAC site visit held on Friday 15th of September 2021 at St Peter's, Poulshot.

Purpose of the meeting:

This is a report of an inspection of the bells and fittings at St Peter's, Poulshot which was carried out on Friday 15th of September 2021 at the request of, and in company of, the Church Warden, Dankay Cleverly. The inspection was requested as the PCC are considering restoration of the church bells and improvements to tower access.

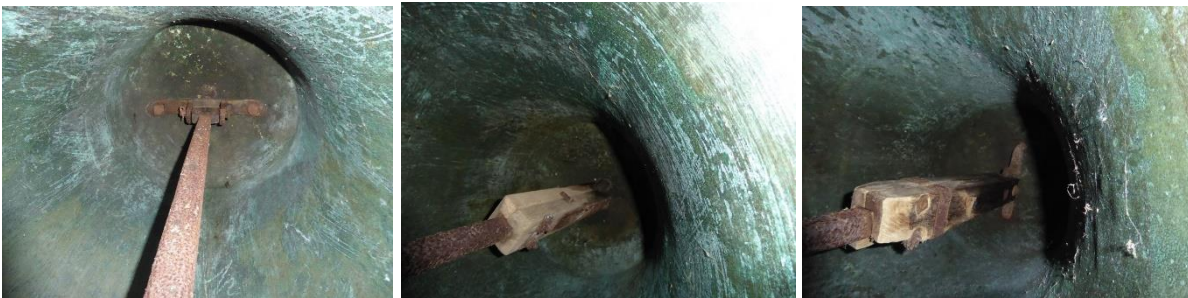
The tenor bell has been quarter turned. The remaining bells have not been turned. It was noted that the indentations from the clapper on the treble bell are approaching a sensible maximum indicating that the bell should be turned if re-hung for full circle ringing. The clapper is also striking the bell rather too low, which risks cracking the bell. All clapper suspension points are worn with significant sideways movement of the clappers possible. It would be prudent to drill out clown staples, if permitted, as this is a significant cause of bells cracking in the crown. There is no sign of cracking in the bell crowns at present.

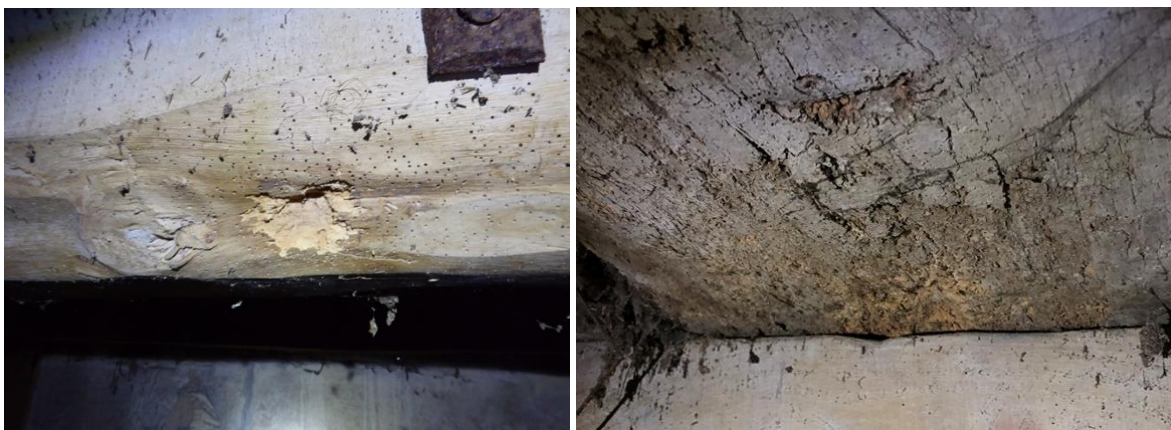
The Frame is set on three oak foundation beams running N/S across the tower, these beams appear to be in fair condition although they exhibit signs of worm and rot. As is to be expected the worst condition beams are those closest to the walls, and beam ends where built into walls. Fortunately, external beam ends bear on corbels in the corners of the tower. The central beam does not have corbels but is in fair condition although the worm damage at some points has caused the surface of the timber to become detached. The foundation beams sit on a ledge formed by a reduction in the thickness of the tower walls. Some of the floor boards above these beams are showing signs of advanced decay.

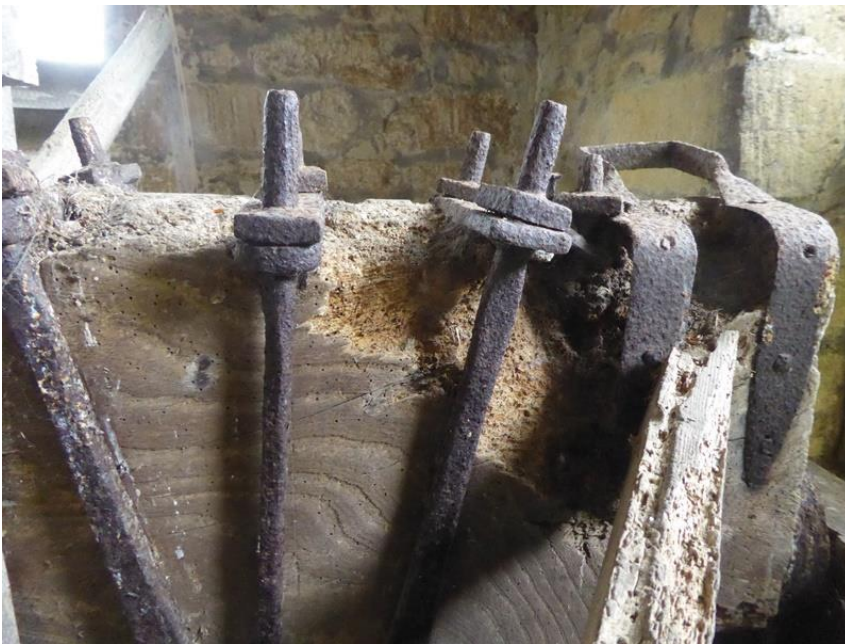
1) Headstocks and Bearings

All bells have Elm Headstocks and are mounted on plain bearings with strap gudgeons. None of the bells are loose on their headstocks, but the headstocks are in poor condition, especially the treble, which is exposed to the driving rain from the north louvre, which is close by.

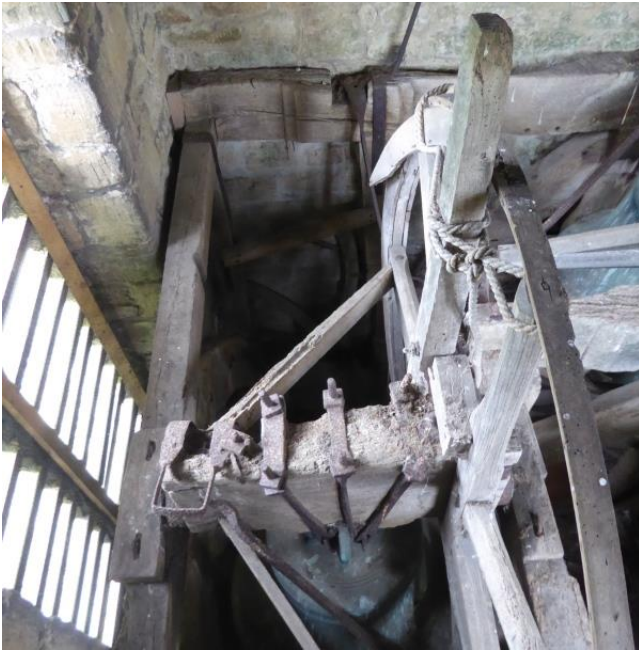
4) Stays sliders and running boards

Straight timber stays have been fitted to the side of the headstocks but sliders and pins are not in evidence. The treble bell seems to have been fitted with a stay on the opposite side to the wheel at some point, but currently has the stay immediately adjacent to the wheel, which is an unusual arrangement.
