The Church of St Peter, Poulshot Tower Repairs: Phase II Bells and Tower Access Improvements

Tender Documents

The Church of St. Peter, Poulshot Tower Survey 2016

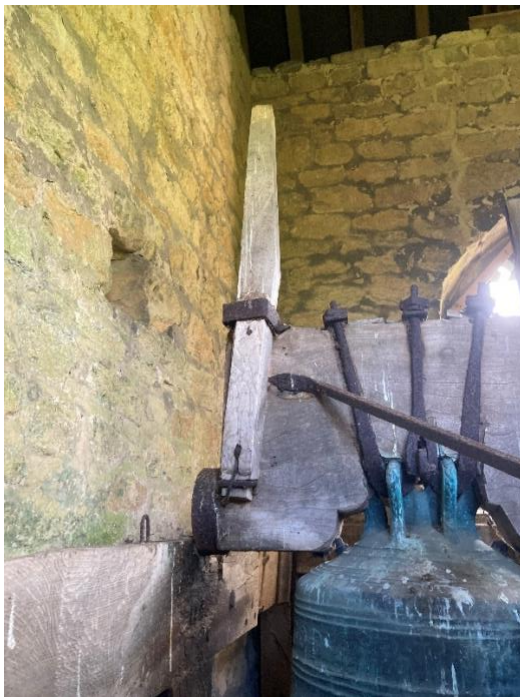
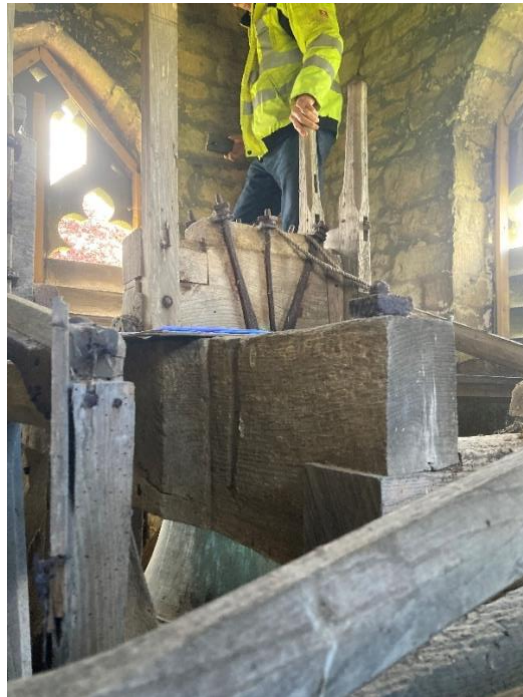
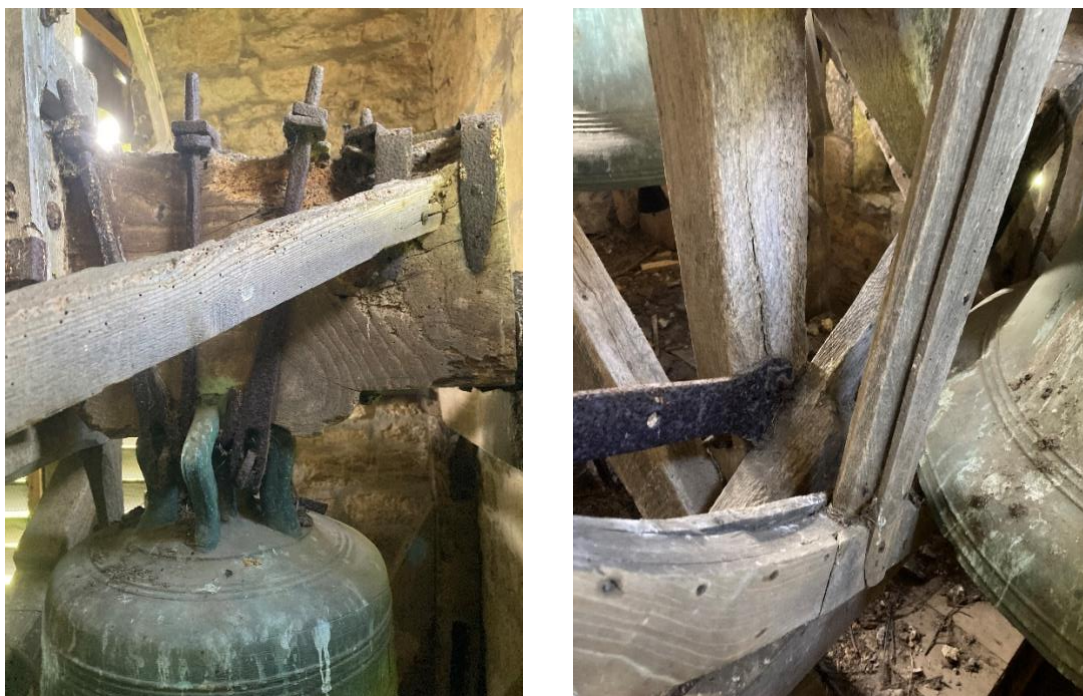
Fig 2: photos of the Bell Chamber, the bell frame, and bells.

The conditions of the bell chamber and the bell frame have been of concern for many years: see Fig 2 photos. The three bells have not been rung together in living memory although one bell is believed to have been rung up until more recent times. The three bells and their frame were inspected by Nicholson Engineering Ltd in 1997 and a report made on their age and

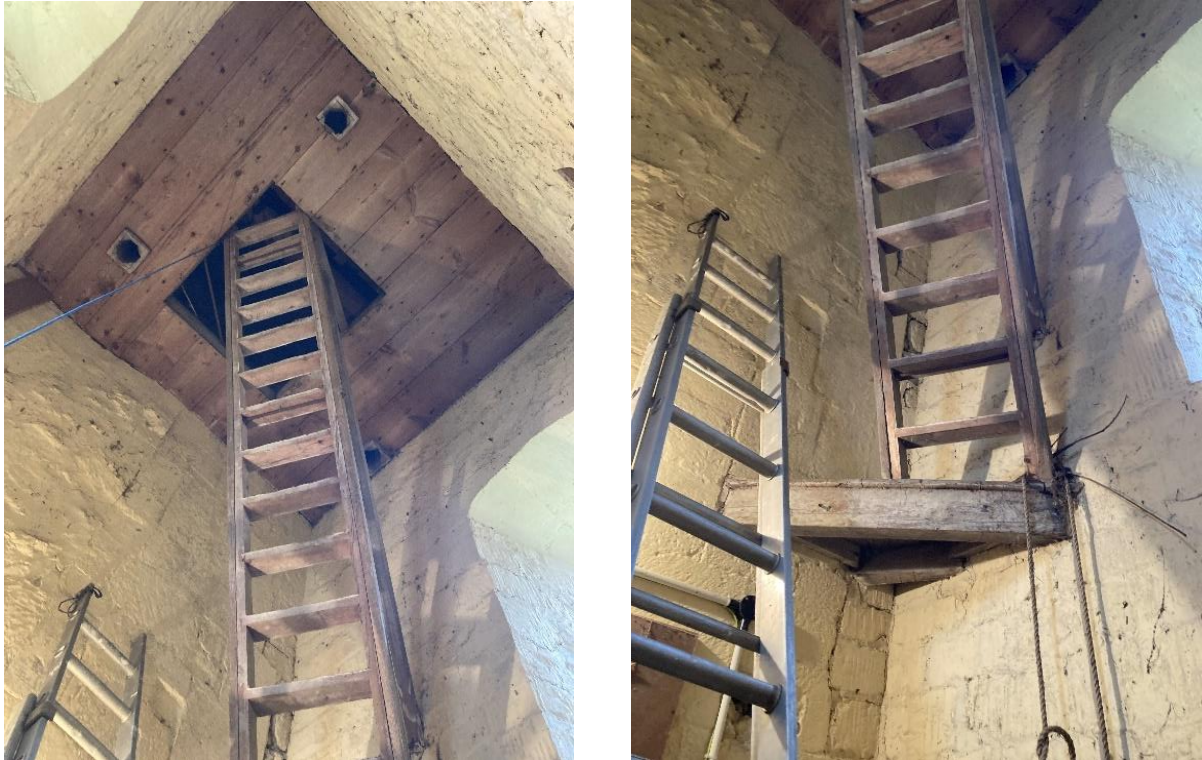
Fig 3: photos of existing access platform and fixed ladder to Sound Deadening Chamber

Also considered in the Phase II works is the improvement of access to the Sound Deadening Chamber and Bell Chamber from the ground floor of the Tower. At present the access to this level is by a fixed timber ladder set on a small timber platform located in the southeast corner of the tower about 2.7m above the ground floor of the tower. This platform is small, and the ladder and platform are in questionable condition: see Fig 3 photos below. An improvement in access would facility more regular and safer inspection and maintenance of the bell chamber. The proposal is to remove the existing platform and provide a larger timber access platform to the east end of the tower situated at the same level as the existing platform. A new fixed timber ladder can then be fitted with a straight rise to the existing floor hatch to the Sound Deadening Chamber. Guarding and handrails are also proposed to provide greater safety. A propriety aluminium 'loft' type ladder will be fitted to the north end of the new

3.2	Supply and install new fixed timber access ladder to Sound Deadening Chamber as shown on drawings. Include for handrail on inner (east) side of ladder as shown. To all be constructed from well-seasoned Douglas Fir. All fitting to be stainless steel.

3.3	Allow for £300 Provisional Sum for supply and installation of proprietary retractable aluminium access loft ladder to new access platform.	£300
3.4	Allow for repair and refixing of existing floor hatch to sound Deadening Chamber as shown on drawings. To include supply and fitting of new stainless-steel hinges and gas piston stay (110°) to existing timber hatch and new stainless-steel handrail to side of hatch opening. Include for removal of existing ferrous metal stay/handle to hatch opening.

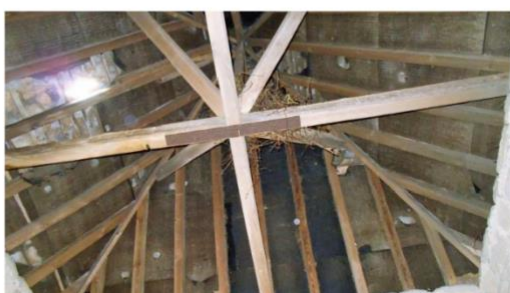
nesting jackdaw within timber beams

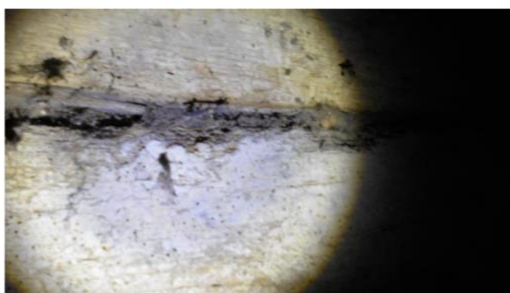
gaps in timbers of first floor with cobwebs
and nesting debris

2.02	Clear nesting debris from floorboards to the Sound Deadening Chamber and Bell Chamber.	
2.03	Once bells are removed allow for architect to inspect Bell Chamber floor and to schedule repairs to flooring to chamber.

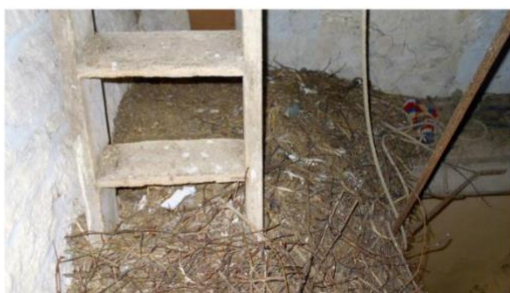
nesting debris within first floor of tower

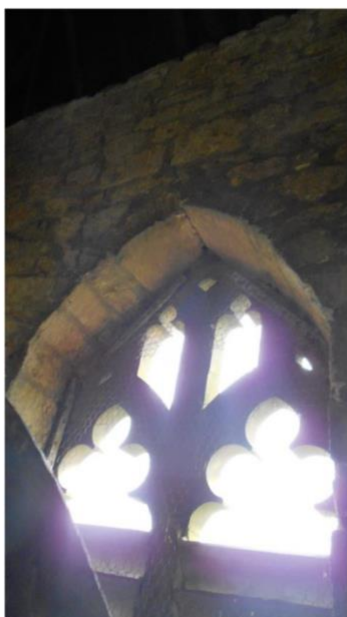
second floor window with missing wire mesh

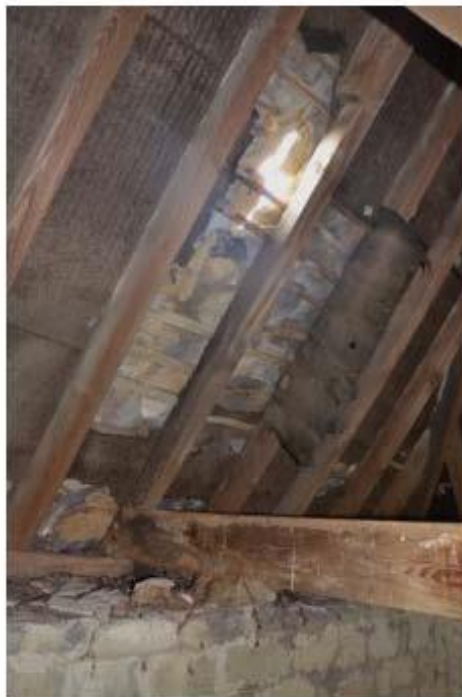
The roof is in a poor state of disrepair. There are tiles missing on the South quadrant, the felt is torn on every elevation and many timbers are rotten through to varying degrees. The apex of the roof, where the king post meets the hip blades and central rafters is extensively rotten through, which is undoubtedly compromising the structural integrity of the roof. It is quite probable that the lead detail beneath the Cross is unsatisfactory.

Fig.1: Leaking roof on the South quadrant

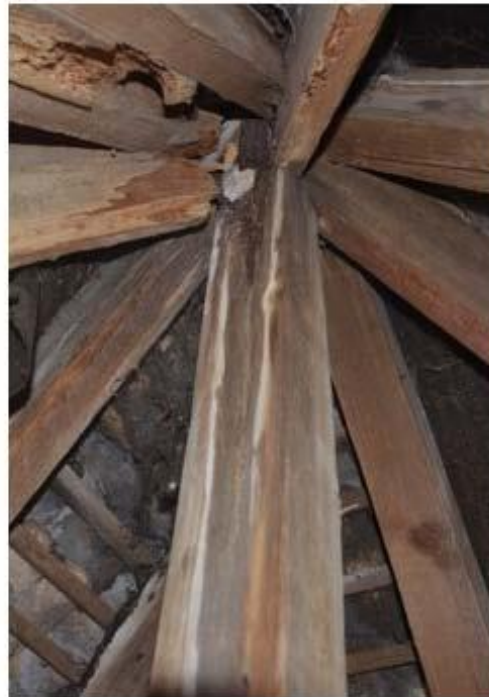
Fig.2: Extent of rot to roof apex

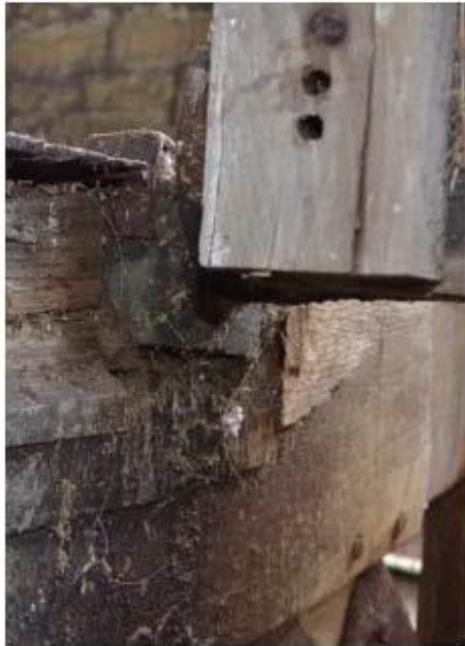
The condition of the bells, frames and floors do not appear to have changed significantly since the 1997 survey carried out by Nicholson Engineering. The bell frames are suffering from mild surface rot, however given the age of the timbers and the hardwood used should not be of concern. The headstocks and mountings of the bells however may benefit from restoration.

Fig. 3: Damaged bell frame below Second strap gudgeon

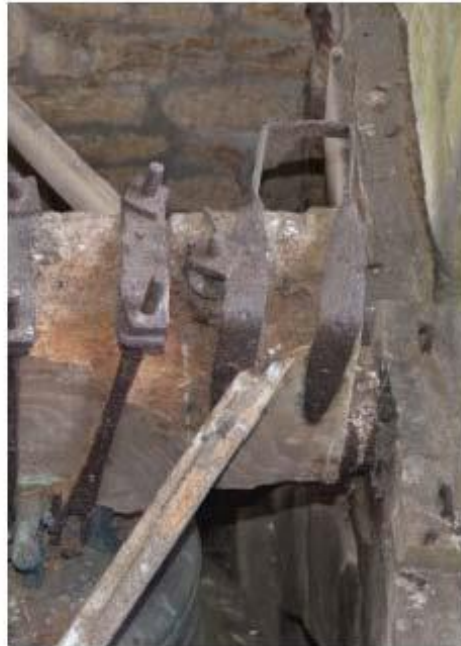
The headstocks are now generally in very poor condition, that to the treble being perhaps the worst with much serious rot at its north end. The headstock to the second shows more general decay and attack by wood boring insects. The headstock to the tenor is in only fair condition.

Fig. 4: Extent of rot to Treble headstock

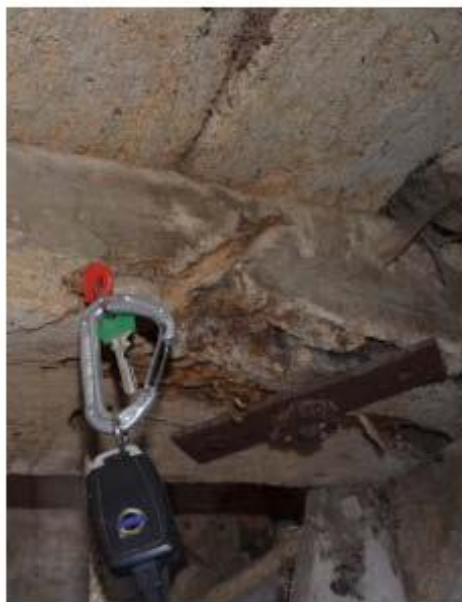
Accurate assessment of the floor of the bell chamber was clearer from below. The beams and floorboards are suffering from varying degrees of rot, ranging from decayed knots to mild surface pilling from woodworm. Following the defrassing of a couple of areas, we could ascertain that this rot ranged between 5 and 20 mm deep, even on the floorboards this may not be of concern given their thickness. The central beam is bearing onto wall plates approximately 100 mm wide, also suffering from woodworm, the South being in poorer condition than the North. Water ingress from the missing tiles on the South Quadrant is evident here and on the floorboards above. The East and West beams are bearing onto more modern corbels, (perhaps a Victorian addition) however the Northwest Corbel has approximately 25% missing on its West side, indicating movement at some stage. Iron bracing has been installed to tie the bell frames and beams together, however their efficacy is questionable. The bell chamber floor has a small area of relatively new repairs near the centre by the staircase, in the form of tansilised boards. The marginal nature of this repair suggests that the works applied for in 2004 were not granted.

Fig. 5: Extent of rot/decayed knots to Treble support beam

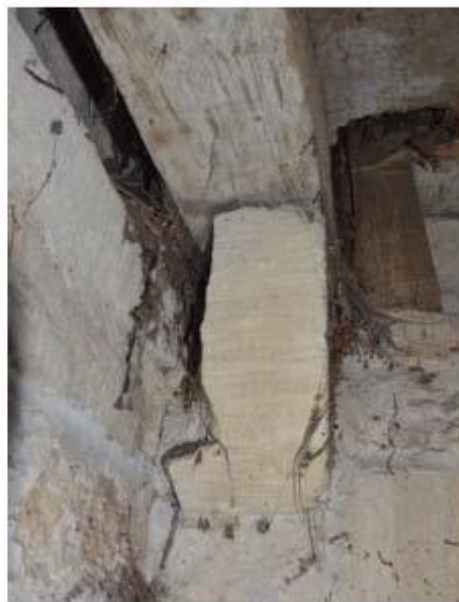
Fig. 6: Spalled corbel stone

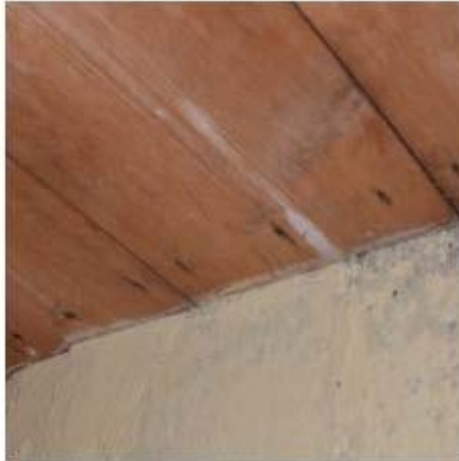
The ceiling boards are made from a high quality softwood, perhaps Pitch Pine. There is evidence of water ingress from above, in the form of salt residues on the edges and underside of the boards, however no significant rot is evident from below.

Fig. 7: Evidence of leaking on ringing chamber ceiling

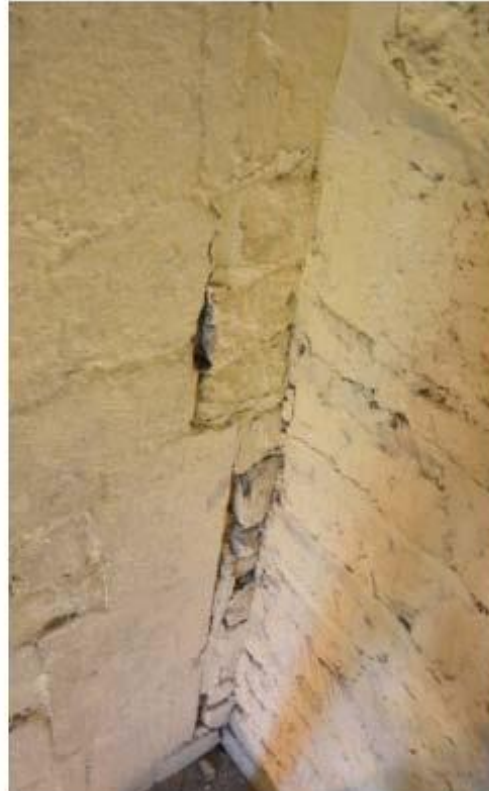
The pointing on all walls has the same tell-tale signs of wet mortar being used in construction, however no structural integrity has been compromised as with the infill area in the middle chamber. The mortar in the window infill behind the ladder has fallen out, however this doesn't appear to be of structural significance.

Fig. 8: Loose mortar around window infill on East wall of ringing chamber
