A27 East of Lewes Improvements

PCF Stage 3 – Preliminary Bat Roost Assessment Report

March 2019

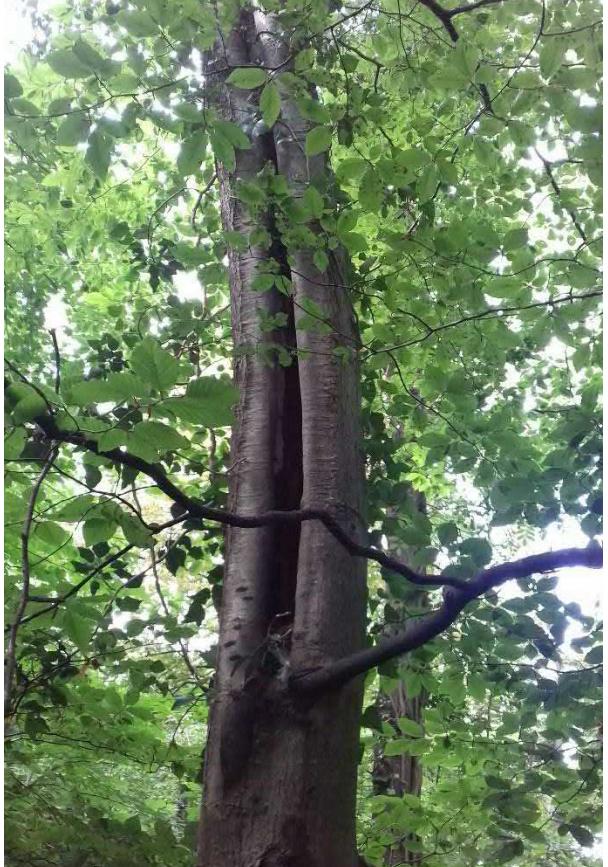
| TREE/GROUP NUMBER | OVERALL SUITABILITY CATEGORY | PHOTOGRAPHS |
|---|---|---|
| T152 | High | |

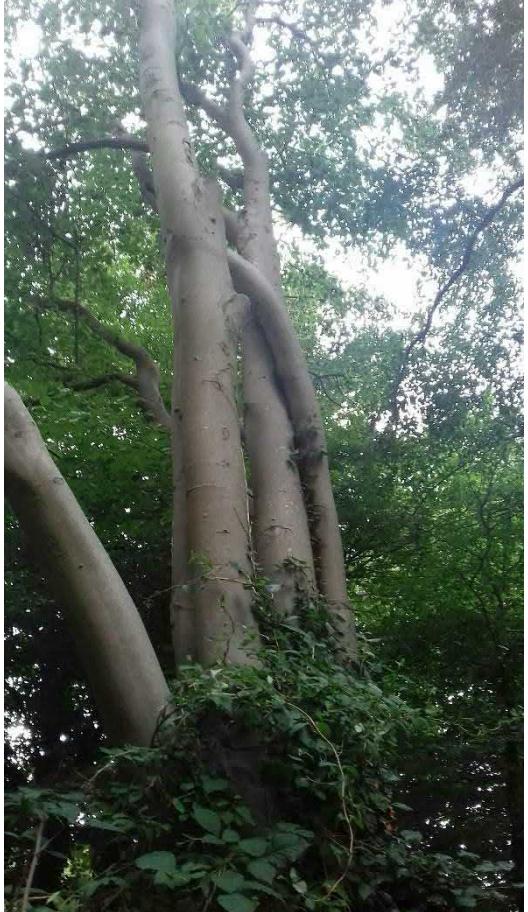
| TREE/GROUP NUMBER | OVERALL SUITABILITY CATEGORY | PHOTOGRAPHS |
|---|---|---|
| T178 | High | |

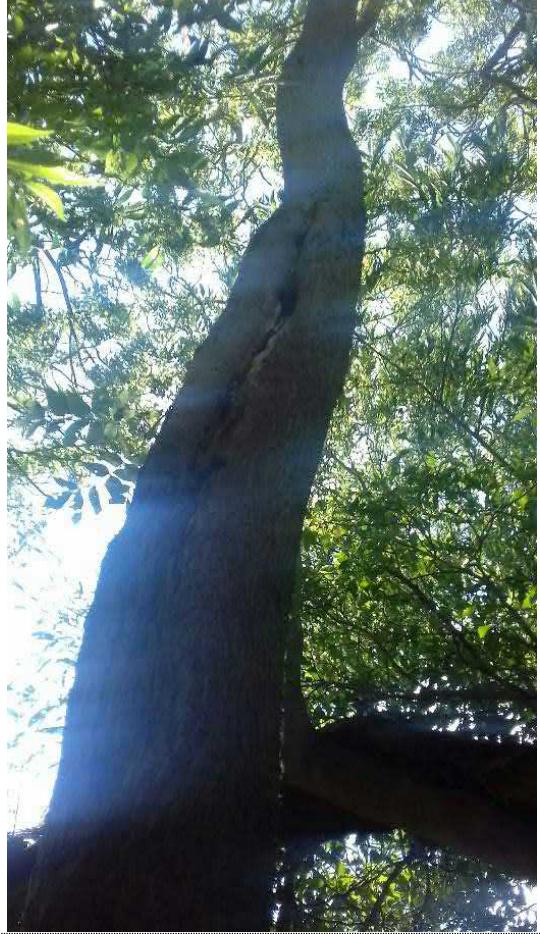
| TREE/GROUP NUMBER | OVERALL SUITABILITY CATEGORY | PHOTOGRAPHS |
|---|---|--|
| G6 | High | |

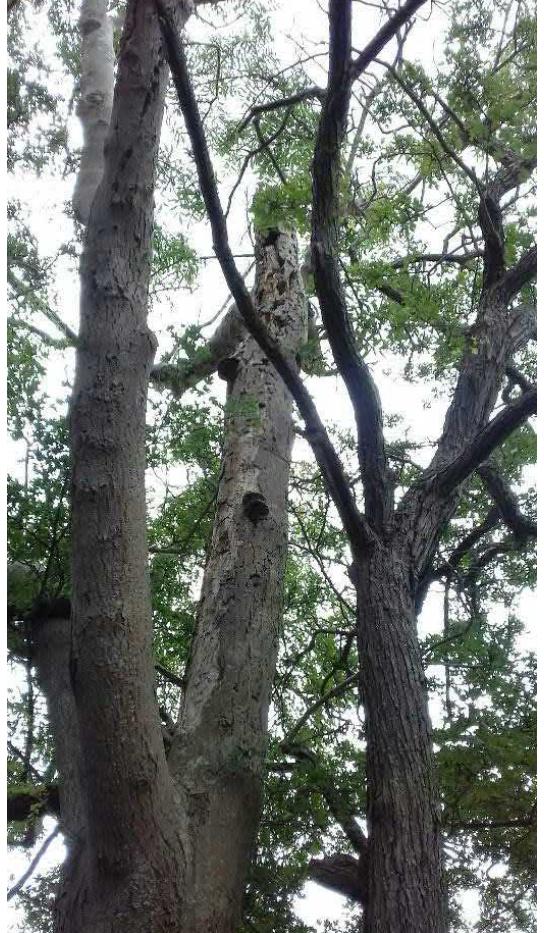
| TREE/GROUP NUMBER | OVERALL SUITABILITY CATEGORY | PHOTOGRAPHS |
|---|---|--|
| G12 | High | |

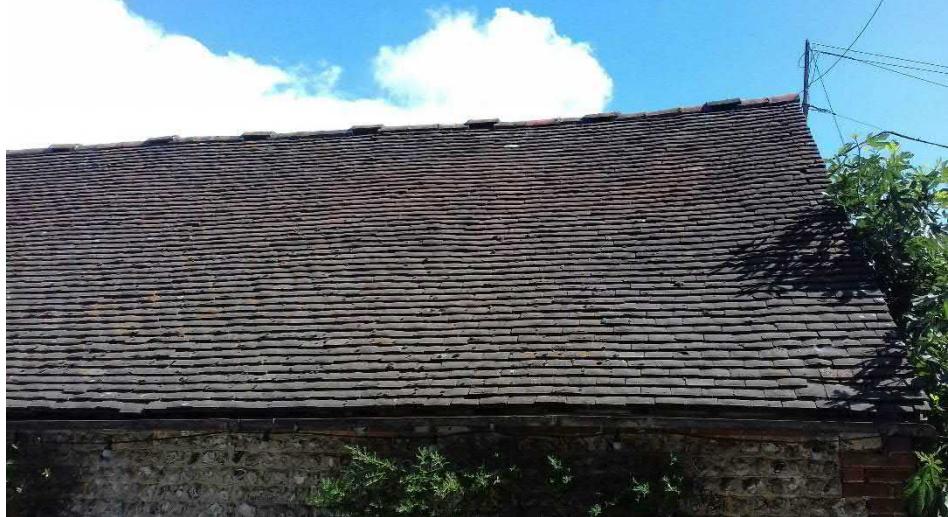
| BUILDING/ STRUCTURE No. | OVERALL SUITABILITY POTENTIAL | PHOTOGRAPH |
|---|---|--|
| B1 | High | |

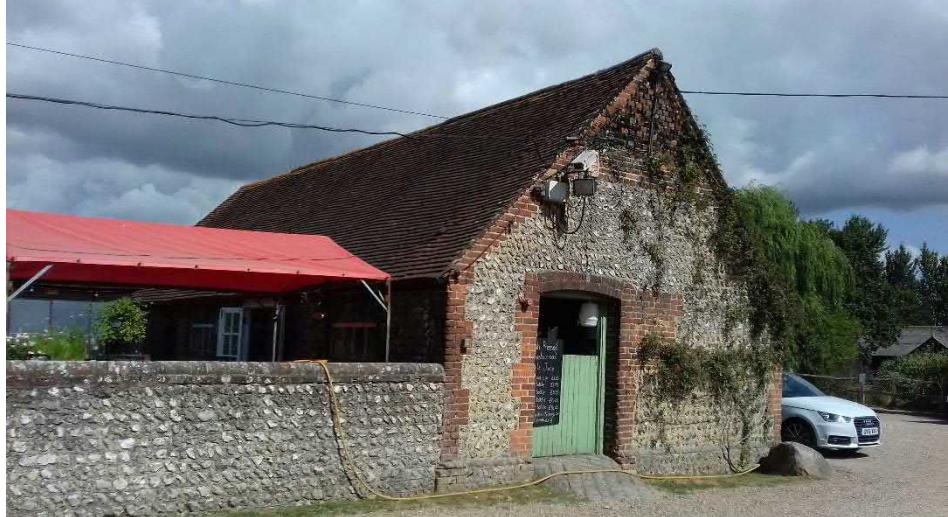
| BUILDING/ STRUCTURE No. | OVERALL SUITABILITY POTENTIAL | PHOTOGRAPH |
|---|---|--|
| B2 | Moderate | |

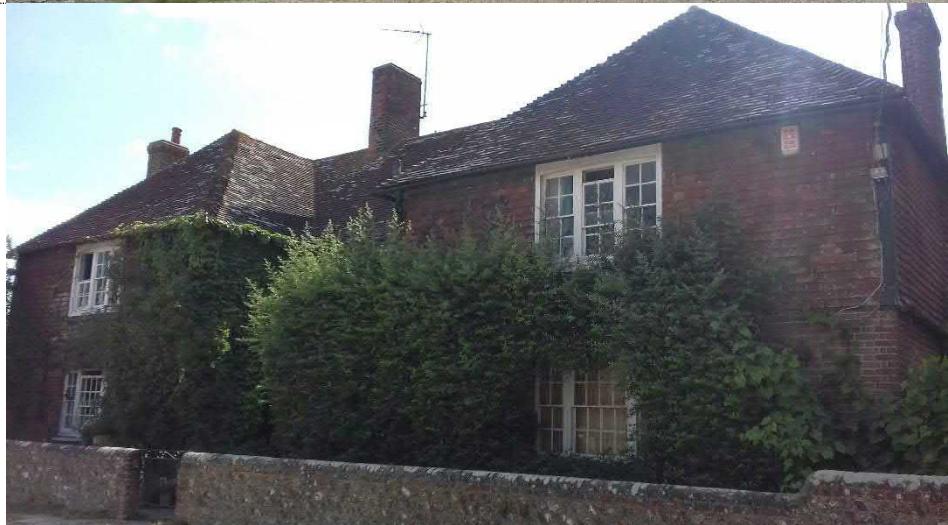
| BUILDING/ STRUCTURE No. | OVERALL SUITABILITY POTENTIAL | PHOTOGRAPH |
|---|---|--|
| B3 | High | |

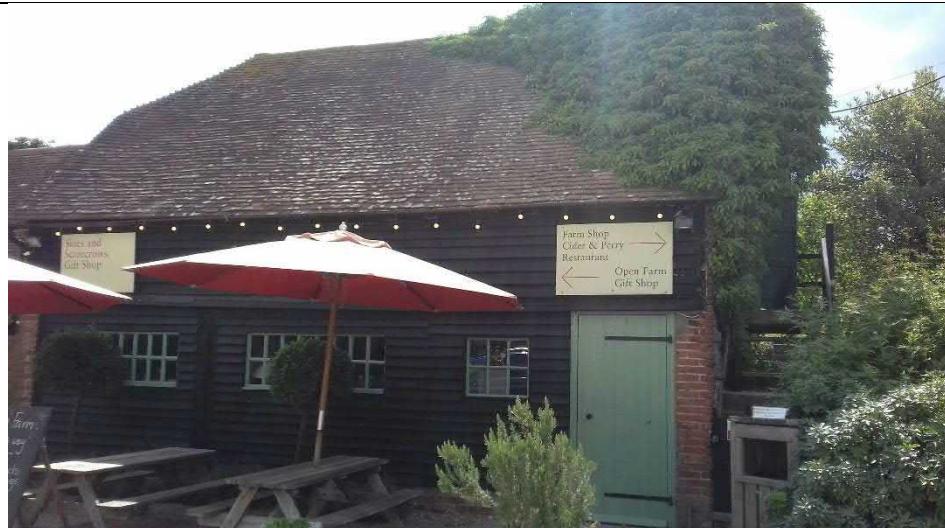
| B4 | High | |

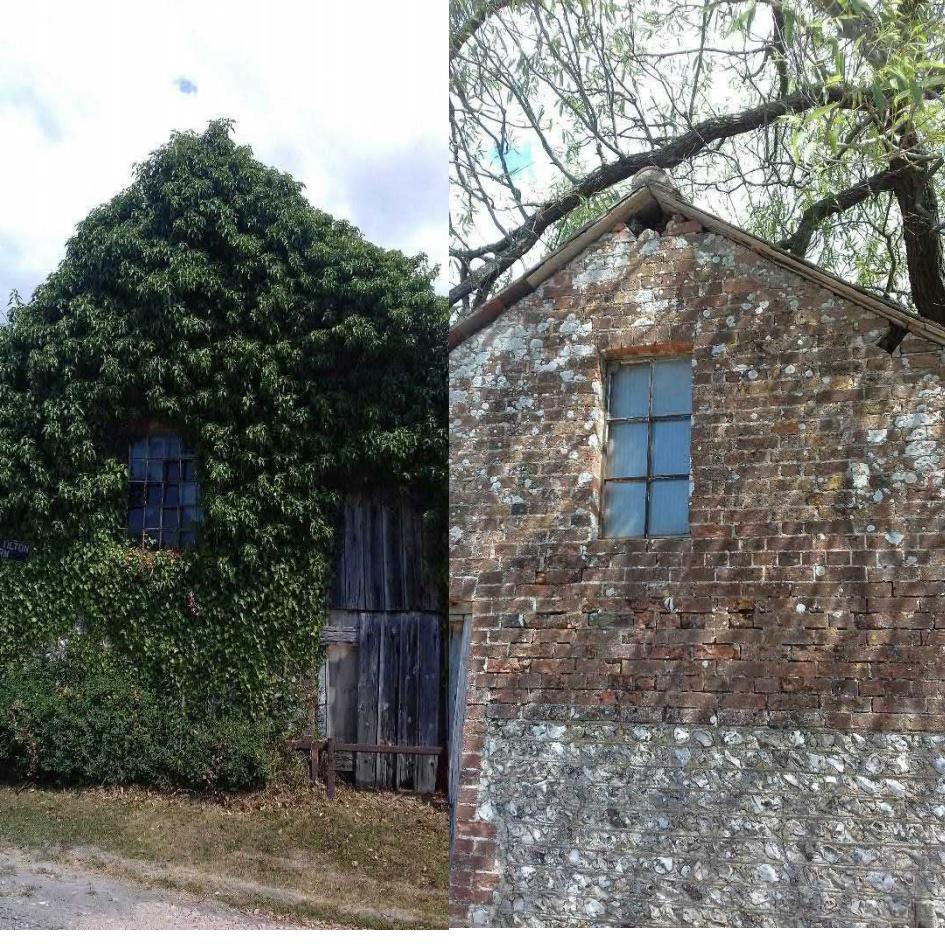
| B5 | High | |

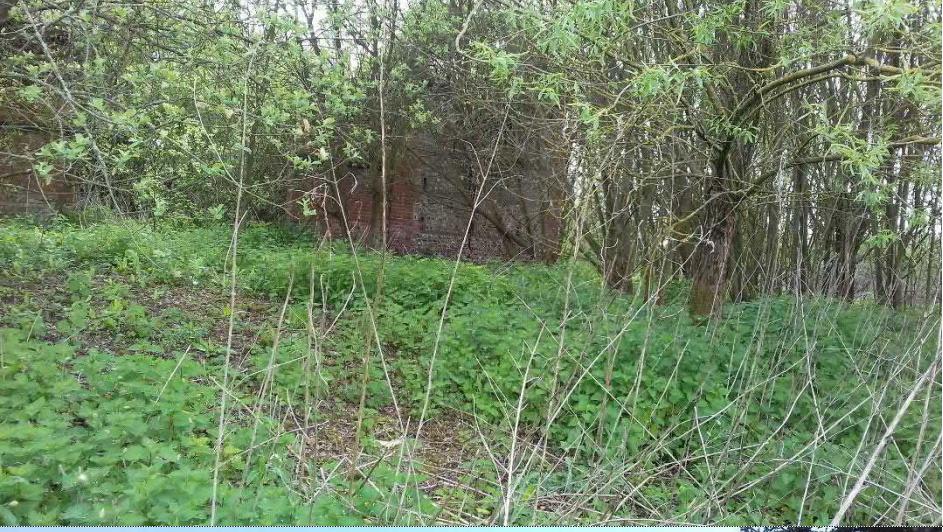
| B6 | Low | |

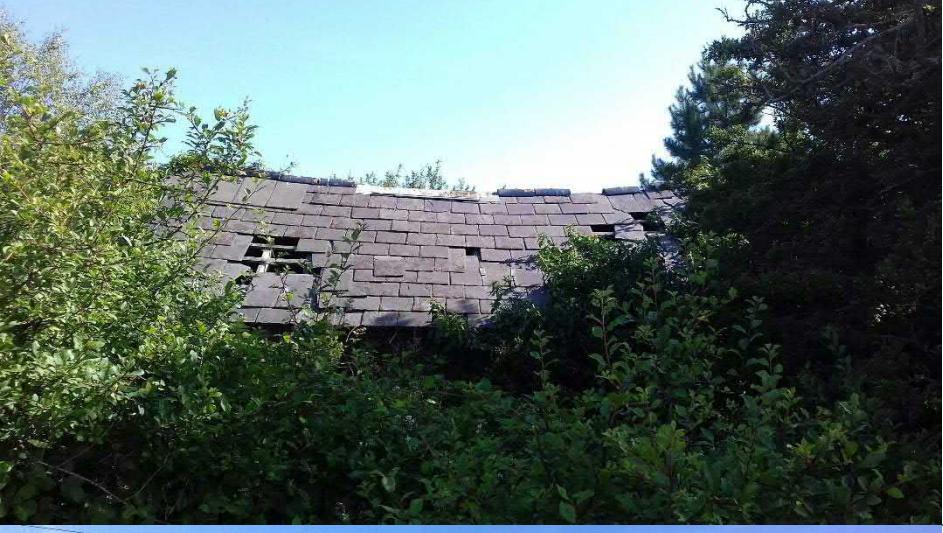
| B7 | High | |

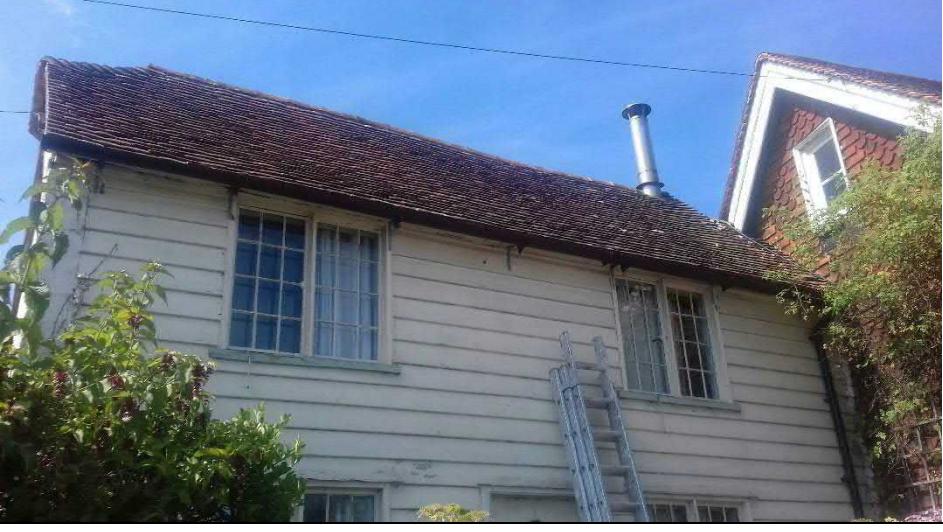
| B8 | Moderate | |

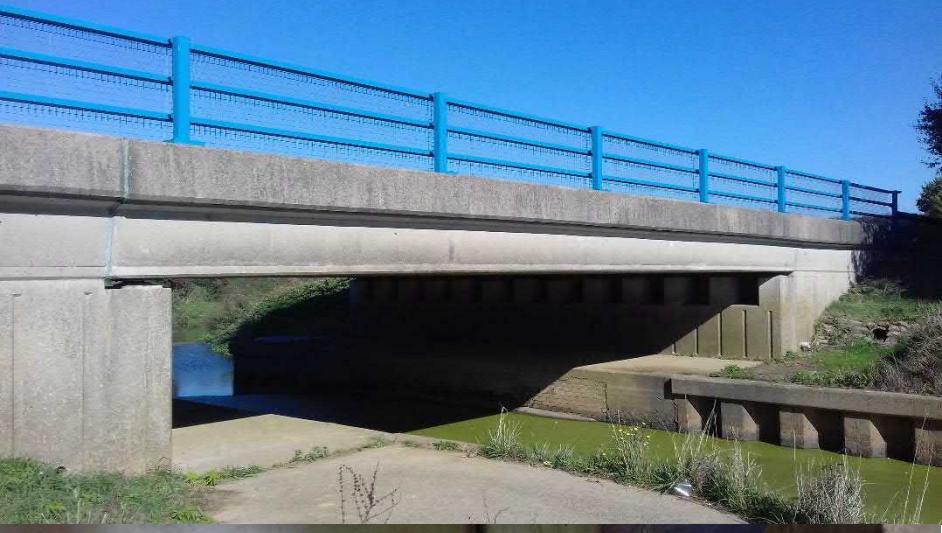
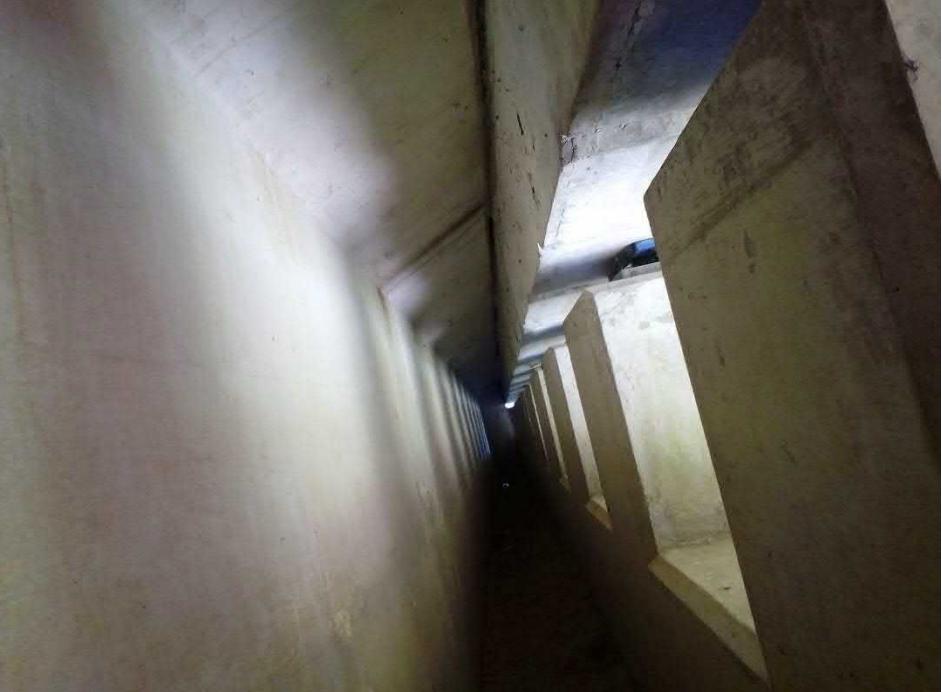
| S1 | Moderate | |

5.2.9 It is recommended that a secondary inspection of PRFs within the Cuckmere bridge (S1) and the culvert (S2) is undertaken to confirm the assessment of their suitability for supporting roosting bats. The Polegate railway bridge (area 12 as detailed in Table 2-2) will require a PBRA to establish if it has bat roosting potential, as the structure could not previously be surveyed and will be directly affected by the Scheme.
