Improving Stability of Emergency Traffic Management Signs

CPR1003

CLIENT PROJECT REPORT

Client: Highways Agency, National Health and Safety Team

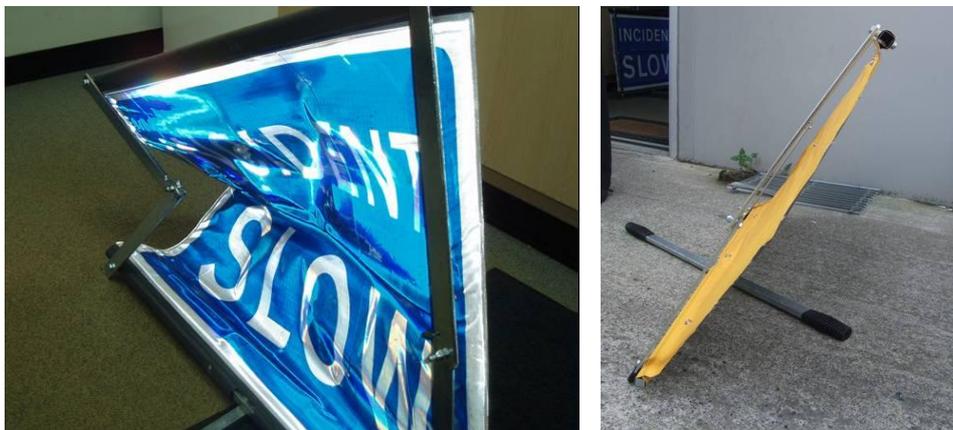
Figure 1: Figure 1: Typical problems: collapsed side arm (left) and weak base pivot joint (right)

Collapsing side arms was the most common problem reported, and Traffic Officers felt that this represented a serious safety concern due to the following reasons:

The problems from signs being blown over were therefore identified from failure mode analysis. This showed that weaknesses at both the base rail/support strut joint and the manufacturing detail of the side arm mechanism were the cause of failures. Other construction details meant that the sign fixings would not stay at the correct tension during use.

The second cause of signs failing was the folding side arms not remaining in position once the sign is deployed. Examination of signs showed that, while earlier signs used a 'peg', later signs used a cut-out in one of the arms and a folded 'tab' on the other. However, it was identified that the cut-out was not deep enough to allow the side arm joint to go sufficiently over-centre and so remain stable.

As those two causes of the two main stability issues were identified very quickly, it was decided to create a prototype sign to examine whether these changes would help to overcome the stability problems. The modifications incorporated were:

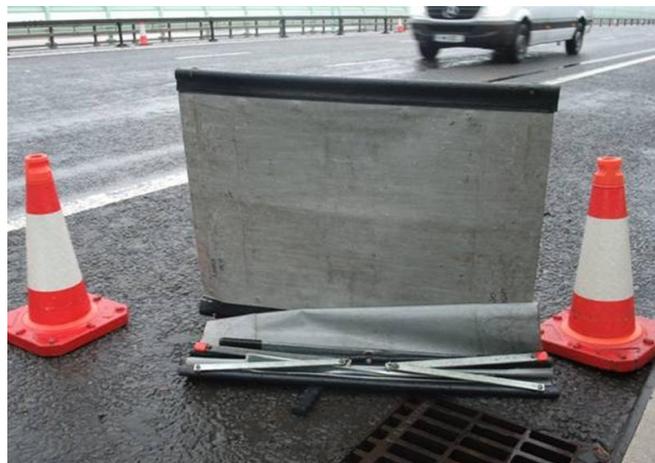
Figure 2: ETM, with rolled sign used to aid stability

The stability problems were most commonly dealt with by the Traffic Officers using ballast weights on the sign to stop them moving or falling over. Ballast used was either spare cones or spare signs, as shown in Figure 2. The cones tended to be used one on top of the other (up to five at a time) on the bottom supporting arm. When asked whether this method of overcoming the problem was effective it was generally thought to be effective. One Traffic Officer stated that it was:

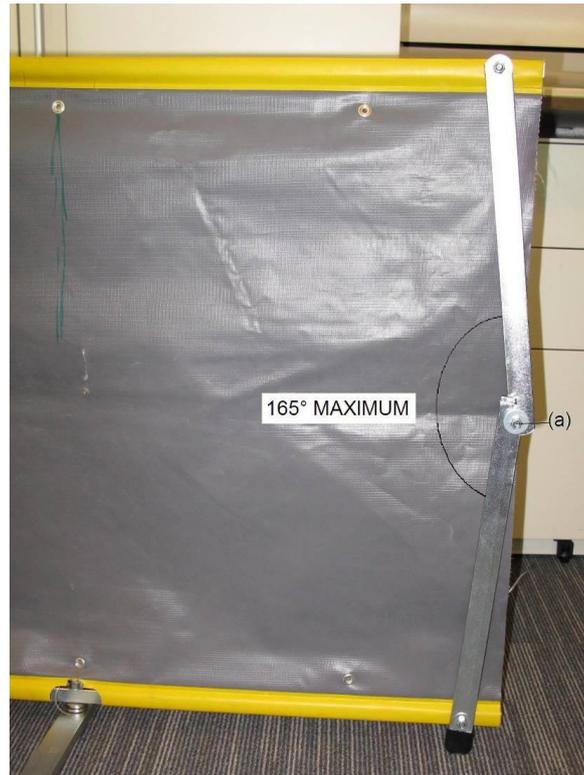
Figure 3: Modified sign, identifying key dimension for side arm, and showing modified base pivot with spring washers

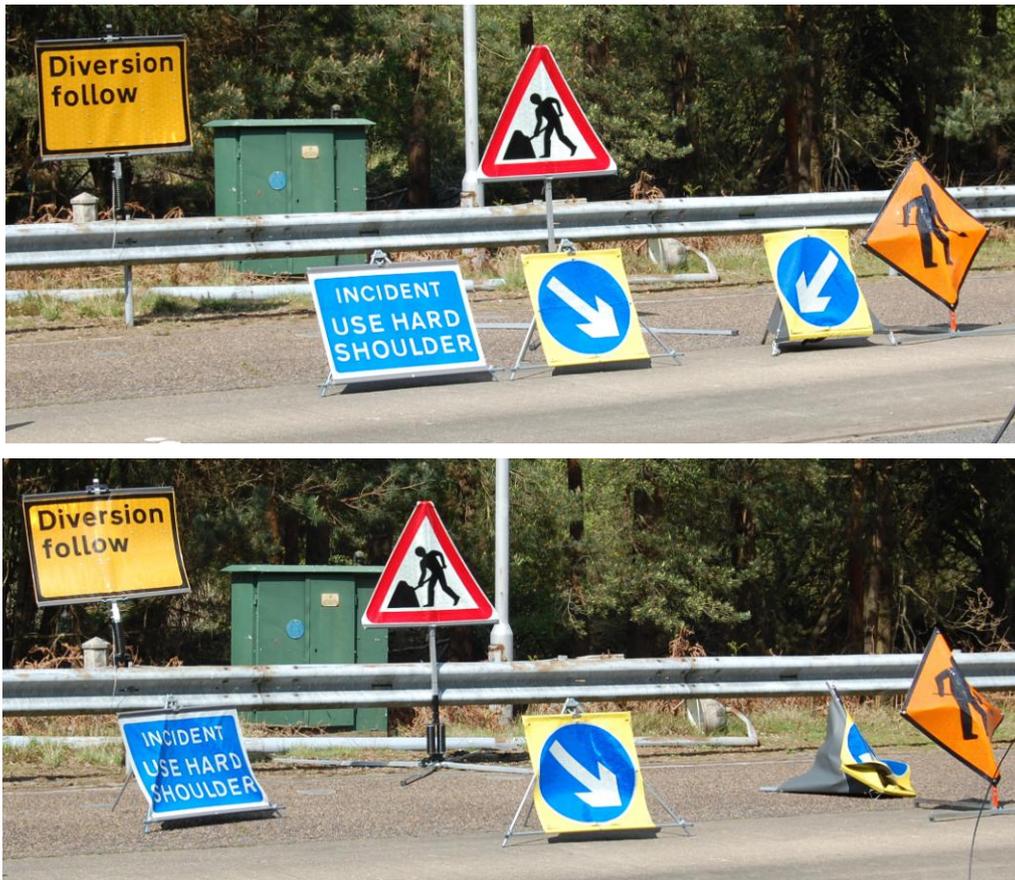
Figure 4: First set of signs, before and during wind testing

During the testing of first set of signs, peak wind speed reached 58mph. The pyramid sign with additional square sign face blew over at about 40mph.

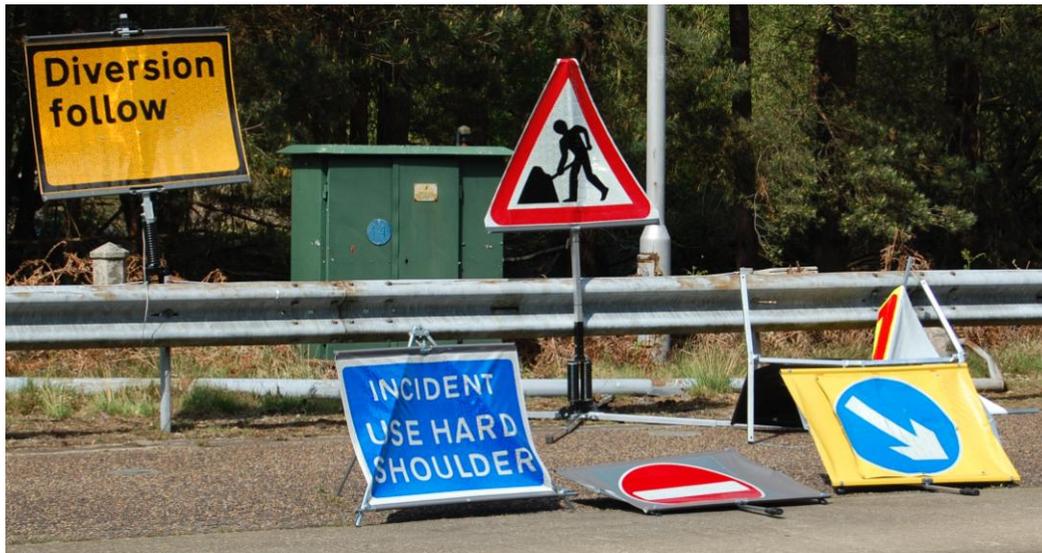
Figure 6: Second set during wind testing (note: TRL prototype moved during test to fill space left by blown-over 'Ambulance' sign)

During the second test, the green 'Ambulance' sign blew over at about 25mph. Peak wind speed reached 45mph on the calibrated anemometer, which was tripod-mounted and so positioned higher than the signs; at the level of the signs, wind speeds reaching 60mph were recorded using a hand-held anemometer. The TRL prototype sign (yellow rectangle) was moved into the 'Ambulance' sign's position after its collapse. The grey rectangular sign visible was a modified Highway Stand, with improved side arms, but with a rubber block in place of the Belleville spring washers specified at the support rail pivot (the correct washers were not available in time for testing). As a result, the pivot bolt bent during the test.

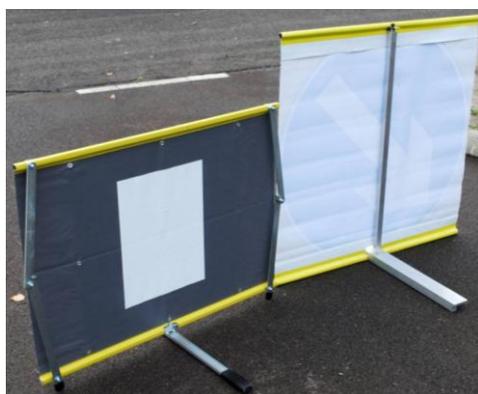
Figure 13: Modified version of current TOS sign (left), TRL designed "T-strut" rigid aluminium 900mm high prototype (right)

Rigid sign performance was significantly worse than the current TRL modified sign as it was difficult to set up in windy conditions. It slid before it toppled, confirming its design principle, but it toppled at a lower speed than all other signs.

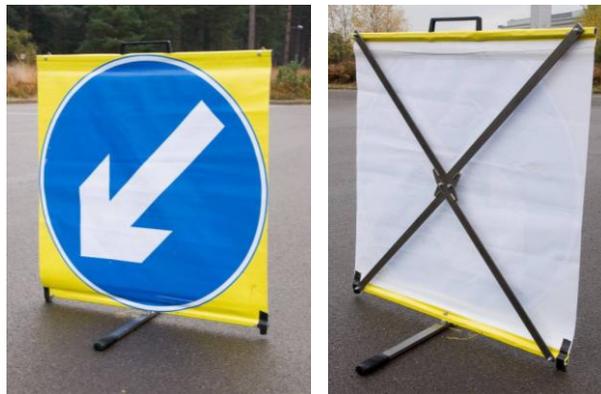
The “X-sign” performance was similar to that of the current TRL modified sign. This sign was also the quickest and easiest to set up in windy conditions and was the design most favoured by all the operational Traffic Officers and Trades Union representatives who reviewed the signs during the project.

Figure 14: TRL designed “X-sign” 900mm high prototype, front and rear views

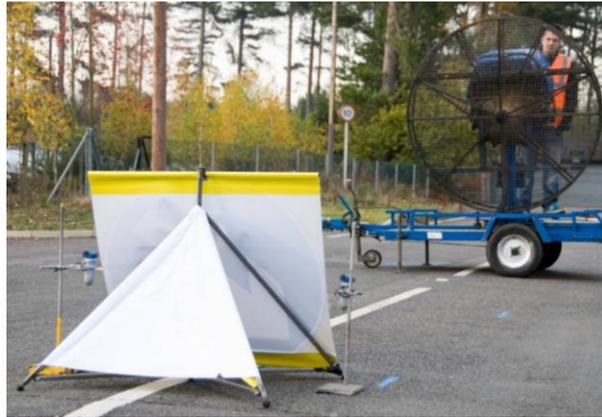
The pyramid sign proved very stable when the air flow was incident on the sign face. However it was difficult to set up in windy conditions and both slid and toppled when turned 180° so that the air flow was directed onto the rear of the sign.

Figure 15: TRL designed “Pyramid Sign” prototype during wind testing

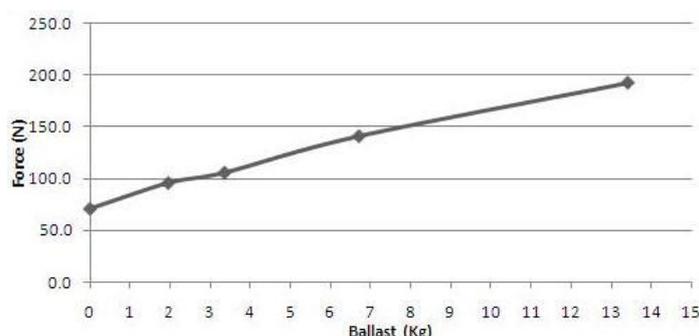
Figure 16: Effect of additional ballast

Unsurprisingly, these results show that increasing the ballast causes a proportional increase in the force required to move the sign. The small variations in the graph are probably a result of variations in the surface texture. Increases in sign resistance to motion as extra signs are added are not linear, as additional signs are put further from the centre of the sign support, which provides a reduced additional benefit from each extra rolled sign added.
