## **CLIENT PROJECT REPORT CPR2874**

### Forensic Examination of Critical Special Geotechnical Measures: Gravity Block Wall Information Note

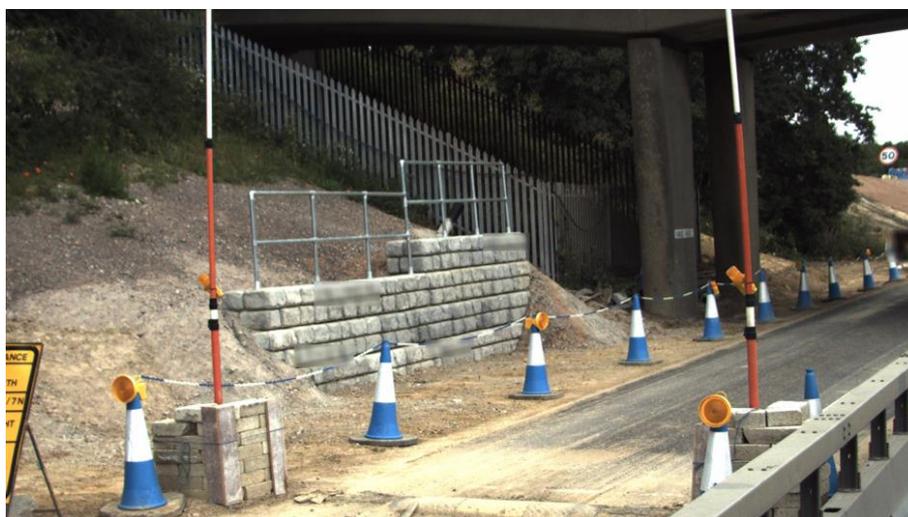
**Figure 1. Modular Block Wall on M23 J9 (©AVIS)**

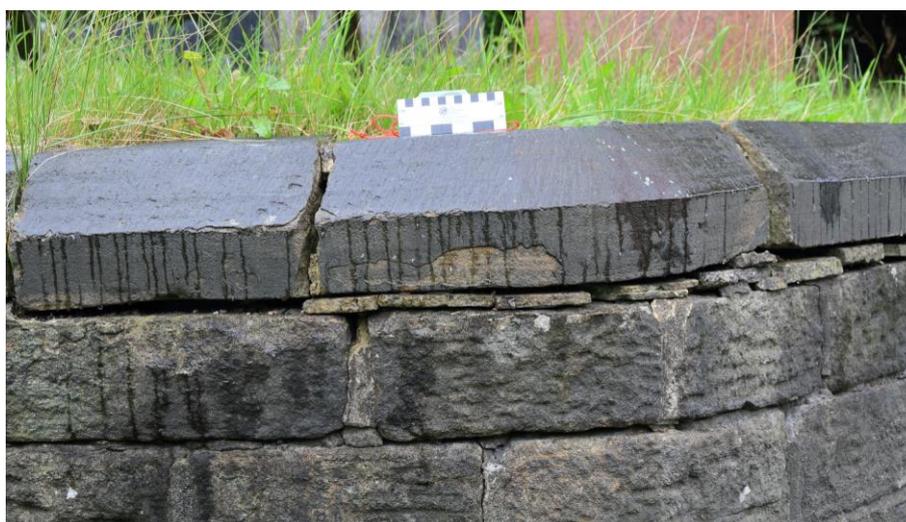
Deterioration of the upper courses was observed as was similar deterioration of the lower courses. The top course deterioration appears to be a result of surface water and/or direct precipitation and vegetation and, in most instances, this was accompanied by a loss of mortar (where present) (Figure 2). Deterioration of the lower courses could be caused by a build up of groundwater behind the wall and/or salt spray affecting the roadside face (Figure 3).

**Figure 2. Deterioration and mortar loss of the top course of a stone block mortared retaining wall (A628, SGM 8885 [unique SGM code from Atkins/Jacobs, 2020], October 2020)**

**Case study 3:** Mortared stone block retaining wall up to 1.65m high (A628, SGM 8885, Figures 2 and 7) The wall shows signs of bulging, leaning and deterioration (including mortar loss) of top course as well as potential changes to the asset alignment. The anomalies to the alignment of the courses relative to absolute level and road level are a cause for concern along with the lack of drainage to the roadside wall that retains the local cemetery. Further, potentially intrusive, investigation of this wall is recommended.

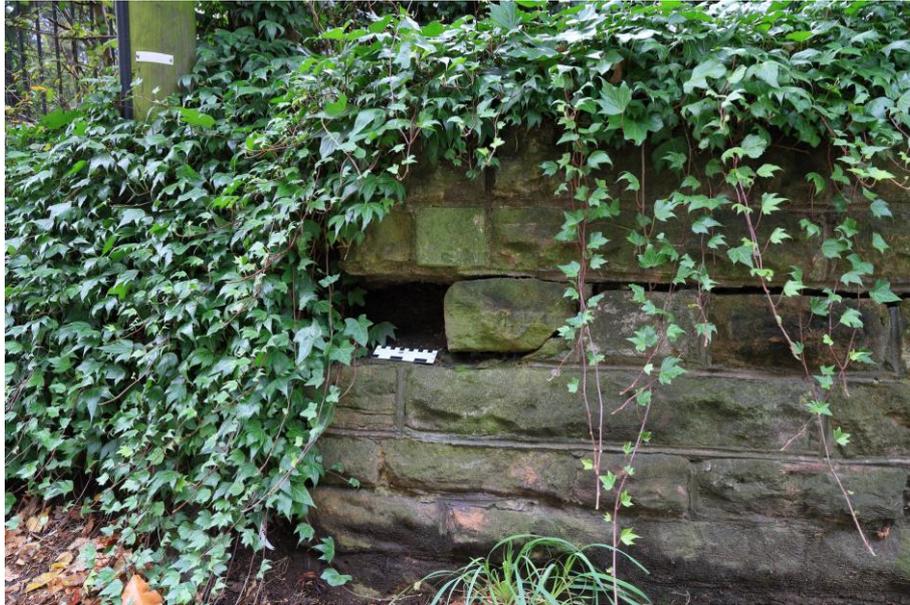
**Figure 3. Deterioration of the lower courses of a stone block mortared wall seems most likely due to salt spray. The deterioration of this wall at this location is through the full height with the loss of block(s) in the central area (A52, SGM 9676, October 2020)**

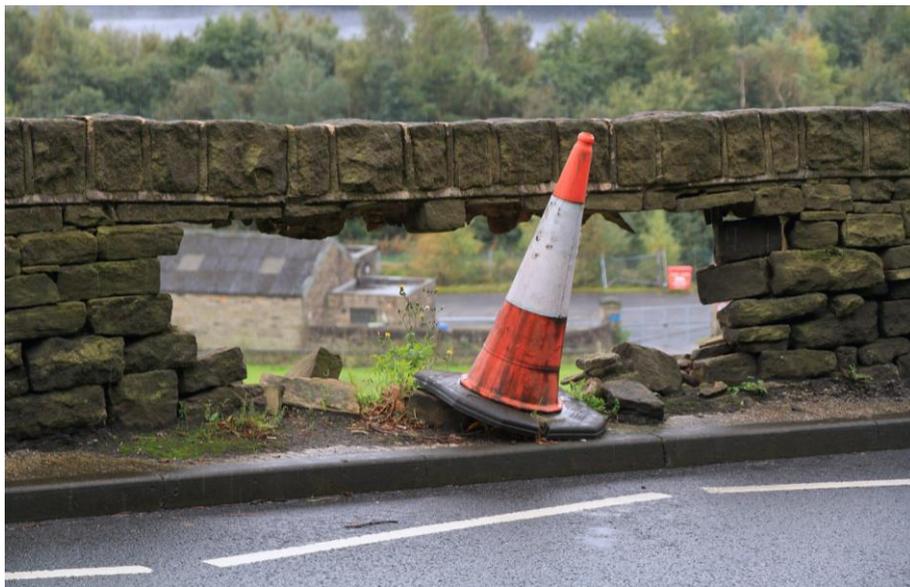
**Figure 4. Upper free-standing part of a dry stone retaining wall (mortared coping) showing the effects of vehicle impact. The wall below the carriageway retains a height of between 2m and 3m below the road. (A628, east of SGM 8885, October 2020)**

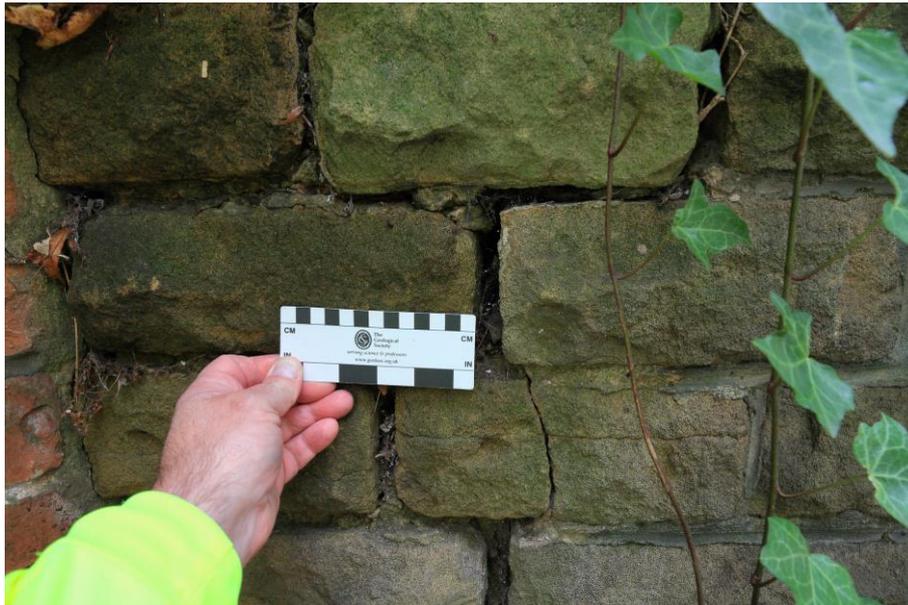
Cracking of blocks and mortar (Figure 5), bulging and leaning (Figures 6 and 7) were all observed during the site inspections. Sagging and hogging of a modular concrete block (mortar free) 'Porcupine'-type wall can also be observed in Figure 8.

**Figure 5. Cracking of stone block mortared wall (A52, SGM 9676, October 2020)**

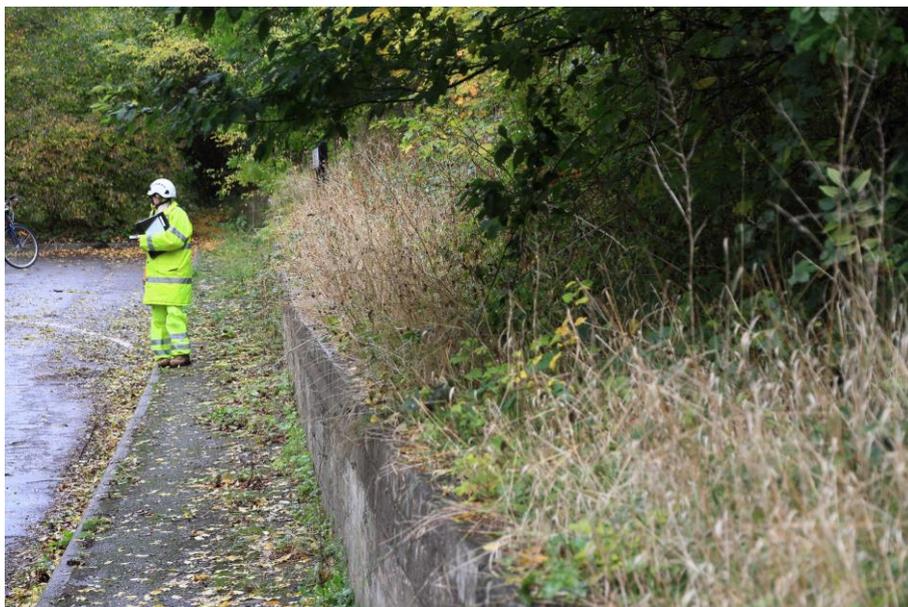
**Figure 6. Bulging and leaning of a concrete block mortared retaining wall approximately 0.9m high along base of embankment (A52, SGM 7825, October 2020)**

**Case study 1:** Mortared concrete block retaining wall, approximately 0.9m high along base of embankment (A52, SGM 7825, Figures 6 and 9). This wall shows signs of cracking, leaning and bulging. However, the complete failure of the wall is likely to cause only minor failure of the embankment but it is considered that this is unlikely to cause immediate damage to the road and/or vehicle restraint system and that it can be managed as and when it occurs.

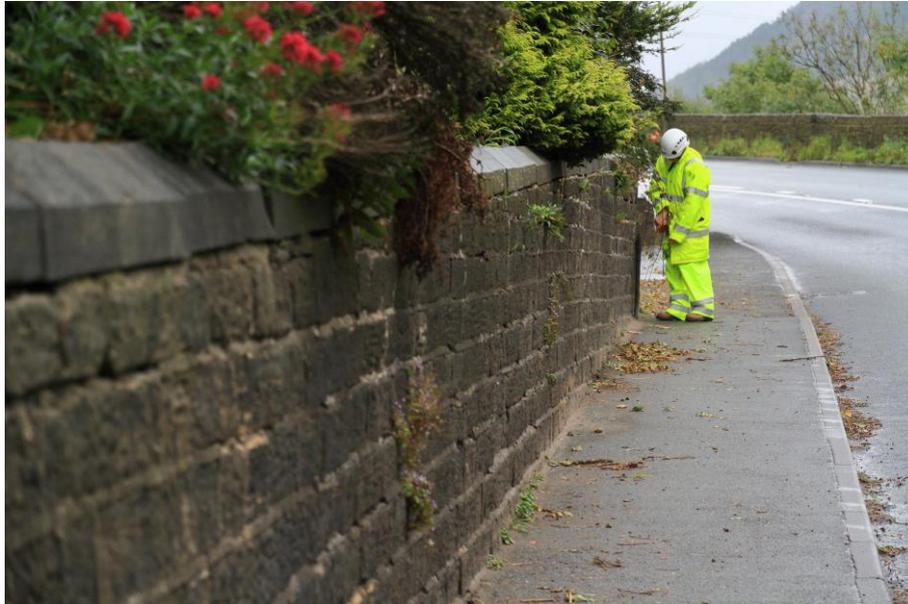
**Figure 7. Leaning stone block mortared wall of approximate height 1.65m. Signs are also evident of bulging and deterioration (including mortar loss) of the top course. Note the change in angle of the masonry courses, the angle between the courses and the coping stones and the vertical alignment of the highway (A628, SGM 8885, October 2020)**

The wall illustrated in Figure 7 is a good example of this wider applicability; while it is far from clear what the sequence of events may have been, it does appear that the lower part of the wall has been buried and the upper part of the wall (which may originally have been free-standing rather than having to perform as a retaining wall) has been removed. The burial of the lower part of the wall may explain the lack of weepholes on the carriageway side (weepholes were present on the side return of the wall).

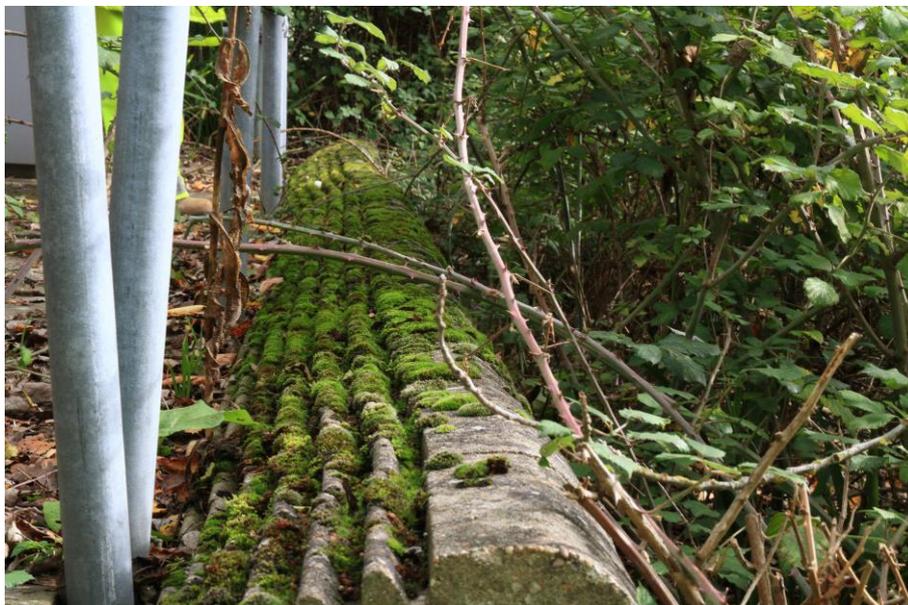
**Figure 8. 'Porcupine' modular concrete block wall showing signs of hogging, sagging and bulging. The wall is located in the middle of a slope showing significant signs of instability (A1307 (formerly A14), above SGM 6082 (Gabion wall), October 2020)**

**Case study 4:** 'Porcupine' modular concrete block wall (A14, above SGM 6082 (Gabion wall), Figure 8). This wall shows signs of hogging, sagging and bulging. While in isolation these are not cause for concern, wider observation of the slope on which the wall is situated reveals that the slope is showing significant and long-term signs of movement and that further investigation is necessary (Figure 16).

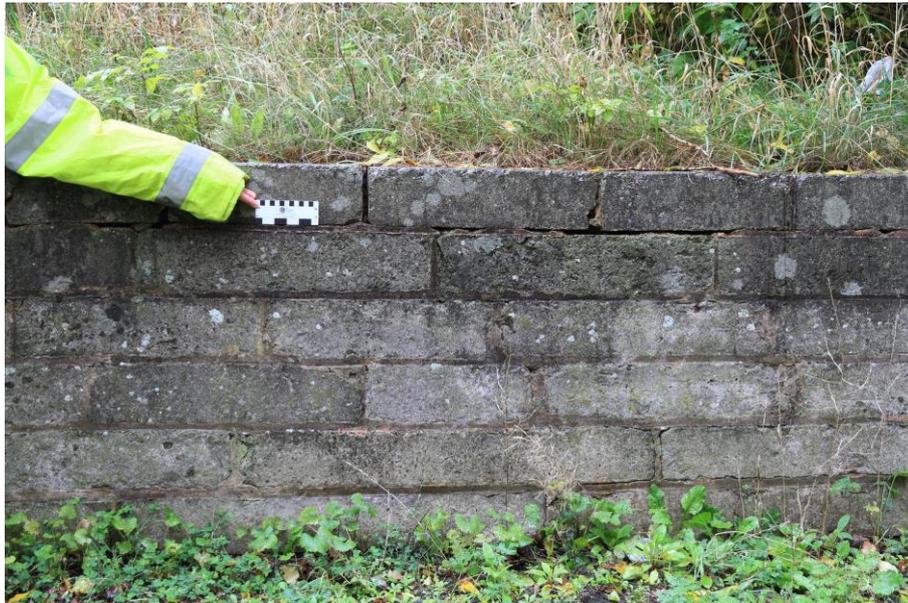
During the site inspections it was found that the provision of weepholes to Block Walls was relatively uncommon. Figure 9 illustrates an example in which there are no weepholes and seepage through the wall can be observed indicating a likely lack of adequate drainage behind the wall. Notable instances in which weepholes were visible are shown in Figures 10 and 11. In addition, no instances of a vertical drainage layer behind the wall being used were noted, although this can be difficult to identify and confirm without significant and invasive excavation. Where weepholes were observed these generally appeared to be working although in Figure 10 the washout of gravel particles may indicate that construction materials are also being washed out, indicating that there may not be a suitable filter / separator in the

**Figure 9. Mortared concrete block retaining wall, approximately 0.9m high along base of embankment showing signs of bulging, leaning and deterioration of top course (A52, SGM 7825, October 2020)**

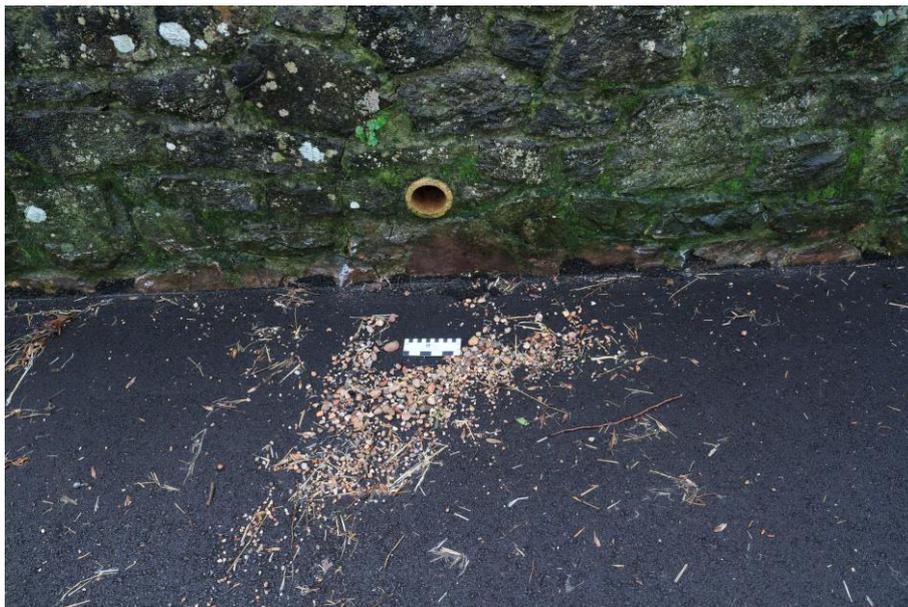
**Figure 10. Weepholes (80mm internal diameter at 6m centres) in a 789m long, 0.75m high stone block mortared wall. The gravel particles in front of the wall appear to have been washed out of the weepholes indicating that they are functional but possibly washing out material that forms part of the construction (A30, SGM 1306, January 2021)**

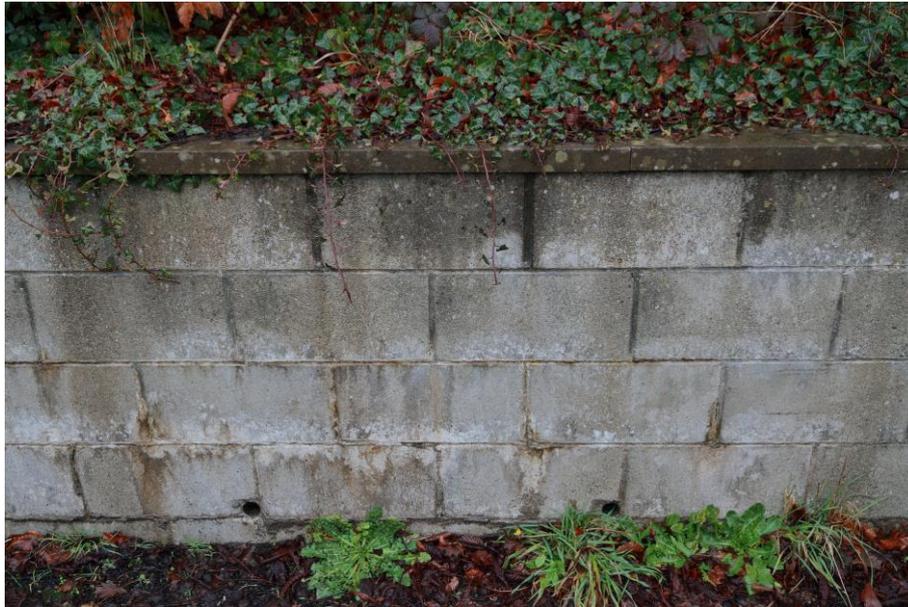
Significant evidence of what appears to be efflorescence was observed at one site (Figures 11 and 12). Efflorescence is formed by soluble salts being drawn out of blocks and concrete by the effects of water including, for example, condensation, rain, snow, dew, spray and the drainage of water through the wall. Efflorescence in and of itself is not generally an indicator of long-term durability issues it can be unsightly. While such aesthetic concerns are unlikely to be an issue on most of the SRN there may be some areas where it does create aesthetic

Notwithstanding the foregoing, efflorescence may lead to osmotic effects causing water to migrate towards salts to reduce its concentration creating potentially large hydrostatic pressures within the block and subsequent spalling.

**Figure 11. Weepholes (50mm internal diameter) in a 57m long, 1m high concrete block wall. The weepholes were observed to be functional, and what appears to be efflorescence was observed in the blocks and mortar (A38, SGM 10857, January 2021)**

**Case study 5:** Concrete block mortared wall where efflorescence is evident in both the blocks and the mortar (A38, SGM 10857, Figures 11 and 12). Efflorescence can be an aesthetic concern in areas accessible to the public and in such cases, cleaning may need to be considered as part of the maintenance regime. The associated osmotic effects can also cause large hydrostatic pressures within block leading to spalling and observations targeted at identifying this phenomenon shadow be part of the inspection regime.

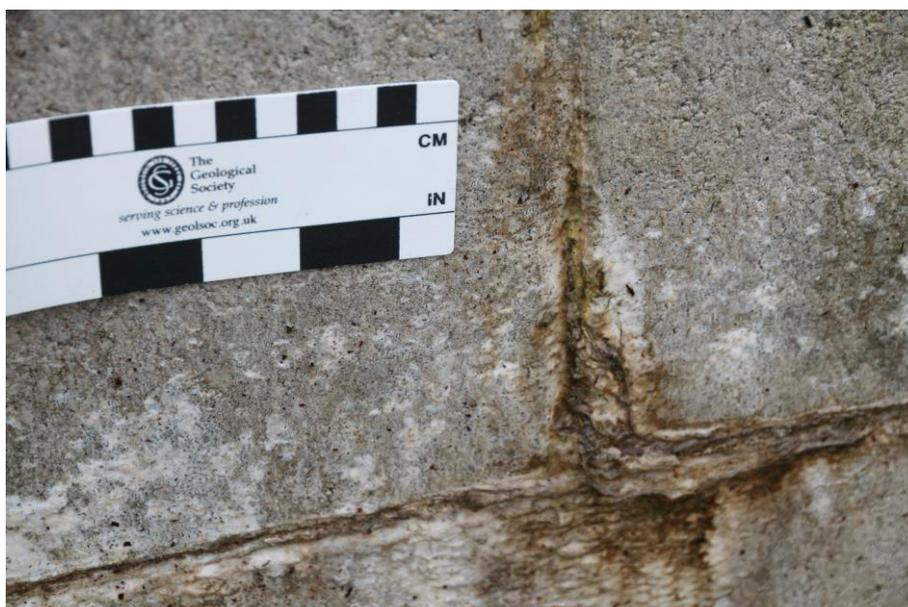
**Figure 12. Concrete block wall showing what appears to be efflorescence in the blocks and particularly in the mortar (A38, SGM 10857, January 2021)**

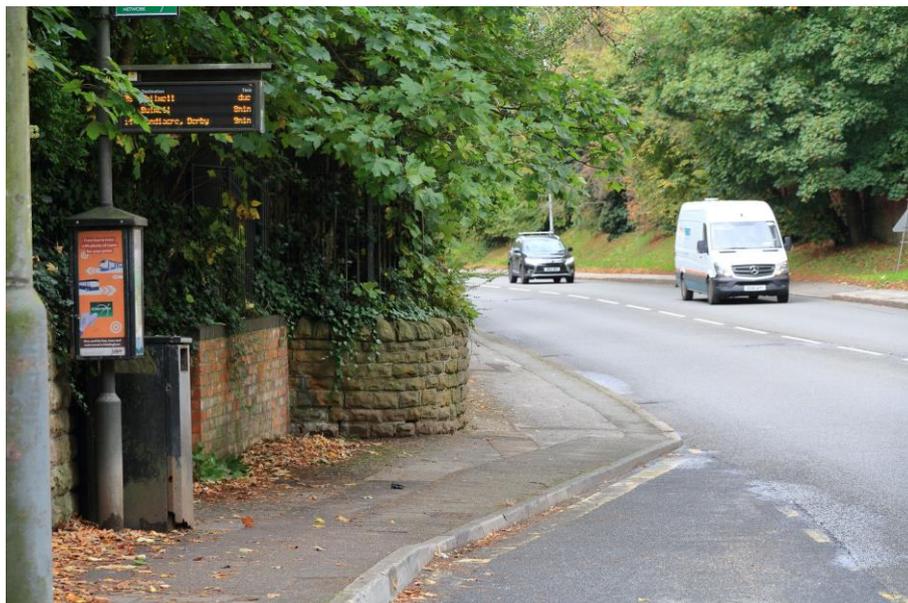
Block Walls often form the boundary to third party properties and there can be doubt as to the ownership of the walls. Such walls are commonly observed to have undergone a change in function. At least one example of a block wall was observed during site inspections that appears to be owned by a third party and appears to have been converted from a free-standing block wall to a low height retaining wall (Figures 3, 5 and 13).

**Figure 13. Mortared stone block wall up to 1.7m high showing signs of leaning, block and mortar loss. Brick infills seem to coincide with former driveways; where the block wall is now retaining this may not have been the case originally (A52, SGM 9676, October 2020)**

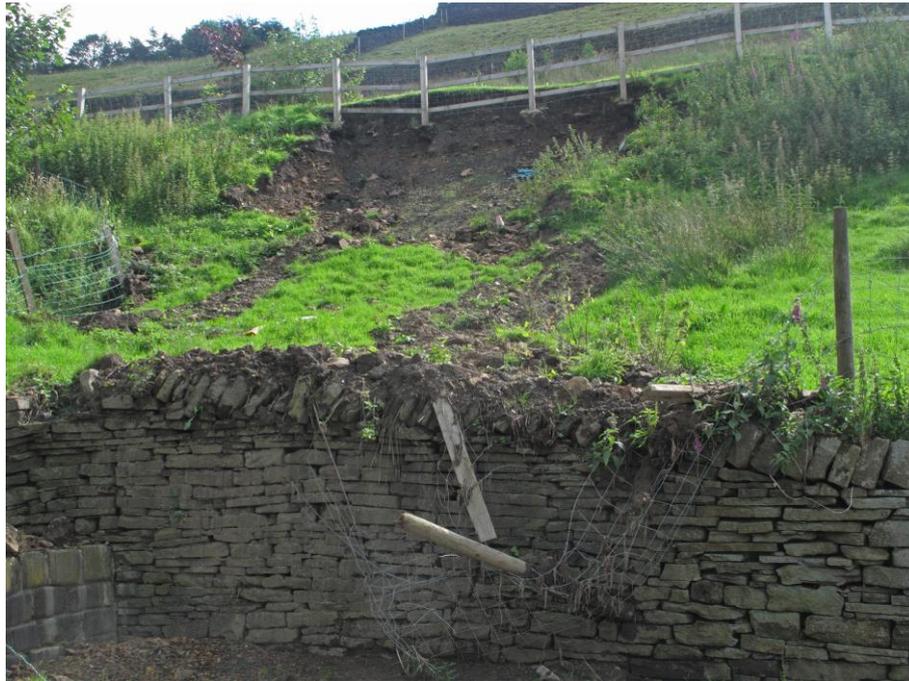
Notwithstanding the issues outlined above, dry stone walls in particular can be a relatively resilient form of structure and Figure 14 shows such a wall that has resisted the effects of a small landslide which has overtopped the wall.

**Figure 14. Dry stone retaining wall approximately 1.2m height that has been affected by the failure of the slope above (off network, West Yorkshire, August 2012)**

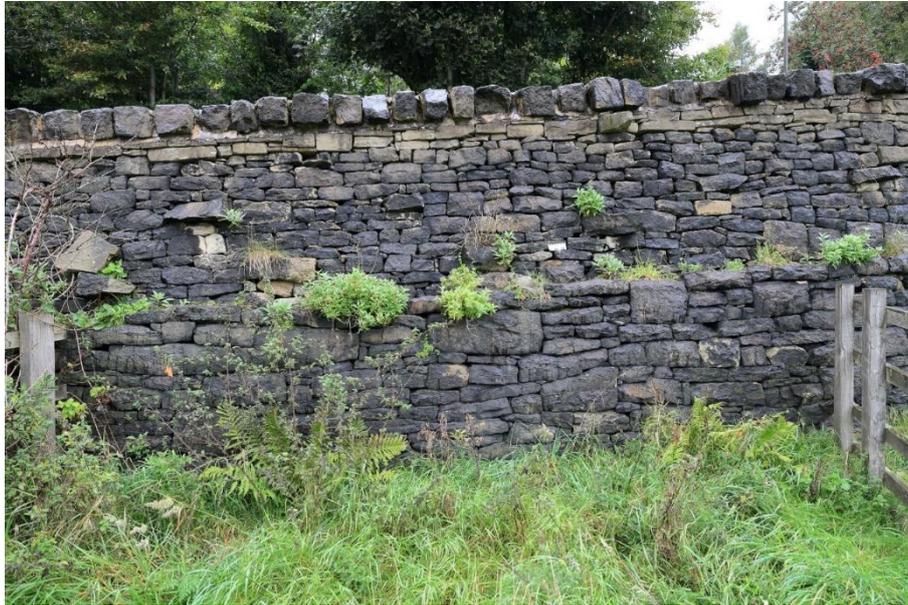
**Figure 15. Dry stone wall approximately 2.5m high including 0.5m free-standing (A628, SGM 8923, October 2020)**

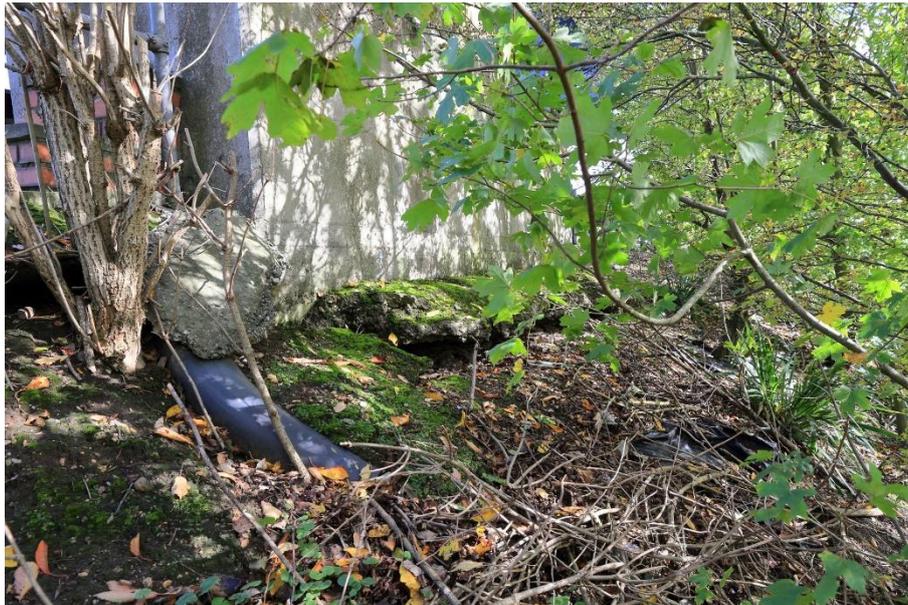
**Figure 16. Slope above the ‘Porcupine’ modular concrete Block Walls (Figure 2) showing settlement beneath the foundation for a variable message sign and significant long-term twisting of tree trunks indicating a wider instability issue (A1307 (formerly A14), above SGM 6082 (Gabion wall), October 2020).**

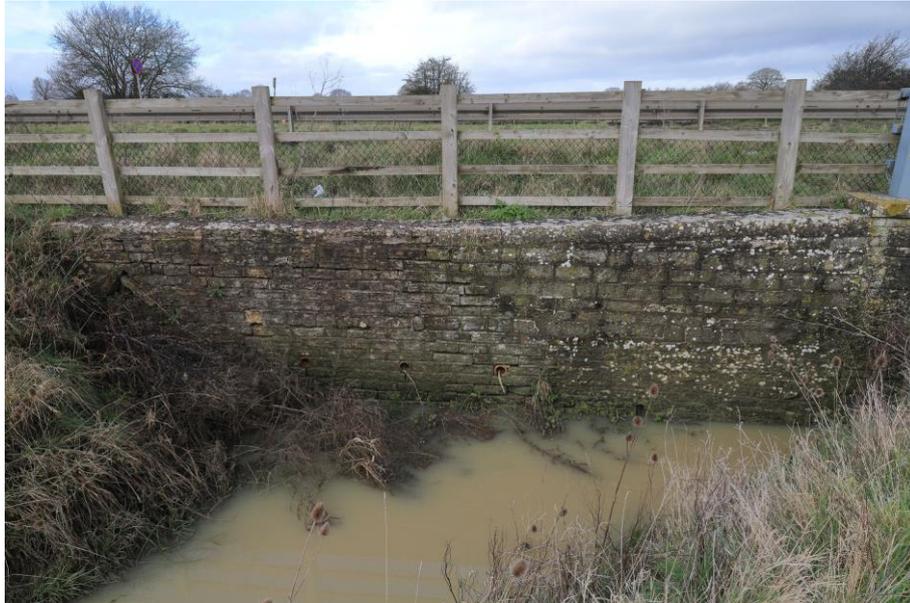
**Case study 6:** Stone block mortared wall (A303, SGM 1268, Figures 17 and 18) forms the headwall to a deep drain that subsequently leads to a larger channel (Bearley Brook) that passes under the carriageway. Visual observations indicate that there is substantial mortar loss, sagging and bowing of the wall and that, in places, this has led to substantial misalignment of the individual blocks with the potential for individual blocks, or groups of blocks, to be lost. Failure of the wall would most likely lead to undermining of the foundation of the vehicle restraint system (just visible through the wooden fence in Figure 17). It is recommended that further assessment of the stability of the wall is undertaken. It is also notable that remediation works have been carried out to the wall effectively burying the structure in the area immediately adjacent to the wall pictured in Figures 17 and 18.

**Figure 17. Stone block mortared wall showing significant signs of instability (A303, SGM 1268, January 2021).**

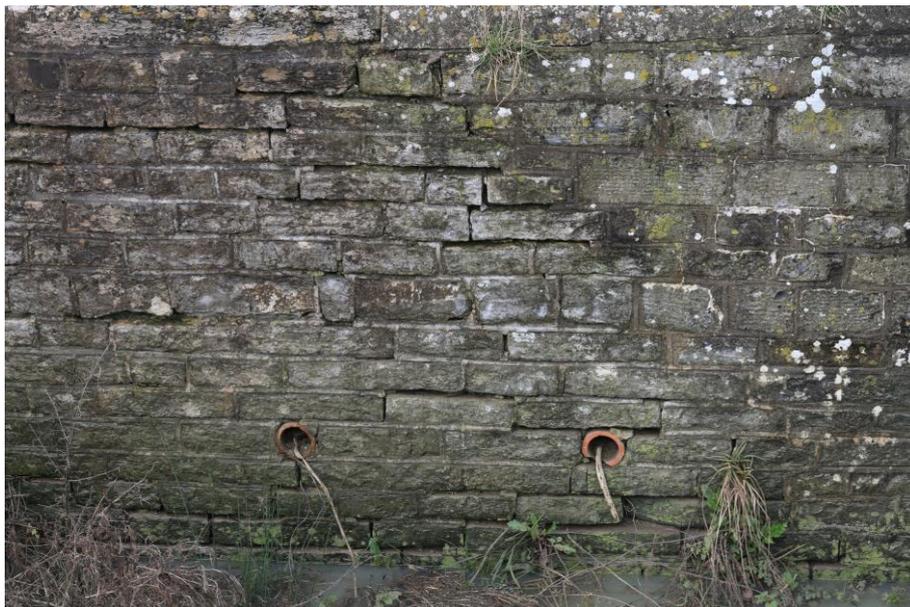
**Figure 18. Stone block mortared wall showing significant signs of deterioration, as well as gross instability as shown in Figure 17 (A303, SGM 1268, January 2021).**

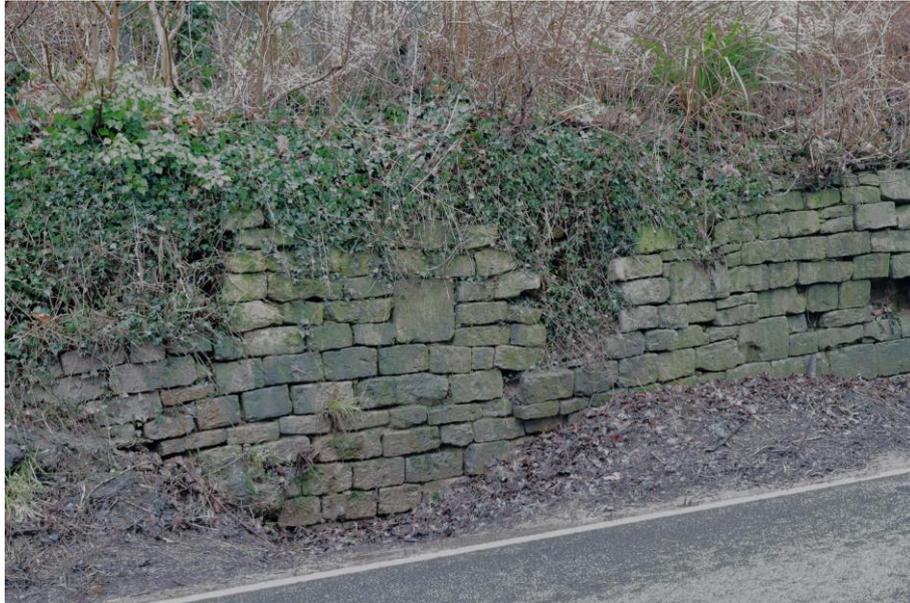
**Case study 7:** Dry stone wall (A36, SGM 9077, Figure 19) immediately adjacent to the carriageway exhibits substantial bowing, distortion and block loss as a result of vegetation invasion, landsliding and potentially the action of frost and de-icing damage. It is clear that reconstruction of this wall is a priority and it is understood that this is planned for the near future.

**Figure 19. Dry stone wall showing significant signs of instability (A36, SGM 9077, January 2021).**
