Appendix 8-7

Water Vole and Otter Habitat Appraisal

To inform the proposed highways improvement works on the A27 East of Lewes, hereafter referred to as 'the scheme', a habitat appraisal of riparian habitat on the River Cuckmere was completed in August 2018 to assess the potential for water vole *Arvicola amphibious* and otter *Lutra lutra*. The approach taken and results of the habitat appraisal are contained within this memo.

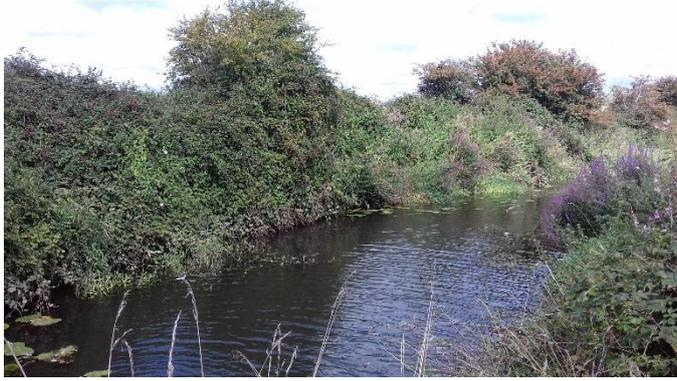
The river banks are made from earth beyond approximately 7m south of the bridge and 4m north of the bridge. North of the bridge, the banks are steep and provide suitable burrowing habitat. The tops of the banks are dominated by dense bramble *Rubus fruticosus* agg. and common nettle *Urtica dioica* in places, with more marginal species present nearer the water including purple loosestrife *Lythrum salicaria*, meadowsweet *Filipendula ulmaria*, common reed *Phragmites australis*, sedge species *Carex* sp. and rush species *Juncus* sp. There is some shading of the river by large willows *Salix* sp. on the north-west bank. South of the Sherman Bridge the earth banks are shallower in gradient and dominated by coarse grasses and common reed, with occasional sedge and rush species. Himalayan balsam *Impatiens glandulifera* was also recorded, on the banks north and south of the bridge.

River Cuckmere north of the Sherman Bridge. Steep banks, densely vegetated with bramble. Riparian species growing at the base of the bank.
2

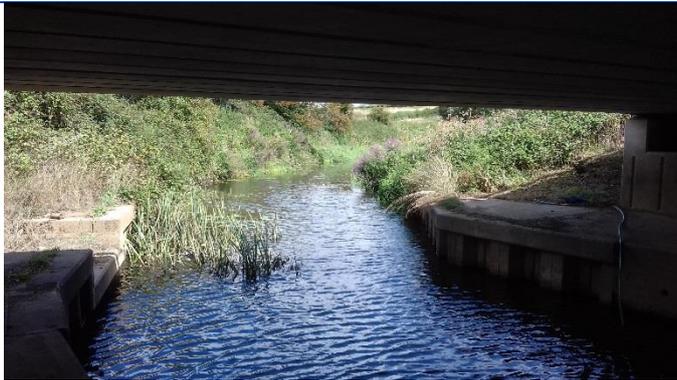
The river channel provides suitable habitat for otter to move through the area. The river is also likely to provide suitable foraging opportunities to otter given its ability to support fish and invertebrate species. The banks of the river provide suitable resting places for otter. During typical flow otters may pass below the Sherman bridge or use concrete ledges present under the bridge.

River Cuckmere north of the Sherman Bridge as taken from under the bridge. In-stream vegetation present. Concrete ledges to allow for mammal passage during high waters.
3

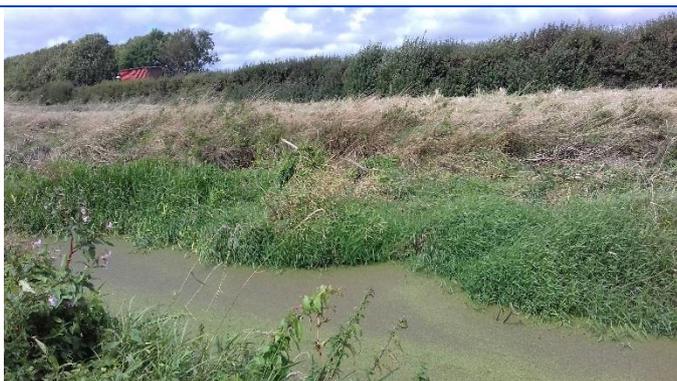
floating sweet grass *Glyceria fluitans* and duckweed *Lemna* sp. Duckweed chokes the surface of the river south of the bridge.

River Cuckmere south of the Sherman Bridge. Shallower banks dominated by reed, coarse grasses and riparian species. The river surface is choked with duckweed.

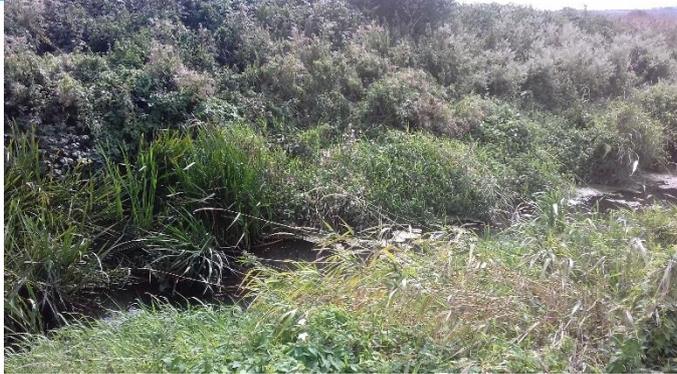
River Cuckmere south of the Sherman Bridge, riparian vegetation.
5

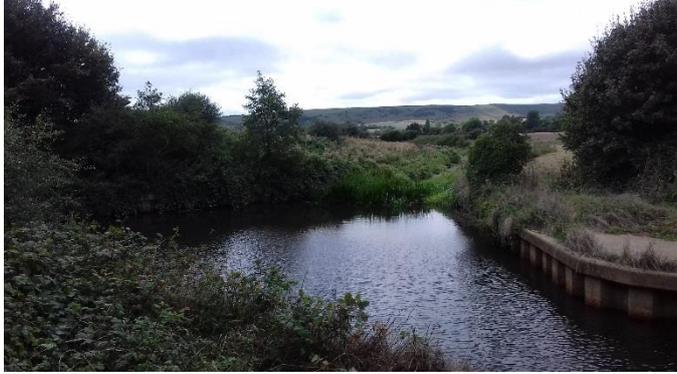
The stretch of the river within the Survey Area is relatively deep, with pools approximately 1-2m in depth and approximately 4-5m at its widest. The river is slow flowing, running in a southerly direction. The banks of the river are reinforced directly under and adjacent the Sherman Bridge with concrete and sheet pile wall. These reinforced banks are unsuitable for water vole to create their burrows. The river pools to the south of the bridge, where a large sheet pile wall has been built on the south bank. A weir was identified approximately 150m north of the bridge. Land surrounding the river is predominately agricultural. A footpath runs along the west bank of the river north of the bridge, with evidence of recreational fishing.

River Cuckmere south of the Sherman Bridge. The deep pool just south of the bridge and the reinforced retaining walls.
6

The forthcoming highways improvements include the construction of a new bridge to support the cycleway. It will be important to ensure that the improvements do not detrimentally affect the River Cuckmere and where possible ecological enhancements are achieved. It is understood that the proposed bridge will be built upon the existing retaining wall and will therefore have no or minimal effects upon the vegetated river banks.

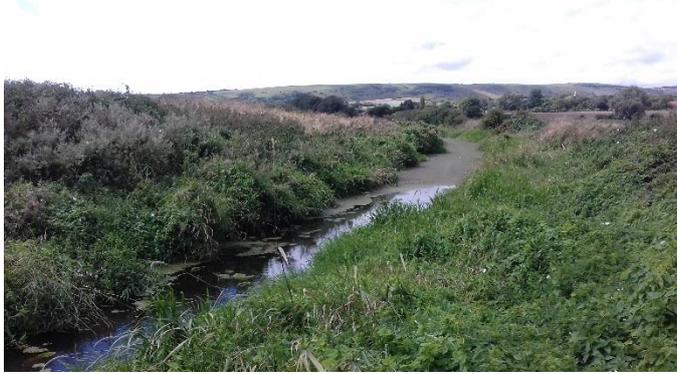
River Cuckmere south of the Sherman Bridge. Shallower banks dominated by reed, coarse grasses and riparian species. Arable fields are present east and west of the river.
7

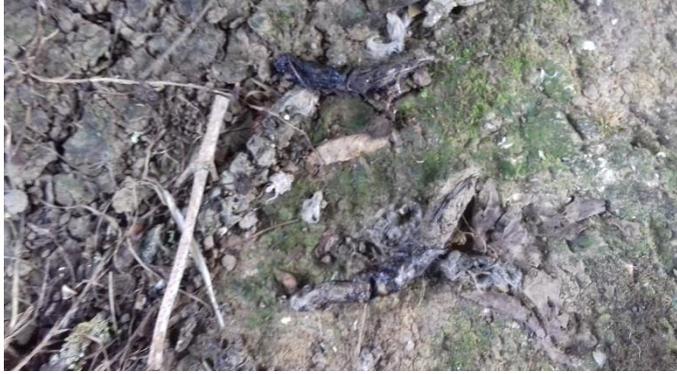
No signs of current use by water vole were incidentally recorded, however the gradient and density of bank vegetation limited access and visibility. Scat thought to be of mink *Neovision vison* were recorded next to a culvert approximately 5m south of the Sherman Bridge (see Figure 1).

It is concluded unlikely that water voles are present in association with this habitat given mink were confirmed to be present and the lack of water vole evidence recorded. Mink are a voracious predator of water vole and have attributed to their rapid decline throughout the UK. Their presence is likely to further reduces the chance that water vole may colonise these channels in the near future. Records of water vole are also all over 10 years of age, suggesting a likely absence of the species during the period of time since then.

River Cuckmere south of the Sherman Bridge. American mink scat located around the deep pool adjacent a culvert.

Given the suitability of the surrounding habitat for water vole and otter, it is however recommended that a pre-construction survey is undertaken. The walkover should include a search for water vole and otter evidence within suitable habitat immediately adjacent the proposed bridge location, and confirm that habitat conditions have not changed between this habitat appraisal and the start of works.

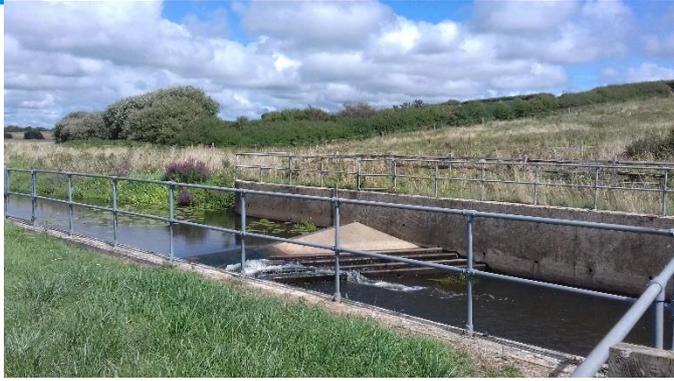
Weir located approximately 150m north of the Sherman Bridge. This is likely to form a slight barrier to water vole and otter movement.

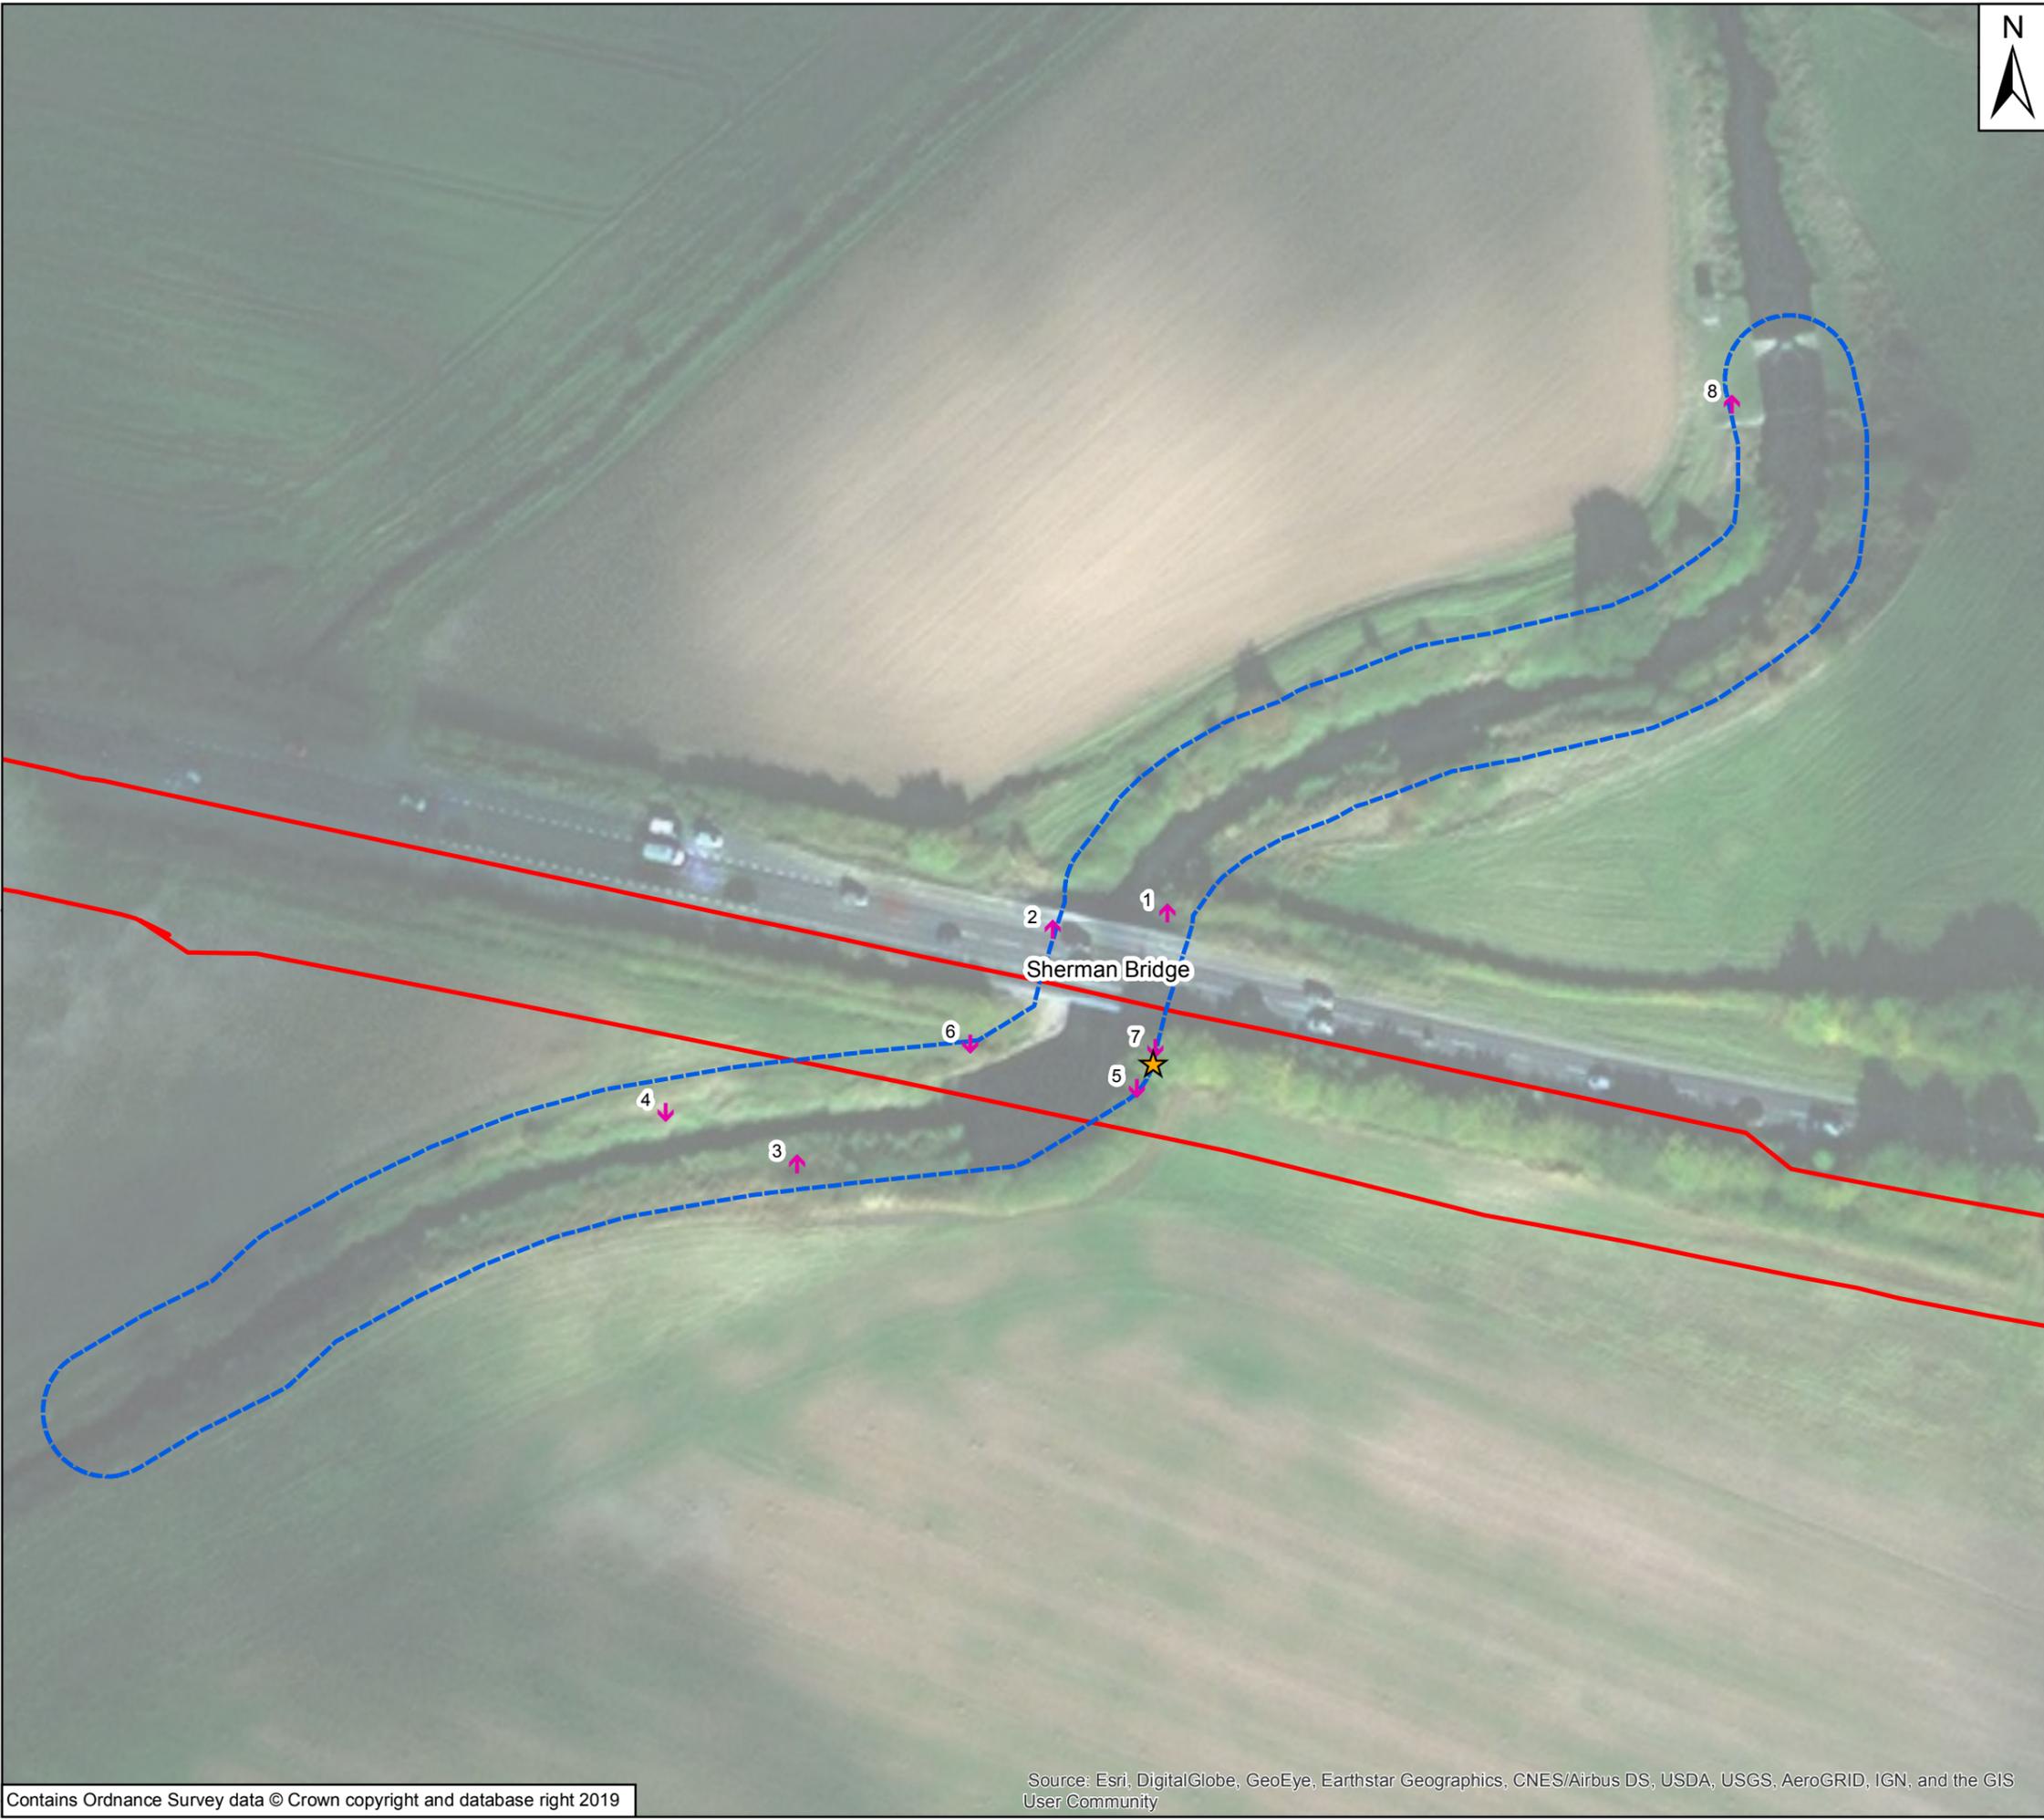
Drawing No: Figure 1	Drawn: BW
Date: January 2019	Checked: VD
Scale: 1,000 @ A3	Approved: LR

The habitat suitability appraisal comprised an ecological desk study and field survey in line with good practice¹. A Survey Area was defined that encompassed the riparian habitat within a minimum of 50m up- and down-stream of the River Cuckmere where it passes under the A27 at Sherman Bridge (Grid Reference TQ 53191 05056) (see Figure 1).

- Scheme Extent
- Survey Area
- ★ Mink Scat
