# Technical Annex to PPR490

## The acoustic durability of timber noise barriers on England's strategic road network

by P A Morgan

Client: Highways Agency, Research and Development  
(Pam Lowery)

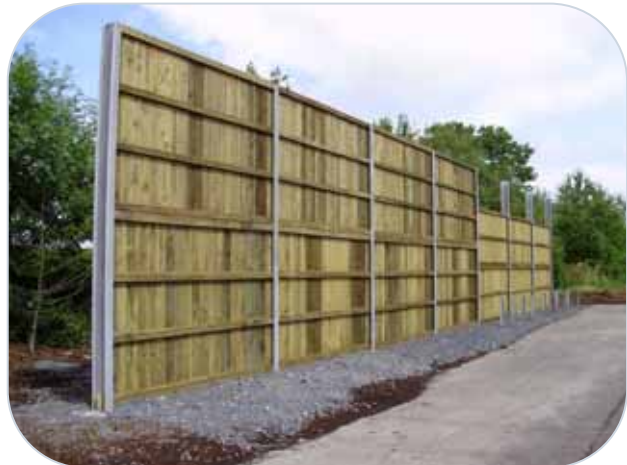
**Figure A.1: TRL Noise Barrier Test Facility, Bishops Castle, Shropshire**  
(Posts for safety fence at right-hand end)

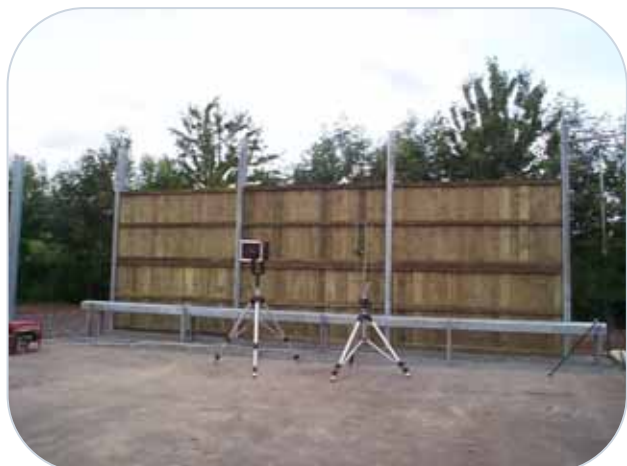
**Figure A.2: View of barrier facility showing safety fence installation**

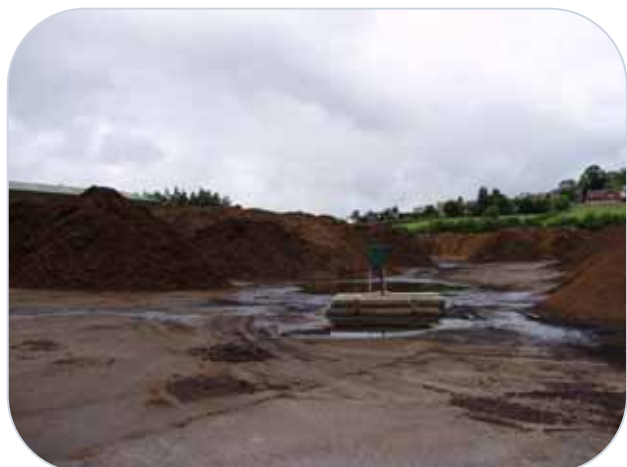
**Figure A.3: Open asphalt area in front of the noise barrier facility**

In front of the barrier there is approximately 1 m of level earth covered with loose stone aggregate, beyond which is a large open area of asphalt which covers several hundred square metres and extends to at least 60 m beyond the front of the barrier.

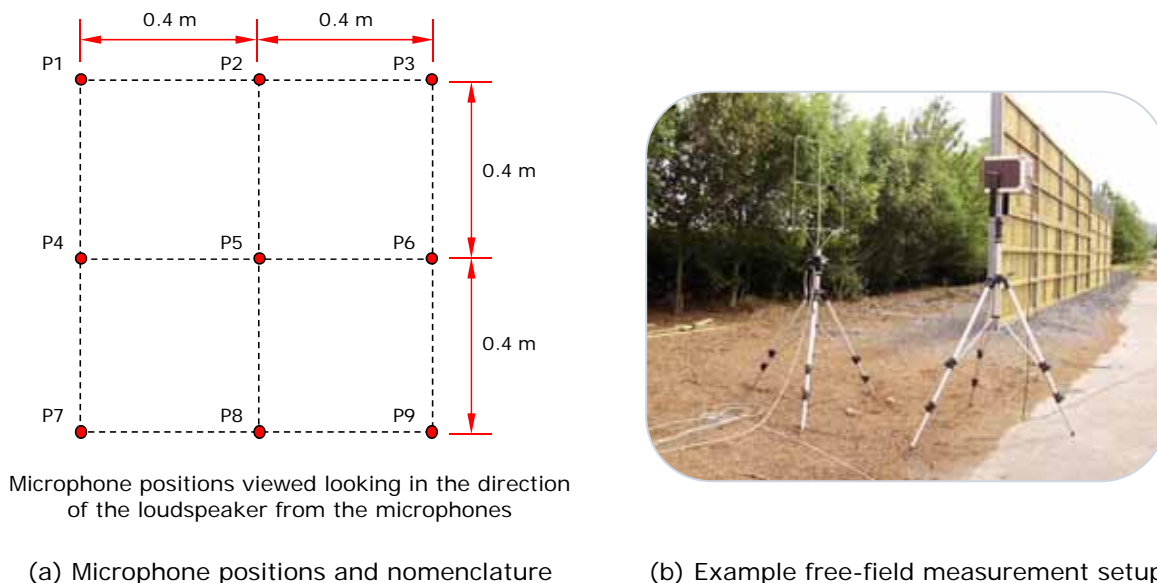
**Figure B.1: Microphone position nomenclature and example free-field measurement setup**

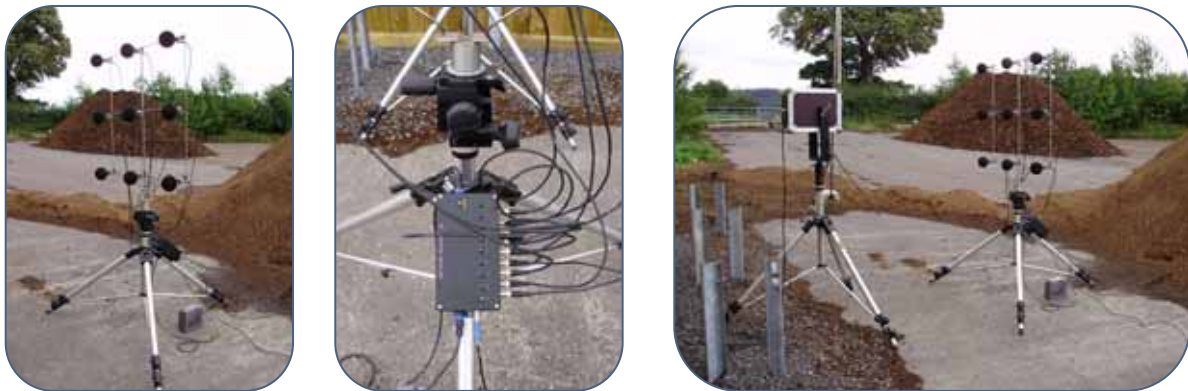
Figure B.2 shows the TRL 9-microphone array system, which uses 9 microphones in combination with a commercially available single-channel measurement system (MLSSA) and a 9-channel switchbox (all photographs were taken at the TRL Noise Barrier Test Facility). The switchbox is operated using a remote control unit based in the test vehicle housing the main PC control systems.

a) 9-microphone array    b) Microphone switchbox    c) Free-field measurement using 9-mic array

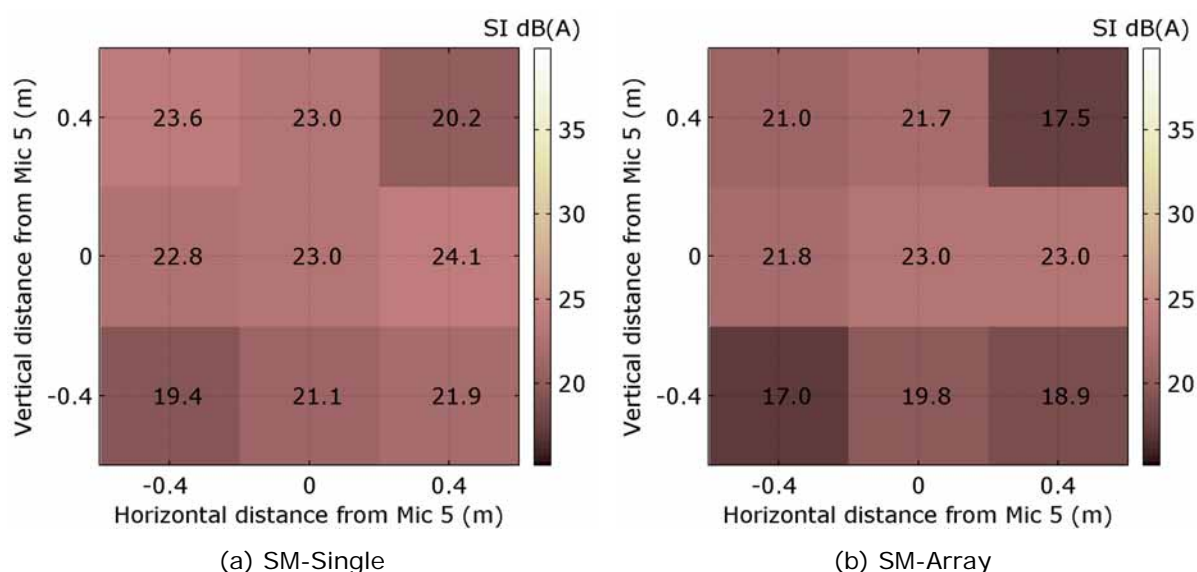
Figure B.4 compares the  $DL_{Si}$  ratings calculated for the individual microphone positions. The darker colours indicate lower values of sound insulation. As for the average results, the Part 5 approach predicts higher sound insulation performance at all 9 microphone positions. It is observed that the differences at the corners of the array (microphones P1, P3, P7 and P9) are the greatest, being approximately of the order of 2.5-3 dB. The differences at positions P2, P4, P6 and P8 are approximately 1 dB. There is no difference between the results at the centre microphone position P5 since there is no path difference correction applied at this position in the Part 5 method.

**Figure B.4: Comparison of sound insulation performance at individual microphone positions derived using Part 5 and Part 6 methodologies for a single-leaf reflective timber barrier**

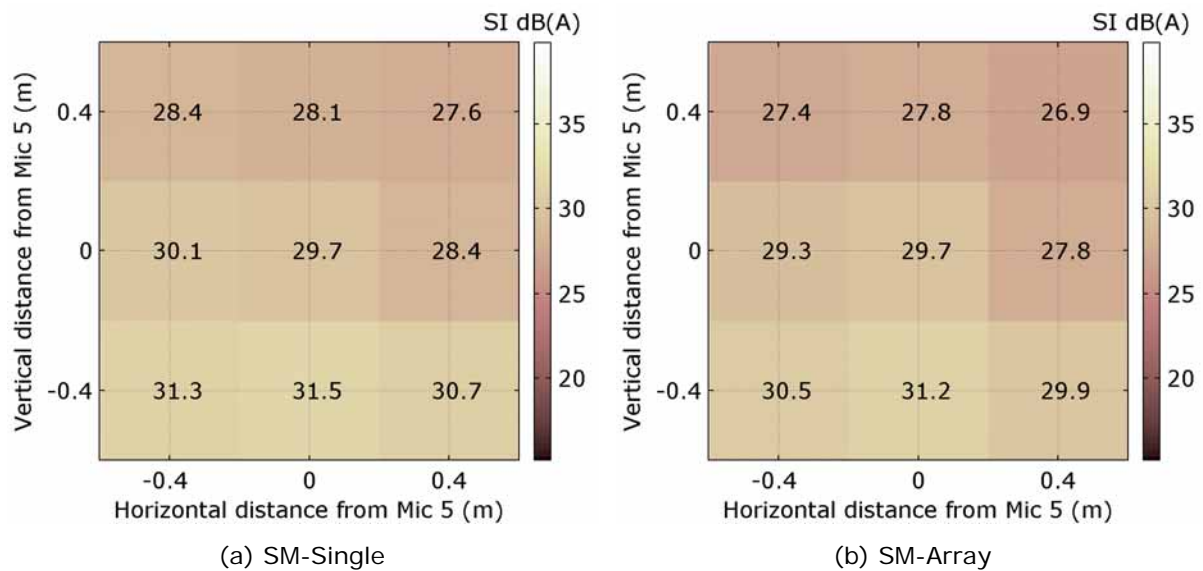
Figure B.6 compares the  $DL_{SI}$  ratings calculated for the individual microphone positions. As for the average results, the Part 5 approach predicts higher sound insulation performance at all 9 microphone positions. It is observed that the differences at the corners of the array (microphones P1, P3, P7 and P9) are the greatest, being approximately of the order of 1 dB. The differences at positions P2, P4, P6 and P8 are less consistent being in the range 0.3-0.8 dB.

**Figure B.6: Comparison of sound insulation performance at individual microphone positions derived using Part 5 and Part 6 methodologies for a sound absorptive timber barrier**

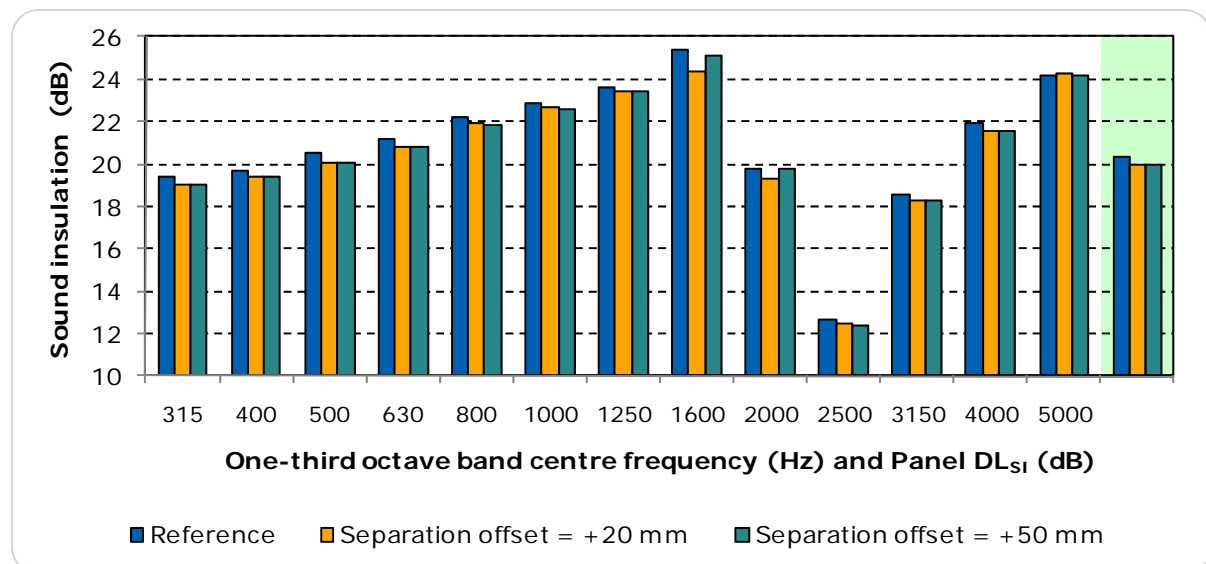
Figure C.1 compares results for those measurements where there was differing horizontal separation between the loudspeaker and microphone array during the free-field measurements with the reference condition using the correct positioning.

**Figure C.1: Sound insulation performance of a single-leaf reflective timber barrier calculated using free-field measurements with different horizontal loudspeaker/microphone P5 separations**

With the default free-field loudspeaker/P5 separation for the barrier under assessment increased by 20 mm, the Figure shows a decrease in the airborne sound insulation,  $DL_{SI}$ , of only 0.3 dB, which is negligible. Further increasing the separation to 50 mm has no additional effect. Considering the one-third octave band spectra, deviations in sound insulation relative to the reference case are generally less than 0.5 dB and therefore within the range of measurement accuracy of the method. Although a difference of approximately 1 dB is observed for the 20mm separation offset at 1600 Hz, this is still within the accuracy of the method.

It is observed that the single number ratings,  $DL_{SI}$  are lower than measured on the same barrier some 14 months earlier (see Chapter 6; Morgan, 2010). It is noted that these earlier results were taken using a single free-field microphone (analysing the current results using a single free-field microphone increases the  $DL_{SI}$  value by 1 dB) and the barrier had been removed and reinstalled prior to the current tests.

The significant dip in performance in the frequency bands around 2.5 kHz, is as observed in earlier tests on this type of barrier, and discussed further in Section 7.3.2 (Morgan, 2010).
