Highways Consultancy Group - Highways Research Group

De-icing Materials and Corrosion – Site Trial

Task Reference: 628(387)MTSC

Report Date: August 2010

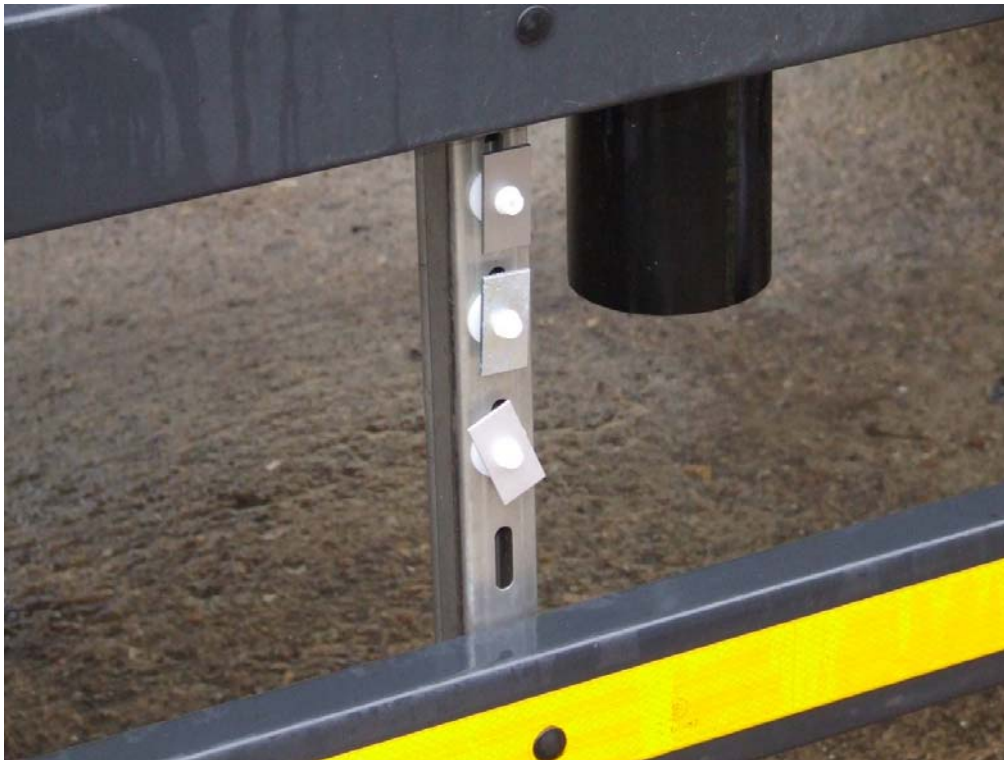
Plate 2-1 Side underrun bar support on Schmidt vehicle

In the case of the vehicles, the coupons were fixed wherever suitable positions could be identified, at locations both near to and more remote from the spreader mechanism. In the case of the new generation of Schmidt vehicles, samples were only fixed in place using pre-existing holes (see Plate 2-1 to Plate 2-3 below). In the case of the older generation Foden vehicles, the original samples were generally placed in previously existing but unused holes, when the samples were replaced following their premature disposal by the maintenance fitters, they were located in purpose made holes in the plastic mudguards (see Plate 2-4).

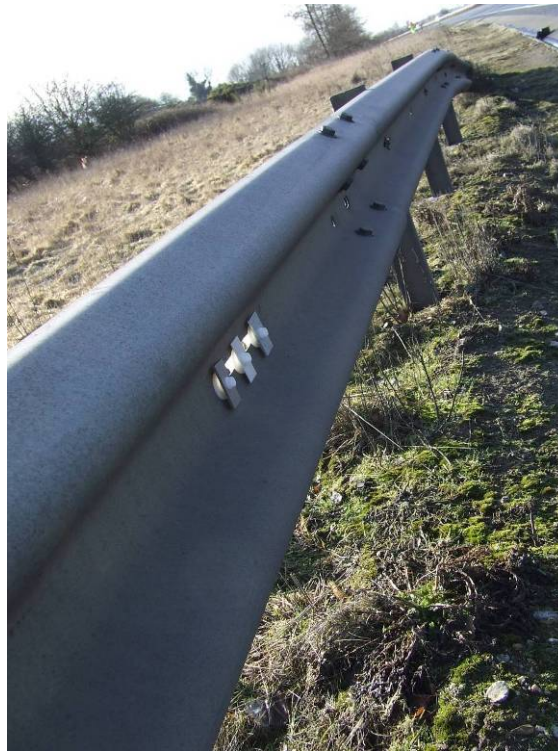
Plate 2-5 Fixing detail on TCB

All coupons were fixed in place using a nylon nut and bolt arrangement. The nut was of the self-locking variety to reduce the possibility of the fixing coming loose, and intermediate plain nuts and ‘mudguard’ washers were also used to hold the coupons off the surface of the item to which it was being fixed and also to compensate for different size fixing holes. The use of nylon fixings ensured that the samples were electrically isolated from the fixing point to avoid the possibility of bimetallic corrosion.

In the case of the TCB, the coupons were fixed to un-used slots running down the centre line of the beam, see Plate 2-5 and Plate 2-6. In addition to the slots providing an easy means of fixing, being located behind the front face of the beam it was thought the risk of loss of the sample and of causing injury to pedestrians and cyclists/motor cyclists in the case of impact would be minimised. Furthermore, being located well above the ground they were thought to be less likely to become overgrown with vegetation therefore providing a more consistent environment with regards corrosion.
