# SPECIMEN MONITORING PROJECT

## THE CORROSION RESISTANCE OF LIGHTWEIGHT AGGREGATE CONCRETE

By AJJ CALDER

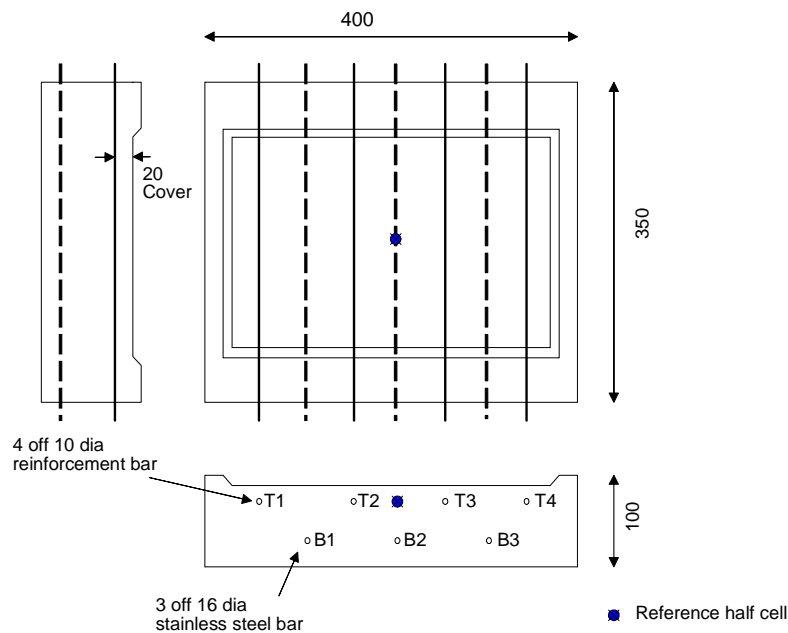
The concrete slab specimens had dimensions of 400mm x 350mm x 100mm (Figure 1) and contained four 10mm diameter high yield reinforcing bars and three 16mm diameter stainless steel bars. They were cast with a lip on the cast face to facilitate ponding. The experimental design is given in Table 1. Each pair of specimens was cast from a single batch of concrete using concrete mixes compliant with the Specification for Highway Works Series 1700.

Figure 1: Design of test specimen

The outer pairs of bars (T1 and B1, and T4 and B3) were electrically connected together to form a galvanic couple with galvanic currents flowing between the bottom stainless steel bars and the top reinforcing bars (Figure 1). The galvanic currents between each of these pairs of bars were monitored periodically using a zero resistance ammeter (ZRA). The electrode potentials of these pairs of bars and the inner top reinforcing bars (T2 and T3) were also monitored periodically relative to an embedded silver/silver chloride (Ag/AgCl) reference electrode.

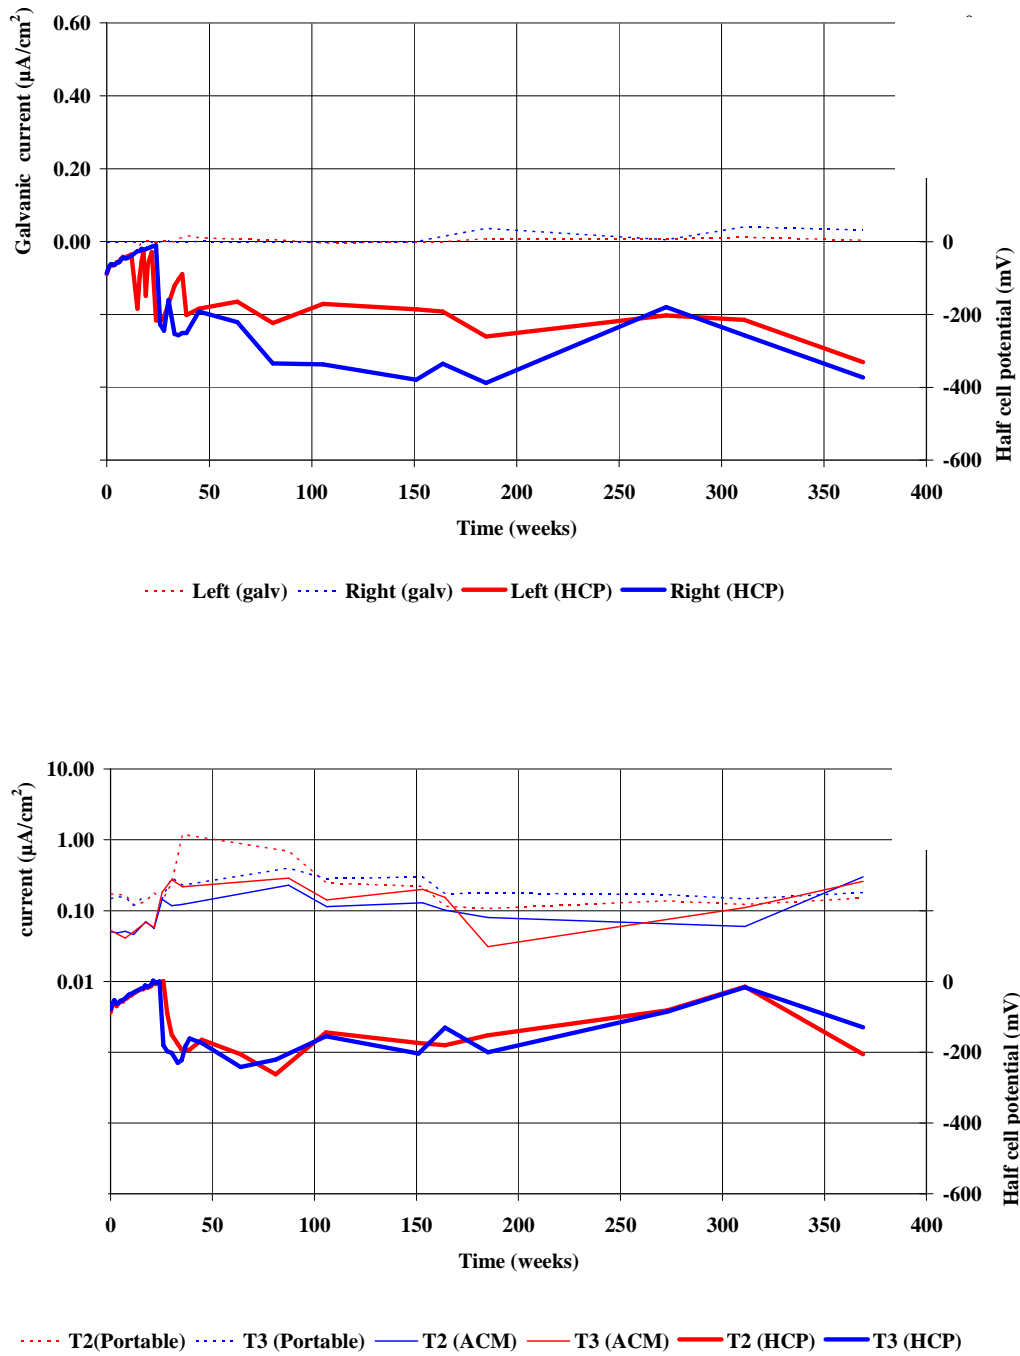
The half-cell potentials measured on the specimen cast with concrete containing natural aggregate (1B) dropped to about  $-200\text{mV}$  within the first year (Figure 2). After that, the potential of the galvanic couples varied between about  $-200$  and  $-400\text{mV}$  and the potentials of the inner bars have generally remained at about  $-200\text{mV}$ . The potentials of the bars in the specimen cast with Lightweight Aggregate A (2B), generally remained less negative in the range  $0$ - $100\text{mV}$  (Figure 3). For the specimen cast with Lightweight Aggregate B (3B), the potentials dropped to values less than  $-300\text{mV}$  during the first few months of monitoring and then drifted to values less than  $-500\text{mV}$  during the duration of ponding (Figure 4).

Figure 2: Results from specimen cast from concrete containing natural aggregates (Specimen 1B)

The results from the monitoring of each specimen are shown in Figures 2-4. The top graphs show the variation of galvanic current and half-cell potential (HCP) with time for each pair of outside bars (left and right). The bottom graphs show the variation with time of:

Figures 2 and 3 show that there was little overall difference in corrosion currents measured using linear polarisation resistance (LPR) for the specimens containing normal aggregate (1B) and Lightweight Aggregate A (2B). Even after nearly seven years of ponding with salt solution, the corrosion currents on bars in the specimens containing Lightweight Aggregate A and natural aggregate were approximately  $0.1\mu\text{A}/\text{cm}^2$  and were therefore in the passive corrosion category. The highest currents were measured on the bars in the specimen containing Lightweight Aggregate B (Figure 4); during the second year of ponding, the mean corrosion currents were in the moderate to high category and during the third and fourth years, the mean increased to the high category ( $>1.0\mu\text{A}/\text{cm}^2$ ) and remained there for the duration of the project.

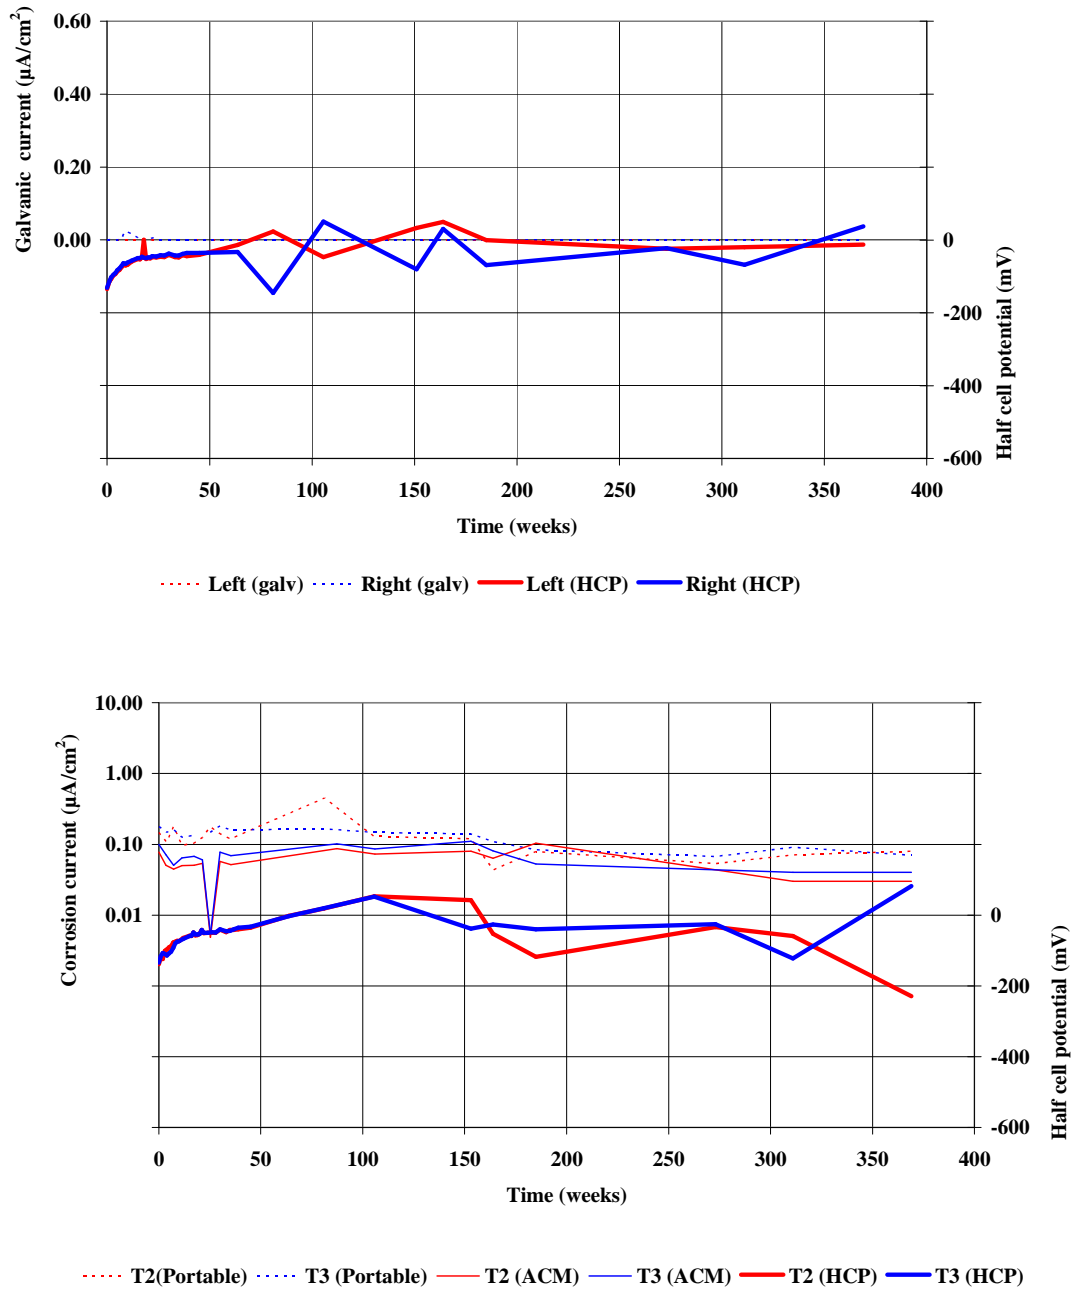
Figure 3: Results from specimen cast from concrete containing Lightweight Aggregate A (Specimen 2B)

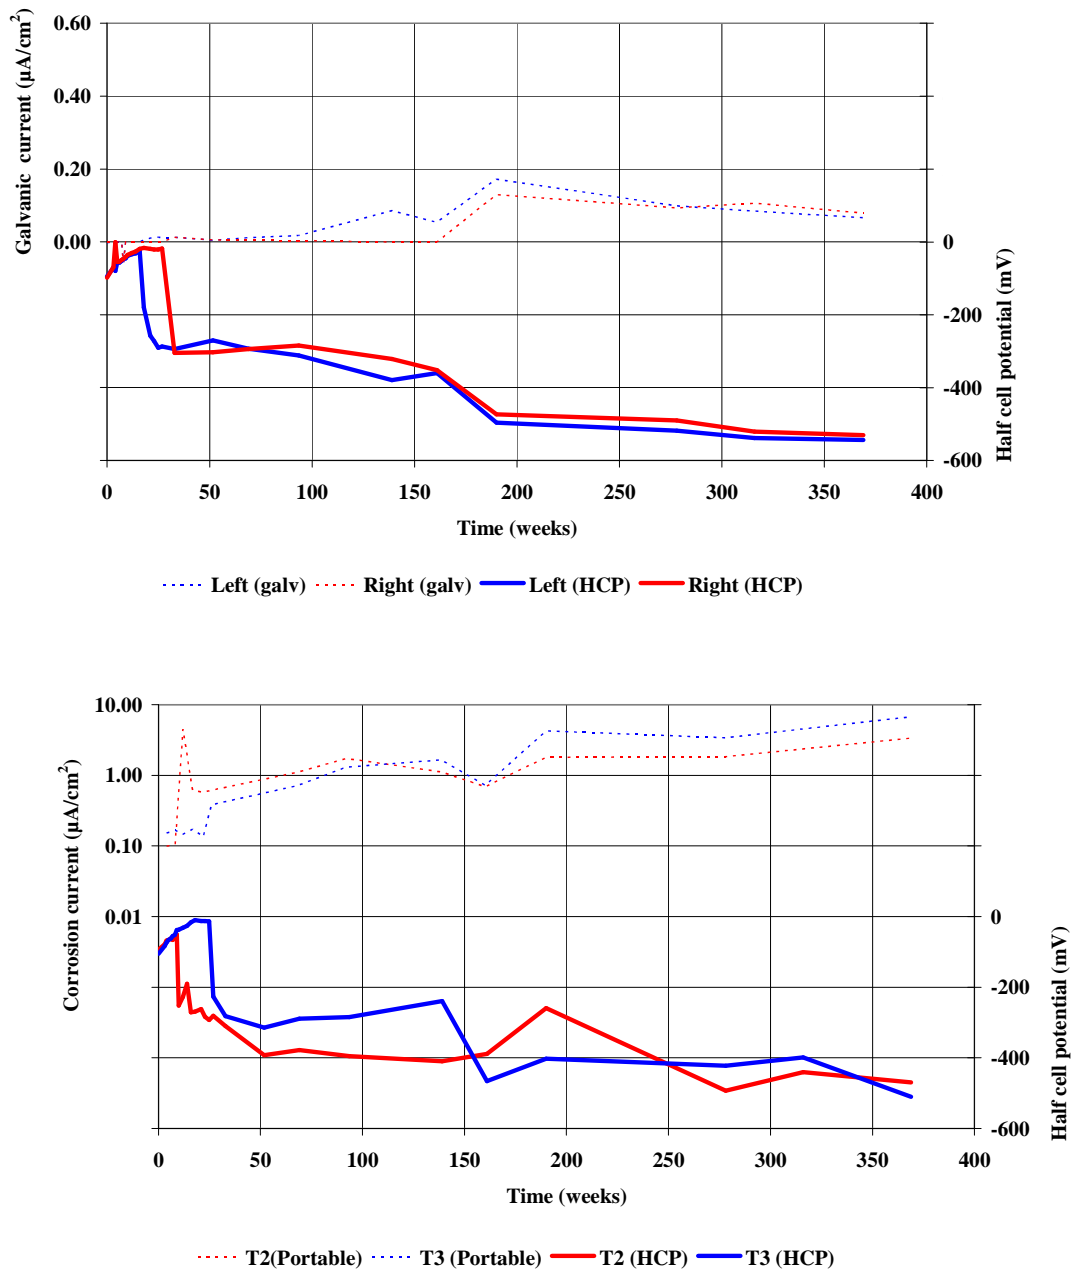
Figure 4: Results from specimen cast from concrete containing Lightweight Aggregate B (Specimen 3B)

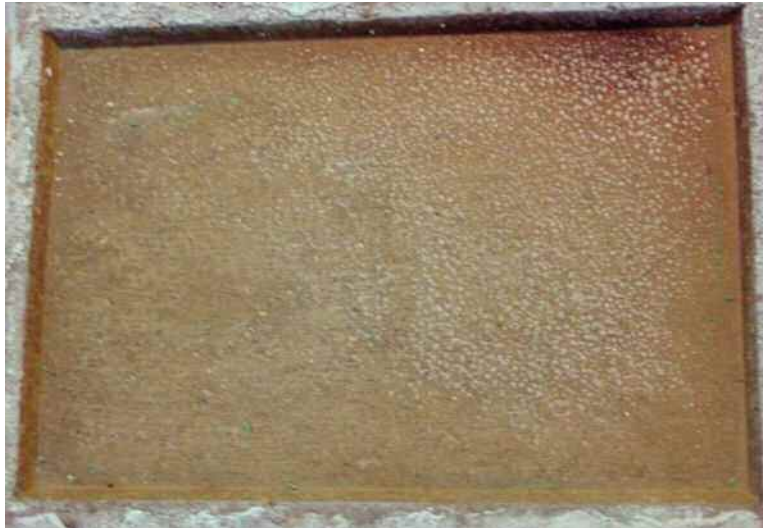
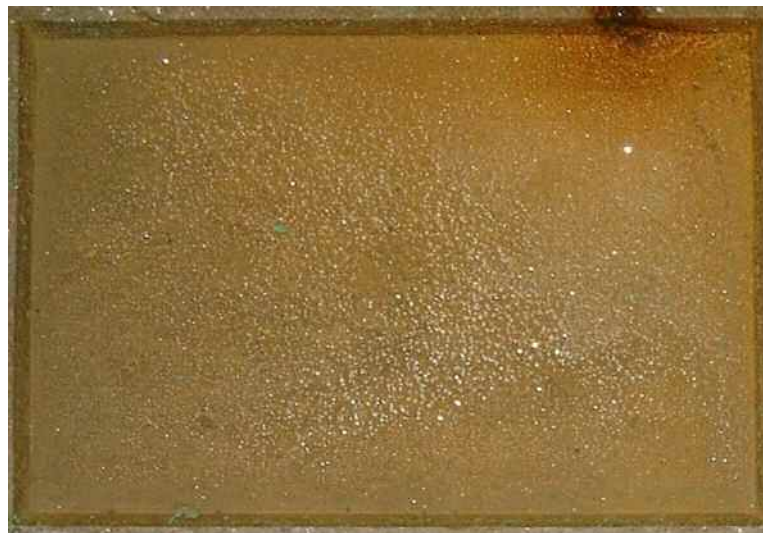
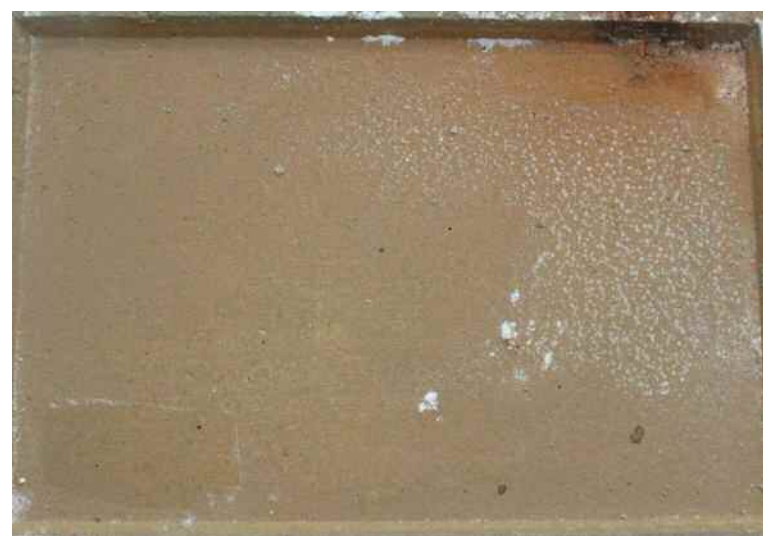
Figure 5: Photographs of ponded area of slab 1B  
(cast with natural lightweight aggregate)

Figures 5-7 show photographs of the ponded surface of each specimen in December 2004, January 2006 and October 2010. There was no evidence of corrosion on the specimen containing Lightweight Aggregate A (2B). For the Lightweight Aggregate B specimen (3B), for which the electrochemical monitoring indicated moderate to high rates of corrosion, there was an area close to the edge of the specimen over bar T4 where rust staining and slight surface spalling were evident. There was also visible cracking along all the top bars in 2004. This cracking had increased slightly by 2006 but by 2010 the rust staining had been washed away by the ponding. There was also some surface staining above bar T4 on the specimen containing natural aggregate (1B), but there was no visible evidence of cracking. Although the electrochemical monitoring had indicated that the bars in this specimen had generally been in a passive state, the galvanic current flowing in bar T4 had been significantly greater than zero for some of the ponding period and the potential had also been close to -400mV. This would explain the presence of the rust staining on the surface.

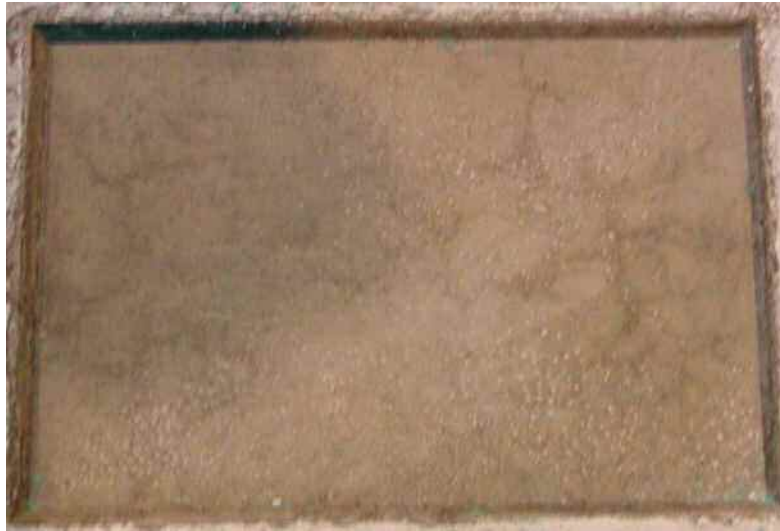
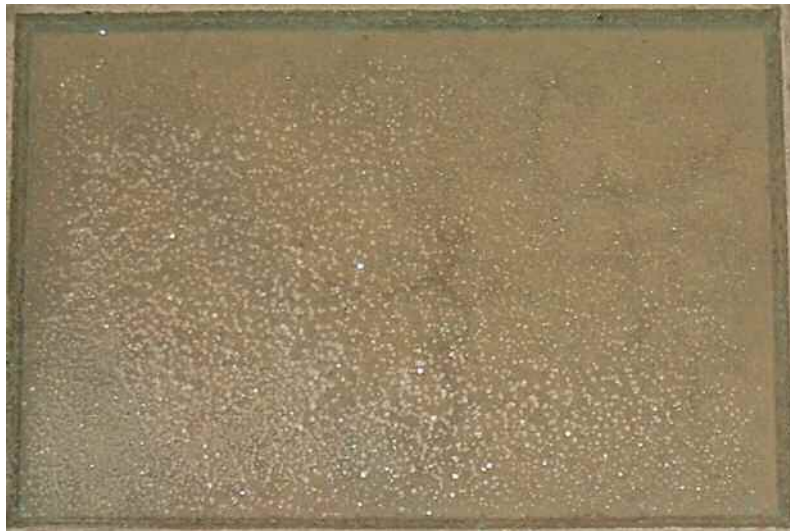
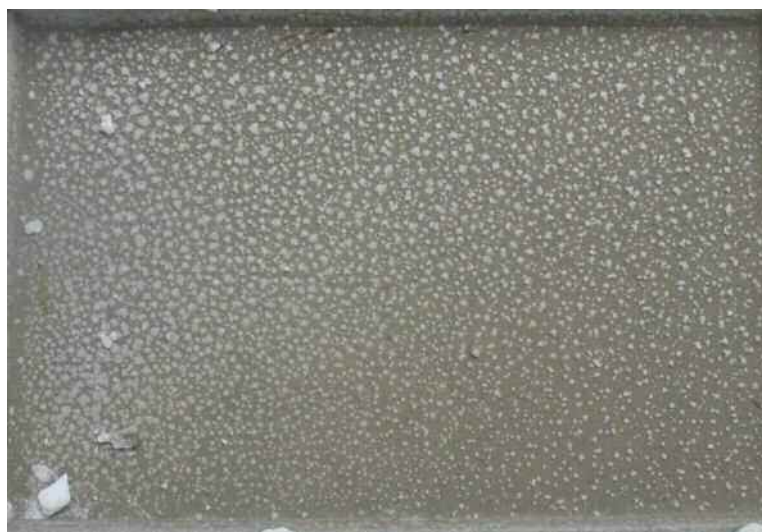
Figure 6: Photographs of ponded area of slab 2B  
(cast with Lightweight Aggregate A)

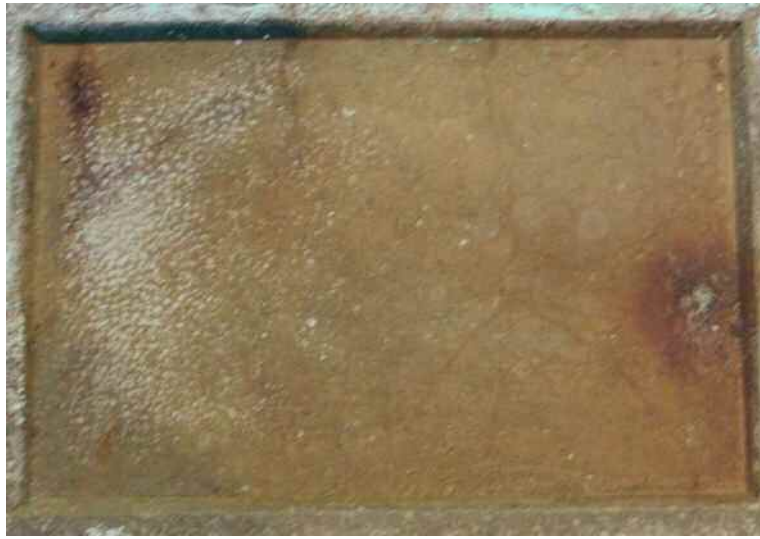
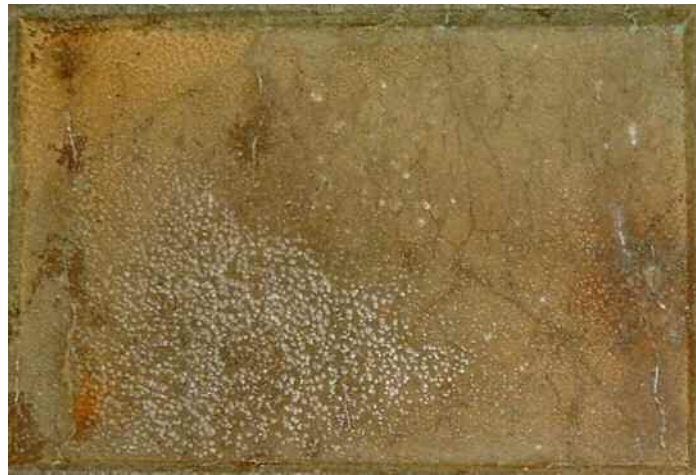
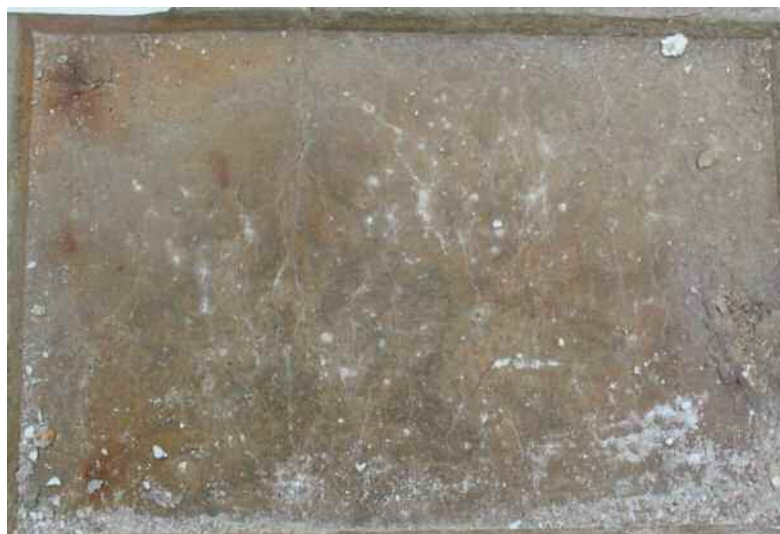
Figure 7: Photographs of ponded areas of slab 3B  
(cast with Lightweight Aggregate B)

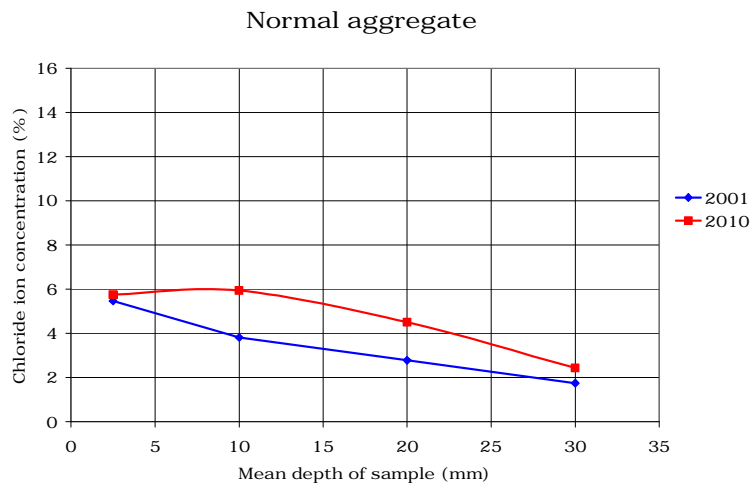
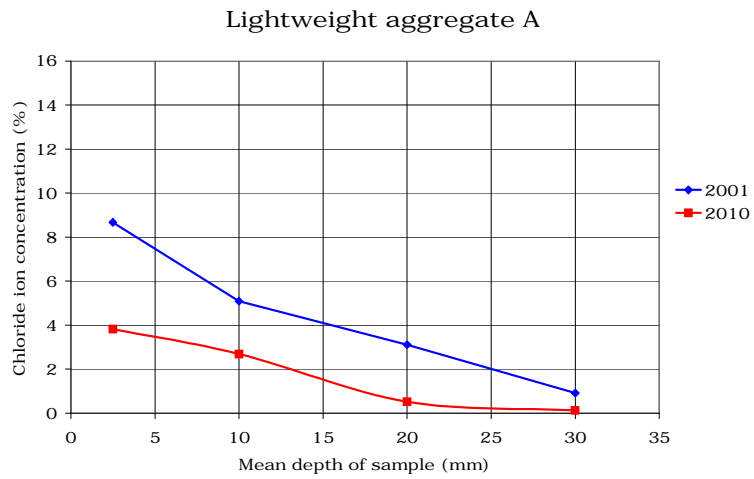
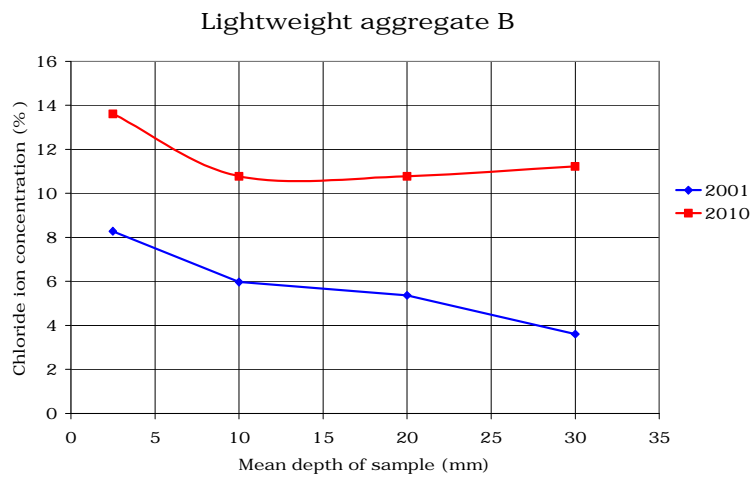
Figure 8: Chloride profiles measured in specimens in 2001 and 2010

The chloride profiles measured in 2001 and 2010 (i.e. after about 2 and 10 years of ponding with salt solution), for each specimen are given in Figure 8.

In 2001, the chloride levels in the specimens containing Lightweight Aggregate A and Lightweight Aggregate B were very similar and markedly higher than in the specimen containing natural aggregate. In 2010, the chloride levels in the specimens containing Lightweight Aggregate B remained markedly higher than in the specimen containing natural aggregate. However the values measured in the specimen containing Lightweight Aggregate A were lower than those measured in the other two specimens.

The distribution of chlorides measured in 2010 did not reduce with depth from the surface as might be expected, and this deviation from the norm is more pronounced in the specimens containing natural aggregate and Lightweight Aggregate A. A possible explanation is that the specimens would have dried out after ponding stopped in September 2009 and this may have affected the distribution of chlorides within the concrete as moisture moved towards the surface. However, it is not clear why the specimen containing Lightweight Aggregate A appeared to contain less chloride in 2010 than in 2001. It is possible that there was a significant difference between the two samples cast using this aggregate but the reasons for this are unknown.

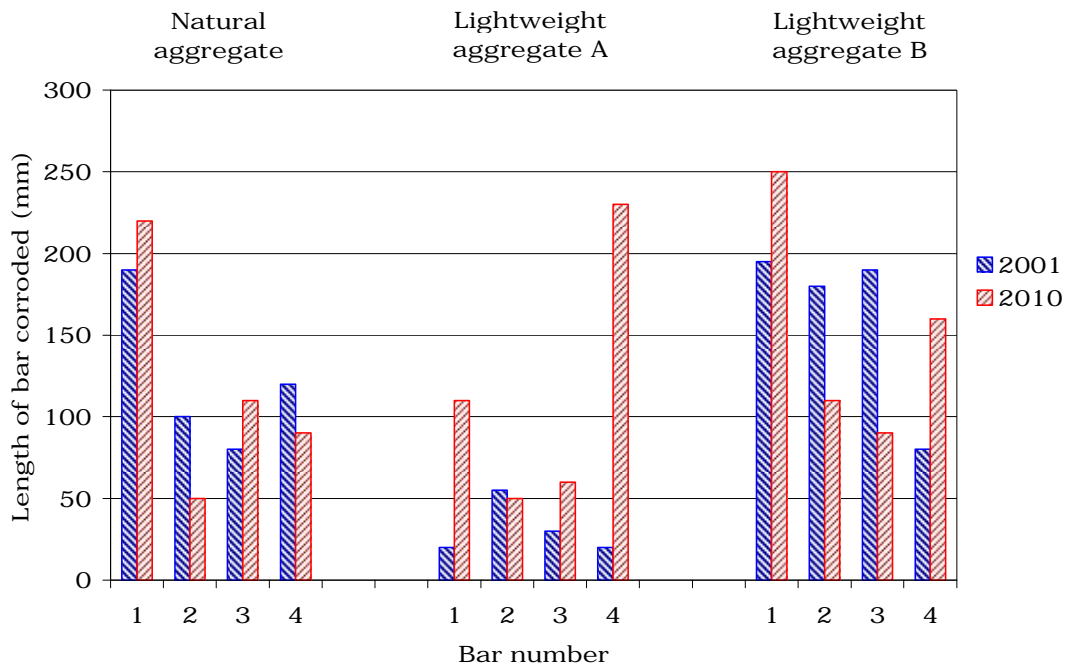
Figure 9: Length of corrosion on bars removed from specimens

The extent and severity of the corrosion on the bars removed from the specimens in October 2010, compared with those removed in September 2001, are given in Table 5 and Figure 9. The length of corroded bar within each specimen was very variable. For the specimens containing natural aggregate and Lightweight Aggregate B, the average lengths of corroded bar were similar in 2001 and 2010, whereas the average corroded lengths for the bars removed from the specimens containing Lightweight Aggregate A were much greater in 2010.

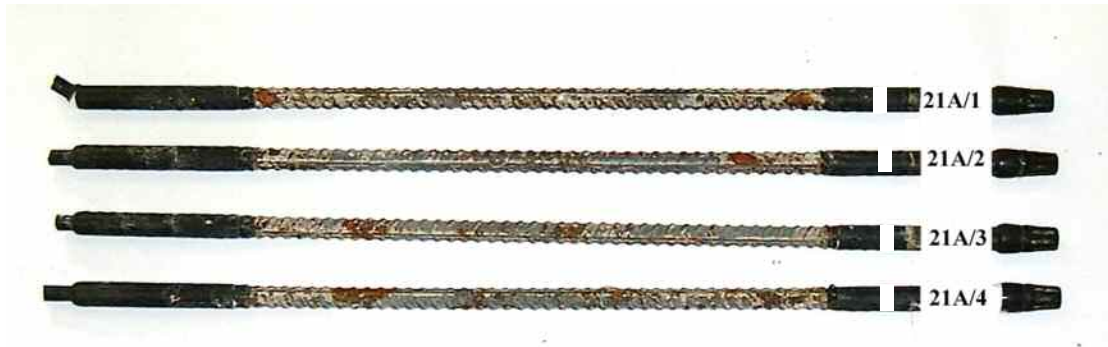
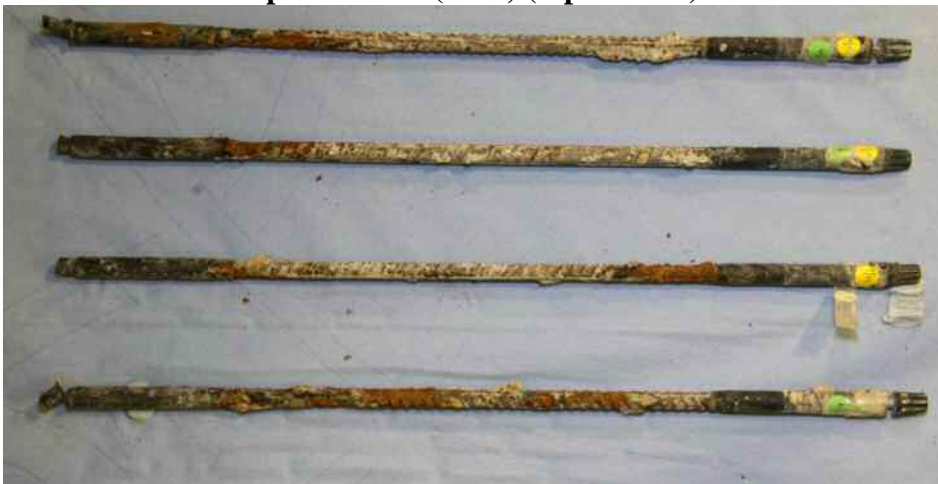
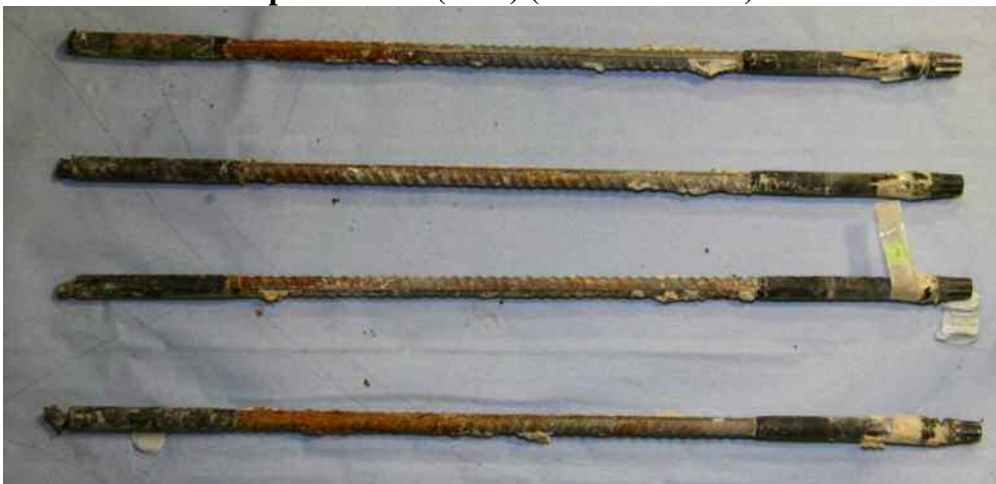
Figure 10: Photographs of bars removed from natural aggregate specimens

The corrosion on the bars generally occurred in discrete areas along the surface of the bar and was light brown in colour. Figures 10-12 show the top surface of the bars removed in 2001 and the top and bottom surfaces of the bars removed in 2010. There was no corrosion on the underside of any of the bars removed in 2001 nor was there corrosion on the underside of the bars removed from the specimens containing Lightweight Aggregate A in 2010, whereas there was significant corrosion on the underside of the bars removed from the specimens containing natural aggregate and Lightweight Aggregate B in 2010.

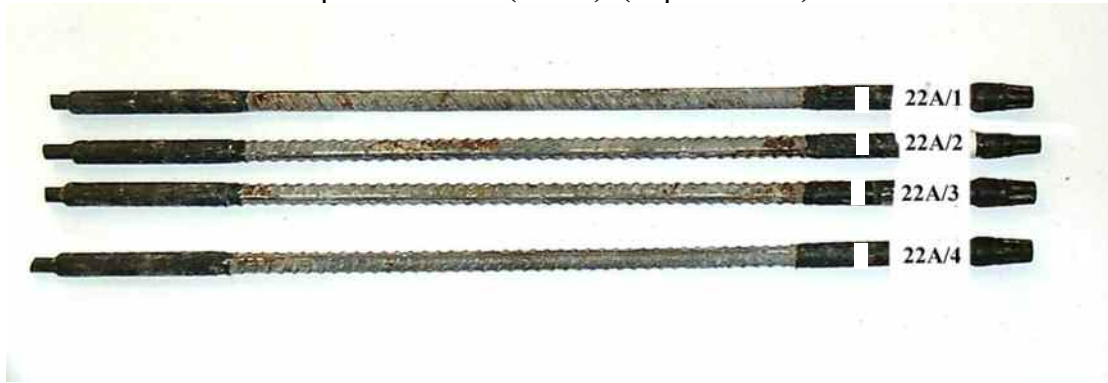
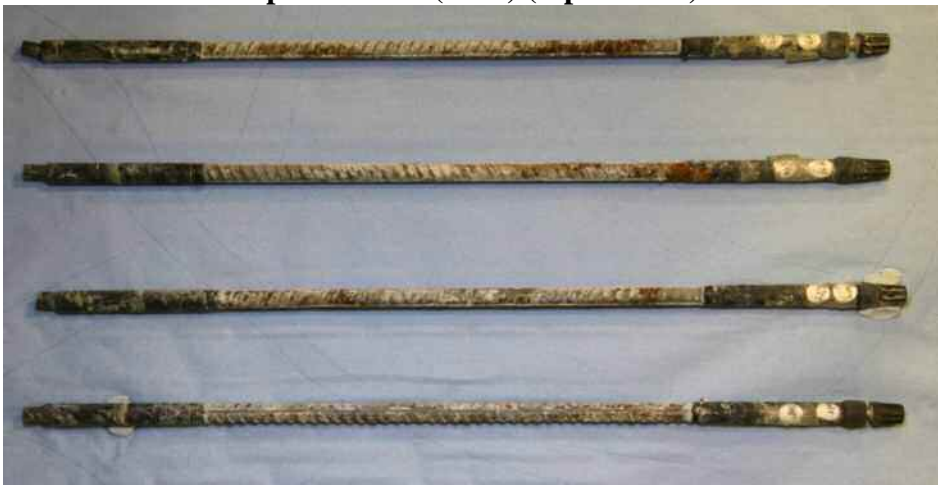
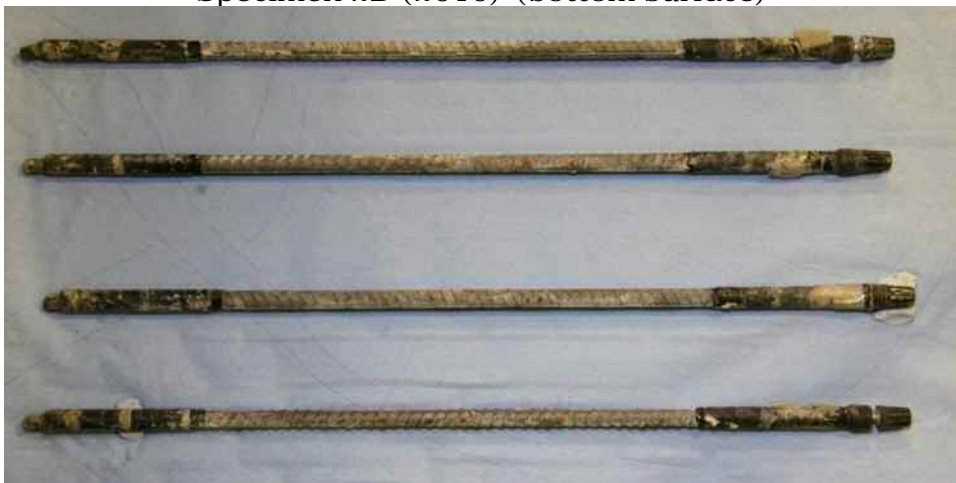
Figure 11: Photographs of bars from removed Lightweight Aggregate A specimens

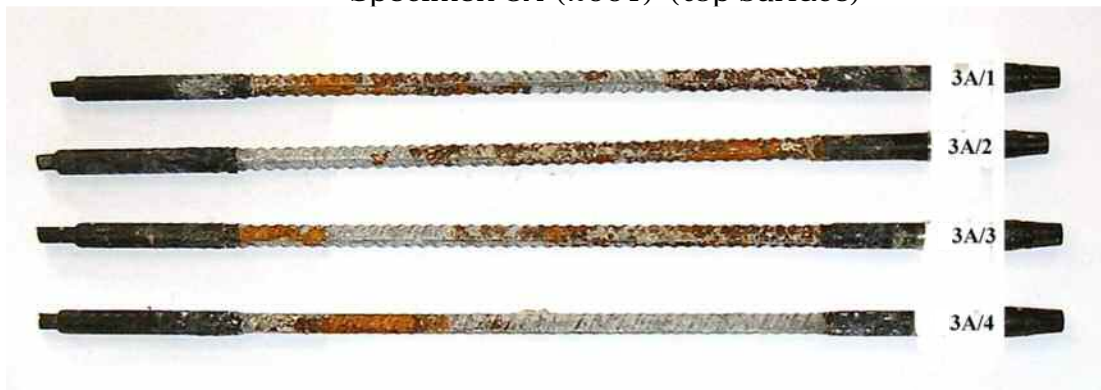
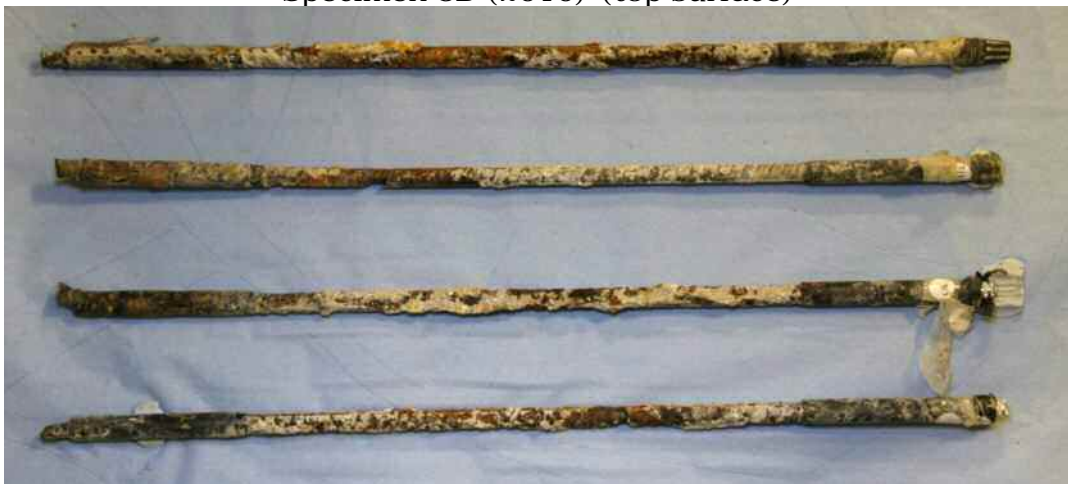
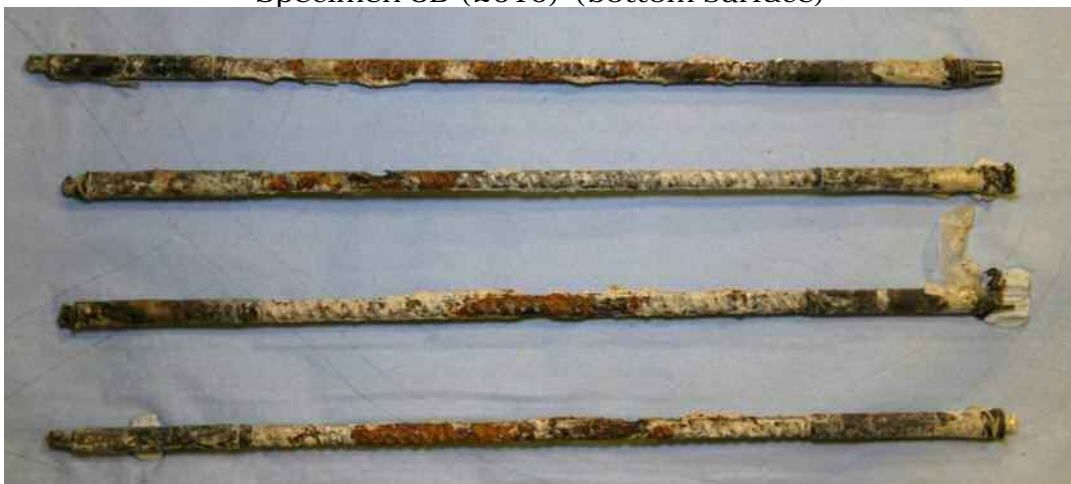
Figure 12: Photographs of bars removed from Lightweight Aggregate B specimens

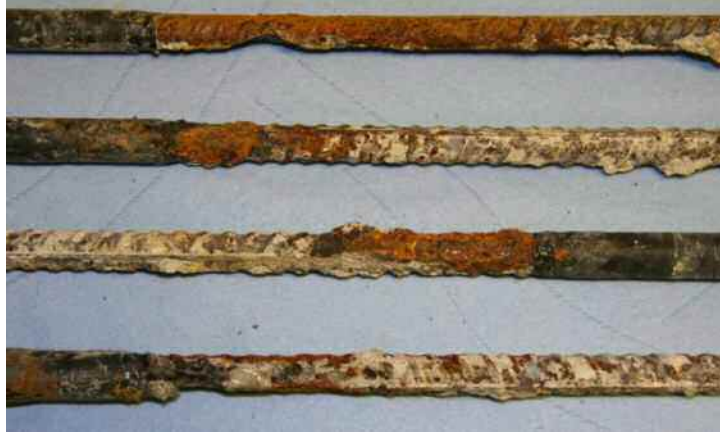
Figure 13: Close up photograph of bars removed from natural aggregate specimens

Figures 13-15 show close up views of the areas of corrosion on the bars removed from the specimens in 2010. It is clear that the corrosion was much more severe on the bars from the specimens containing natural aggregate and Lightweight Aggregate B than on the bars removed the specimen containing Lightweight Aggregate A.

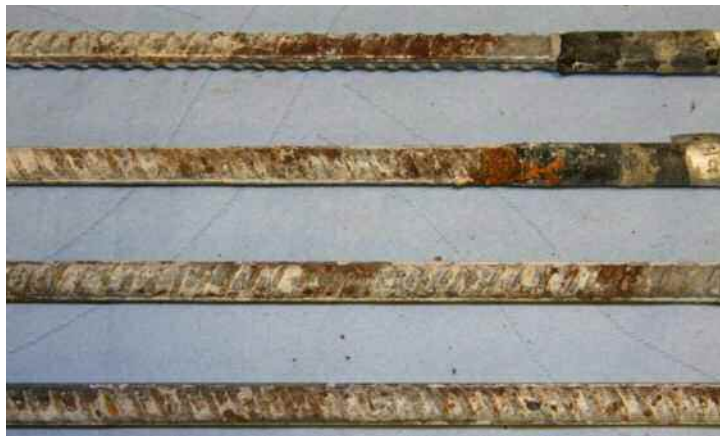
Figure 14: Close up photograph of bars removed from the specimens containing Lightweight Aggregate A

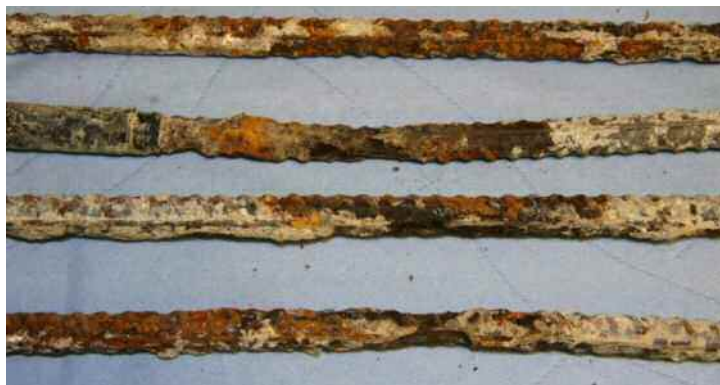
Figure 15: Close up photograph of bars removed from the specimens containing Lightweight Aggregate B
