The acoustic durability of timber noise barriers on England's strategic road network

PUBLISHED PROJECT REPORT PPR490

Acoustic durability of noise barriers over time

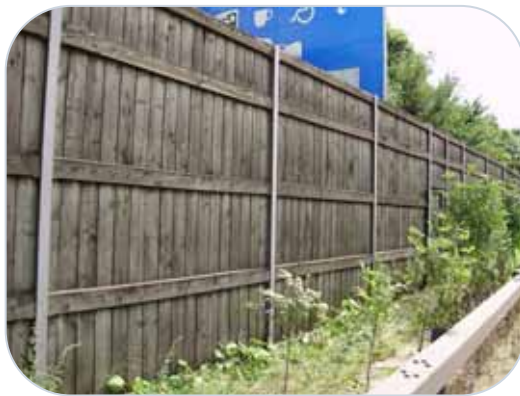
(a) Sound reflective noise barrier

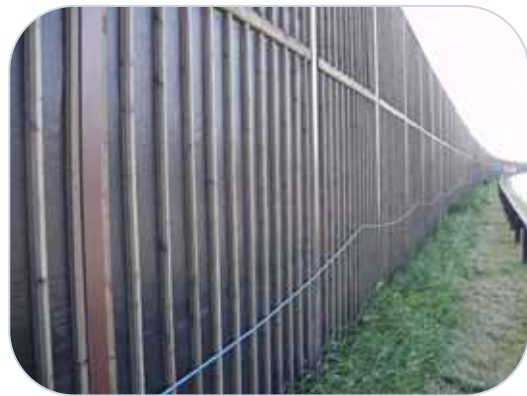
(b) Sound absorptive noise barrier

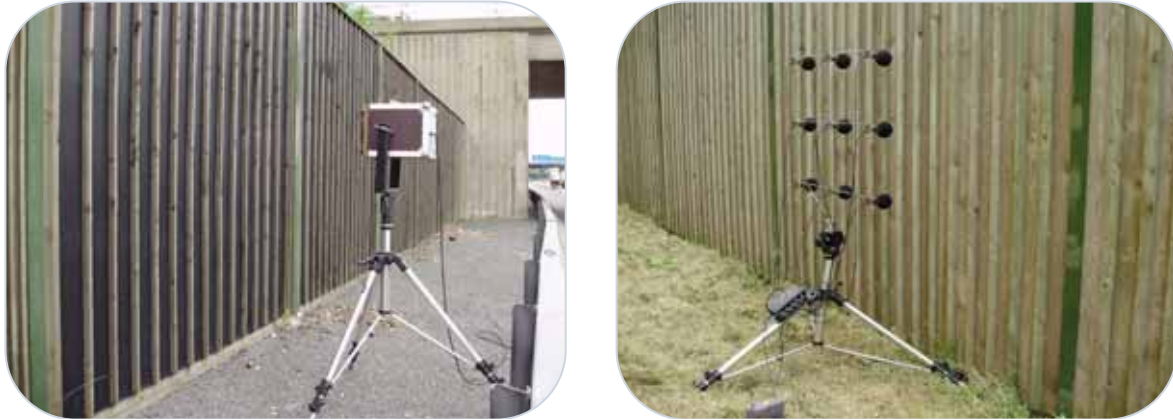
Figure 2.3 shows the loudspeaker and microphone array used in the measurements performed in this study (the microphone array is shown is fitted with 9 microphones).

Figure 2.3: Loudspeaker and microphone array used in the current study

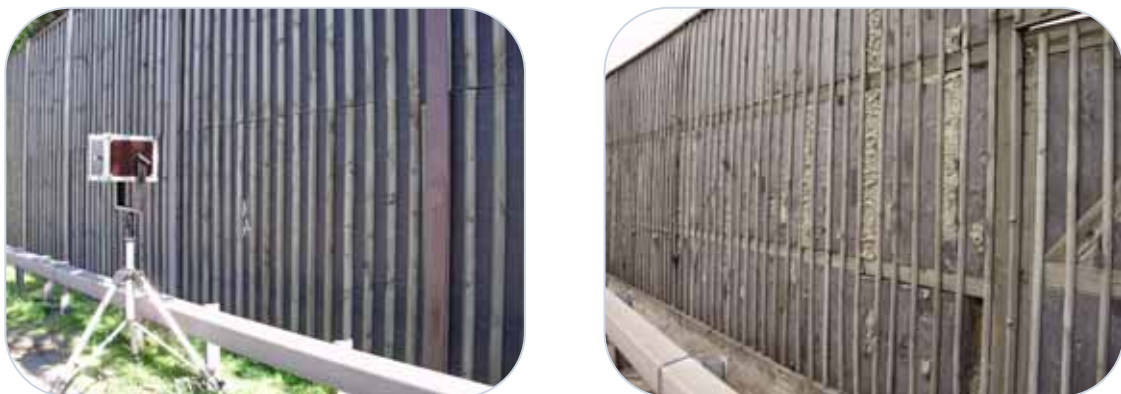
The age of the barrier affects the transmission loss due to the timber acoustic elements (panels) shrinking and warping, which create gaps in the barrier allowing sound leakage. Age is also a factor when discussing the decay of the wood and stability of the barrier. The age of the barrier can have an added effect if the barrier is absorptive as the absorbing material (usually fibre glass or similar) deteriorates significantly and can accumulate at the base of the barrier as a result of exposure to meteorological conditions. Figure 4.1 shows examples of absorptive barriers in good and poor condition.

Figure 4.1: Sound absorptive noise barriers in good and poor condition

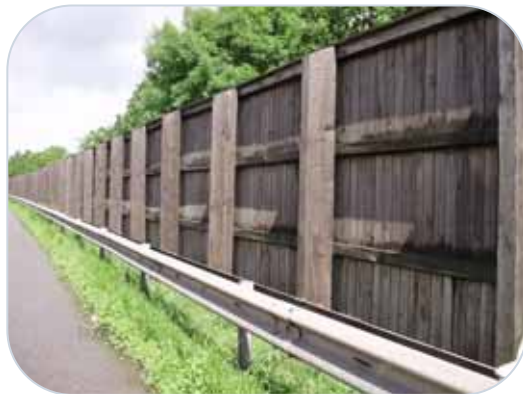
(a) Vertical elements, timber posts

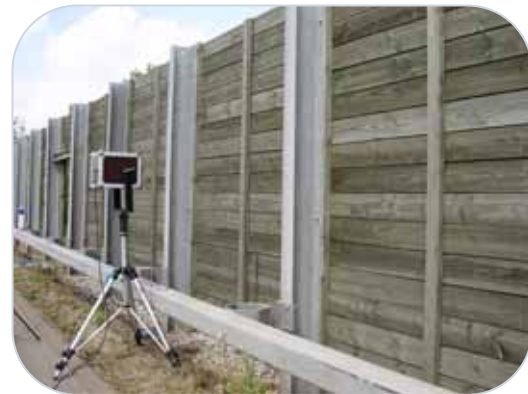
(b) Horizontal elements, steel posts

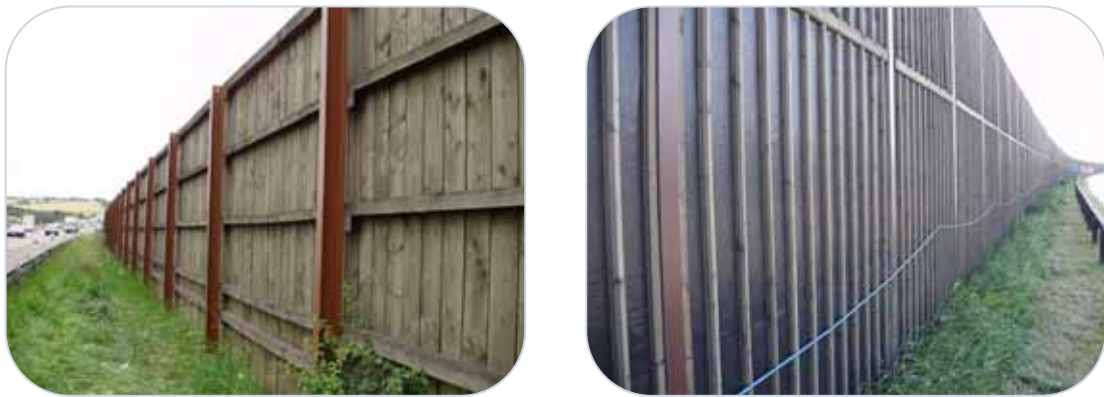
Examples of these different constructions are shown in Figure 4.3

a) Continuous, single-element barrier

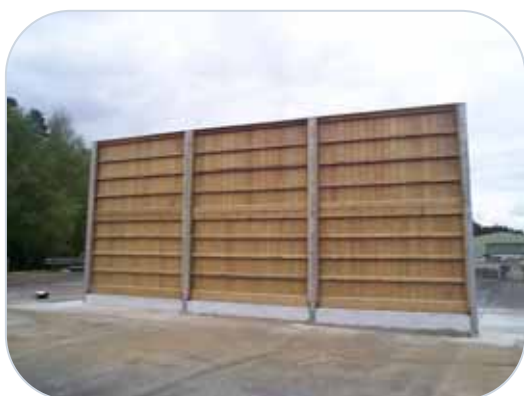
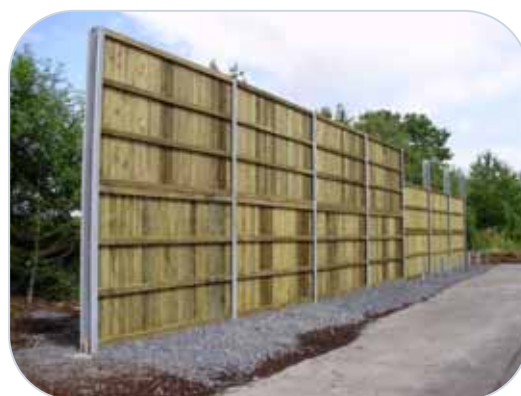
Figure 4.4: Timber noise barriers erected on the TRL noise barrier test facilities

(a) Barriers tested by Watts and Morgan (2005)
(Crowthorne test facility)

(b) Barriers erected during current study
(Bishops Castle Test Facility)

Figure 4.4 shows examples of the barriers installed on the TRL noise barrier test facilities.

It is considered that one of the main reasons for this may have been that the latter tests were performed using the modified test arrangement shown in Figure 5.3b⁵. It is noted from both Figure 5.3b and Figure 5.3c that these arrangements differ from the normal Part 2 panel arrangement since they include *upper and lower* panel elements on either side of the post and therefore a horizontal joint is present approximately midway up the barrier. This approach was adopted so as to provide the best comparability with the barriers evaluated using Part 6, which used multiple 2 m high panels to achieve the overall 4 m height (i.e. a multi-element construction as defined in Section 4.5; see, for example, Figure 4.4b), with the loudspeaker/microphone axis opposite the joint between the two panels.

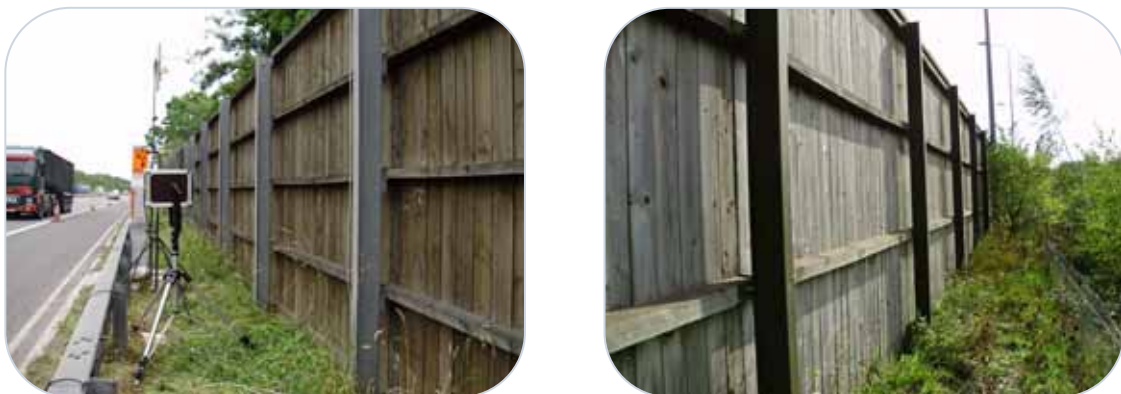
However as noted in Section 4.5, some of the barriers were constructed as continuous sections mounted onto either the front or rear face of the supporting posts as shown in Figure 5.2. In these cases, post measurements were not taken since it was considered that the presence of the post should not have any detrimental effect on the sound insulation performance due to there being no opportunity for sound leakage through the joint between the panel and post.

Figure 5.2: Noise barriers constructed as continuous sections with front or rear supporting posts

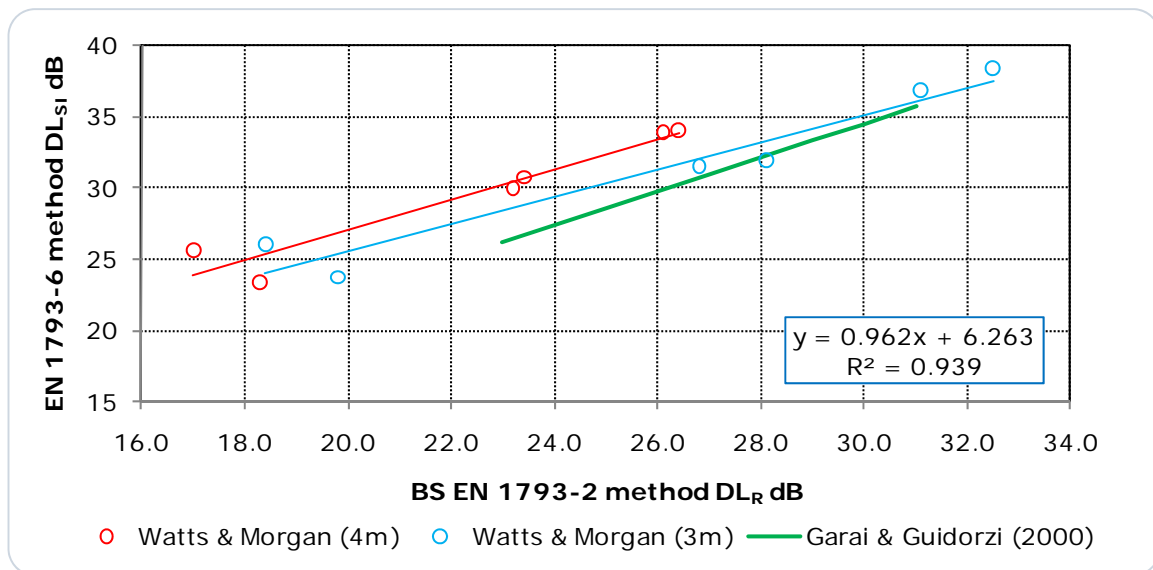
Figure 5.5: Relationships between single number ratings of sound insulation DL_R and DL_{Si} from Watts & Morgan (2005) and Garai & Guidorzi (2000)

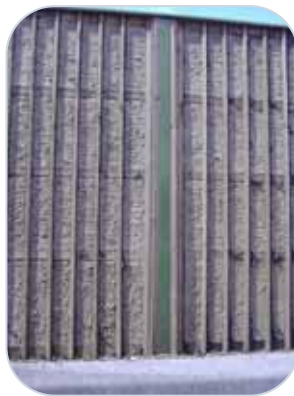
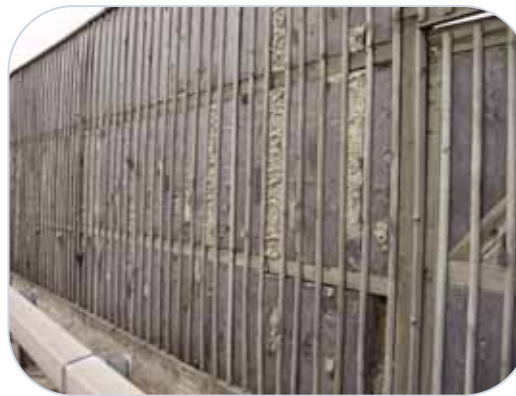
It is noted that the local conditions to which these barriers are exposed may accelerate degradation. For example, it is noted from specific visual inspections of some of the candidate barriers as well as general observations when driving on the network that sound absorptive timber barriers appear to be more prone to vandalism than their reflective counter parts. Numerous sections of barrier have been observed where the protective membrane appears to have been deliberately removed (i.e. the damage is extensive with large sections of the membrane missing, and much greater than might be expected from degradation due to exposure to sunlight, splash/spray, flying debris, etc.)

(a) M25 J12-13

(b) M25 J9-10

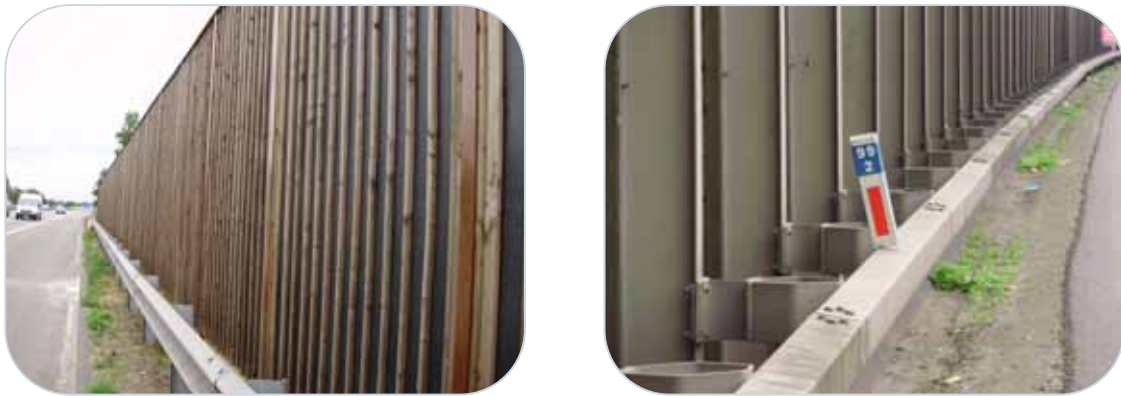
Figure 6.1: Examples of safety fences in close proximity to noise barriers

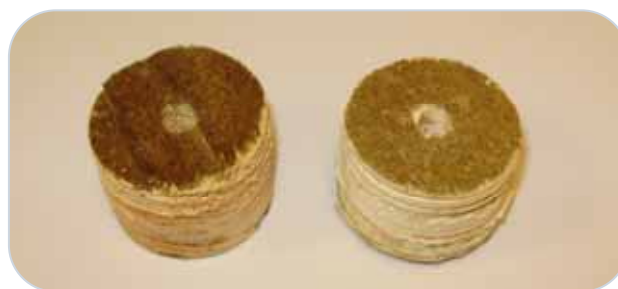
All test cores were extracted from the vertical timbers forming the main part of the panel screen, using a holesaw with an external diameter of 40 mm. These timbers were 22 mm thick. In accordance with the method described in BS 4072-2:1987, it was intended that the dry weight of the core should be in excess of 8 grams. Figure 7.1 shows two such cores from the barrier. Two cores were extracted for each moisture content evaluation, the cores being taken from the same two timbers each time. Core samples were not extracted from the horizontal timbers of the barrier due to the thickness of these elements.

Figure 7.1: 40 mm diameter core samples extracted for moisture content determination

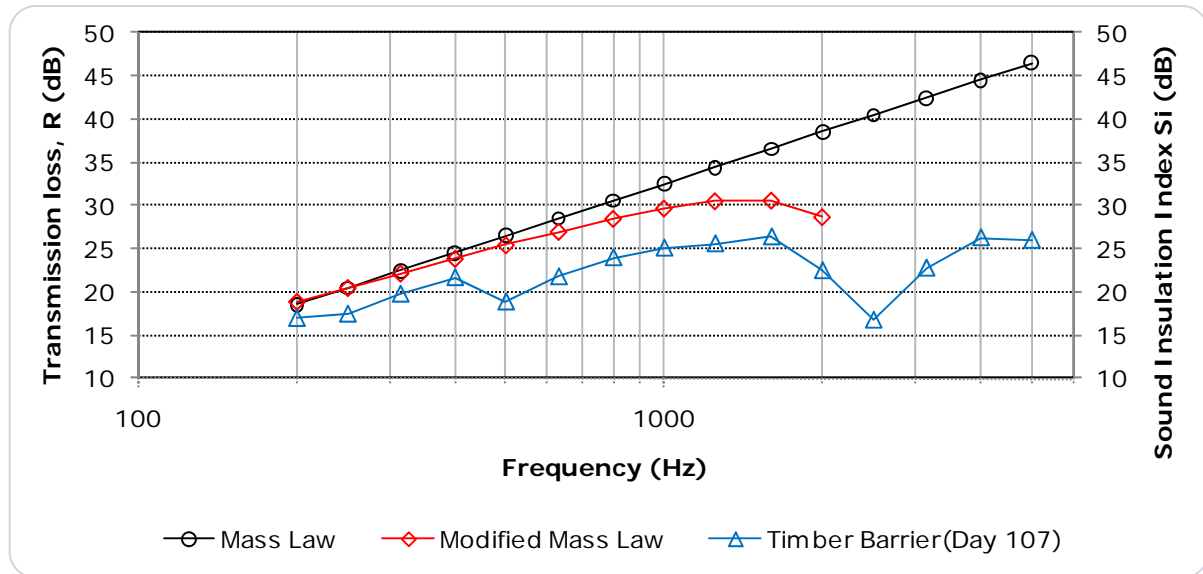
Figure 7.7: Predictions of sound insulation, R , based on surface density and measured values of sound insulation, S_i , using EN 1793-6

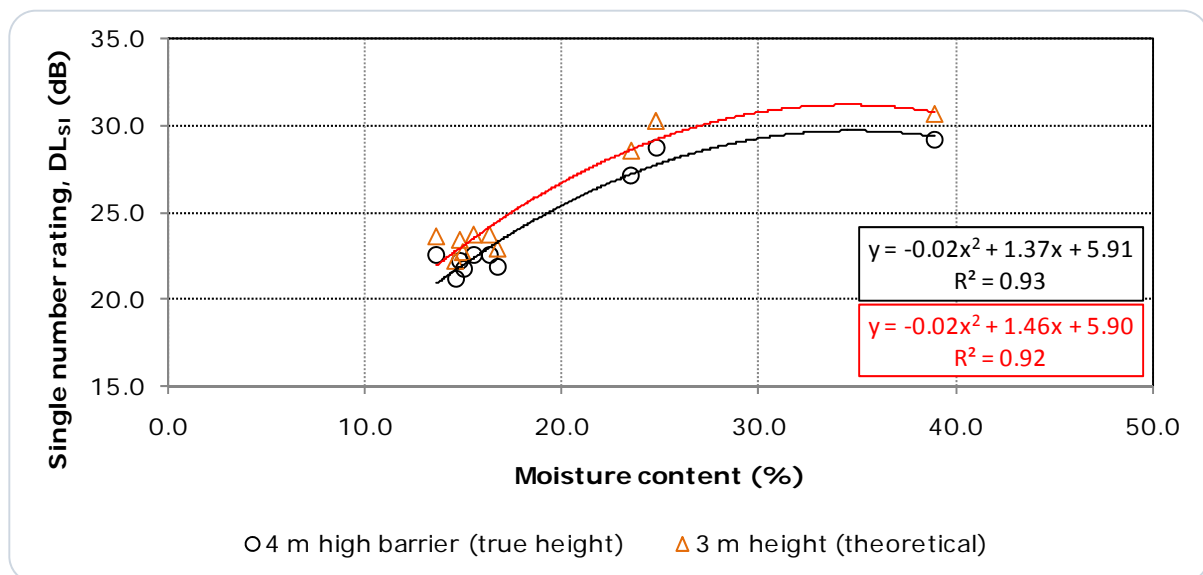
Figure 7.8: Relationship between moisture content and sound insulation performance

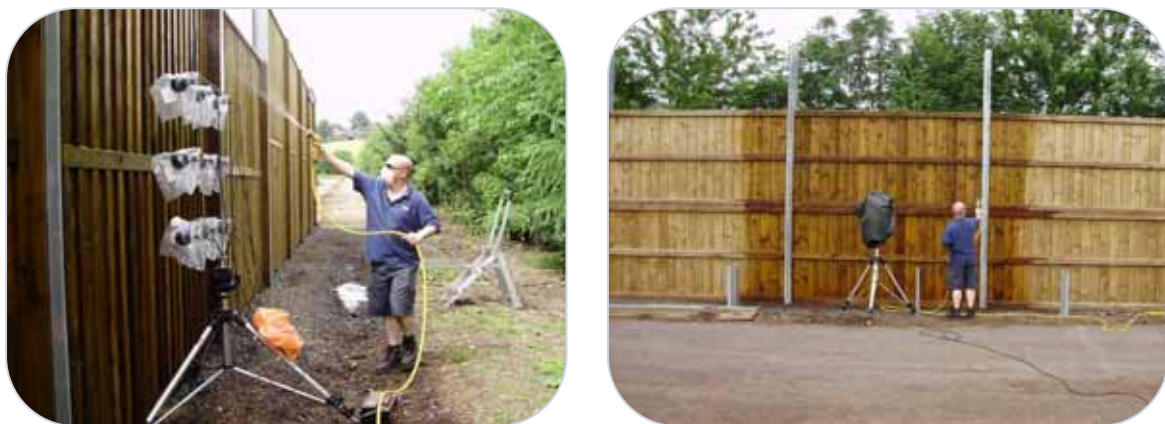
Figure 8.1: Wetting of noise barrier for simulated rainfall study

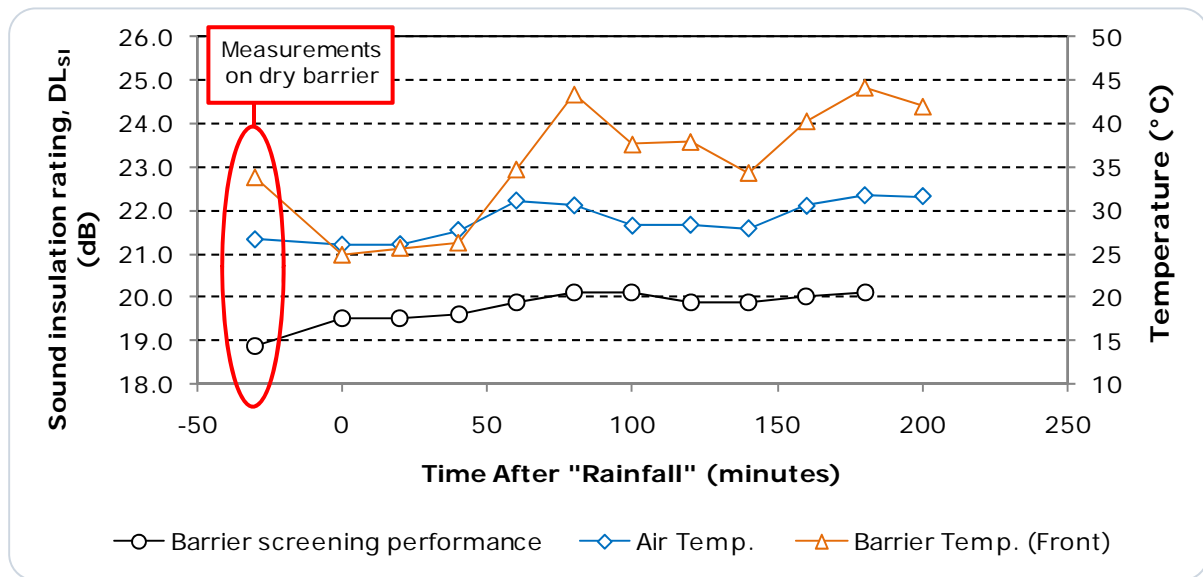
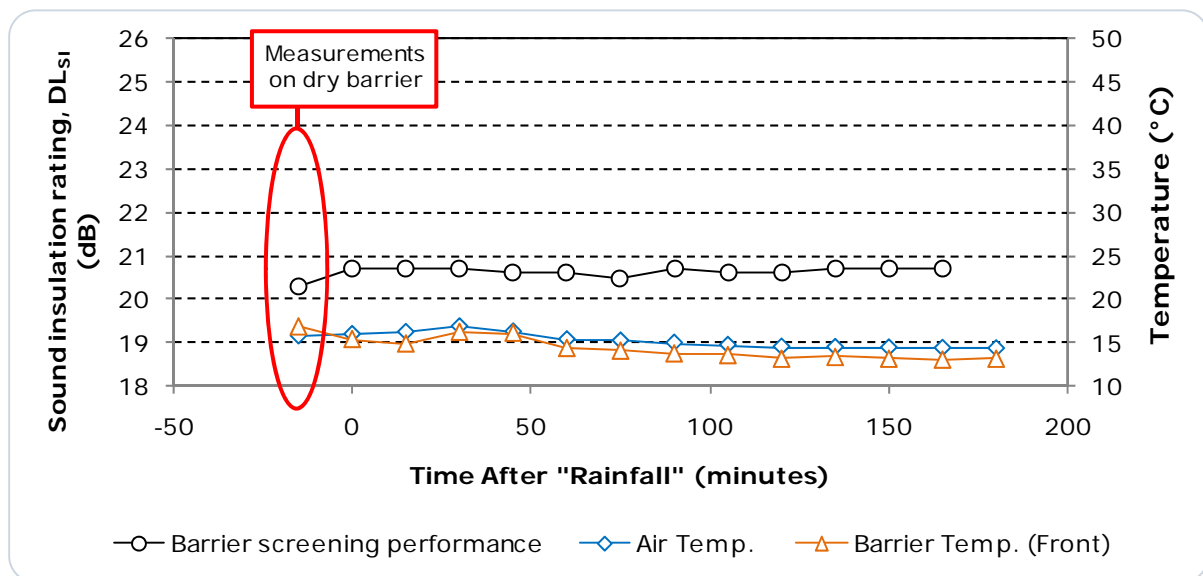
a) July 2009 assessment (summer conditions)

b) October 2009 assessment (autumn conditions)

Figure 8.2: Variation in sound insulation performance with 'drying time' as measured during simulated rainfall study

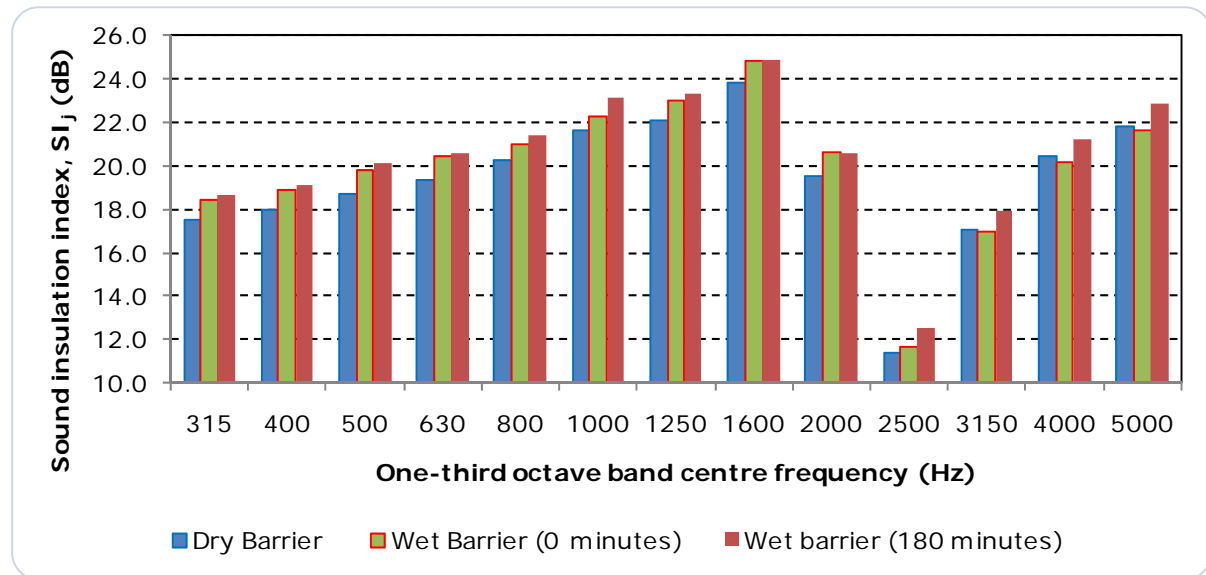
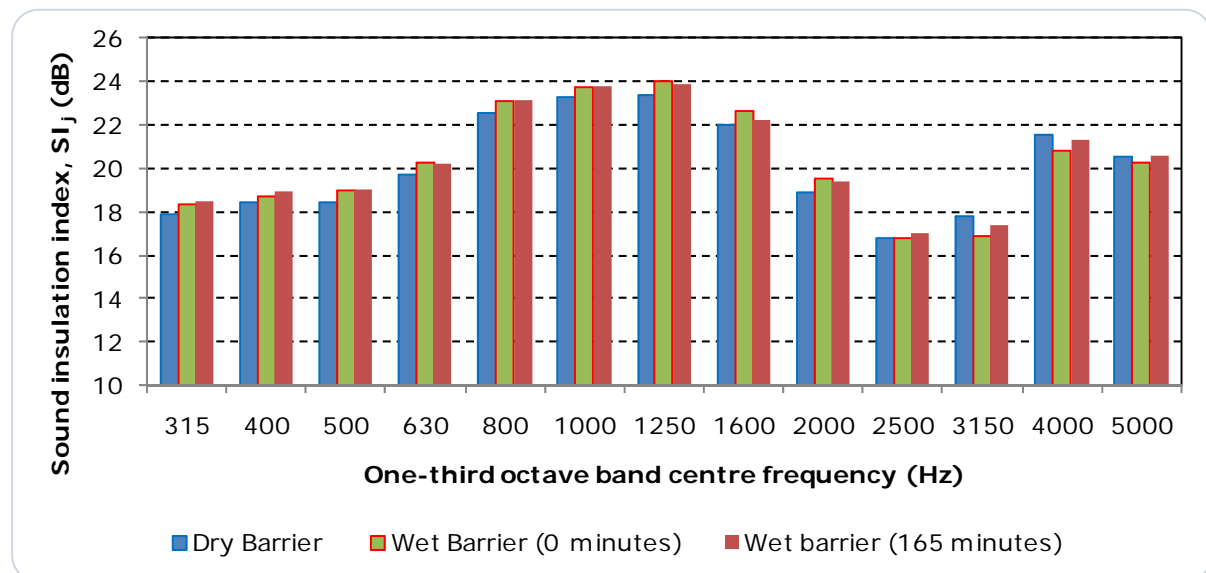
b) October 2009 assessment (autumn conditions)

Figure 8.4: Variation in one-third octave band sound insulation performance with 'drying time' as measured during simulated rainfall study

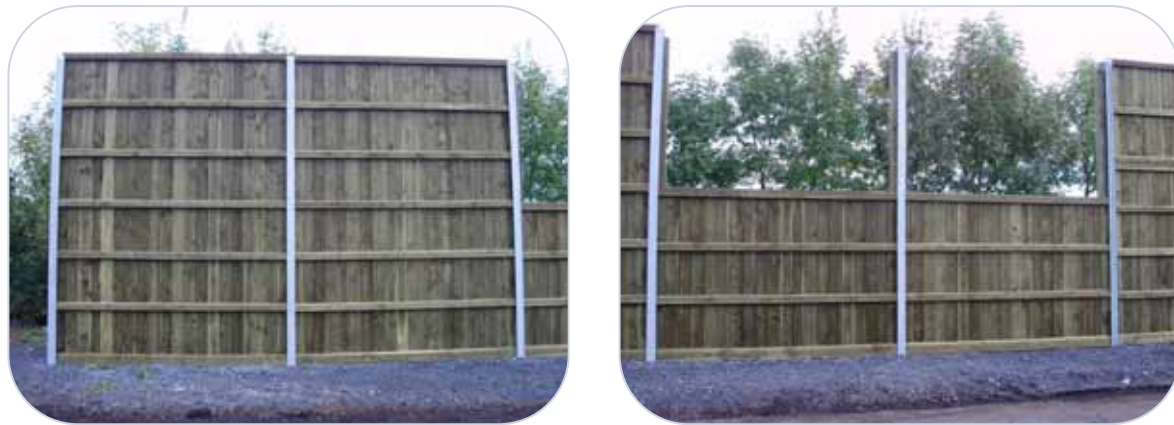
(a) Barrier A (4.0 m high panels)

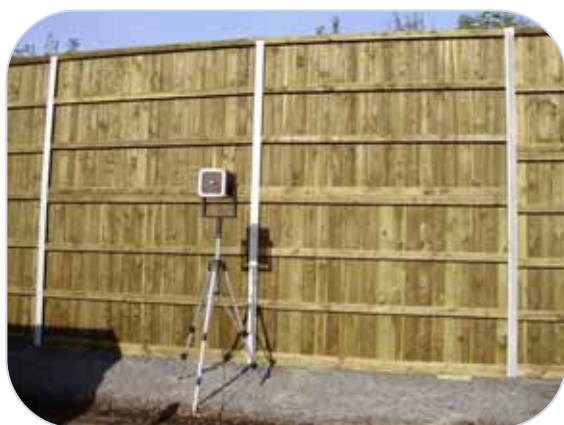
(a) Barrier B (2 m + 2 m high panels)

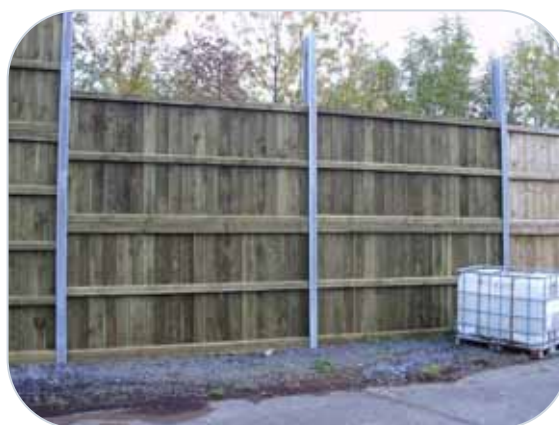
(b) Barrier E (1.5 m + 1.5 m high panels)

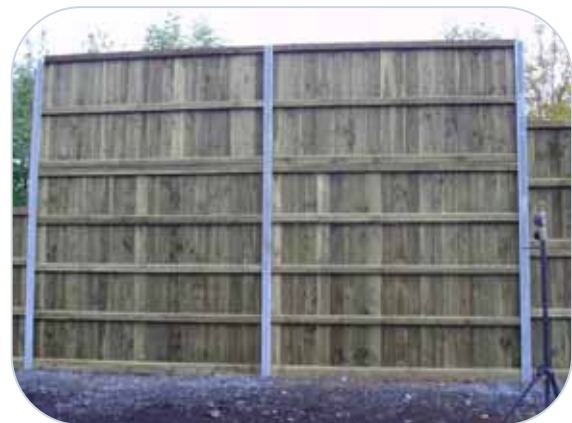
**Figure 9.9: Barrier C (2.5m + 1.5m high panels)**
