**PUBLISHED PROJECT REPORT PPR643**

**Detection of changes in pavement texture condition using high resolution 3D surface measurements**

Research into pavement surface disintegration: Phase 2 - Task 2

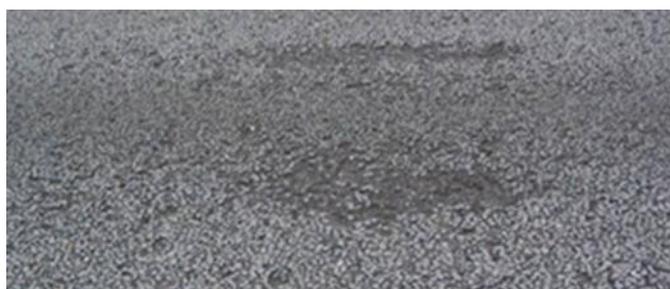
**Figure 1:** Example of surface disintegration on hot rolled asphalt.

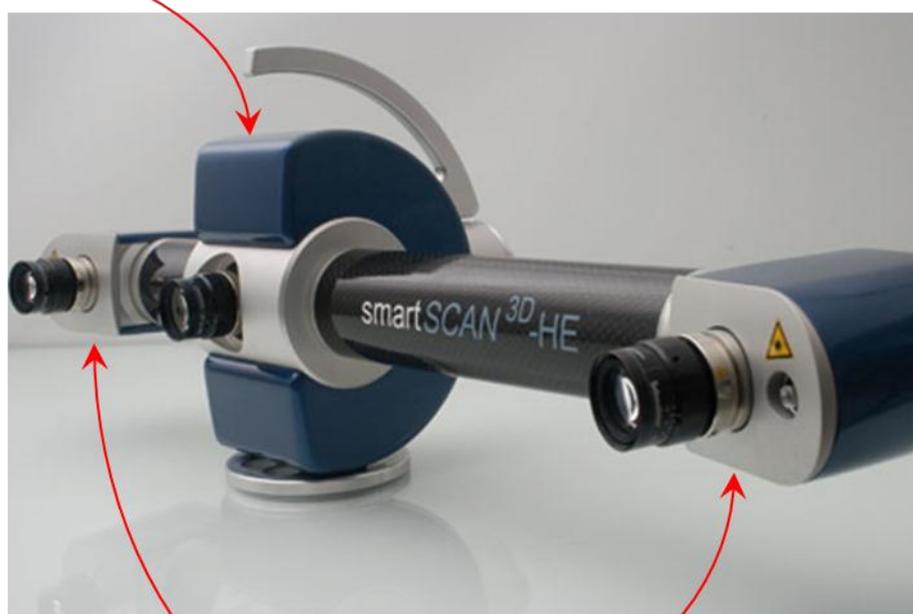
Light source

High resolution  
digital cameras

The Breuckmann SmartSCAN HE system (Figure 3) has to be static so as to ensure an optimal data capture. This is because up to 11 different light patterns are successively projected on the area under inspection to work out the 3-D information of the scene while a series of images are collected. The scene must not change during the collection of the images. It takes approximately one second to perform the scan, then a few more seconds for the processing and extraction of 3-D data from the images. There is no way to operate the system whilst moving without a significant degradation of the measurements.

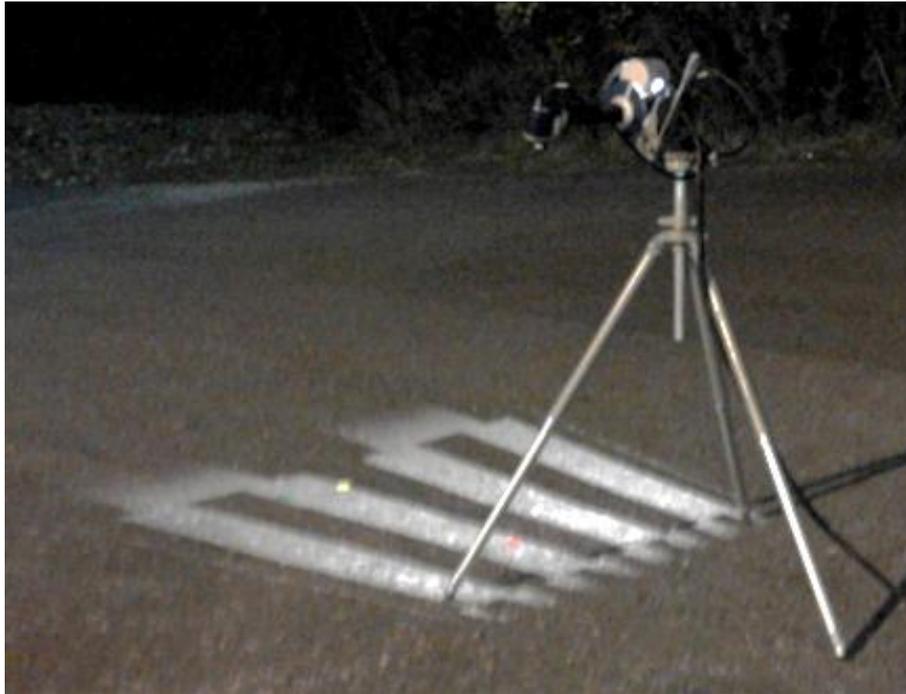
**Figure 4:** Breuckmann SmartSCAN HE system mounted on tripod with the lighting unit projecting various patterns.

Initial work to establish the capabilities of the SmartSCAN HE system (McRobbie, et al., 2011) used a set-up where it was mounted on a tripod and pointed down (as shown in Figure 4) to optimise the ability to measure the full extent of the surface texture depth.

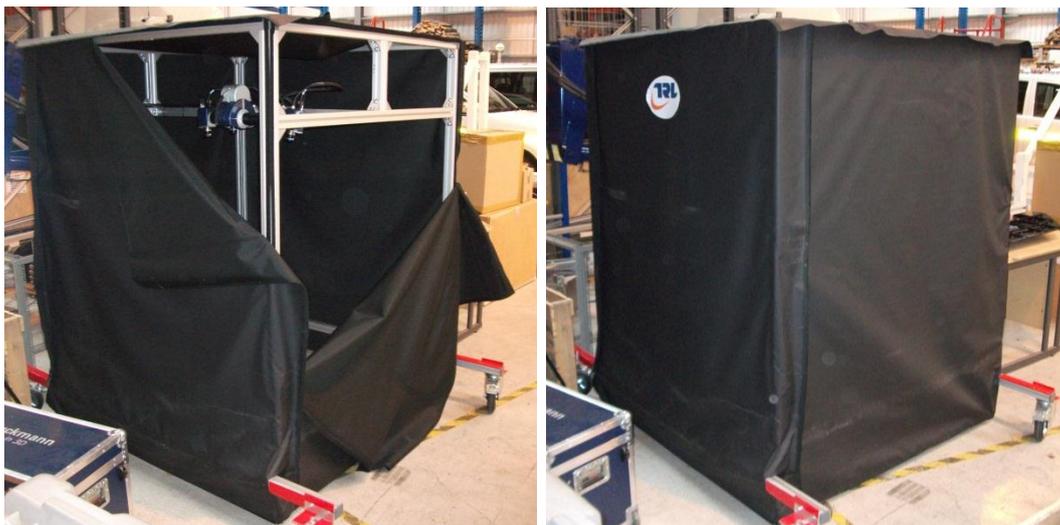
**Figure 5:** Mobile mounting platform with side panels partially opened (left) and closed (right).

Therefore the constraints on developing a “mobile” platform were that each image had to be collected statically, and in controlled lighting conditions. This resulted in a final design for the mounting platform in which the camera is 1.5m above the ground, levelled horizontally, and pointing vertically downwards (the precise location of the system can be adjusted by sliding the mounting bar along the side arms of the platform). The system has walls and a ceiling made of darkroom material and fastened using Velcro strips which can be detached to allow access to the device. Four wheels are used, two of which are lockable. These wheels are placed outside the main body of the enclosure so as to rotate fully and not impinge on the area being studied. A handle aids moving the platform from location to location, and the entire system can fit into the back of a van, for transport to site without requiring a rebuild of the platform before use. Photographs of the mobile mounting platform for the system are shown in Figure 5 and Figure 6.

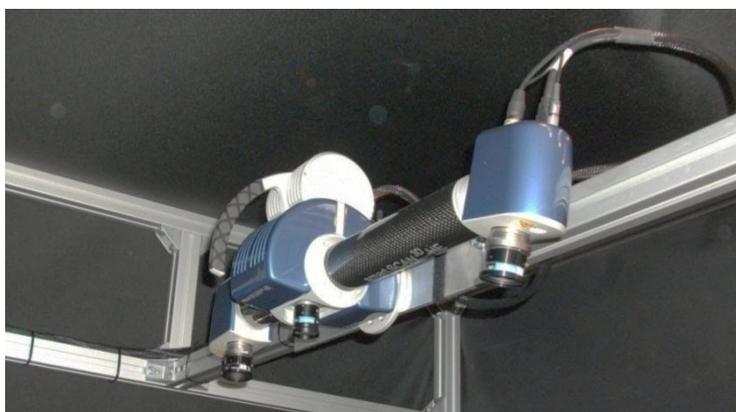
**Figure 6:** SmartSCAN system installed inside the mobile platform.

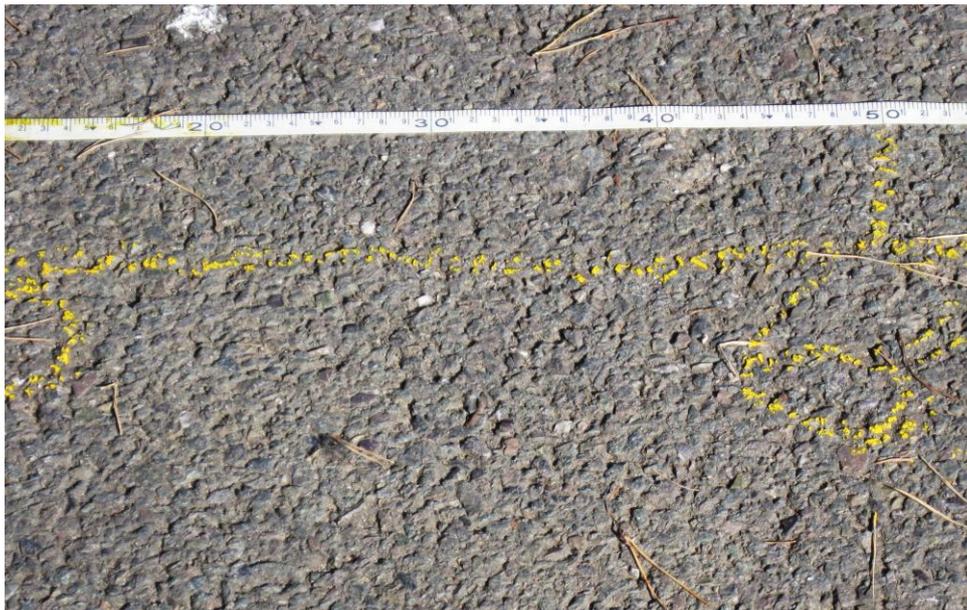
**Figure 32:** Site 1 surface – as found.

Site 1 was located on an access road to the TRL Small Road System (SRS). This site had an HRA surface, in good condition, with a typical aggregate size of approximately 10mm. The surface at this site was in good condition at the time of measurement, but had to be swept clear of numerous fallen pine needles prior to collecting data. Figure 32 shows a relatively close-up view of the surface at Site 1.

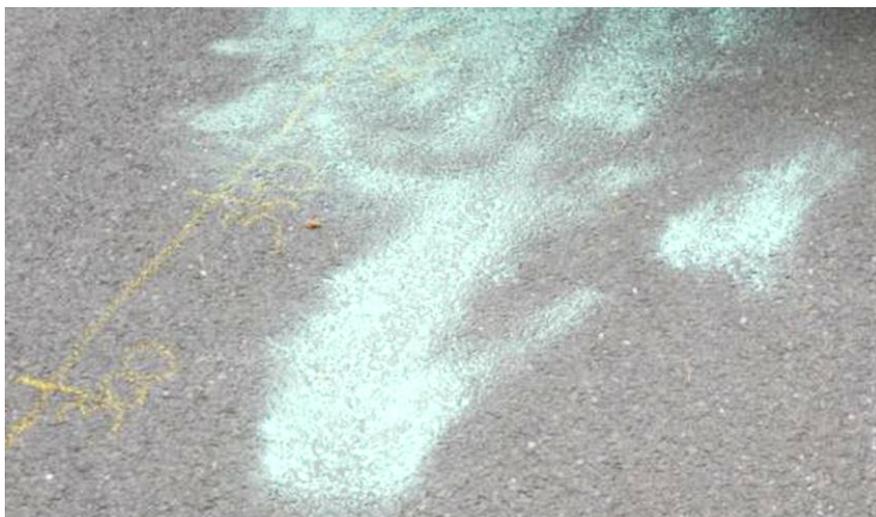
**Figure 33:** Site 1 surface showing sand used to mask texture.

Data was collected over the site in its as-found condition, and then finely textured sand was spread over the surface to fill in and mask some of the texture (Figure 33), before a subsequent data collection run was undertaken.

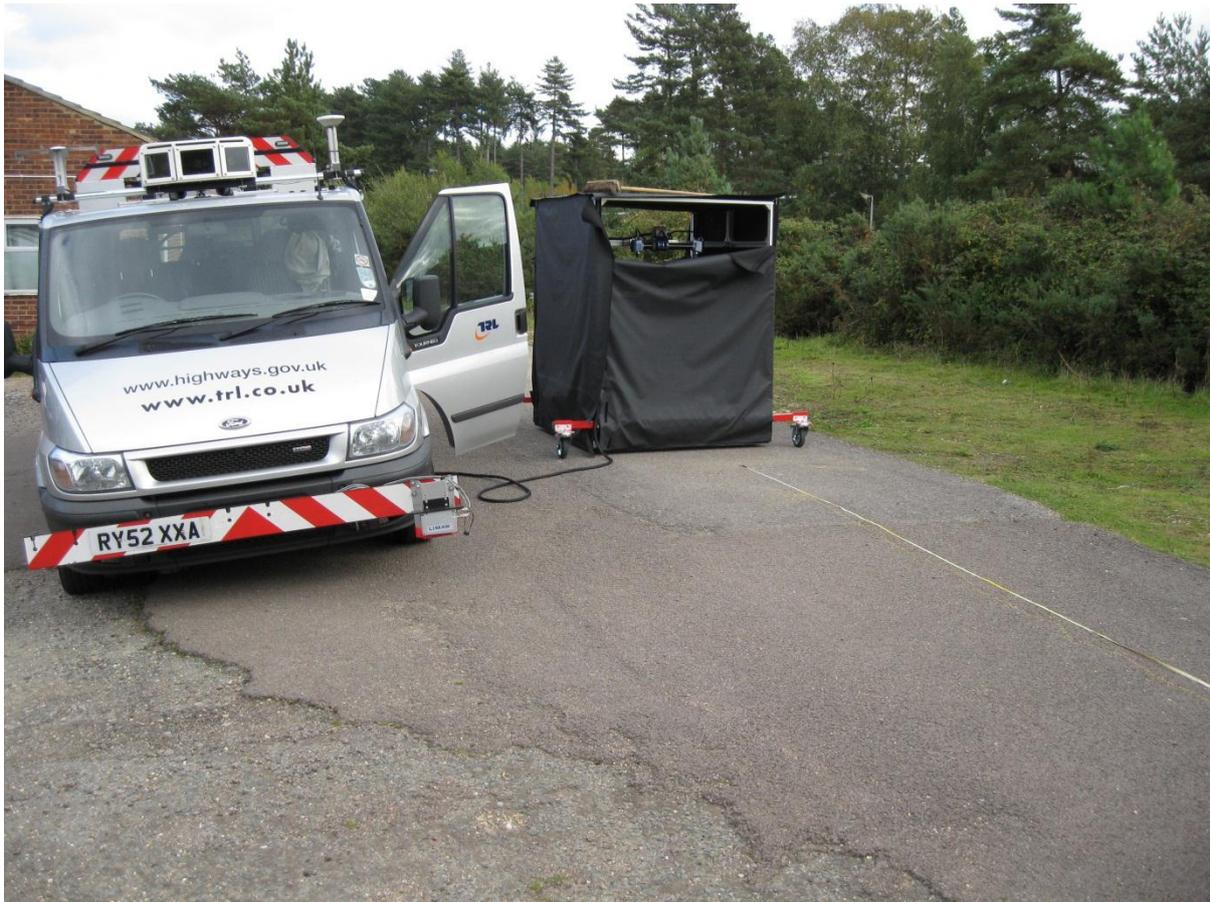
**Figure 35:** General overview of Site 2 and equipment.

Site 2 was located near the car park beside the TRL tennis courts (Figure 35). The area chosen for the trial was an old HRA surface in very poor condition, with lots of loose and missing aggregate (as shown in Figure 36). As before, the surface was prepared for survey (marked and swept) before collecting data on the surface. The loose aggregate was then removed from part of the site (Figure 37) and it was surveyed again.

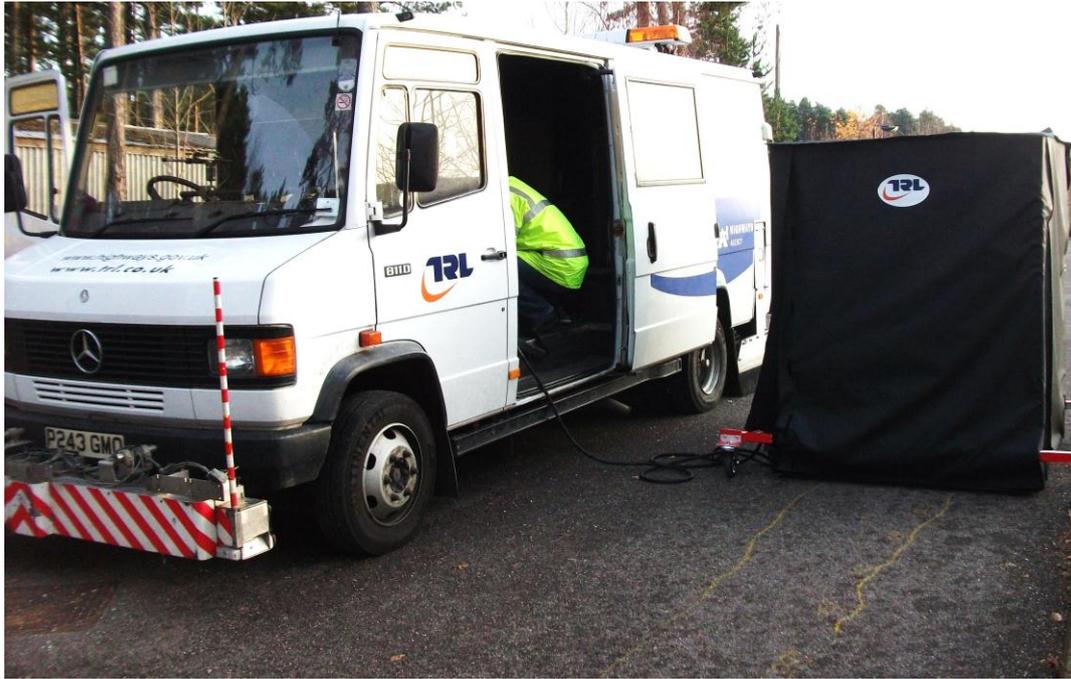
**Figure 41:** General overview of Site 3 and equipment.

Site 3 located within the TRL staff car park (Figure 41) is a Thin Surfacing System, with a typical aggregate size about 8mm. The site was in better initial condition than the Site 2.

As before, the site was prepared, swept, marked and then data was collected along its length. The site preparation this time included marking on two 150mm × 150mm areas on the surface. The surface within these marked areas was subjected to some forced deterioration before undertaking a second survey pass.
