**Thin Surfacing  
Performance Review (2013)**  
Final Report  
Highways Agency

January 2014

This document and its contents have been prepared and are intended solely for Highways Agency's information and use in relation to DfT T-TEAR Task 209.

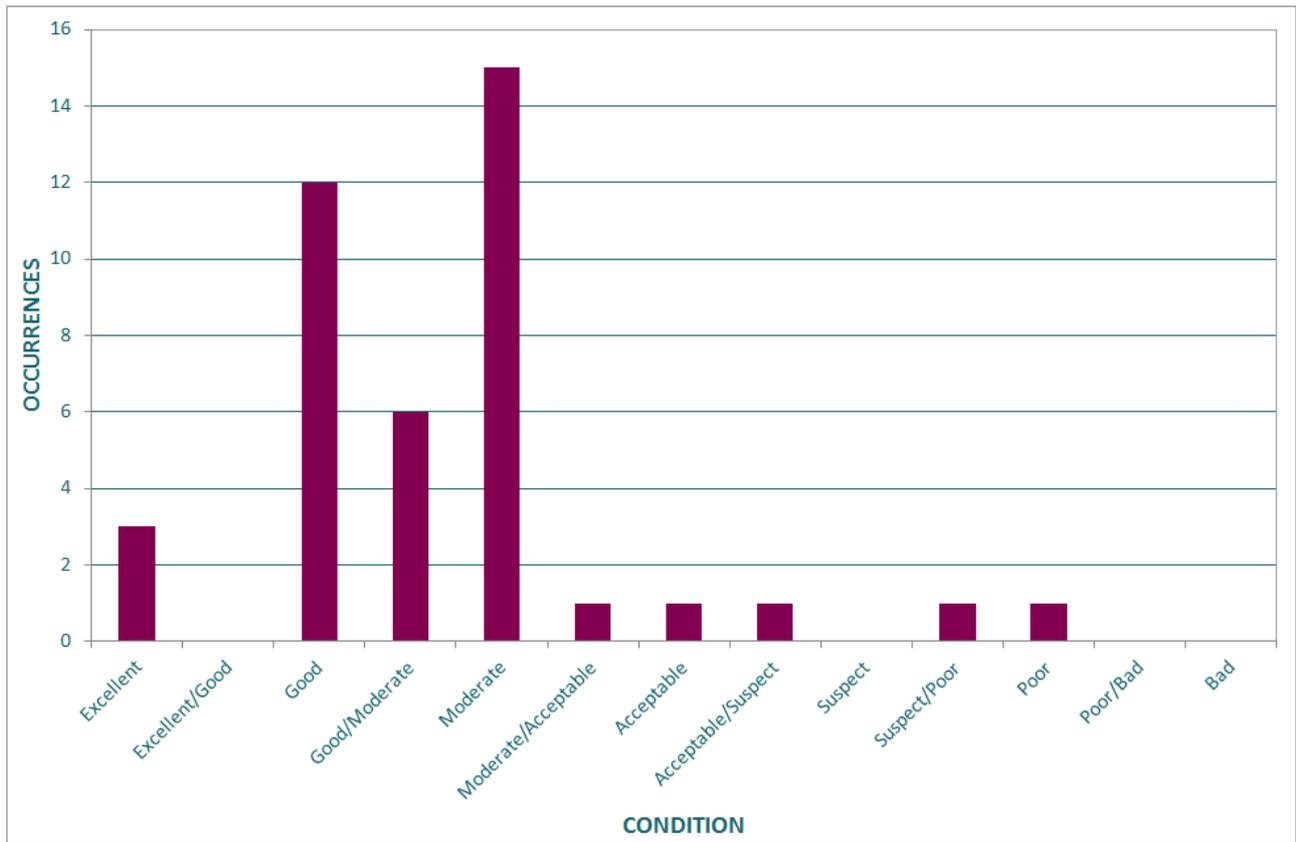
Figure E-1: Summary of condition ratings of inspected sites

Figure E-1 in Appendix E shows the number of sites falling into each of the condition categories (Table 4-1). The following features were noted:

- There is uncertainty in the probability distribution function of the sample data (e.g. normal or long-tail) – because the sample size of forty sites is relatively small and the condition assessments were dispersed.
- Not all condition categories presented in Table 4-1 were encountered within the sample data. The following were absent:
  - ‘Excellent/Good’
  - ‘Suspect’
  - ‘Poor/Bad’
  - ‘Bad’

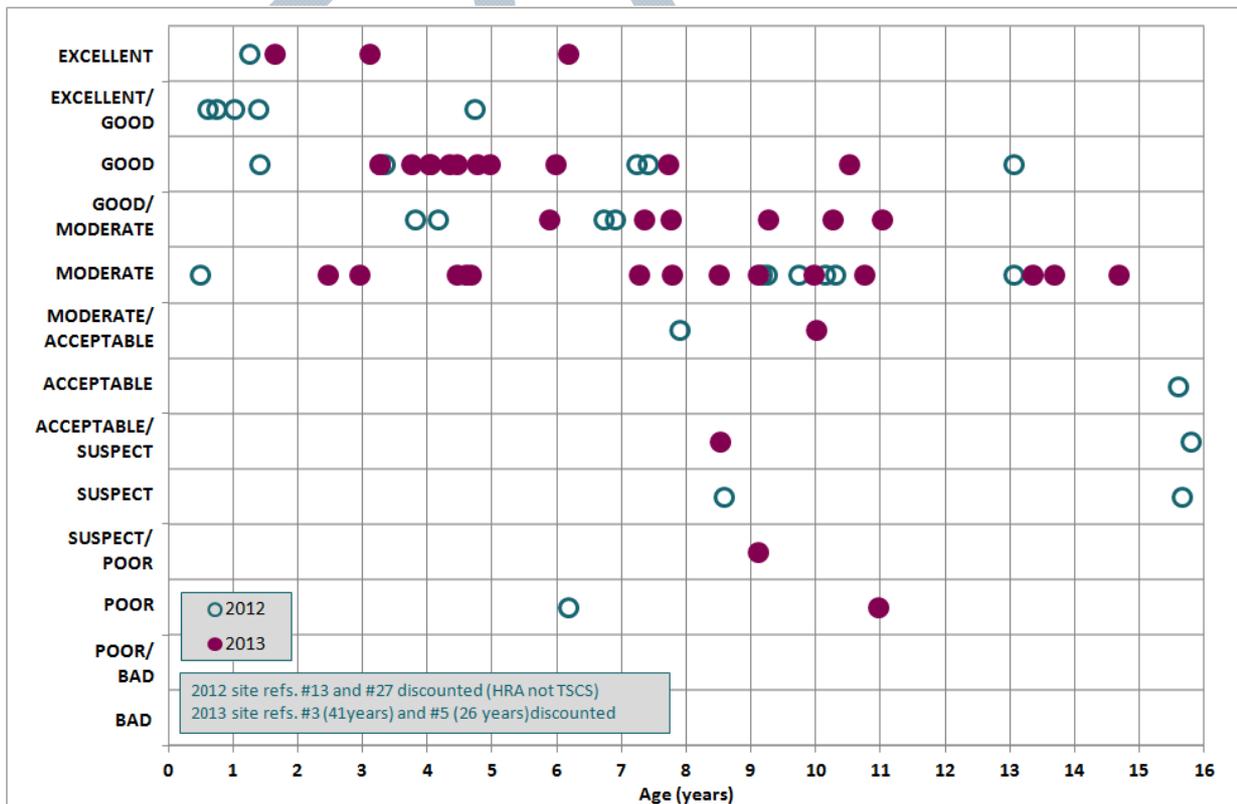
Figure F-1: Condition –Vs- Age

Figure F-1 in Appendix F presents the same data in a graphical format. No convincing trend can be discerned between age and condition.

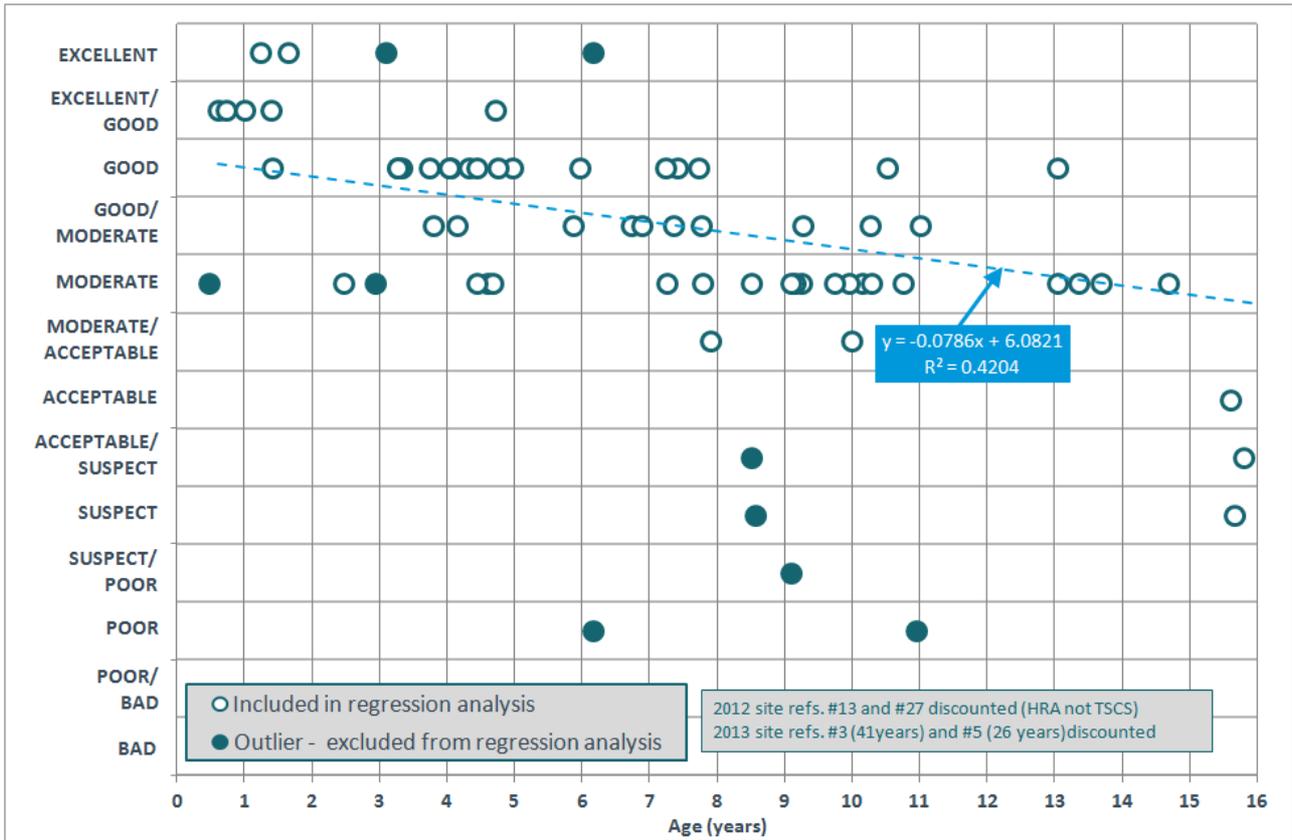
Figure F-2: Condition –Vs- Age regression analysis #1

Figure F-2 in Appendix F is a refinement of Figure F-1. It shows that by excluding nine of the sites that were considered to be "outliers" from the main data set plus four sites with clearly erroneous construction records then a linear relationship between condition and age could be approximated.

- There was no statistical logic for excluding the nine outliers. Discarding a relatively large proportion of such a small sample in this way is not considered to be a robust approach.
- Any correlation determined at sample site level would need to be applied to all HAPMS construction records to arrive at a network-wide estimate of condition. The regression analyses shown in Figure F-2 and F-3 are based upon filtered data. To apply this at network level, all construction records in HAPMS would have to be similarly filtered to remove errors. This would be a significant undertaking.
- When plotted against time, condition deterioration profiles normally follow an S-curve – not a linear pattern.
- The Coefficient of Determination (" $R^2$ " value) in both Figures D-2 and F-3 does not represent a close fit.

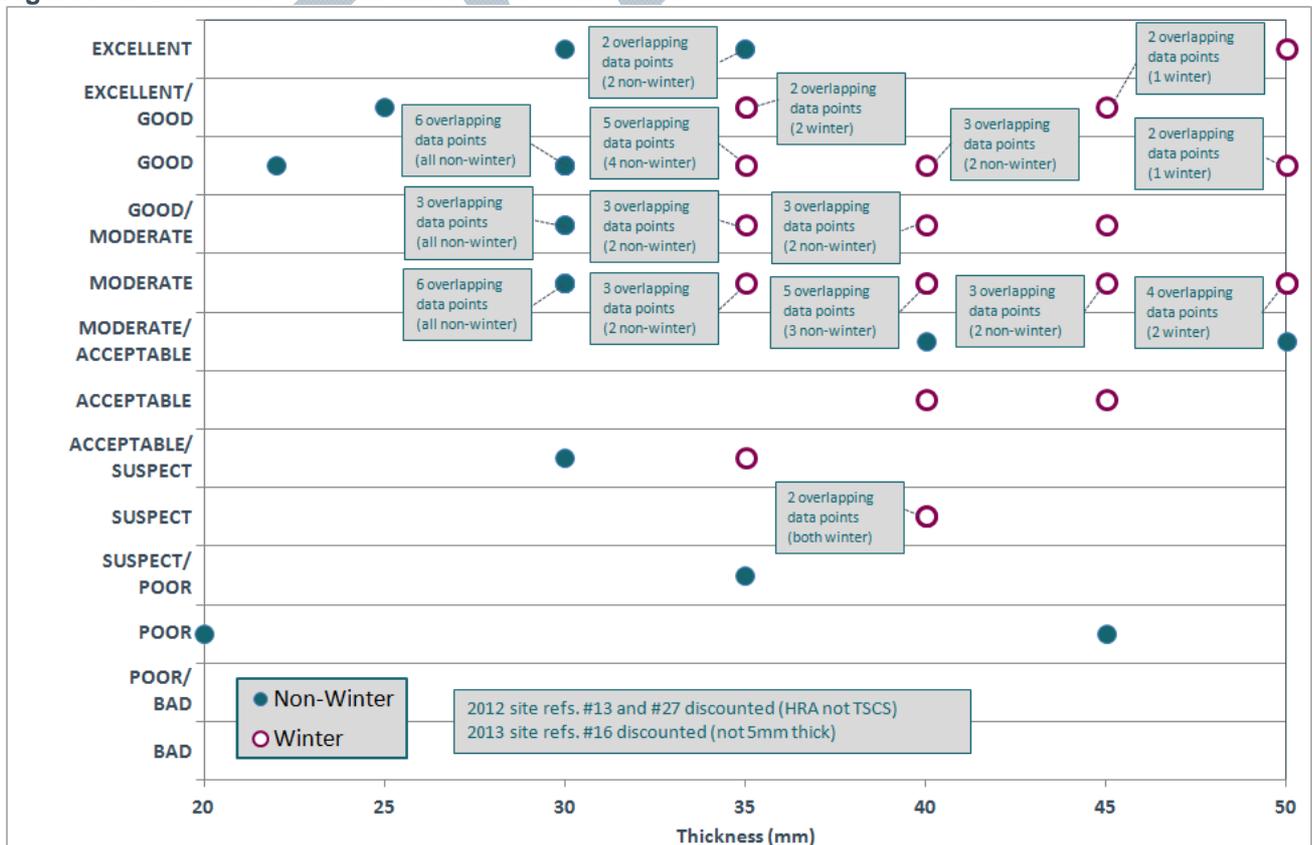
Figure F-4: Condition –Vs- Thickness and season laid

Table F-3 in Appendix F shows the condition results for the sample sites against the thickness of the thin surfacing material and the season when it was laid (from HAPMS). Figure F-4 in Appendix F provides a graphical illustration of the same data. No noteworthy trends were apparent.

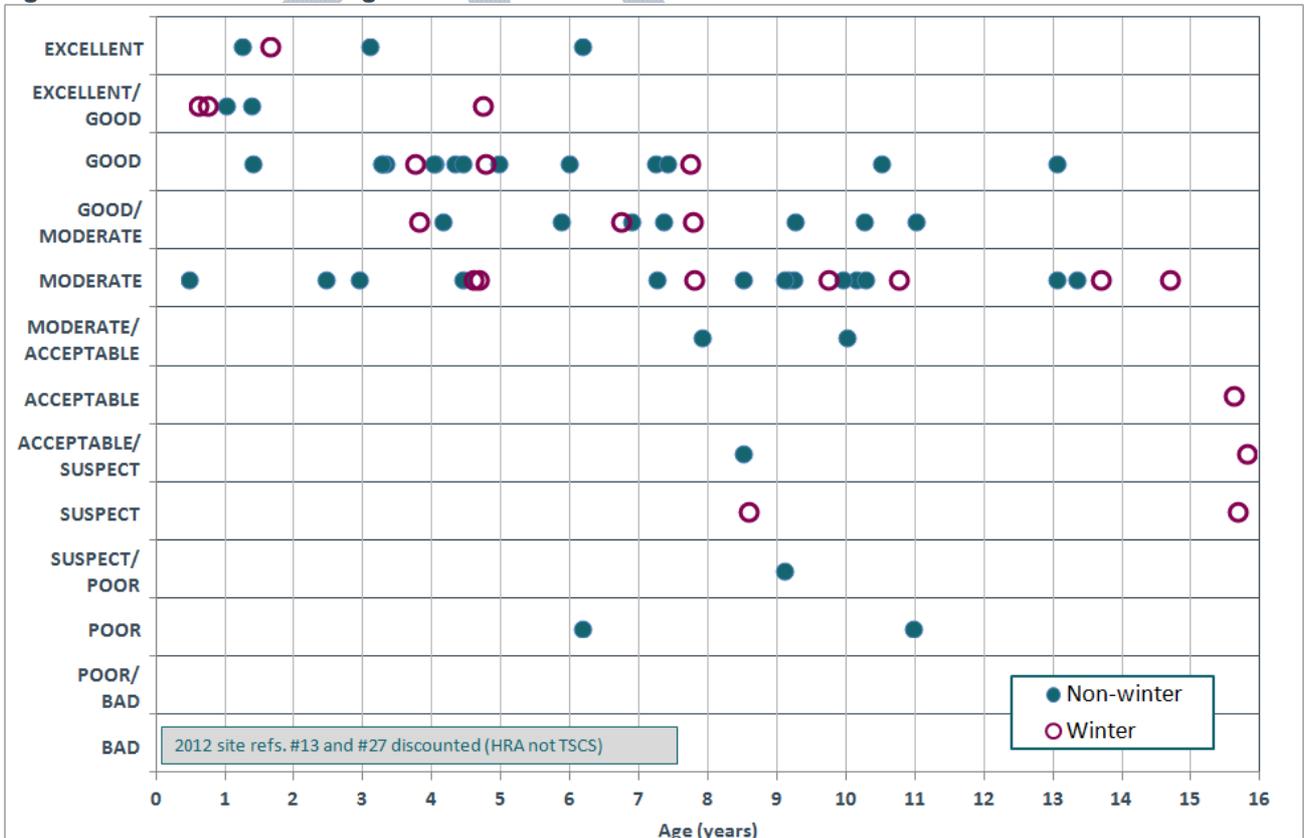
Figure F-5: Condition –Vs- Age and season laid

Table F-4 and Figure F-5 in Appendix F compare condition against age and season laid. Figures F-6 to F-8 in Appendix F show further attempts to investigate possible correlations for these three variables:
