**WP 1-086(PPRO 4/45/12) - Application of Remote Survey Data
for Geotechnical Asset Condition & Performance**

Phase 2 Report

22 August 2017

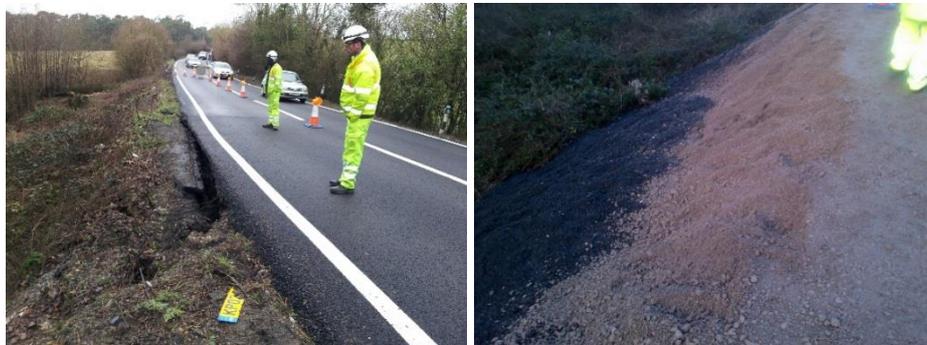
Figure 11 Lamberhurst site photos from HAGDMS showing the failure (left) and completed remedial works (right). The bottom panel shows the 2016 rotary wing LiDAR point cloud at the site with vegetation filtered

Figure 11 shows photos of the embankment slope failure at the Lamberhurst site taken from HAGDMS (this site has a sidelong ground profile). This failure occurred in winter 2014 due to prolonged rainfall, and because of poorly constructed older earthworks. Emergency remedial works including granular replacement were carried out in 2014 and a gabion wall was put in place to remediate a deep seated failure in 2016.

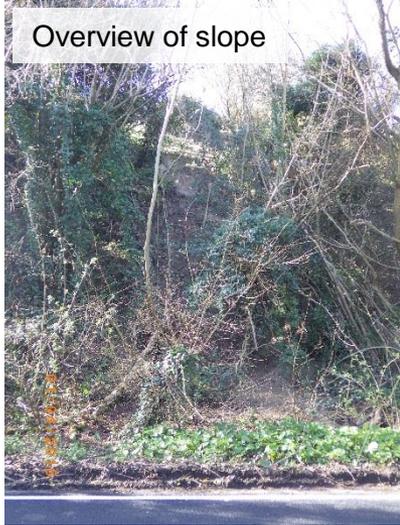
Overview of slope

- HAGDMS: “Mudslide over the whole height of the slope on the south-side of the road. This is a natural slope not an earthwork. The mudslide has not reached the carriageway but has deposited mud on the verge. Slope immediately adjacent appears unstable.”

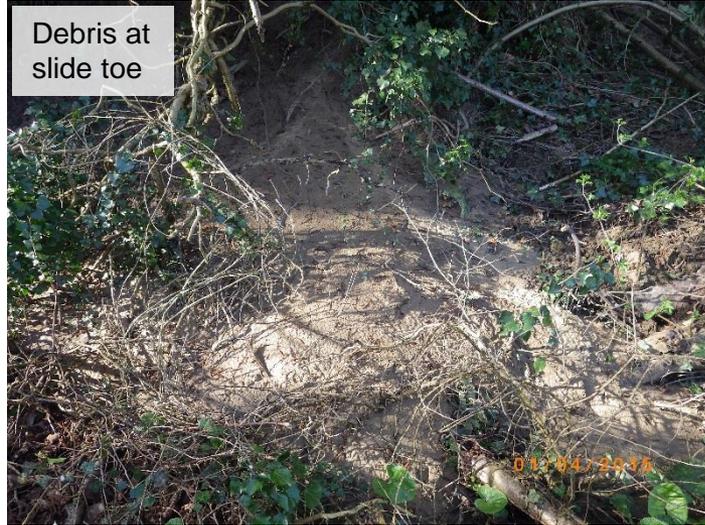
Debris at slide toe

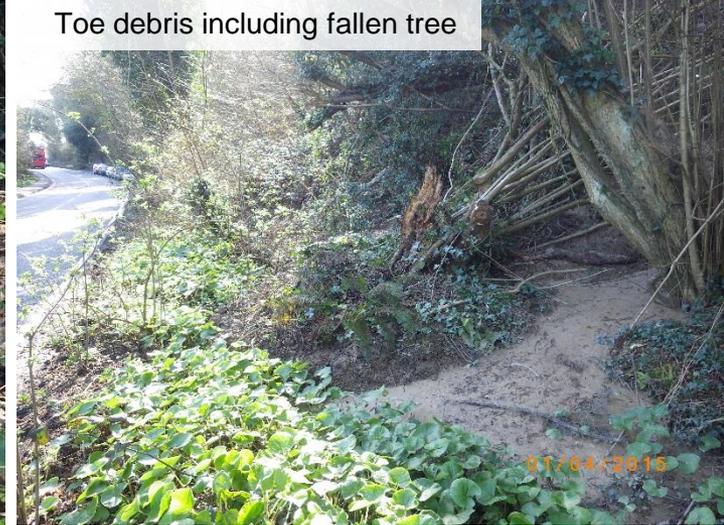
Toe debris including fallen tree

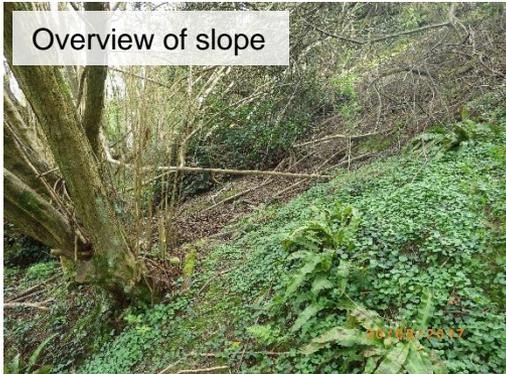
Overview of slope

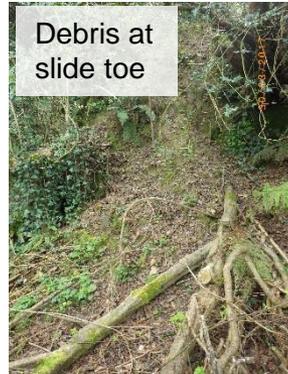
Debris at slide toe

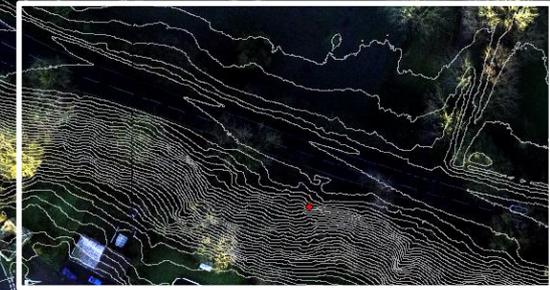
2016 Survey aerial orthoimagery

- Aerial orthoimagery suffer from shadowing due to tall, steep cutting and due to dense vegetation.
- The 25cm contours (derived from 2016 rotary-wing LiDAR) allow the cutting morphology and any potential slips to be observed in spite of the vegetation and shadowing.

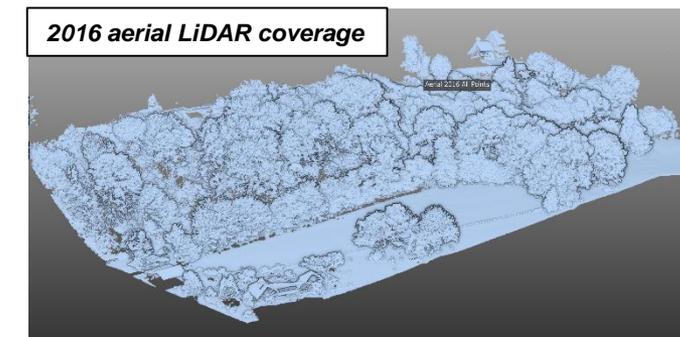
- The figures below show a comparison of the point density (left) and spatial coverage (right) between the 2016 aerial (top) and 2013 Mobile Mapping System (MM) (bottom) LiDAR data at the Tanyard Lane site
- The 2013 MM LiDAR has a much higher point density on the carriageway than 2016 aerial survey, however, the MM data has low point density on the slope due to limitations of the sensor line of sight and the dense vegetation.
- The MM has a more limited spatial coverage than the 2016 aerial LiDAR
- Change detection was not successful between the two datasets because the point cloud classifications of the 2013 and 2016 data were not equivalent and because of the limited spatial coverage and low point density of the MM data, particularly on the slope, relative to the 2016 data.

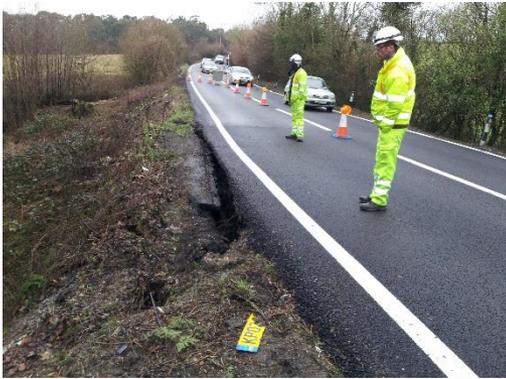
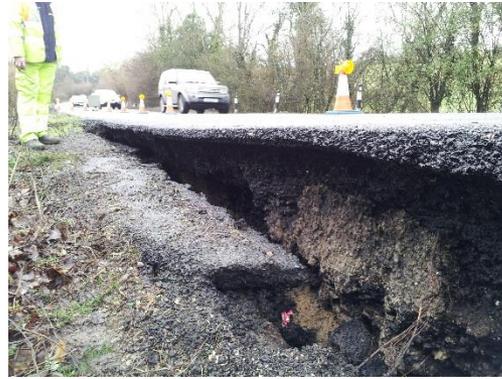
**PRE-FAILURE
winter 2014:**

- HAGDMS (obs: 544255): “Granular replacement of the slope retained by 1 tonne sandbags at toe. Feb 2014 emergency works. Not a permanent repair, so risk of movement reoccurring.”
- GeoAMps Report (2016-2017): “Deep-seated earthwork failure due to prolonged rainfall, and poorly constructed older earthworks. Remedial works – gabion.”

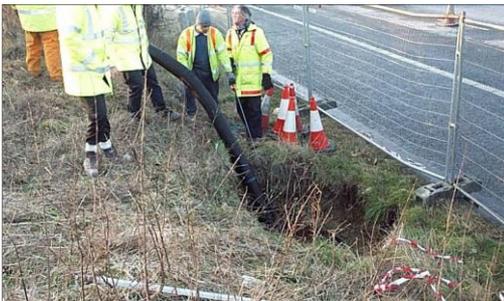
M2 Denehole, 2001 (Atkins)

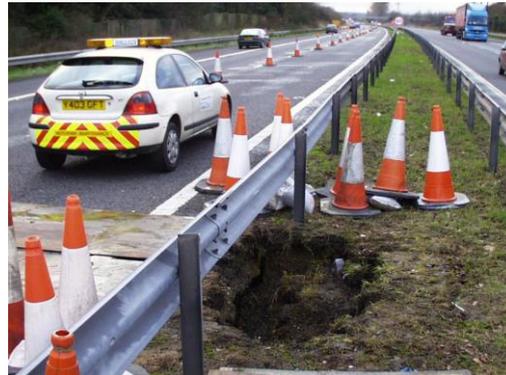
M2 Solution feature, 2002 (Atkins)

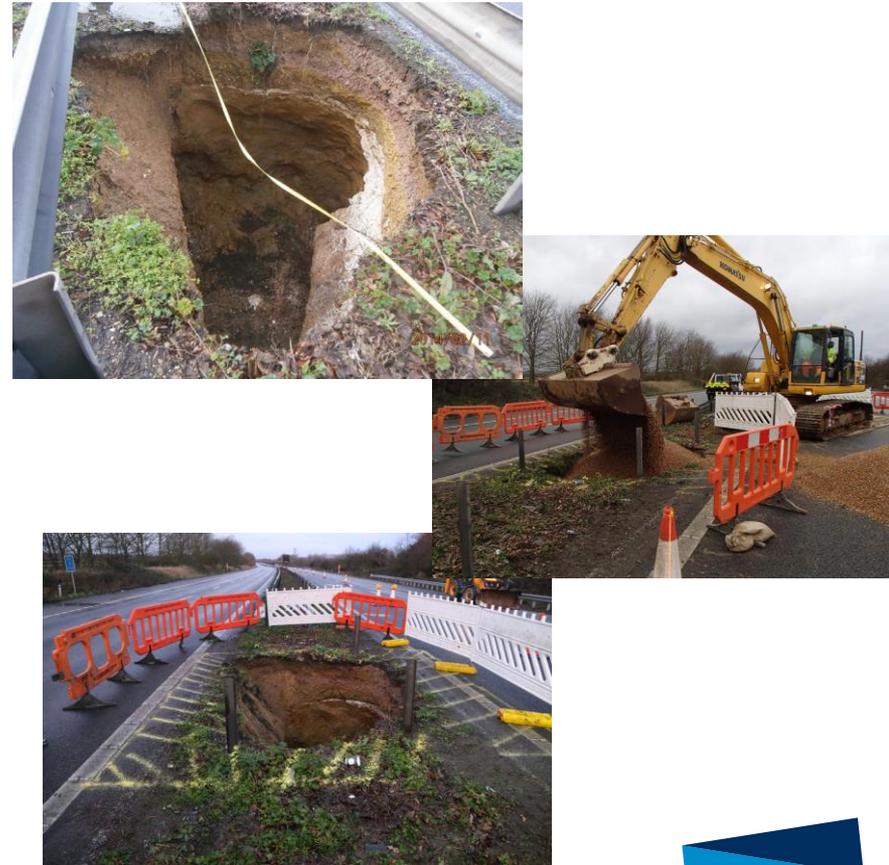
The pictures to the right show the location, in relation to the position in the central reservation of this particular dissolution feature.

It was later suggested that this incident occurred due to a failed drainage asset which led to increased water infiltration after a period of heavy rainfall, and which caused the washout of material forming the cavity.

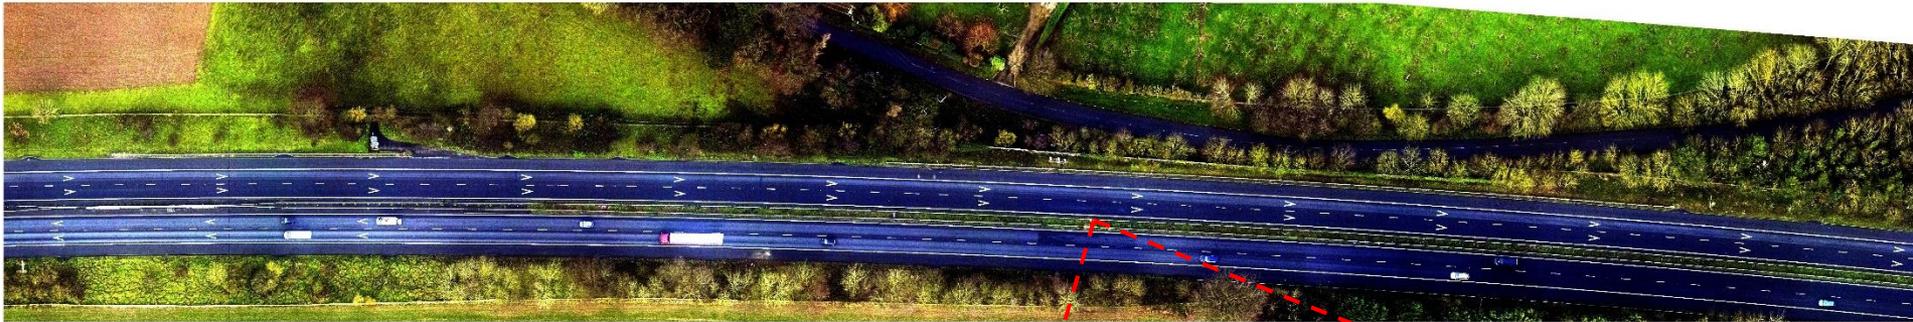
The aerial data available is following the cavity collapse and the remedial measures carried out can be seen.

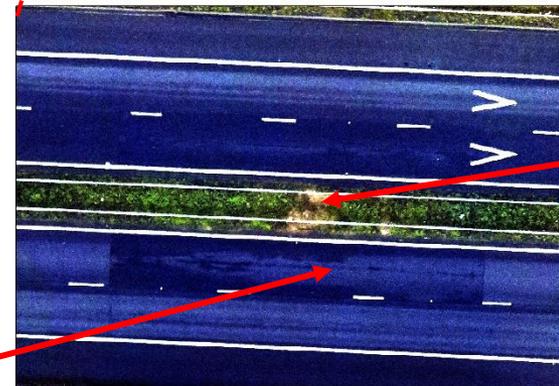
It is difficult to tell from this data if aerial imagery would be of use in identifying the signs leading up to a failure.

Pavement
repair

Location of
incident

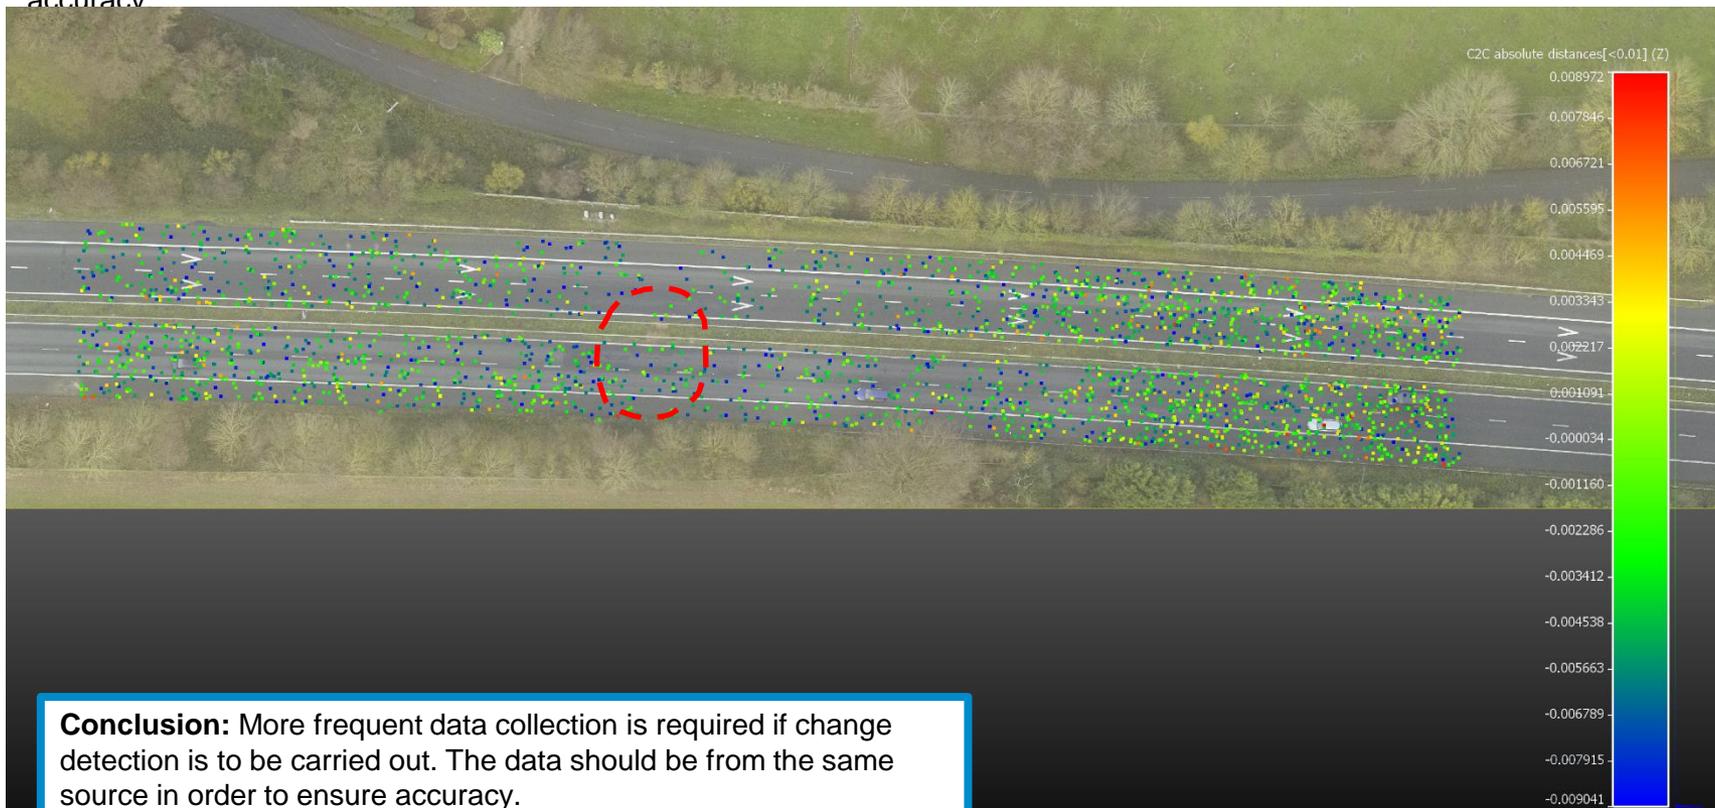
Change detection was carried out between the LiDAR datasets. This compared the Mobile Mapping System data and the Aerial data. These were captured in 2015 and 2016, i.e. after the remedial works were carried out for the cavity that opened up on the central reservation. The image below shows the vertical height difference between the datasets. The location is marked by a red dashed line. No trend in the data is discernible. In order to use remote sensing for change detection the frequency of the data needs to be greater, and ideally the data needs to be from the same source in order to ensure accuracy

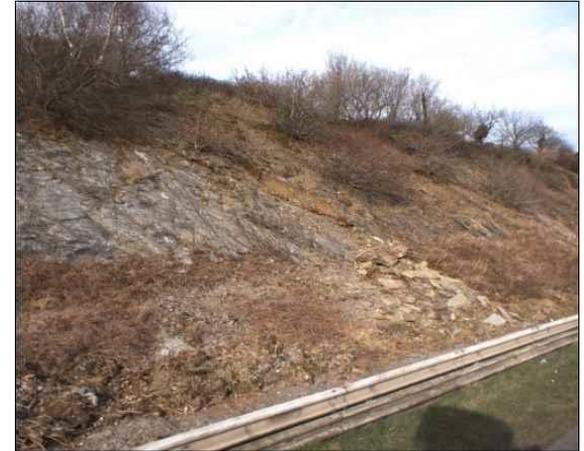
**Ravelling of Rock Cutting on A38 Area 01,
1100A38/147, 0 km, 430.53 m,
258503.05, 55573.34.**

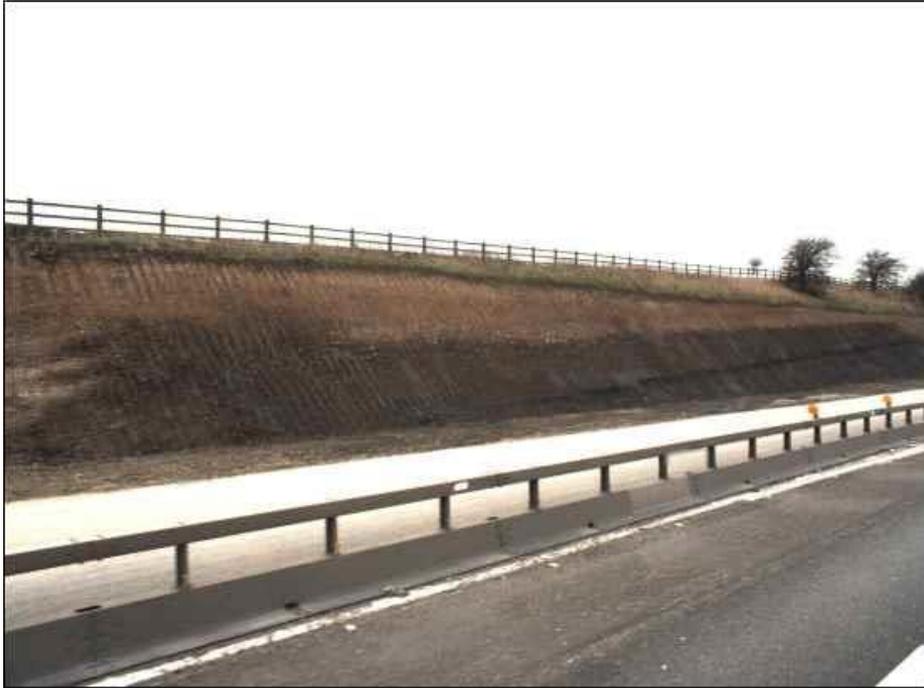
Plate 2. Geological variation evident in cut slope along M1.
M1 Area 12, March 17, 2016, 4400M1/192, 1 km, 672.15 m, 438841.41,
392538.35

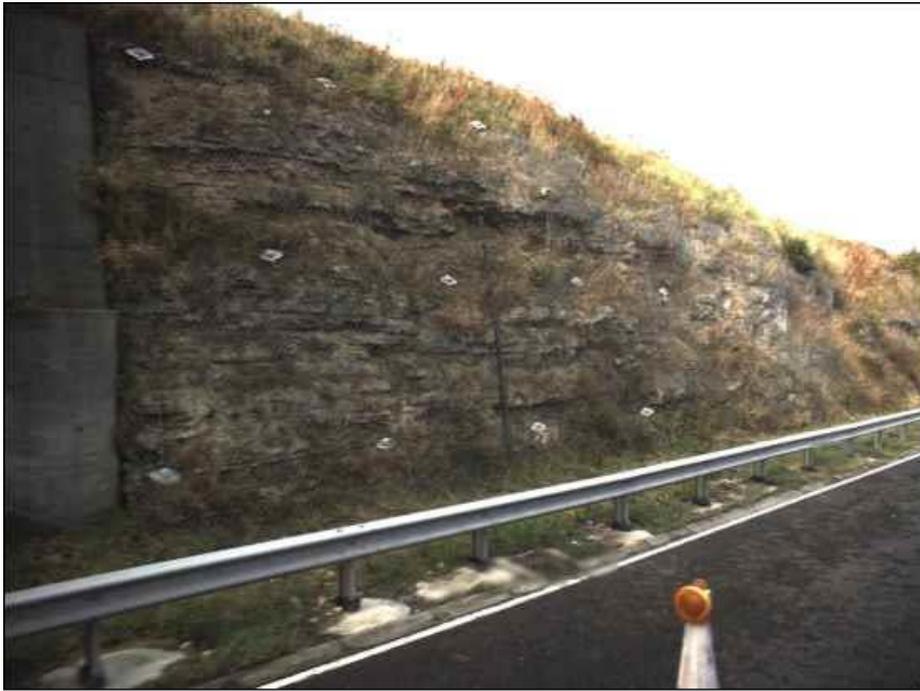
Plate 3. Remediated rock slope using pattern rock bolting and double twist mesh.

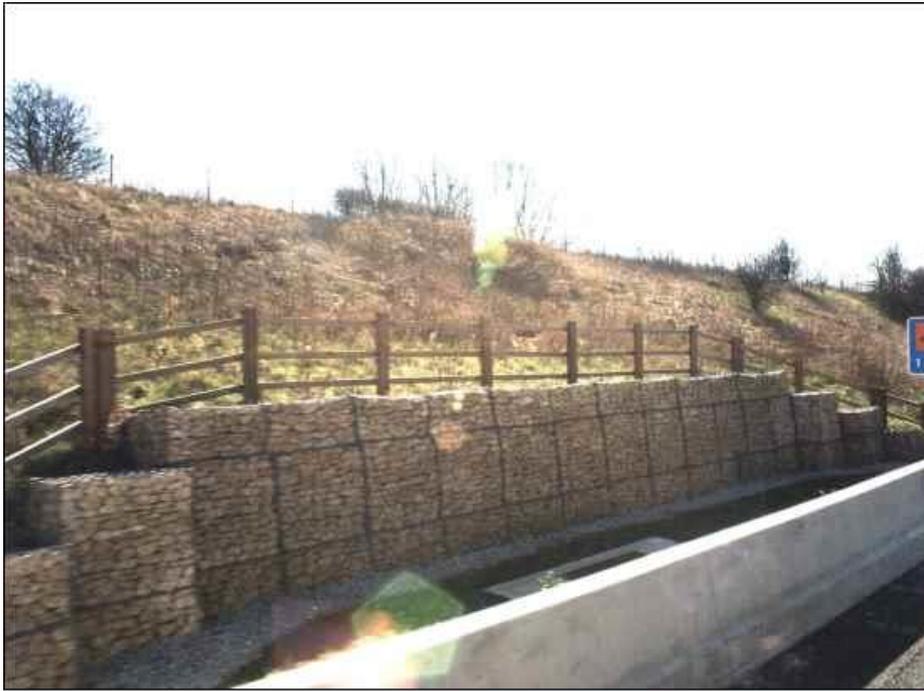
Plate 4. High quality image of Mobile Mapping System images of highway slope and retaining structure along the M1.
M1 - M1 Area 12, March 17, 2016, 4700M1/136, 0 km, 609.64 m, 430797.05, 424451.11

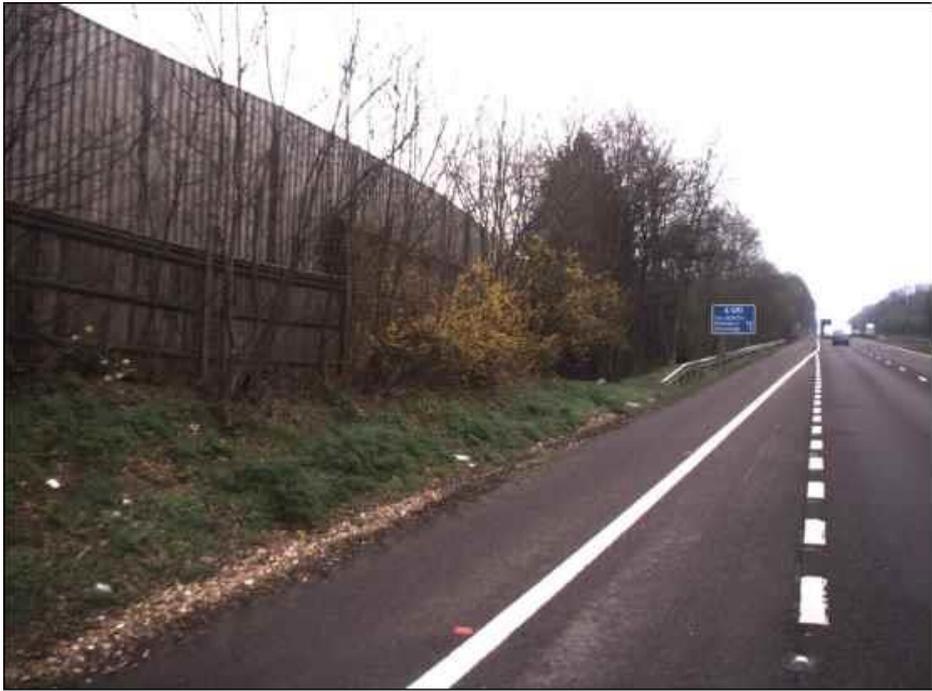
Plate 5. Highway boundary fence along the A1(M).
A1M - A1M Area 08, March 28, 2014, 1900A1M/63, 0 km, 756.32 m,
523811.12, 217217.1

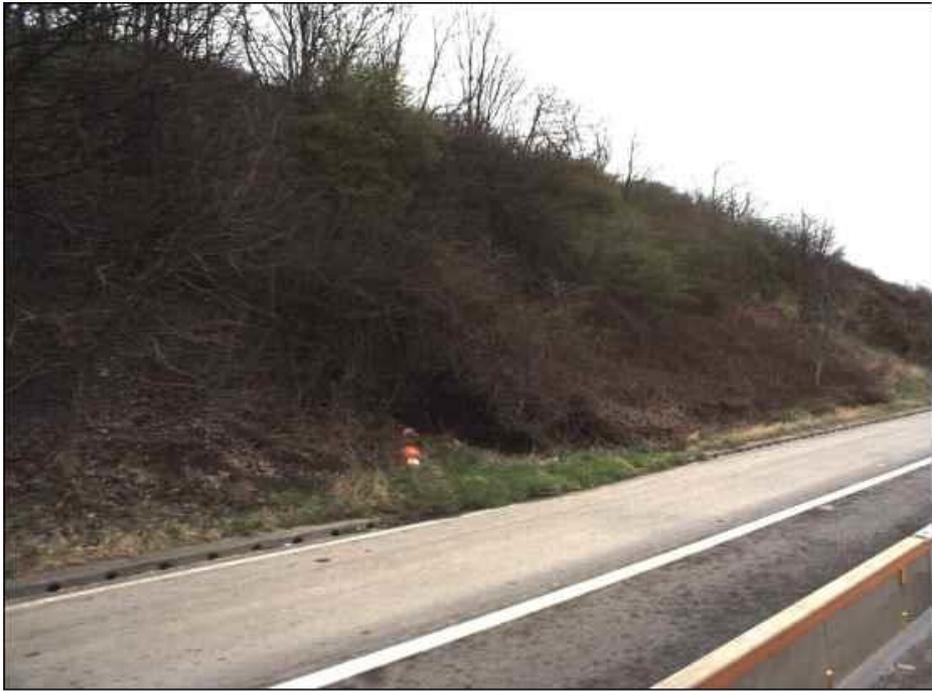
Plate 6. Seepage and erosion of cut slope along M1 (near Junction 34, Meadowhall)
M1 - M1 Area 12, March 17, 2016, 4400M1/154, 0 km, 100.73 m, 438997.24, 392213.91

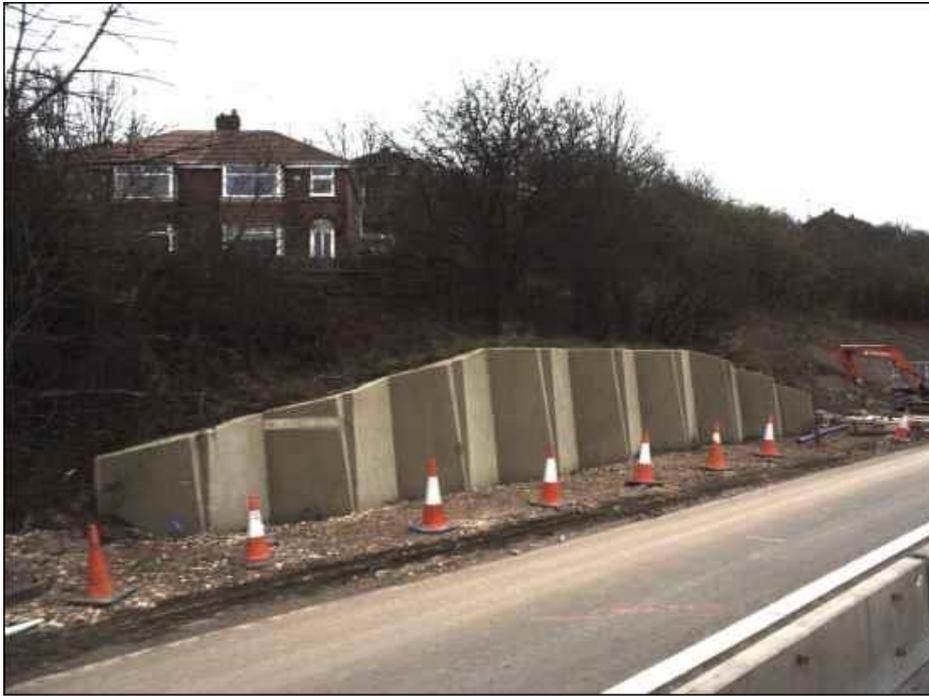
Plate 7. Concrete retaining wall along M1 (near Junction 34, Meadowhall)
M1 - M1 Area 12, March 17, 2016, 4400M1/154, 0 km, 100.73 m, 438997.24,
392213.91

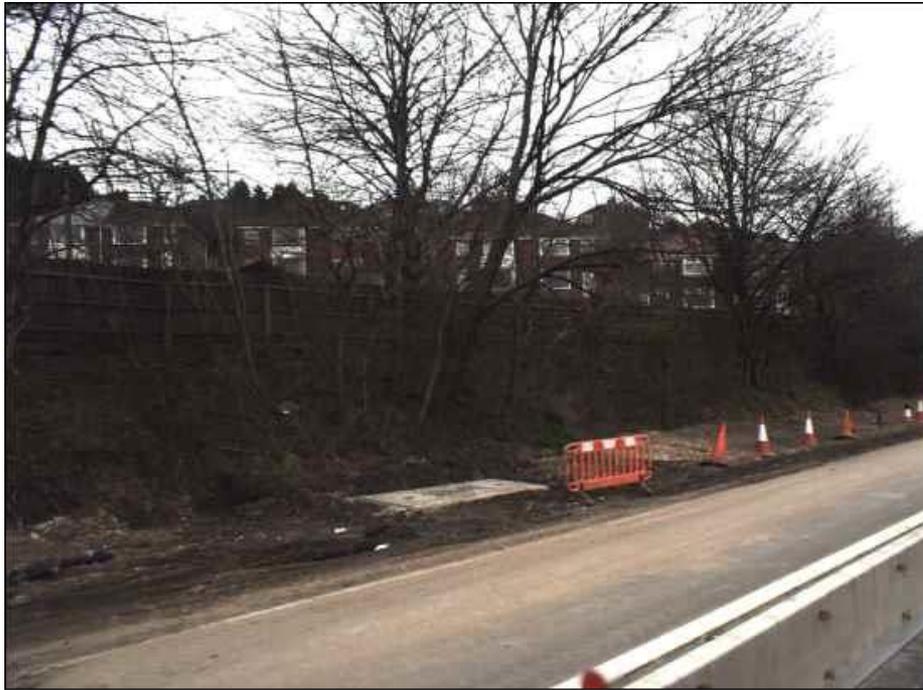
Plate 8. Leaning trees overhanging hard shoulder along M1.
M1 - M1 Area 12, March 17, 2016, 4400M1/192, 1 km, 672.15 m, 438841.41,
392538.35

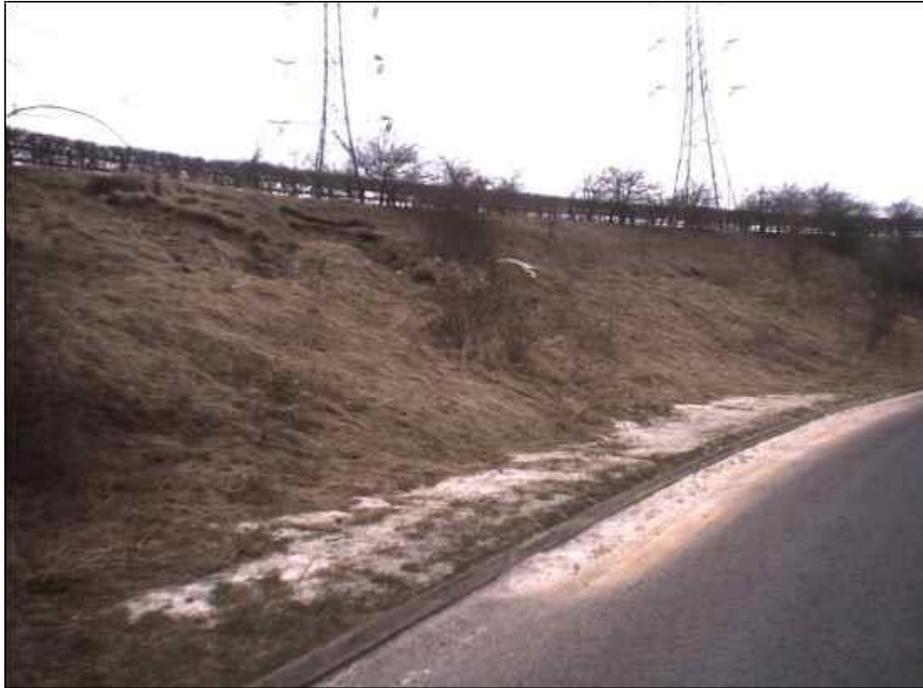
Plate 9. Small shallow landslide within cut slope.
A45 Area 07, 2800A45/487, 0 km, 113.05 m, 486685.29, 264021.65

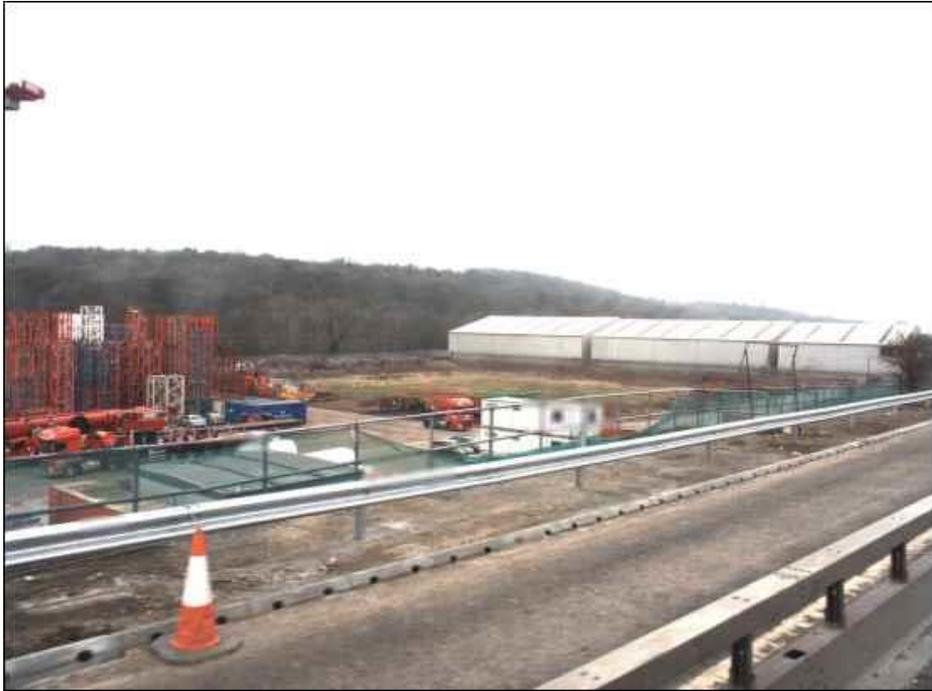
Plate 10. Top of slope retaining wall and safety barrier along M1.
M1 - M1 Area 12, March 17, 2016, 4400M1/291, 0 km, 297.21 m, 438696.36,
392712.56

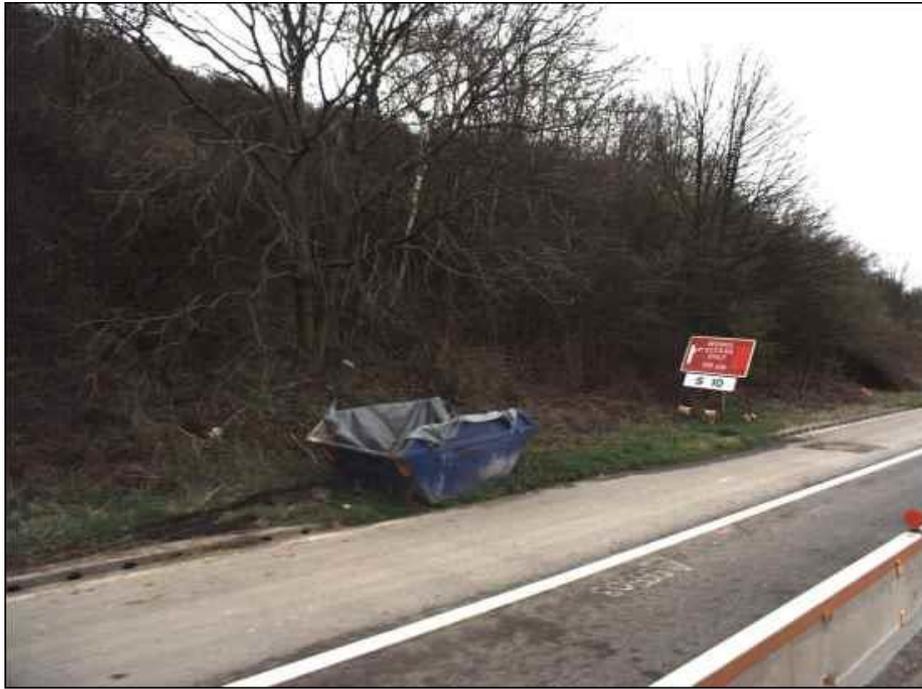
Plate 11. Marshy ground and seepage present along M1.
M1 - M1 Area 12, March 17, 2016, 4400M1/154, 0 km, 86.69 m, 438989.64,
392225.74

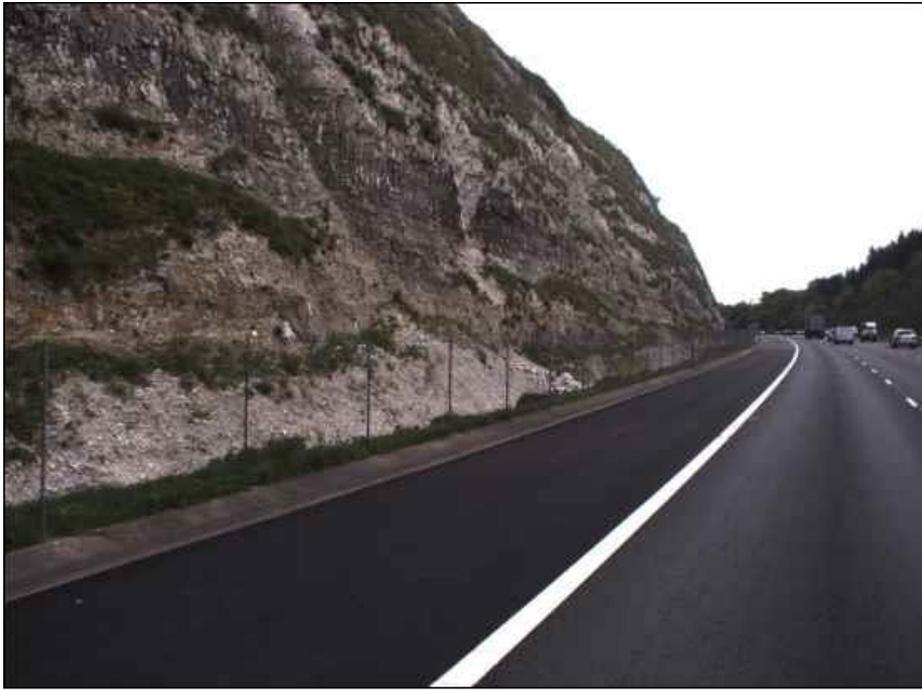
Plate 12. Stokenchurch Rockslope and rockfall netting.
M40 DBFO 2014, 3100M40/586, 0 km, 963.73 m, 473230.35, 196476.72

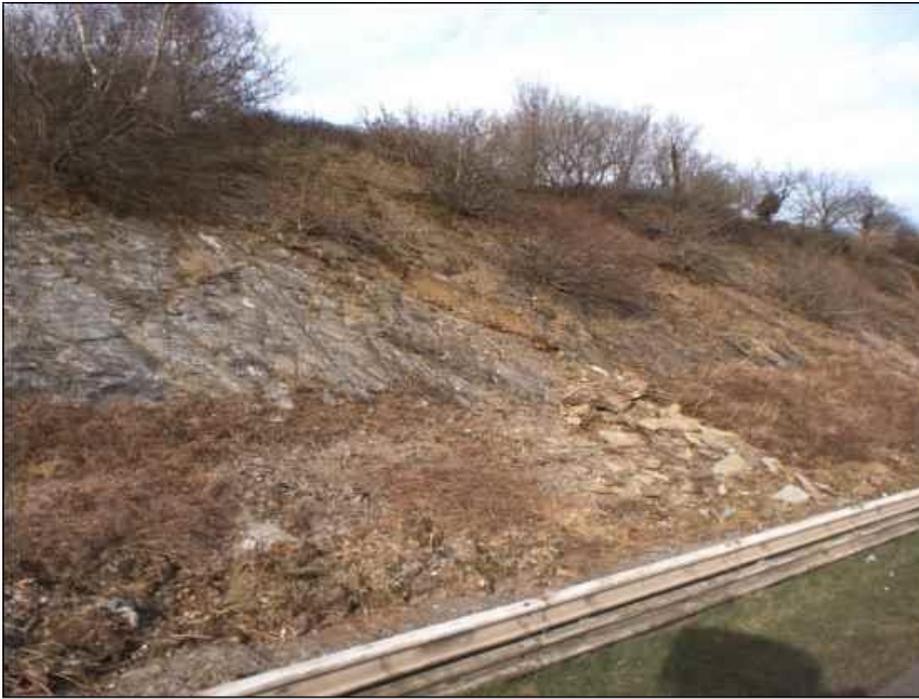
Plate 13. Ravelling rock slope and debris.
A38 Area 01, 1100A38/147, 0 km, 430.53 m, 258503.05, 55573.34.

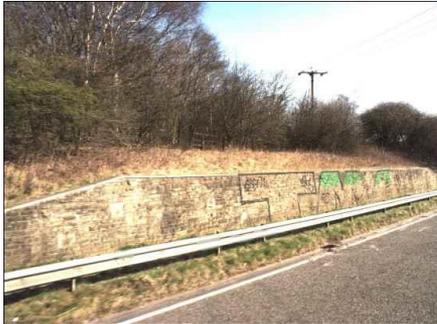
Earthwork ID 34272

Observation ID: 239219
Obs Desc: 2m high retaining wall

AVIS Obs: Covered in graffiti. Upper coping stones are loose. Surface stonework colour is variable, potentially indicative of water flow along facing.

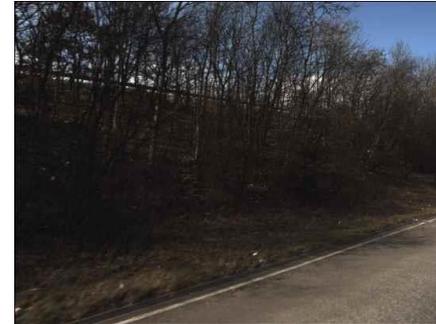
Earthwork ID 42407

Observation ID: 276918
Obs Desc: Vegetation

AVIS Obs: Survey performed March 2016, therefore trees are without leaves. Many of the tree along this stretch are large, mature and frequently overlap onto the hard shoulder. Example of overgrown trees between 0 km, 849m and 0km, 955m, GR 432276, 405692 and 432228, 405787.

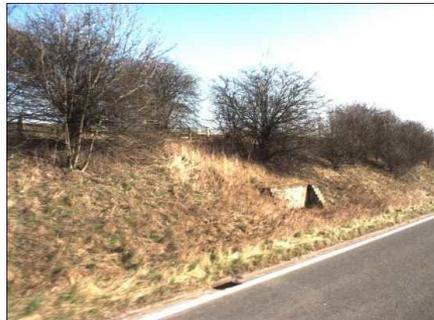
Observation ID: 239222
Obs Desc: Drainage

AVIS Obs: Manholes present every 8-10m.

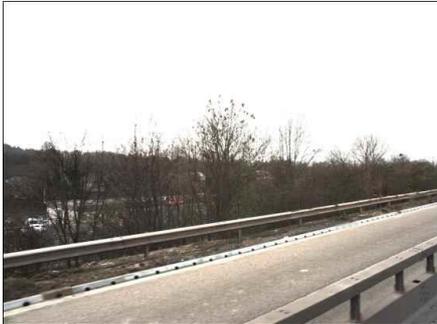
Earthwork ID 43931

Observation ID: 488122

Obs Desc: Vertical gully p991/2
– Could be vertical french drain
possible seepage – moss/reeds

AVIS Obs: Top of slope drain
not visible due to line of sight
nature of acquisition system.
No reeds or moss visible
possibly due to time of year.
Top of slope drain potentially
visible, as a light grey area,
potentially loose gravel but
insufficient to confirm.

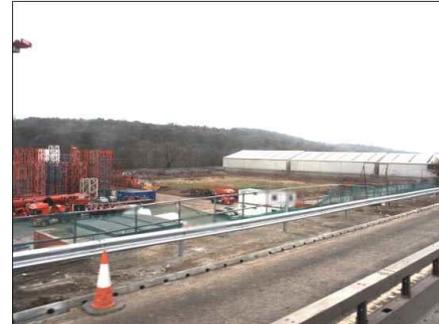
Observation ID: 285667, 285668,
285669, 285670

Obs Desc: Retaining wall p976/7,
8m, 5m, 2m high.

Only partially visible in some
areas:

- (1) top of safety barriers between
0km 220.91m, GR 438718,
392689;
- (2) disused, damaged, small,
roofed structure at 0km
266.60m, GR 438718, 392689
and;
- (3) top of wall and safety fence at
0km 439m, GR 438597,
392813.

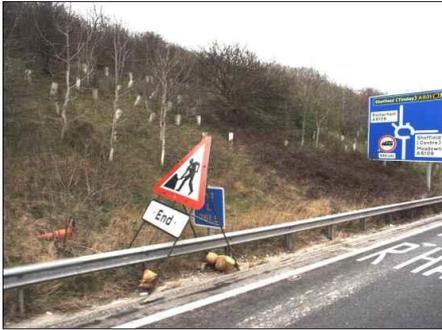
Observation ID: 290393

Obs Desc: Vegetation

AVIS Obs: Some large, mature trees. Much of the site is concrete retaining wall. Some trees towards the start of the feature could overhang the hard shoulder when in bloom.

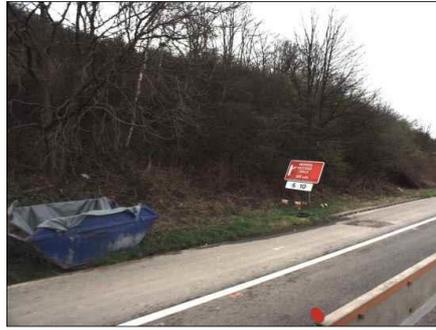
Observation ID: 290400

Obs Desc: Seepage observed from lower bench - geometry given is for overall slope - hydrovegetation present and erosion of slope caused by seepage - landfill adjacent p204-207

AVIS Obs: Large tree present at base of cutting, some are leaning towards carriageway. Seepage visible on carriageway hard shoulder.

Top soil and grass has flowed over onto hard shoulder and is encroaching onto hard shoulder by ~0.2m. Evidence of reeds indicate hydrophilic vegetation present.

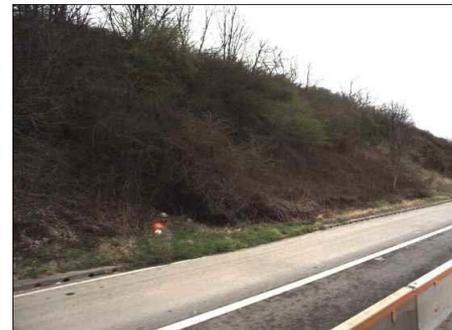
Observation ID: 290401

Obs Desc: seepage & dislocated trees and erosion p208-11. Running water observed. Slope benched at 16m, seepage at 10m on 1st slope.

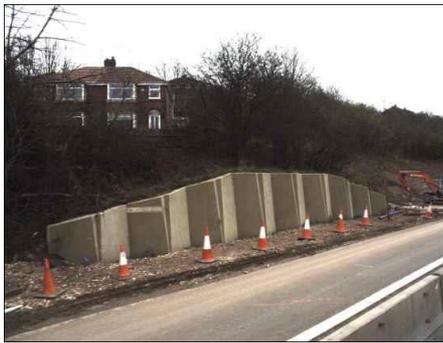
Observation ID: 290395

Obs Desc: Retaining Wall

AVIS Obs: Appears to be in good condition. No clear defects present.

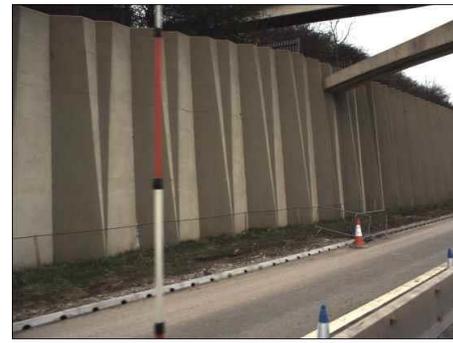
Observation ID: 290398

Obs Desc: Retaining wall 10m high at max pt

AVIS Obs: Appears to be in good condition. No clear defects present. Pedestrian foot bridge present at top of structure.

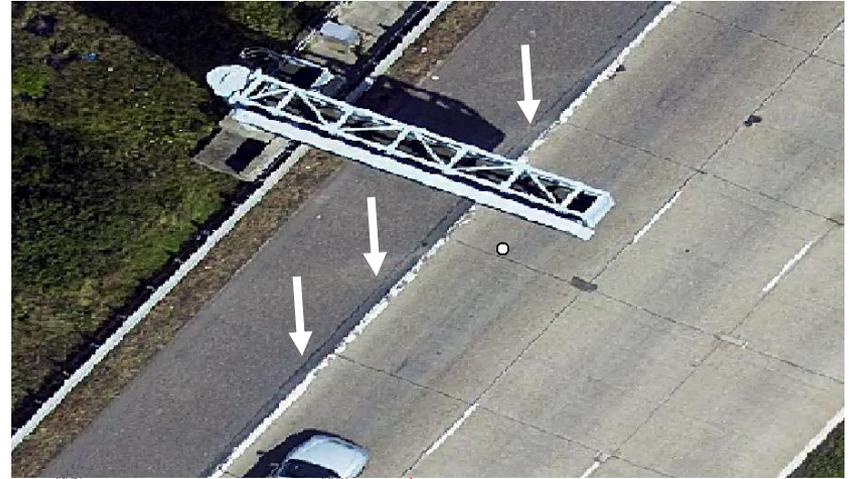
The available 4 cm high-resolution colour photography for the M11 site, collected by rotary-wing survey in 2004, is shown as an overview in the figure below. The white dashed oval indicate the zoomed view of the gantry area shown in bottom right figure.

The area of the dashed white box is shown in above. Cracks (the black irregular line) in the pavement can be observed along the northwest boundary of the carriageway, as indicated by the white arrows.

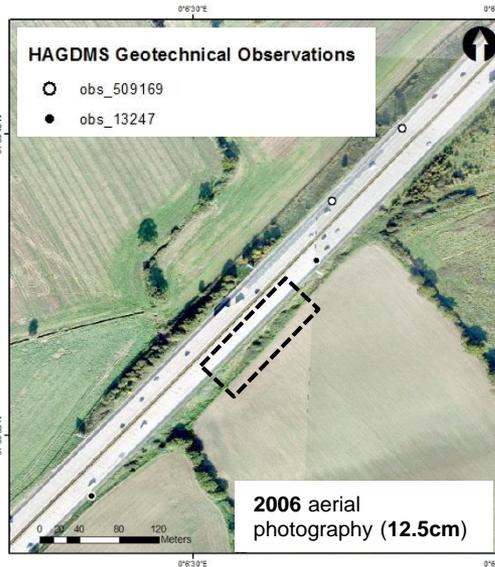
- Soil slip, terracing, tension cracks, and distorted structure were recorded on HAGDMS in 2003
- Regrading remedial works were carried out in 2010
- The approximate area shown in the black dashed box in the left-hand figure is shown in the centre and right-hand figures (different survey dates).

- Observations of the aerial imagery in 2006 indicate no clear evidence soil slip, terracing or tension-cracking. This is possibly because the resolution is not high enough.
- It is difficult to see any evidence of the soil regrading works carried out in 2010 in the 2014 photographs.

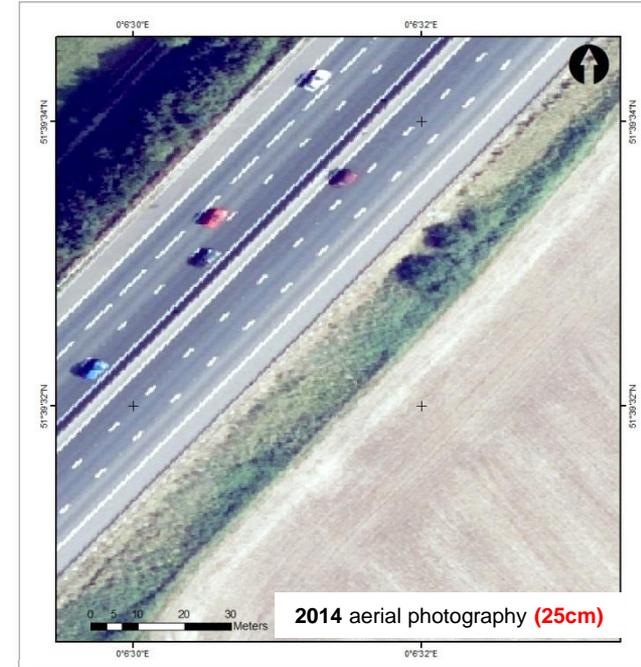
- The 2006 survey and 2014 survey figures below are the same as the previous slide. For comparison, the 4cm resolution 2006 photography survey of the same area shown in the figure in the centre.
- It is possible to observe evidence for terracing in the 2006 4cm resolution photography also.

- The area shown in the dashed white box above is shown in the bottom centre figure. The white arrows point to a region of possible terracing.

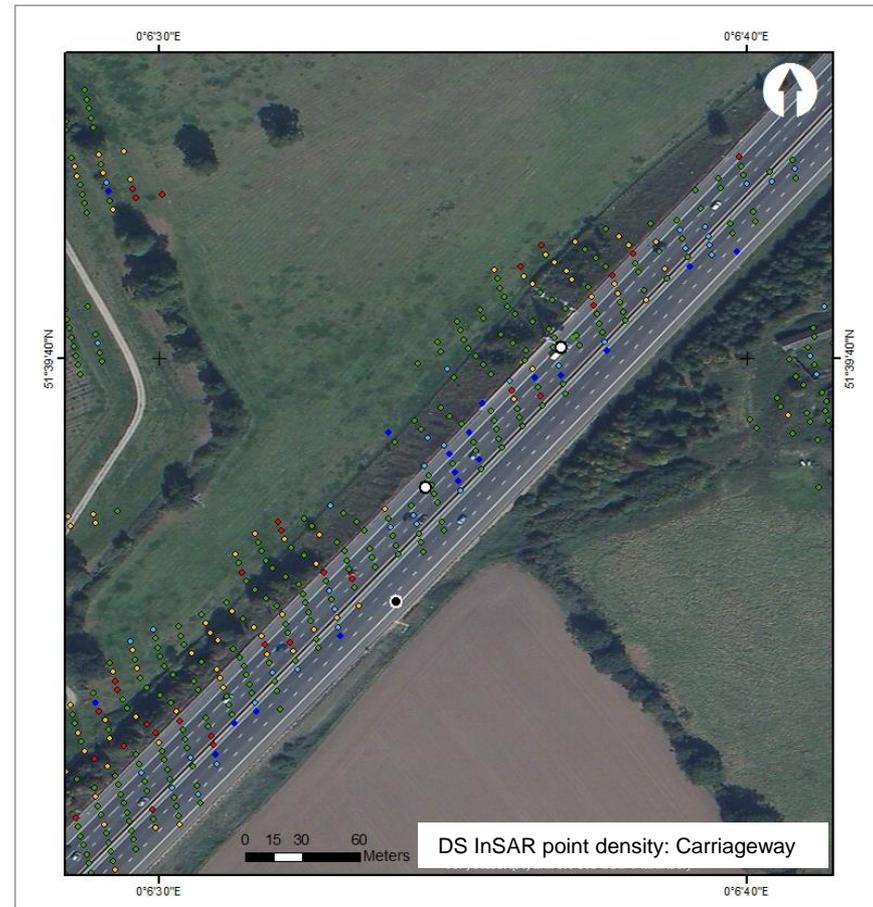
- Points covering the northwest-facing embankment show different amounts of average uplift and subsidence over the embankment:

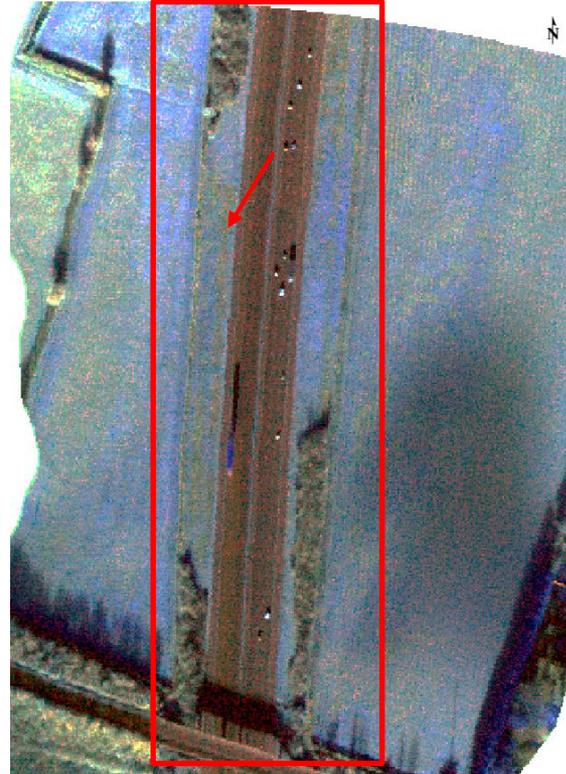
- Band 324 (2291.0500)
- Band 211 (1669.3500)
- Band 62 (801.7100)

- **SWIR & IR (Short Wave Infra Red and Infra Red) Band Combination**
- SWIR & IR bands highlight different spectral signature between vegetated/ non-vegetated parts of the cutting.
- Possibly the hyperspectral can characterize between wet and dry (high moisture content/ low moisture content) soils.

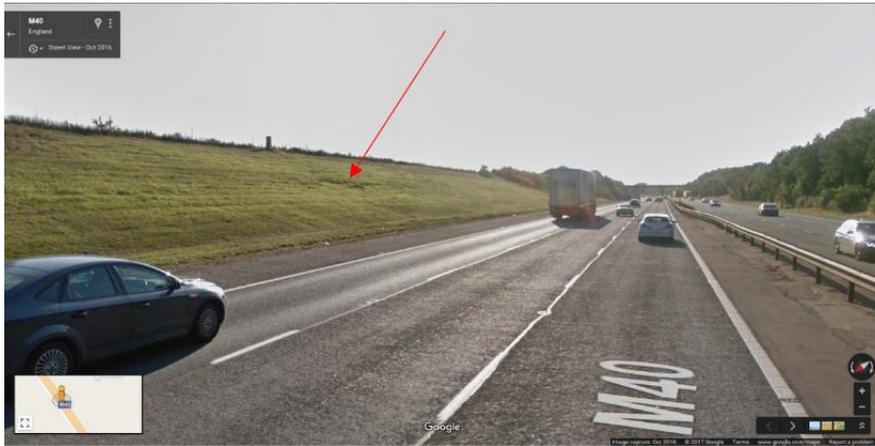
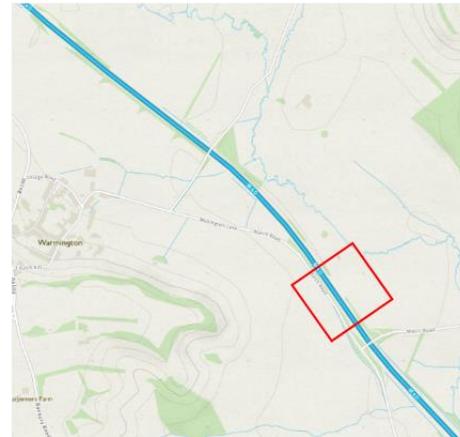
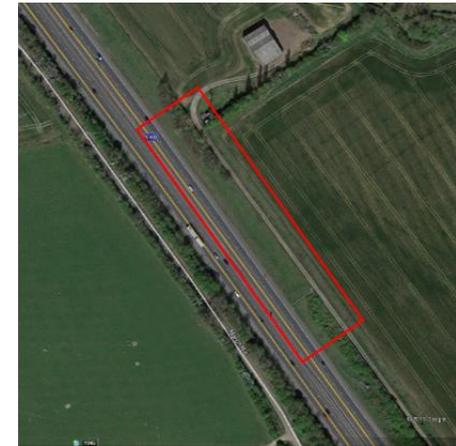
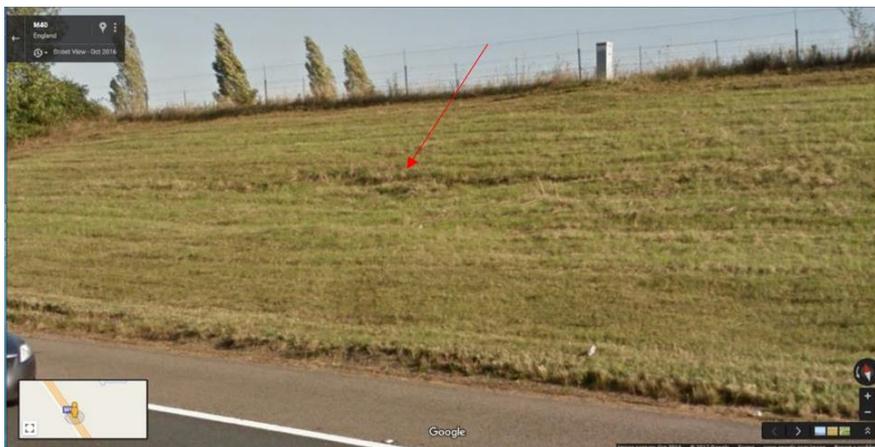
- Possible cutting slope failure developing. Feature highlighted looks like a tension crack or small back scar with a slight dip in the slope just below this and a slight bulge lower down the slope

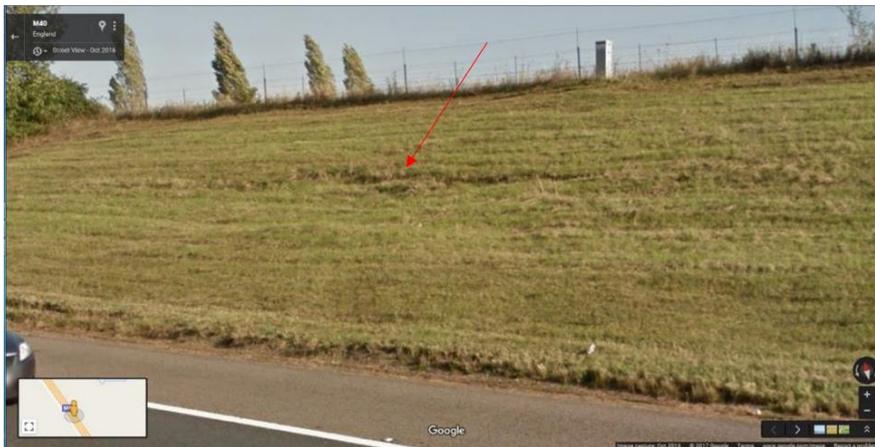
6.1 Data Analysis M40 Site 5: 2016 Rotary-wing LiDAR contours + orthophotos

- Tension crack or small back scar with a slight dip in the slope just below this and a slight bulge lower down the slope
- Captured very clearly in the 25cm LiDAR contours and less well in the orthophotos.

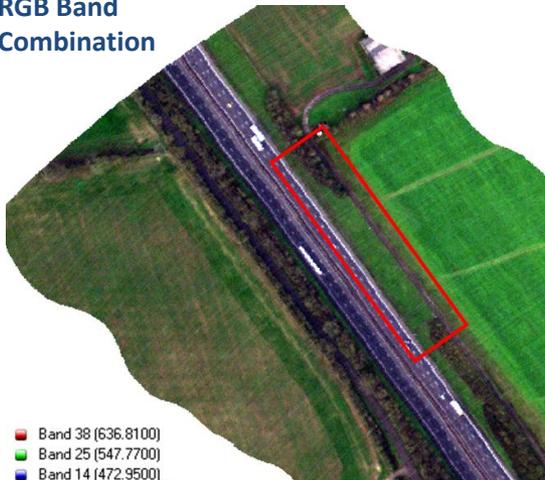
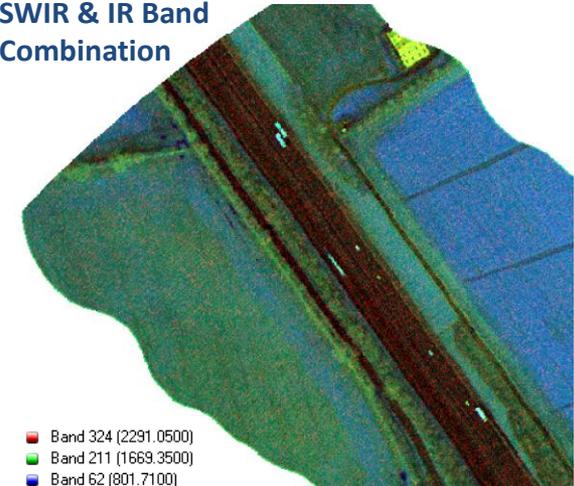
- In the figures of the different hyperspectral band combinations shown below, the tension crack or small back scar with a slight dip in the slope just below this and a slight bulge lower down the slope is not visible.
- This is likely to be because the resolution of the imagery is too low.
