**WP 1-086(PPRO 4/45/12) - Application of Remote Survey Data
for Geotechnical Asset Condition & Performance**

Phase 2 Report

22 August 2017

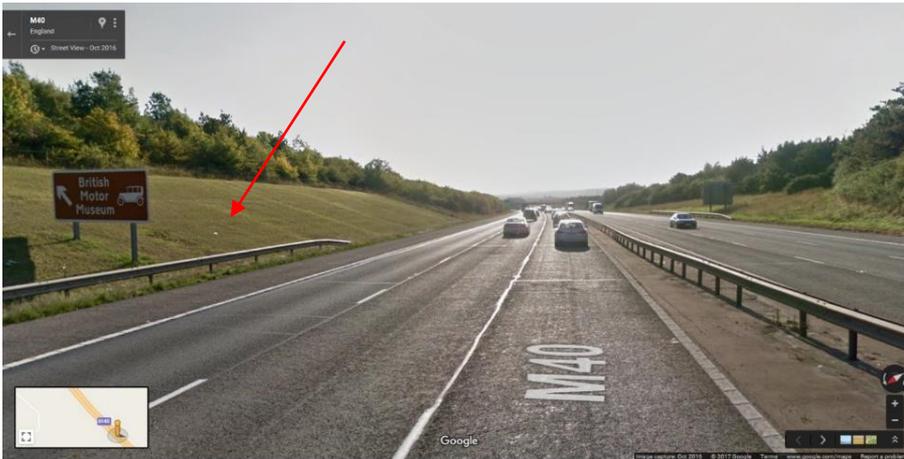
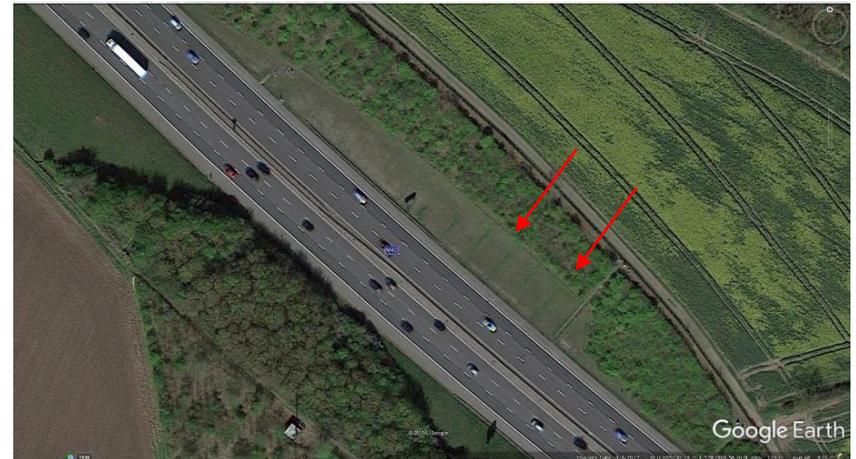
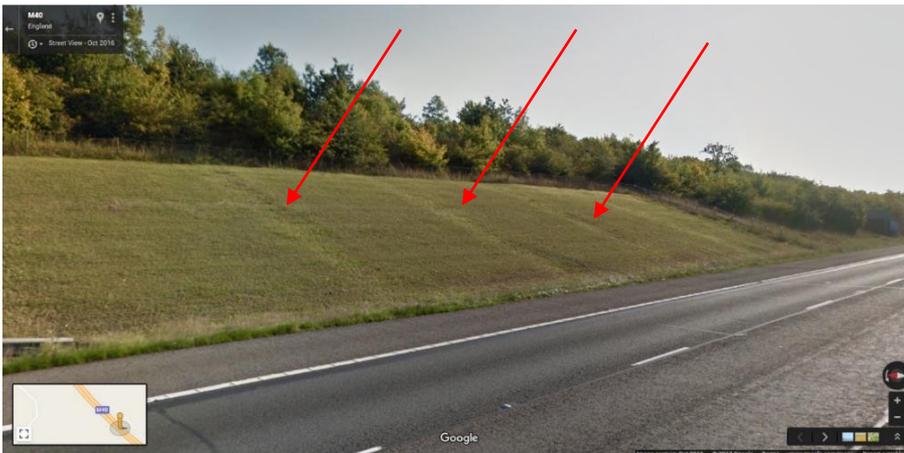
- Assumed to be a set of parallel counterfort trench drains installed in cutting slope. Likely as a remedial measure due to poor slope drainage and / or slope instability.

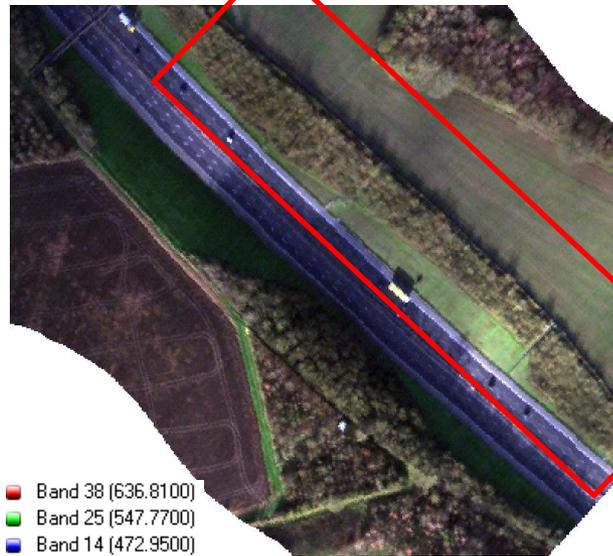
- Assumed to be a set of parallel counterfort trench drains installed in cutting slope. Likely as a remedial measure due to poor slope drainage and / or slope instability.
- Drains are highlighted in hyperspectral data (CYIENT © 2017)

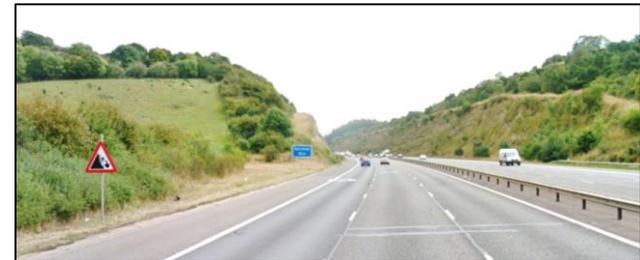
The base of the cutting has seen the installation of a catch fence (a special geotechnical measure of unknown installation date) that has been installed (see top right image) and is situated on each side of the carriageway. Rockfall warning signs have also been placed at the location (see bottom right).

Rockfall hazard warning sign, M40 Southbound (Source: Google Maps, Sep 2016)

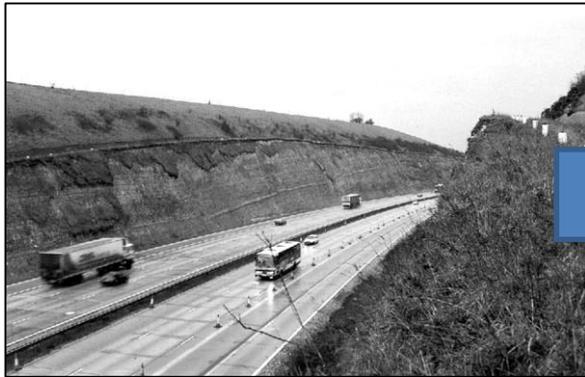
The images below present an idea of the deterioration that has taken place at Stokenchurch gap since its construction.

Cutting shortly after construction (Source: R Mortimore)

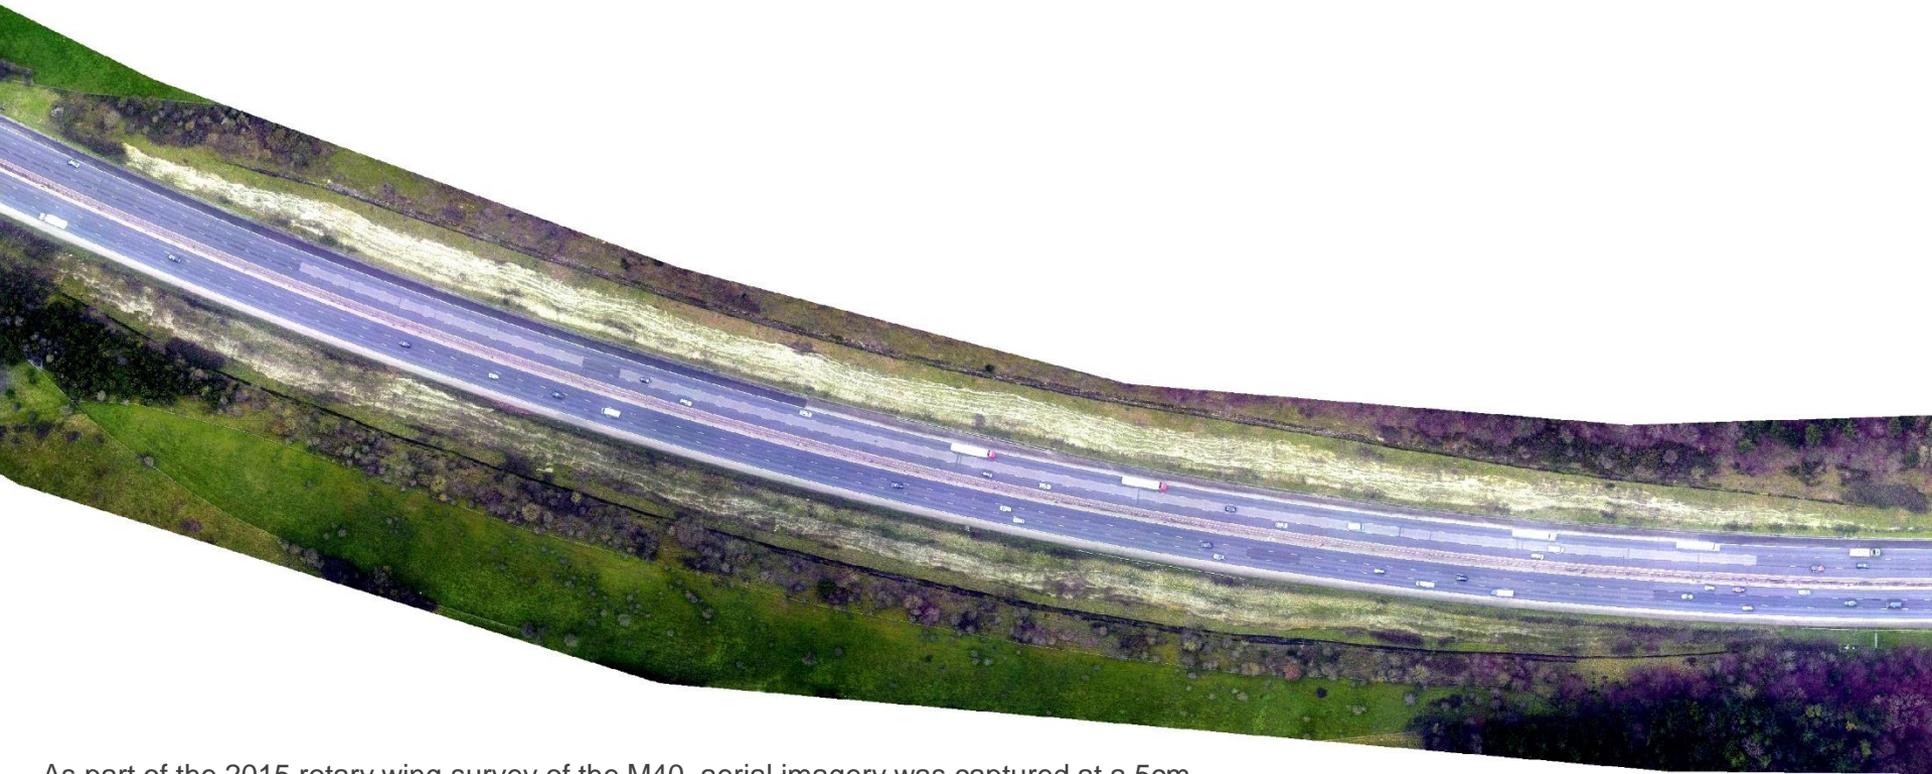
As part of the 2015 rotary wing survey of the M40, aerial imagery was captured at a 5cm resolution. An extract of this data for the area of Stokenchurch Gap is presented above.

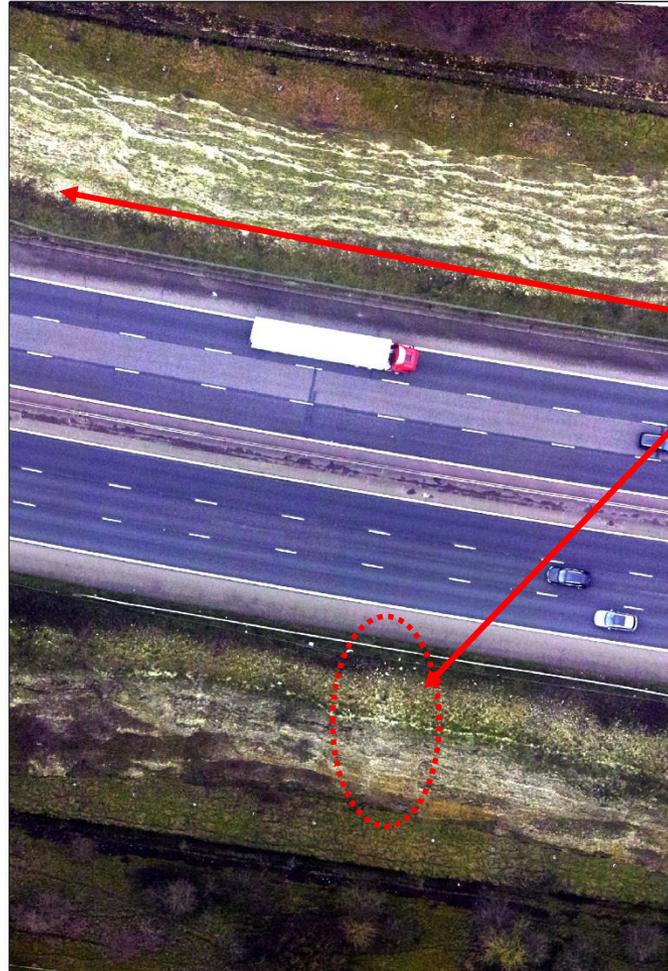
Potential rockfall –
whiter material
indicating fresh
'unweathered' chalk?

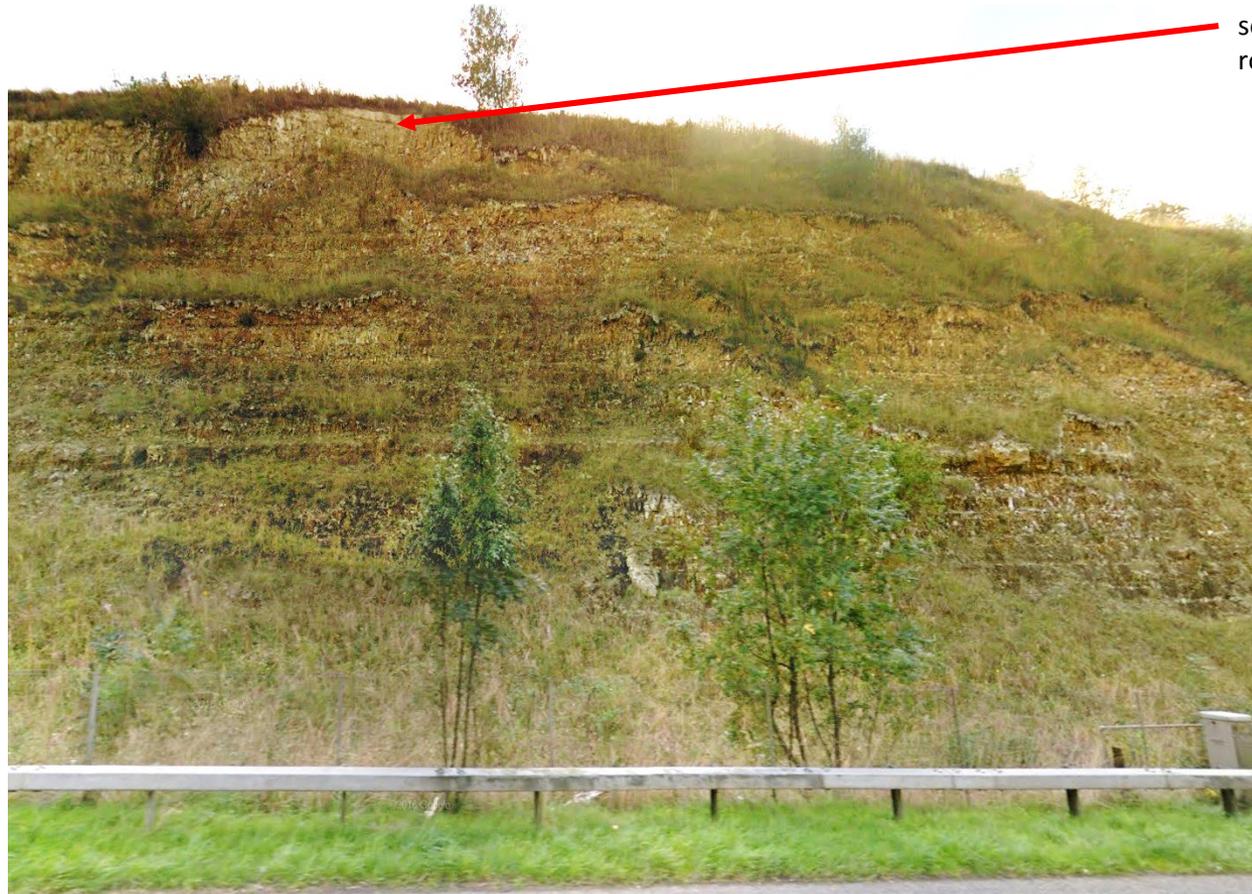
The Google Streetview image to the right shows the likely location for the rockfall identified in the aerial imagery.

Potential source of rockfall?

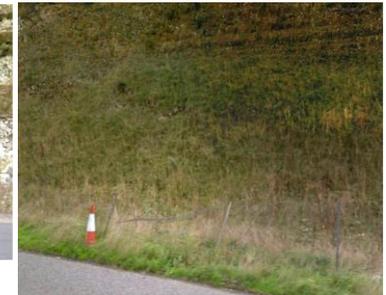
Damaged fencing. (Google, Sep 2016)

Conclusion: The use of AVIS would currently require a manual process of viewing known sites where such measures are known to be located for any defects to be recognised. However, AVIS allows, in this case, for the viewer to see and locate the SGM.

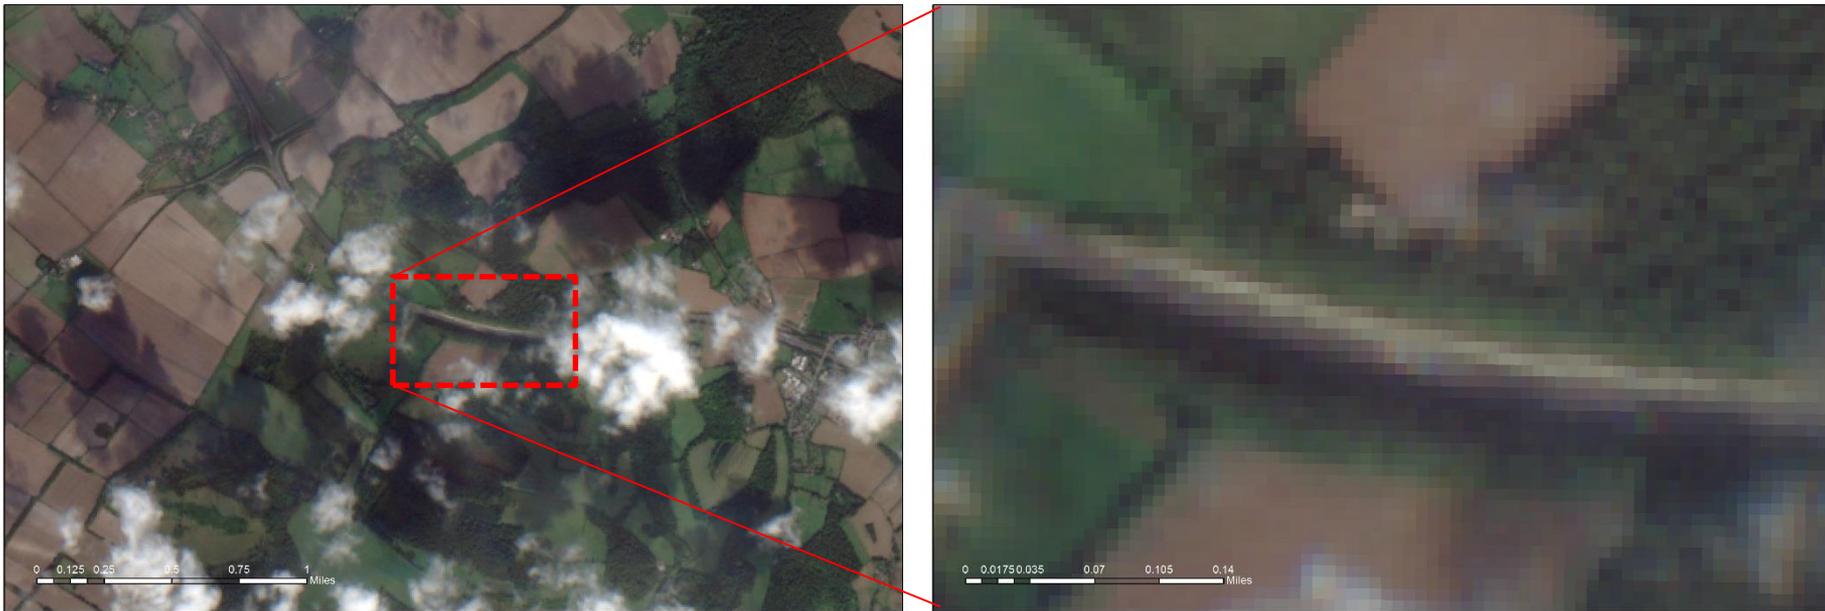
The right image shows a zoomed in view of the cutting, with the white chalk face on the northern side visible. Whereas, the southern cutting face is masked by shadow.

Cloud cover for this image, whose overall extent was much greater than that represented, was 84%, which represented the lowest value available within the period considered.

Natural colour image, Sentinel 2A L1C Product, capture date
13/03/2017

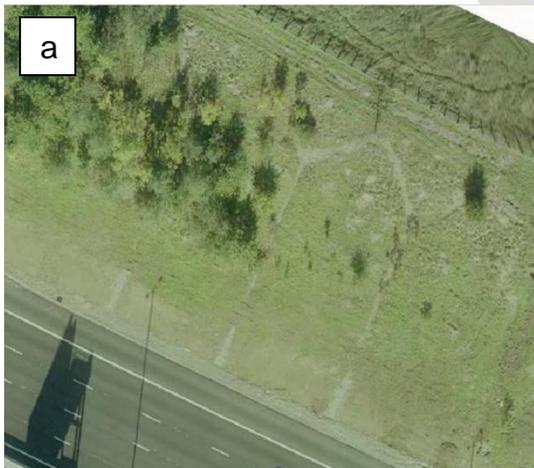
Figure 3a: 10 cm resolution photography showing buried but surface visible slope drainage (M25)

For surface visible SGMs the higher resolution data (better than 10cm) captured from rotary wing aircraft is the optimum imagery product, although some SGMs can be detected with lower resolution imagery (see **Figure 3**).
