## HRE major work review template

### Proforma for SAF consideration

| Structure name | Asset ID | NH Priority Rank |
|---|---|---|
| Malt Kiln Road, Little Smeaton, North Yorkshire | HBR3/124 | P1 |

HBR3/124 is a single span overbridge carrying Malt Kiln Road over the former Hull and Barnsley Line within Little Smeaton, North Yorkshire.

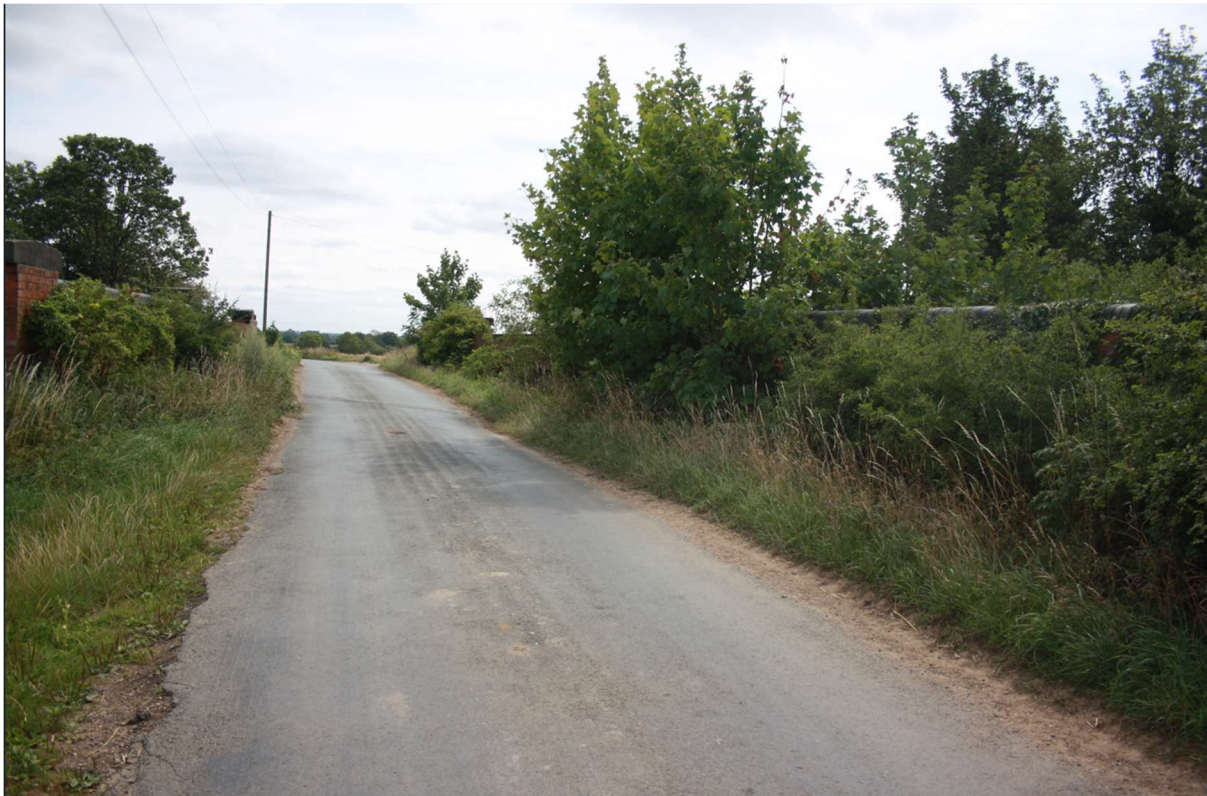
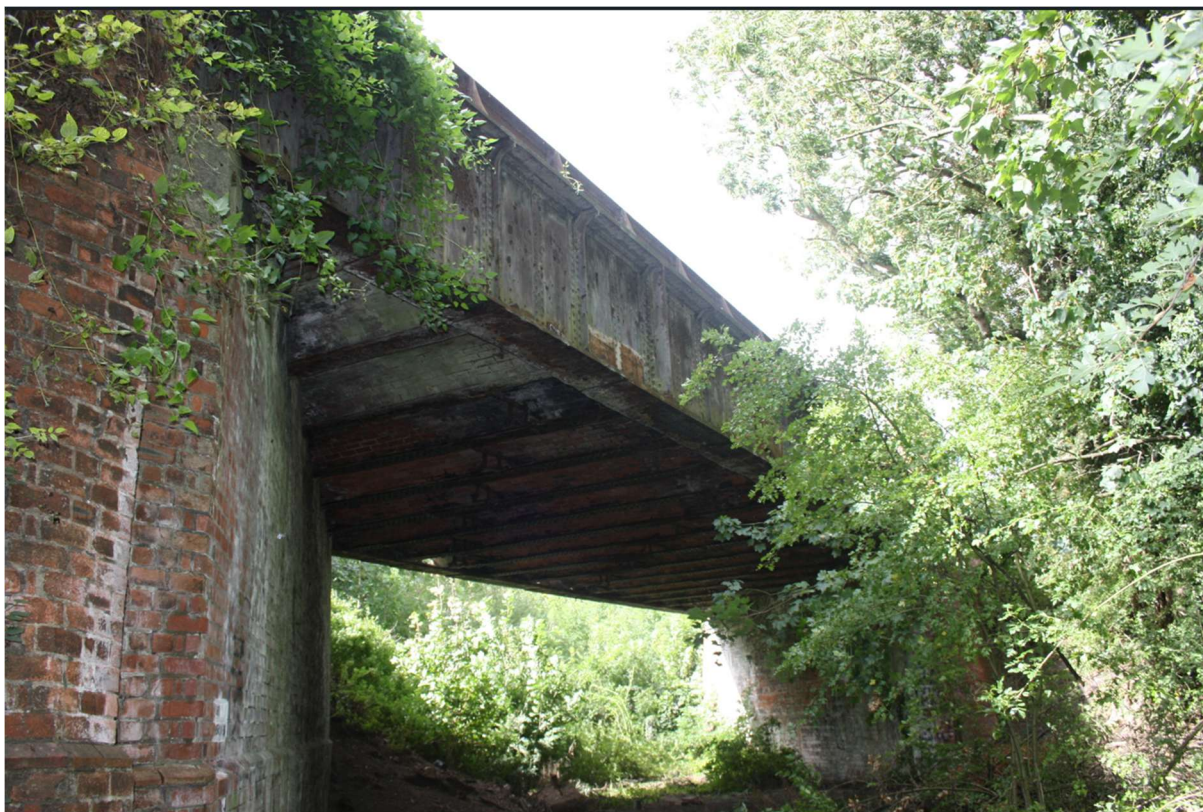
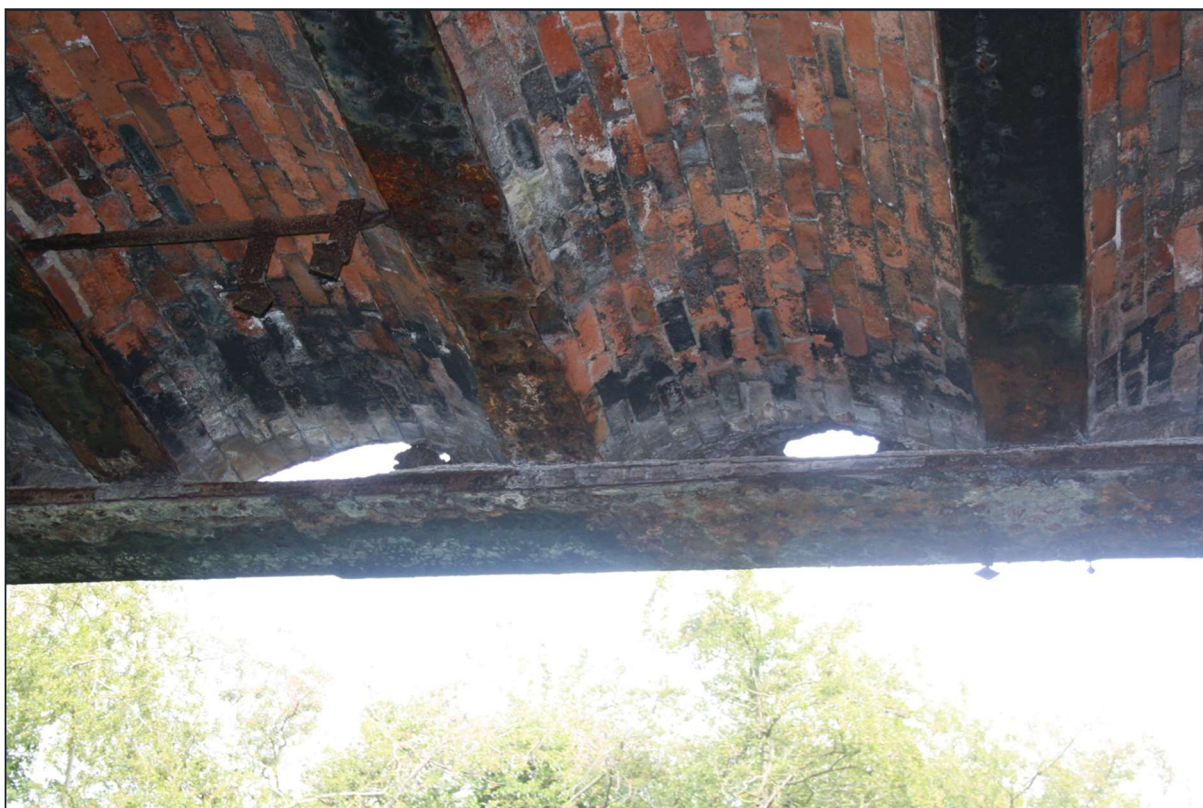
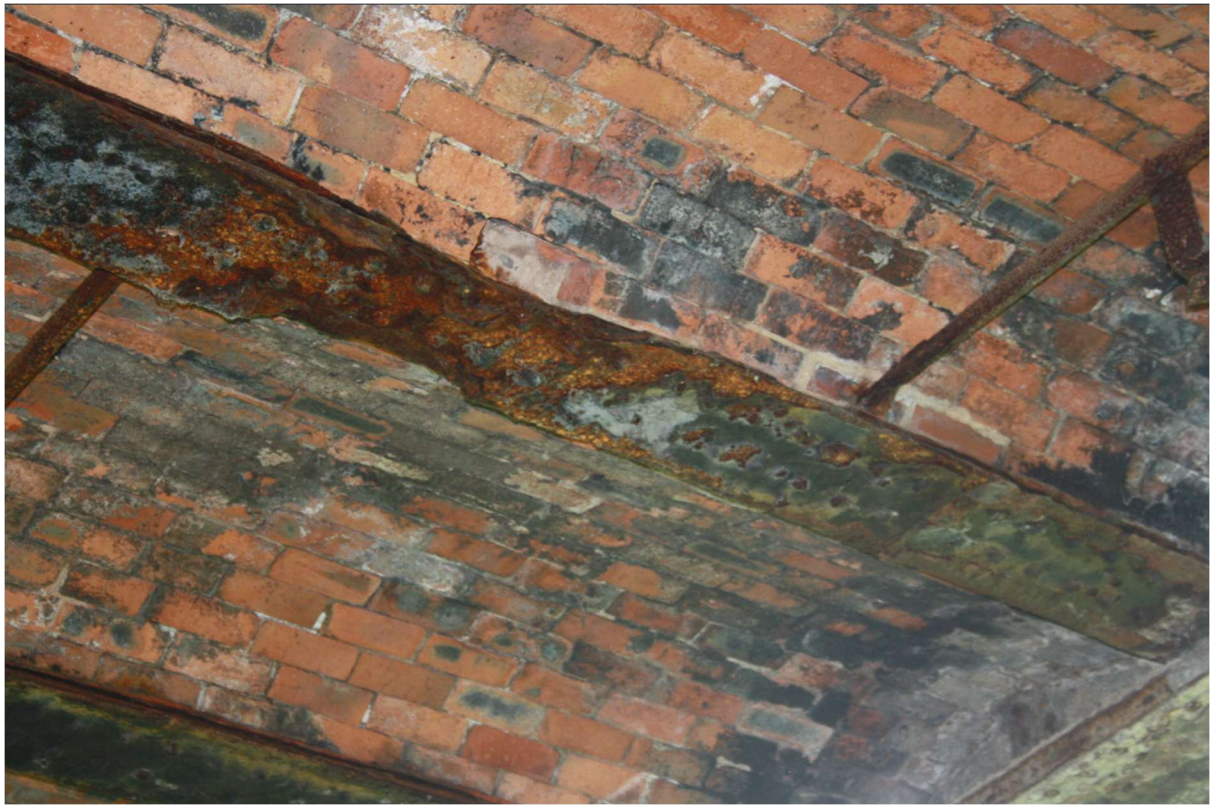
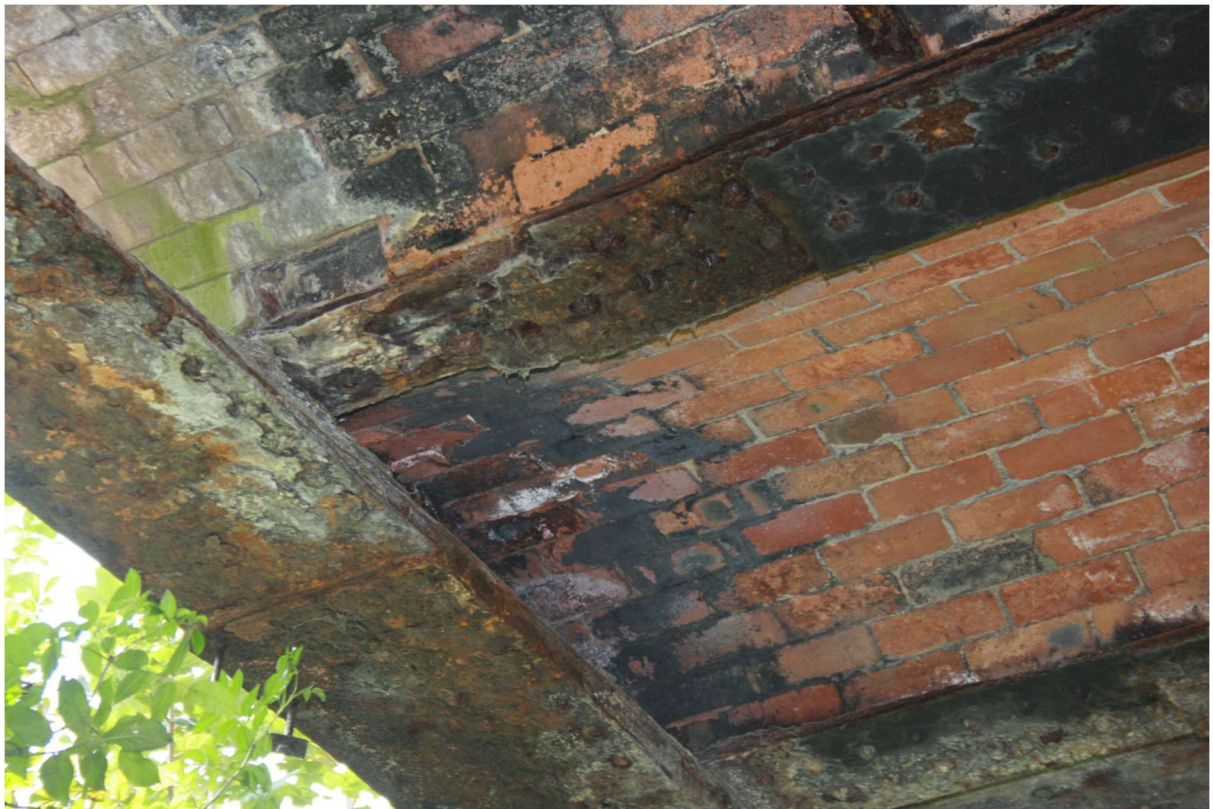
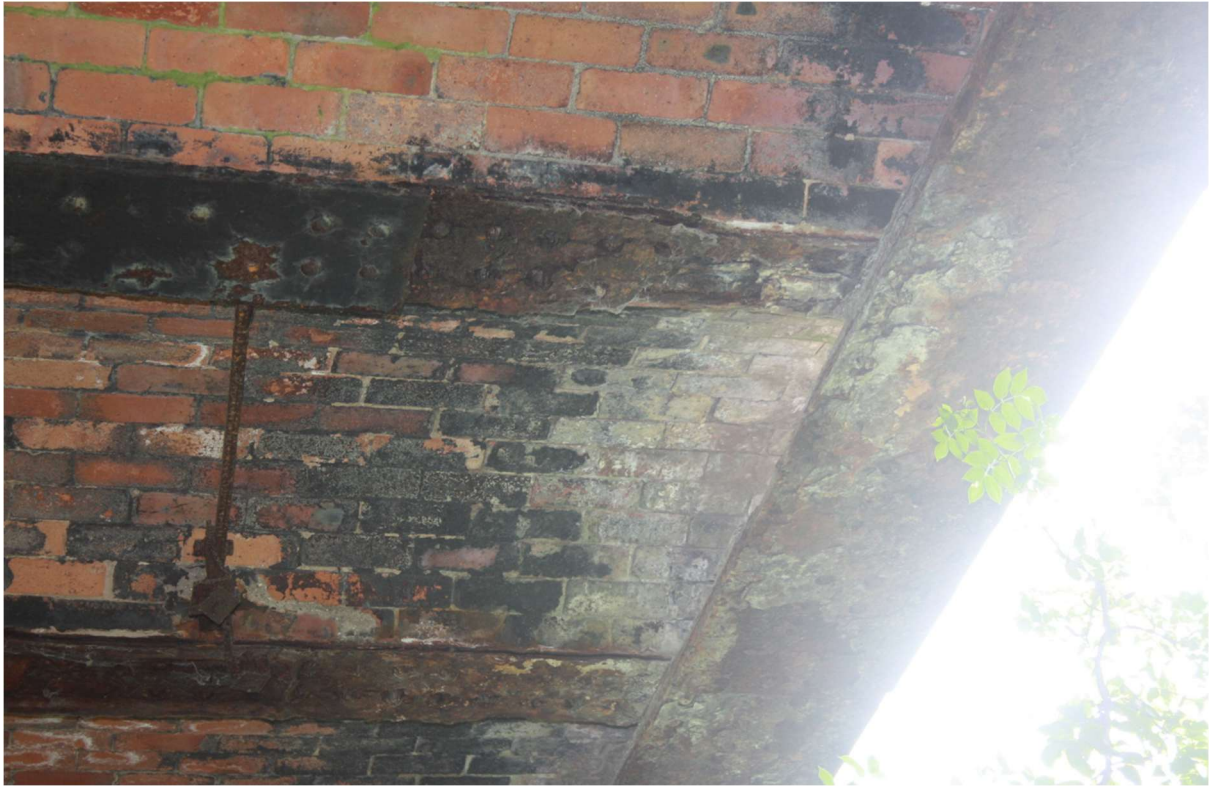
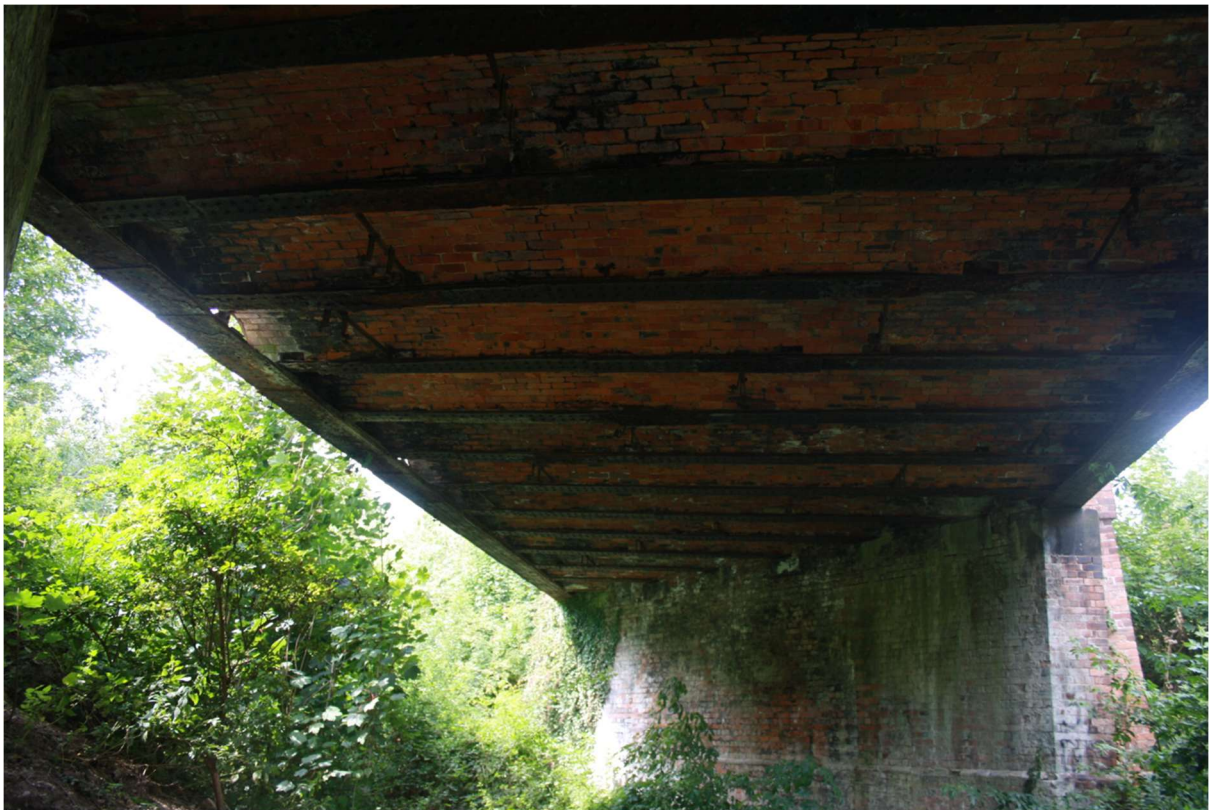
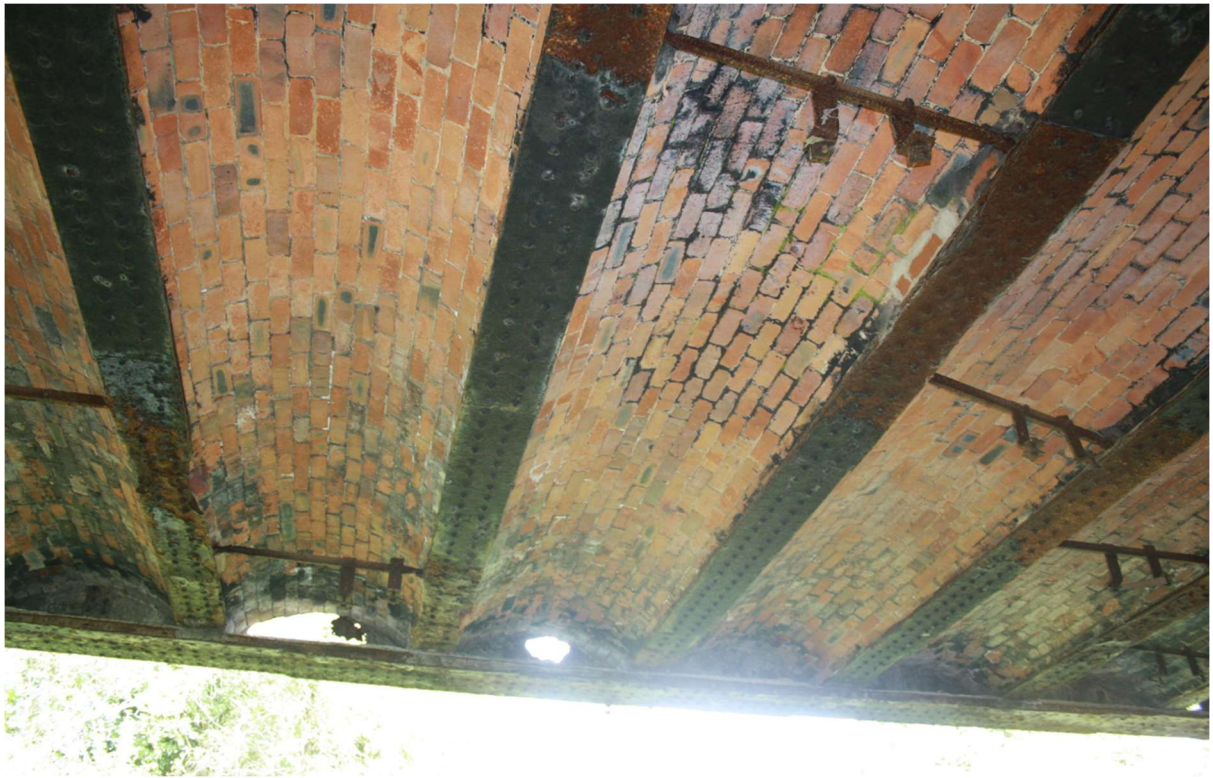
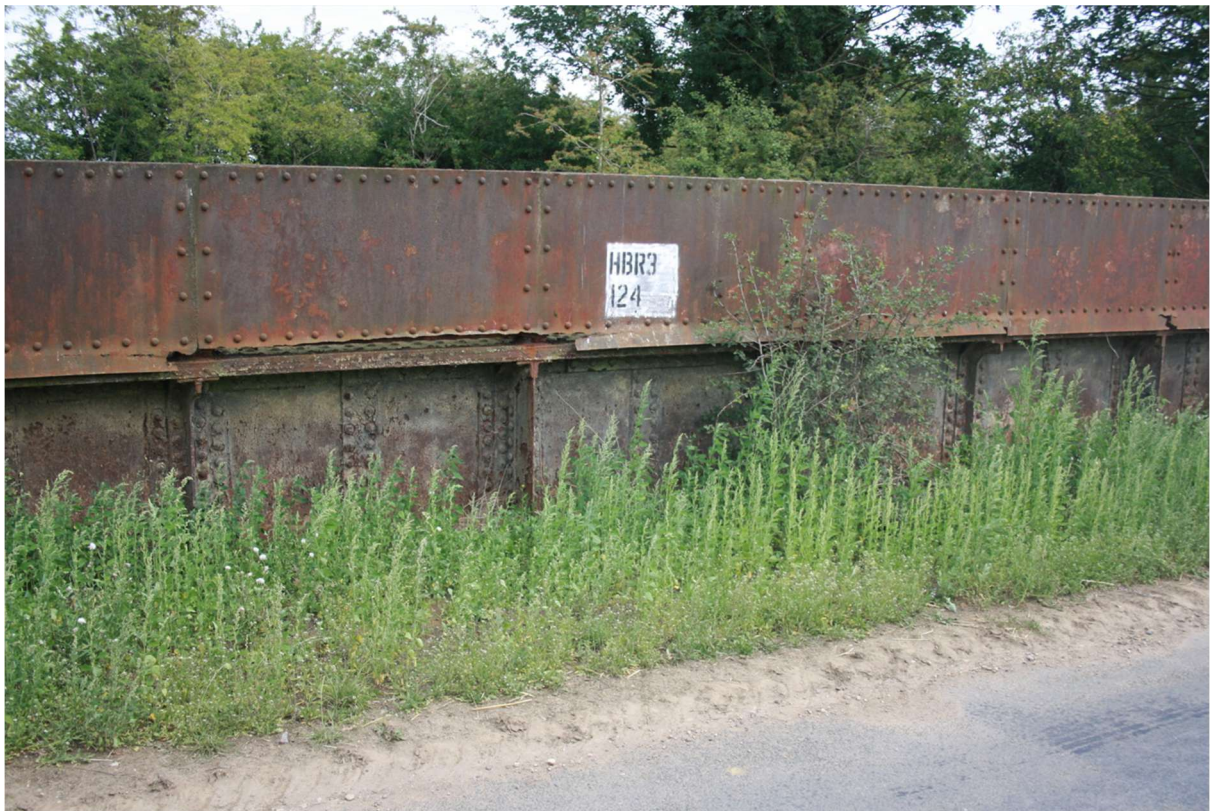
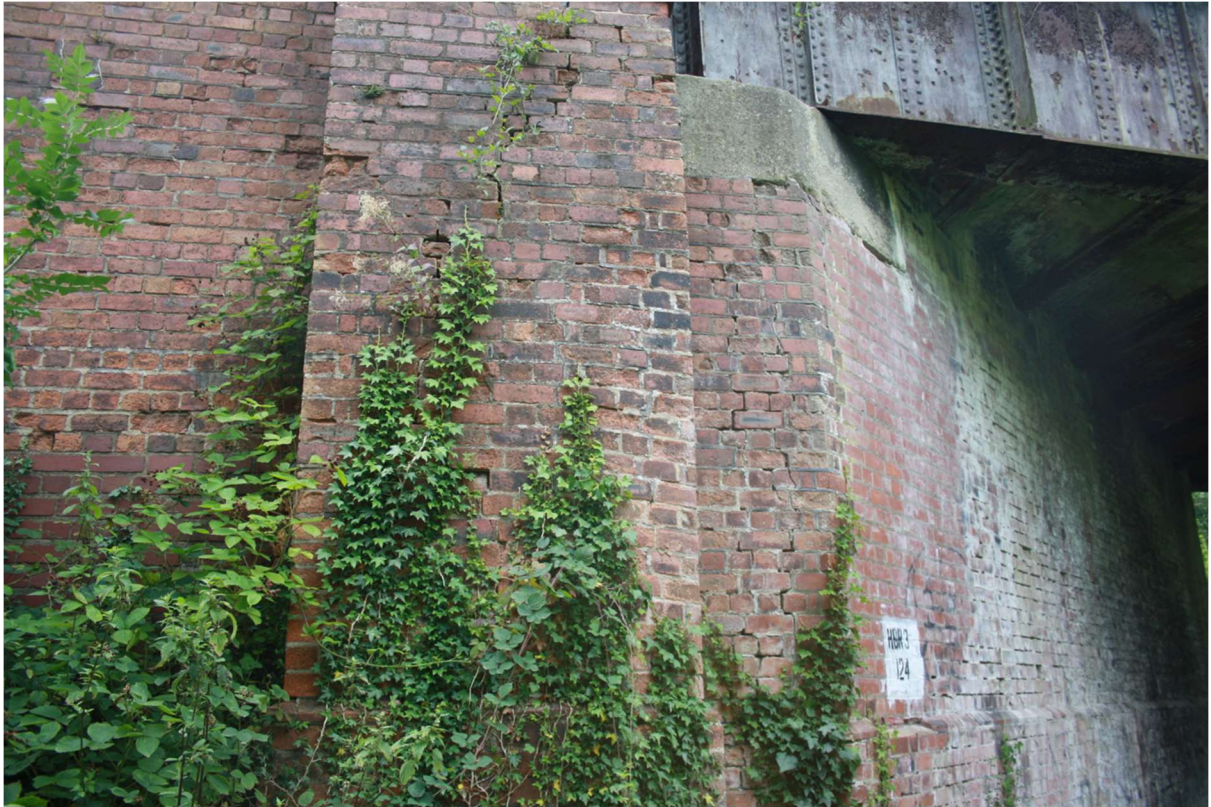
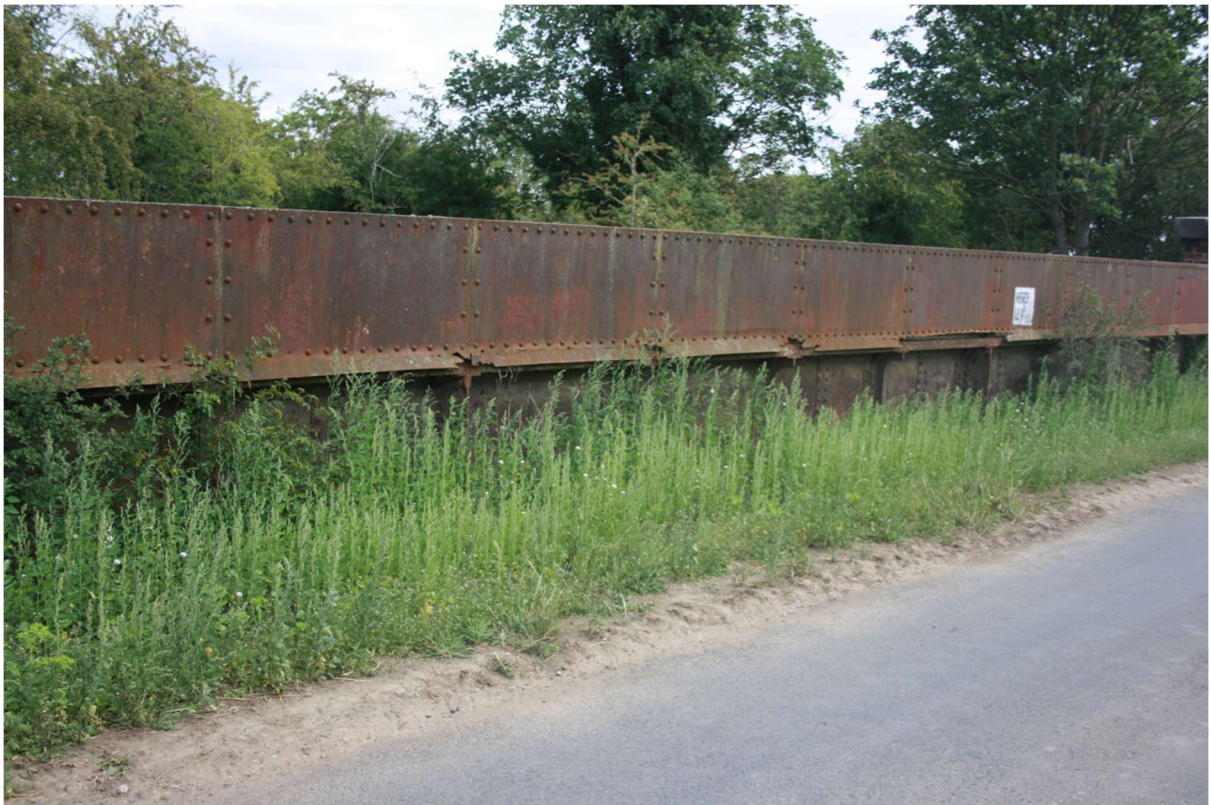
## Some photos to show the current bridge condition:

The structure is in bad condition with extensive corrosion, loss of sections and delamination at various locations of edge girders and transverse beams.

Recent inspection reports on the structure show there is ongoing deterioration particularly to the steel elements of the structure and hence would result in BE4 assessment failure.

| Engineering options | Pro's | Con's | Estimated cost* of remedy |
|---|---|---|---|
| Infill | Full strength bridge<br><br>Retains element of historic structure / fabric<br><br>Minimal future maintenance costs | No access | £500k* |
