CASE STUDY AECOM | 1.1b) January – March 2024

A63 Castle St – Underpass Excavation Monitoring & XWatch GPS Software

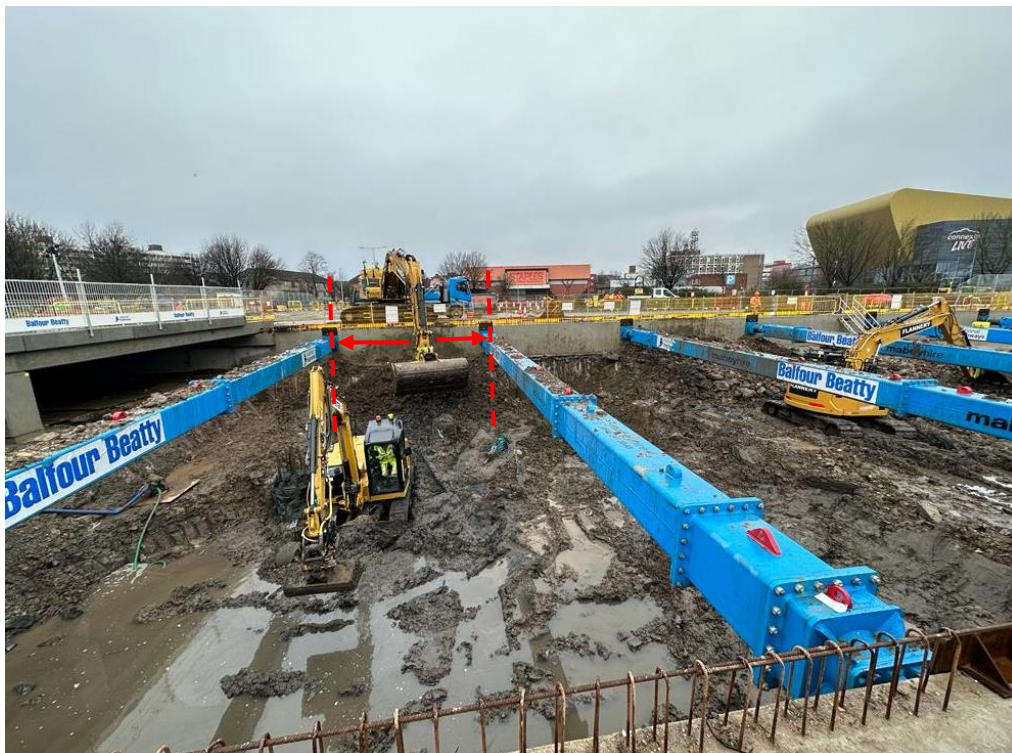
- The software was unable to be fixed on the large 50T excavator. As alternative control measure a slew restriction has been applied to the 50T excavator to restriction movement to stop the bucket and arm colliding with the props (see photo below). The XWatch GPS continues to operate on the other smaller plant within the main excavation area itself.

Figure 2 – Excavation on going, with mark up of slew restrictions on 50T machine.

- AECOM ensured that the XWatch GPS system & slew restriction on the 50T excavator were documented in both the ITPs & RAMS and implemented prior to the excavation works starting.

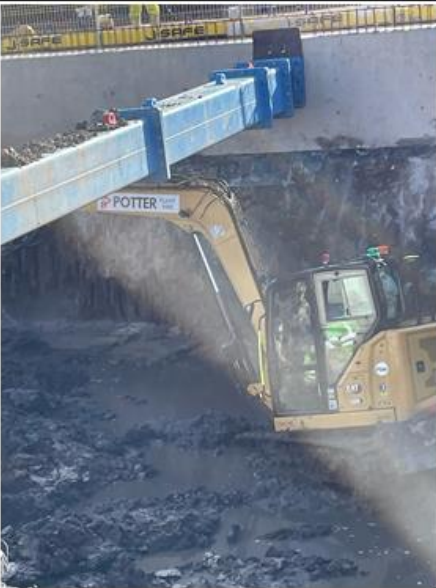
During the first week of excavation work both of these control systems encountered technical issues. AECOM have been directly involved in resolving the technical issues, ensuring they operate correctly again before excavation restarts. See Figure 3 for potential issue.

Date	Time	Source
2024-02-12	11:46	Mobile
Anonymous?	Reported By	Reporter e-Mail
No	Casey Amer	casey.amer@balfourbeatty.com
Request Feedback?	Resolved at Submission?	Location
No	No	53.74101, -0.33760
What Did You See, What Could Have Happened?	What Did You Do?	
Prop hit by machine.	Stopped work and raised with Foreman

Figure 3 – Observation raised by the Contractor for a prop being hit (Almost Hit)

- Due to the possible safety implications of a prop being hit, all excavation works were put on hold until the software could be fixed and operate as required.
