Sub-Task 2.2 – Report on A5 Warm Mix Asphalt

Task 1-111 Collaborative Research Project

Highways England, Mineral Product Association and Eurobitume UK

Project Number: 60523093

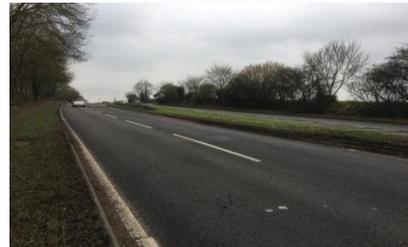
2017 Boundary between HMA & existing surface
(looking in Westbound direction)

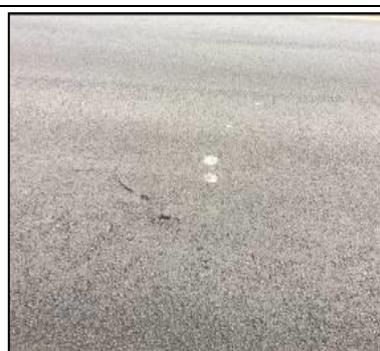
Picture 26: HMA

75-90m	Major rutting and extended crocodile crack defects were observed. In some spots, there was a loss of surface course materials causing potholes. Similar defects were observed in this location in the VCS conducted by TRL in 2014 pre-works.	Picture 13
Hot Mix Asphalt	92-223m	General observations: Some local fretting was observed along with cracking. In some areas there appeared to be some bitumen bleeding in the wheel tracks.	
	135-136m	Minor longitudinal cracks. Visible signs of excessive bitumen on the surface of the road synonymous with fatting/bleeding.	Picture 19
	203m	Visible signs of fretting observed	Picture 25
	204-205m	Medium transverse and longitudinal cracks were observed. Rutting and crazing were recorded in this location as in the TRL 2014 VCS pre-works.	Picture 26

There is evidence of underlying issues (possible subsidence) in certain areas of the demonstration scheme which is observed in the form of rutting, cracking and crazing. It was observed that the recorded defects were located in close proximity to defective areas as identified by TRL in surveys conducted in 2014. This strongly suggests fundamental underlying issues which may be related to the condition of the foundation and/or substrate. Further testing and analysis are required to ascertain pavement condition of the underlying layers. This falls outside the scope of this project.

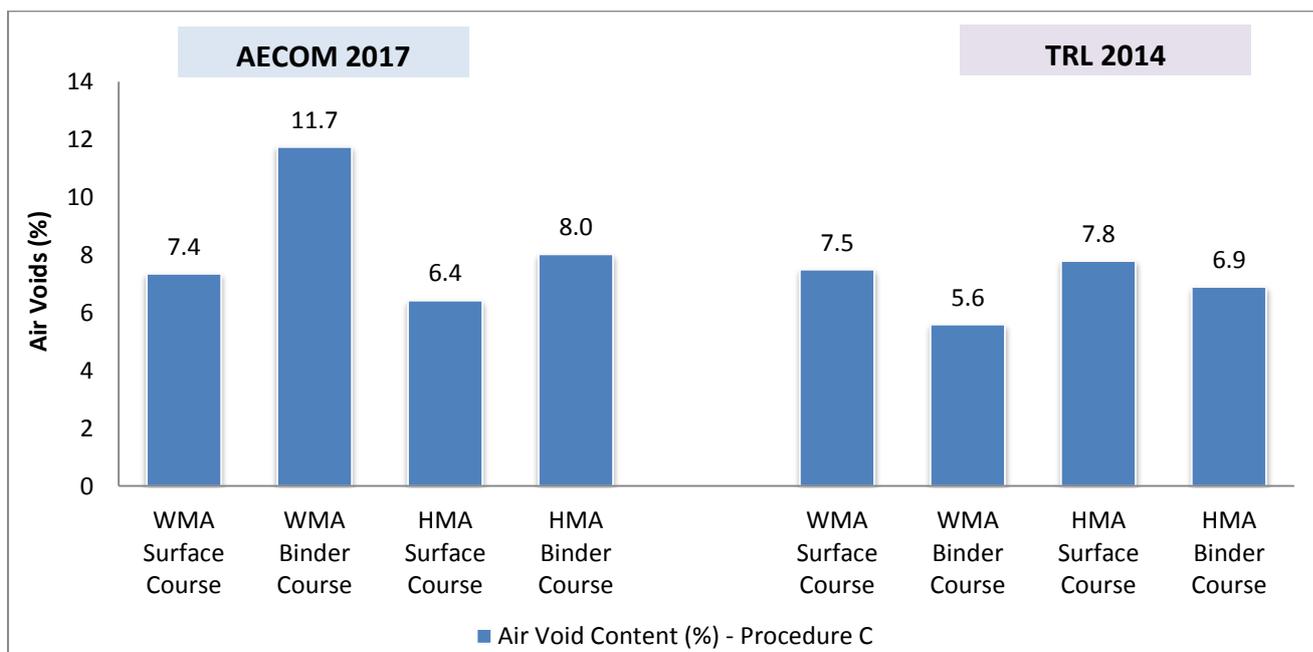
Figure 6: Air Voids Procedure C for AECOM 2017 and TRL 2014

The mixture volumetrics was obtained for both the surface and binder courses using an average of six cylindrical specimens cored from the site. The test results for both Procedures B and C are presented in Appendix C. Comparisons between the mixture volumetrics following testing of samples by AECOM in 2017 and TRL in 2014 (reported in PPR 742, 2014) is shown below in Figure 6.

It should be noted that TRL in 2014 analysed the same number of specimens but made use of laboratory manufactured slabs cored and tested in accordance with BS EN 12697-6 using three procedures: Procedure A (Dry), Procedure C (Sealed) and Procedure D (Dimensions) (Wayman et al., 2015). On this basis, the measured results are not directly comparable and the 2014 testing is not considered to accurately represent the material air voids in service. The air voids for WMA and HMA are higher than would be expected for AC 20 binder course materials. WMA binder course contains 25% recycled asphalt which could contribute to variation in density. This is because the specific gravity of the recycled material may vary to a greater extent than virgin material. PPR742, 2014 reports the average in-situ density measurements as 9.5% and 7.6% for WMA and HMA binder courses respectively. Air voids measured on binder course during this 2017 survey are higher than those recorded in situ.

The air void contents reported varied significantly and were found to be higher than expected. Higher air void contents may indicate that these asphalt materials could be susceptible to increased oxidation and permeability. WMA air voids were found to be higher than HMA. High air voids may result in increased susceptibility to the ingress of water into the pavement structure.

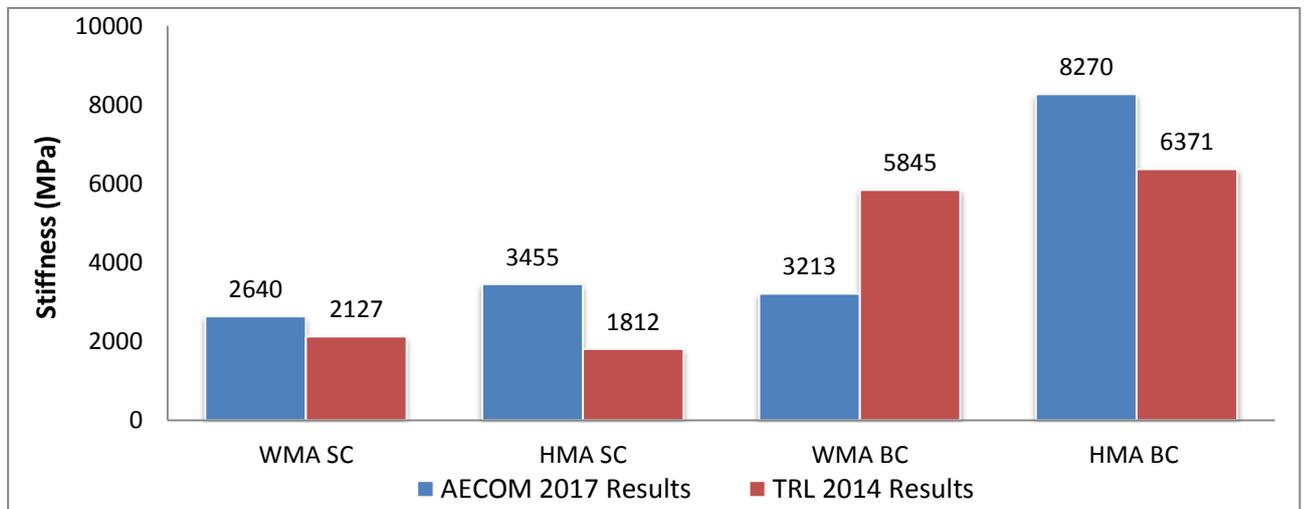
Figure 7: ITSM Test Results

The Indirect Tensile Stiffness Modulus (ITSM) test was conducted in accordance with BS EN 12697-26 at 20°C. The test results are presented in Appendix D. The test results are analysed and summarised below in Figure 7.

The test results as conducted in 2017 by AECOM show that the HMA mixtures have higher stiffness values in comparison to the WMA mixtures for Surface Course (SC) and Binder Course (BC). AECOM 2017 stiffness results would be expected to be higher than testing conducted by TRL in 2014 due to binder ageing. However, TRL testing is based on laboratory manufactured samples whilst AECOM results are based on cores and therefore, results are not directly comparable.

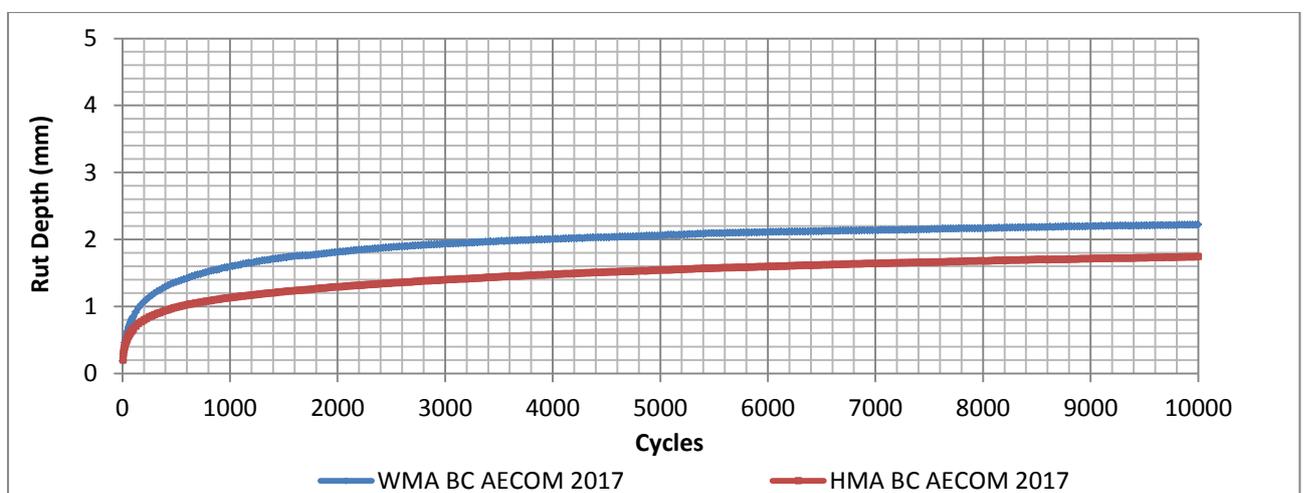
Figure 8: Rut Profile - AECOM 2017

Wheel Tracking Tests were conducted to ascertain the resistance of the asphalt mixtures to permanent deformation. The test was conducted in accordance with BS EN 12697-22, Procedure B in Air at 60°C. Two Binder Course (BC) samples were used in ascertaining resistance to permanent deformation of the WMA and HMA. Appendix E presents the wheel tracking test results. The mean rut profiles are shown below in Figure 8.

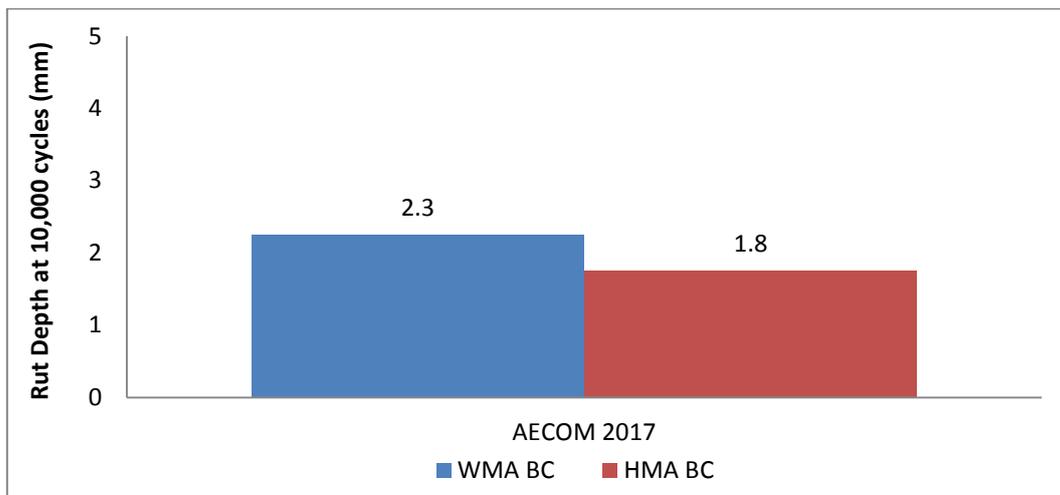
Figure 9: Rut Depth at 10,000 Cycles - AECOM 2017

Figure 9 shows that the rut depth profile of the WMA and HMA materials with rut depths < 3 mm after 10,000 cycles at 60°C (Procedure B).

The mean rut depths for the WMA and HMA binder course were < 3 mm after 10,000 cycles (tested at 60°C in accordance with BS EN 12697-22). WMA rut depth was found to be slightly higher than HMA which could be attributed to higher air voids, the difference in grading which may be associated with the recycled content, or possibly the binder properties. The proportional rut depth and wheel track slope fall within specified limits outlined in PD 9961:2015 Table B4 for asphalt concrete for very heavily stressed sites requiring very high rut resistance.

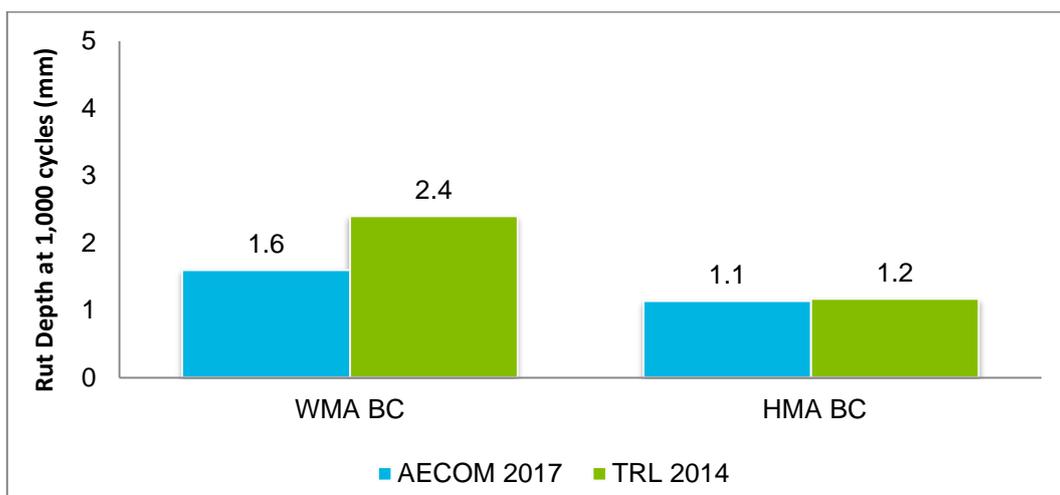
Figure 10: Comparing Rut Depths at 1,000 cycles for AECOM 2017 and TRL 2014

Figure 10 shows the rut depth at 1,000 cycles (Procedure A) used in comparing the resistance to permanent deformation of the AECOM 2017 samples WMA and HMA BC mix. Both rut depths were found to be < 3 mm.

Note for Figure 10: TRL results are based on laboratory compacted samples and not cored samples from the site. Further to this, BS EN 12697-22 Procedure A was followed in ascertaining the rut depth profile.

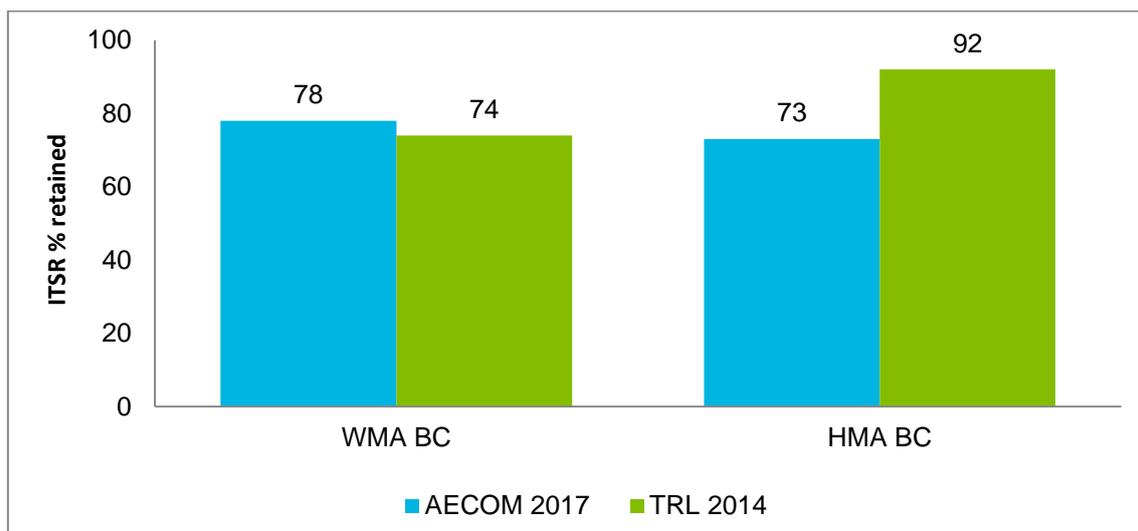
Figure 11: Water Sensitivity Test Results at 20°C

Figure 11 shows that the ITSR values for all the binder course mixtures are above 70% which suggests good resistance to water damage. The WMA BC showed similar test results between the AECOM and TRL samples. The HMA had variable test results with values of 92% for the TRL sample in comparison to 73%. It must be noted that samples used for testing by TRL were laboratory manufactured as opposed to samples obtained from the site. Similar ITSR values are obtained from WMA and HMA mixtures (AECOM and TRL).

The samples tested for moisture susceptibility showed ITSR values for all the binder course mixtures exceeded 70% indicating adequate resistance to water damage of the mixtures. The binder test results recovered from AECOM in 2017 show penetration grade values of 42 dmm and 50 dmm. The penetration grades measured for the WMA and HMA binder course materials are higher than expected for material which has gone through the installation process and has been in service for three years.

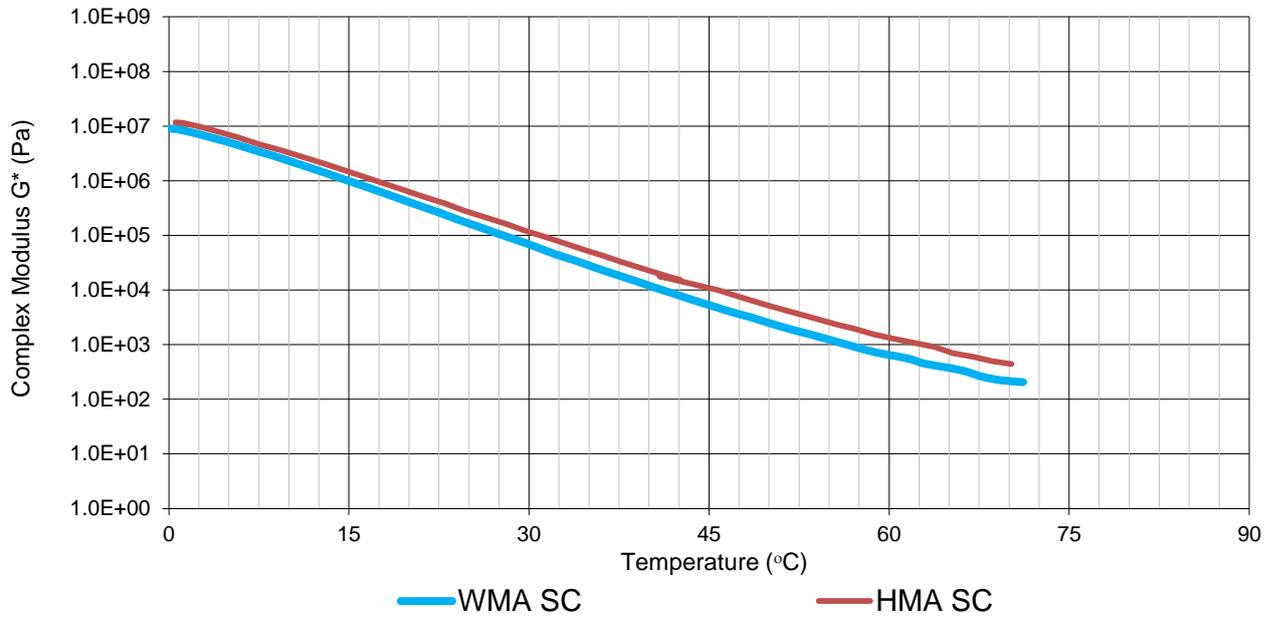
Figure 12: Complex Modulus vs Temperature

The binder rheological properties were tested in accordance with BS EN 14770. The complex modulus as a function of the temperature is presented below in Figure 12. The test was conducted for the surface course WMA and HMA mixtures.

Figure 12 and Figure 13 shows similar binder rheological properties between the WMA and the HMA Surface Course (SC). This indicates that most probably, the same PMB was used in the production of the asphalt mixtures. The initial/original rheological properties of the PMB were not available to facilitate further comparative analysis.

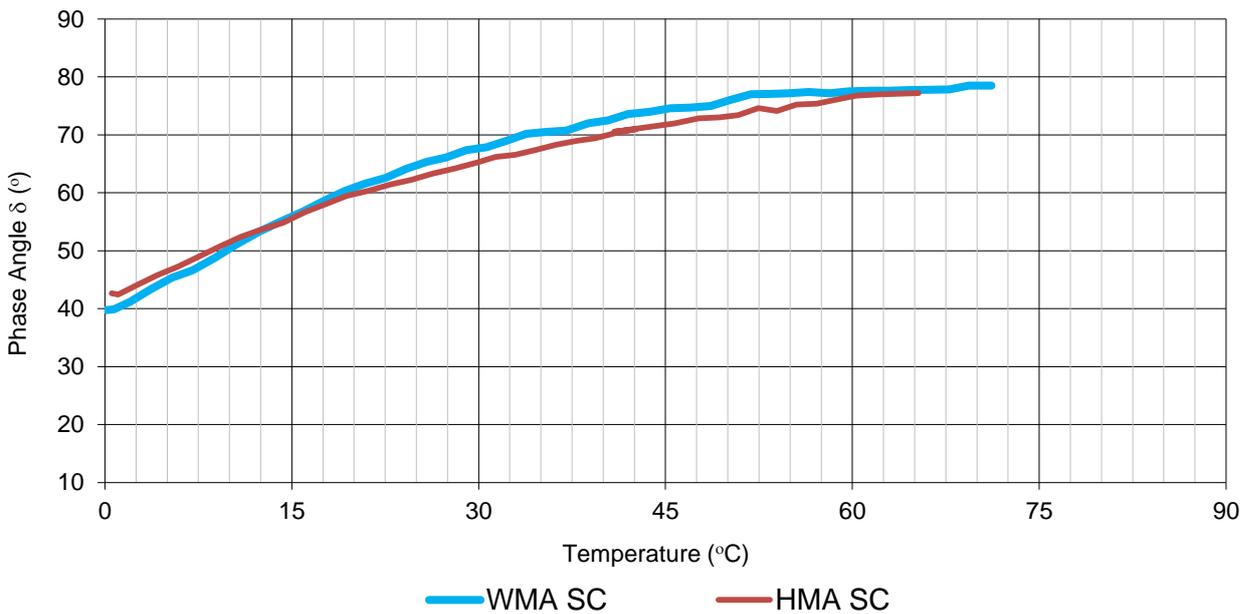
Figure 13: Phase Angle vs Temperature

Figure 13 presents a plot of the phase angle as a function of temperature. The result shows that at increasing temperatures, the phase angles increase to a more viscous state.
