A27 East of Lewes Improvements

PCF Stage 3 – Historic Environment Setting Assessment

February 2019

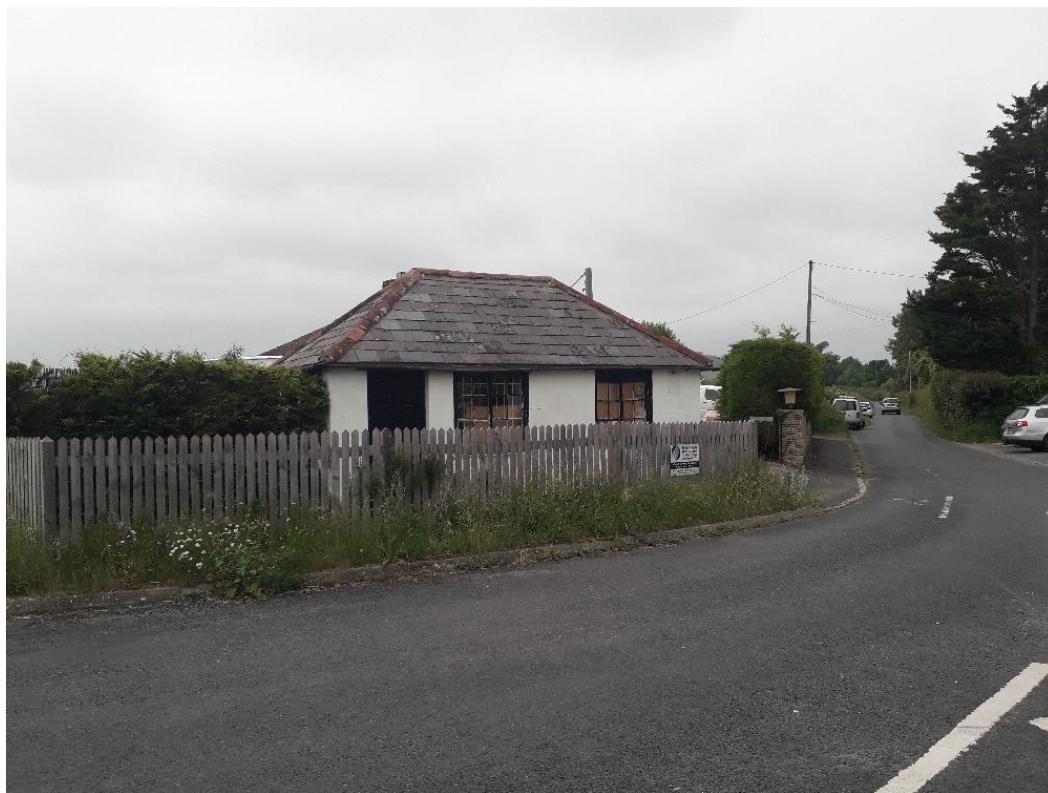
Image 7 – North view of the Grade II Tollgate Cottage (DES1661) situated on the corner of an unnamed country lane and the A27, Glynde. The asset is confined within its immediate setting comprising gardens and fencing which lines the road.

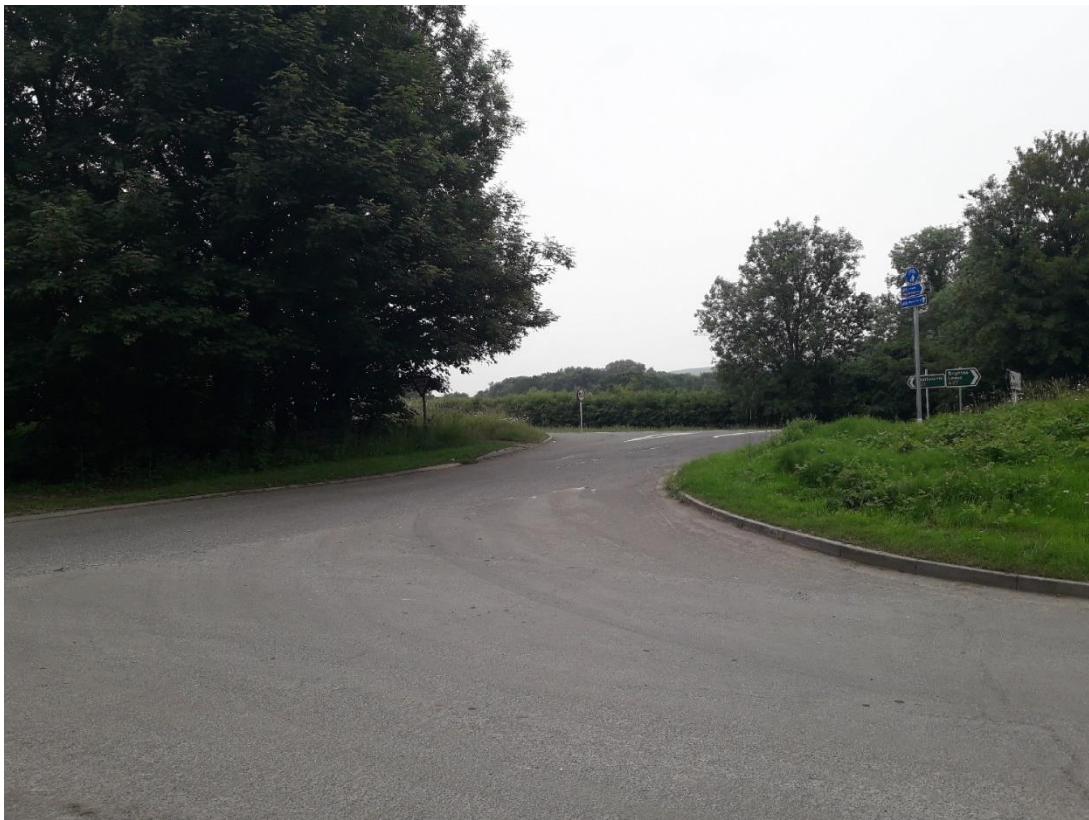
Image 14 - South view from Grade II Remains of Wayside Cross (DES2253) comprising access road to residential streetscape from the A27. Despite the semi-rural setting, the asset experiences movement and activity associated with the A27.

2.6.1 The Grade II Remains of Wayside Cross (DES2253) are situated on a grass bank of Burgh Lane, front-facing an access road and the A27 (**Image 14**). The medieval stone cross has deteriorated over time, comprising the base and remains of monolithic plinth and lower shaft (**Image 15**). The wider setting comprises residential streetscapes and green fields to the rear of the asset and the busy A27 to the south.

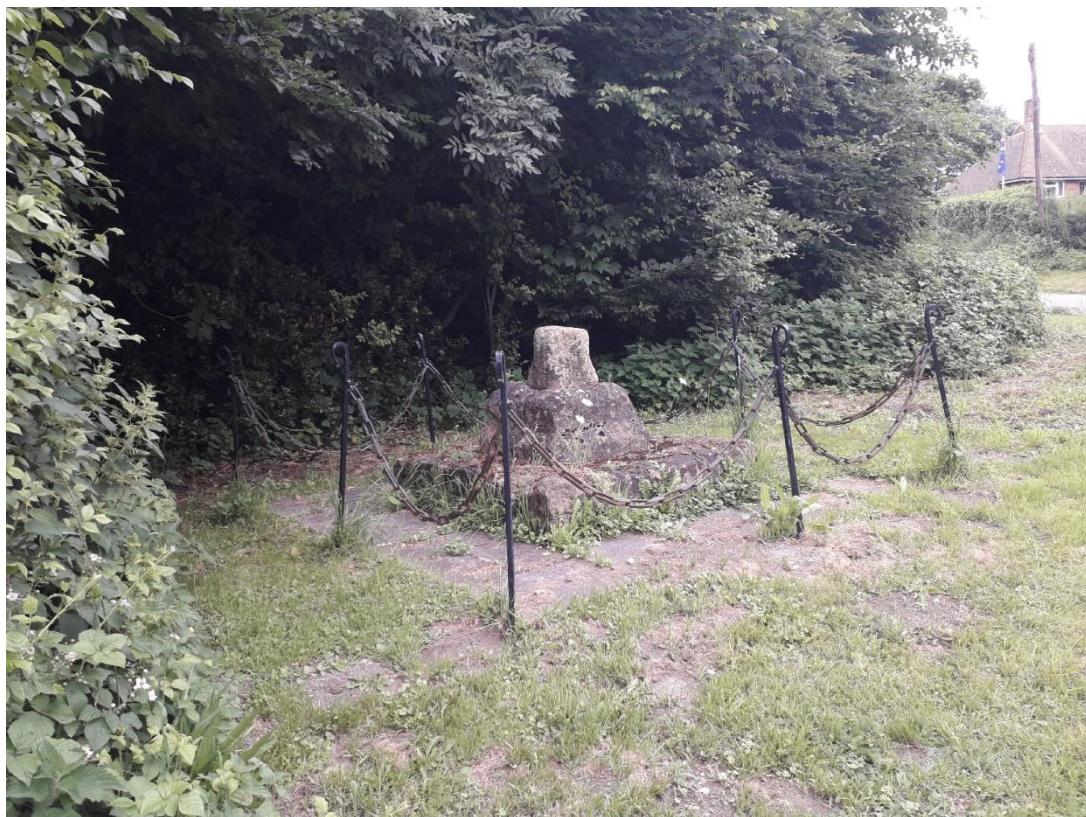
Image 15 – North view of Grade II Remains of Wayside Cross (DES2253) located on a grass bank with tree-lined boundary to the rear. The medieval cross is in poor condition comprising base, plinth and shaft.

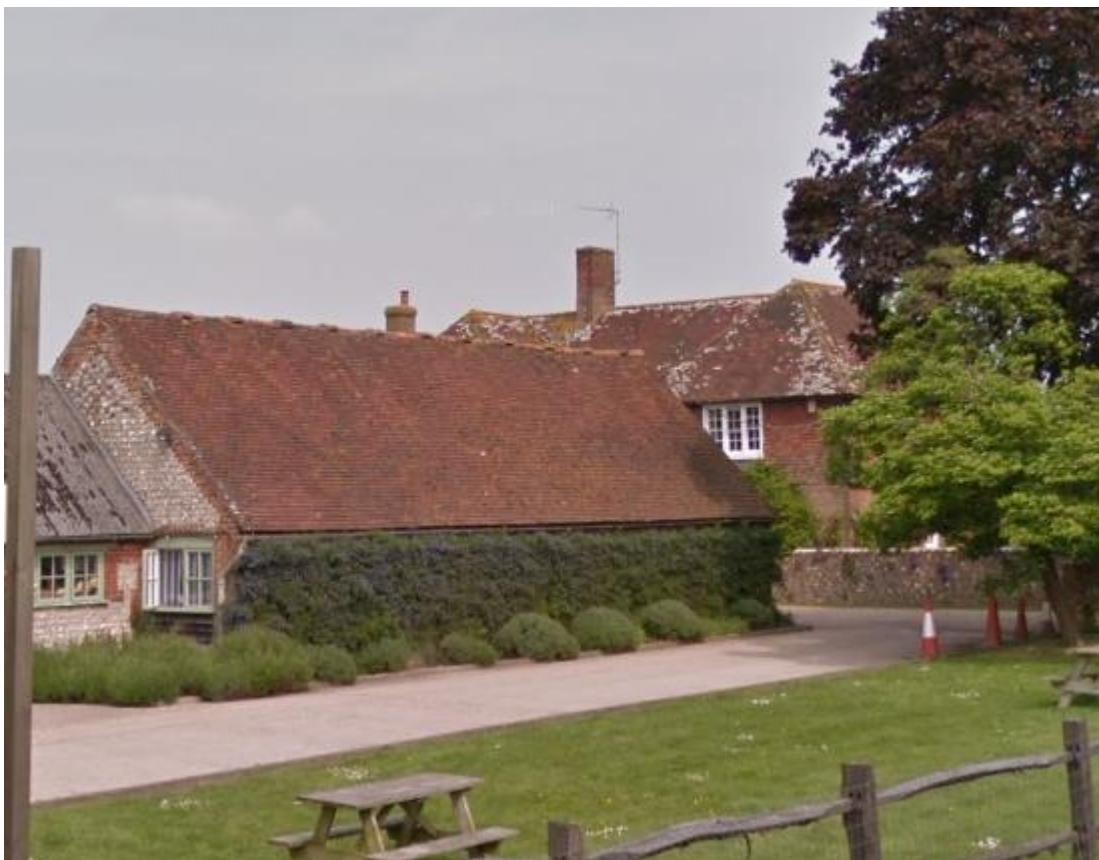
Image 16 – Grade II Middle Farmhouse (DES1697) situated within historic farmstead off the A27, near Firle. The red brick asset shares an immediate setting with associated agricultural buildings and garden to the rear, close to the A27.

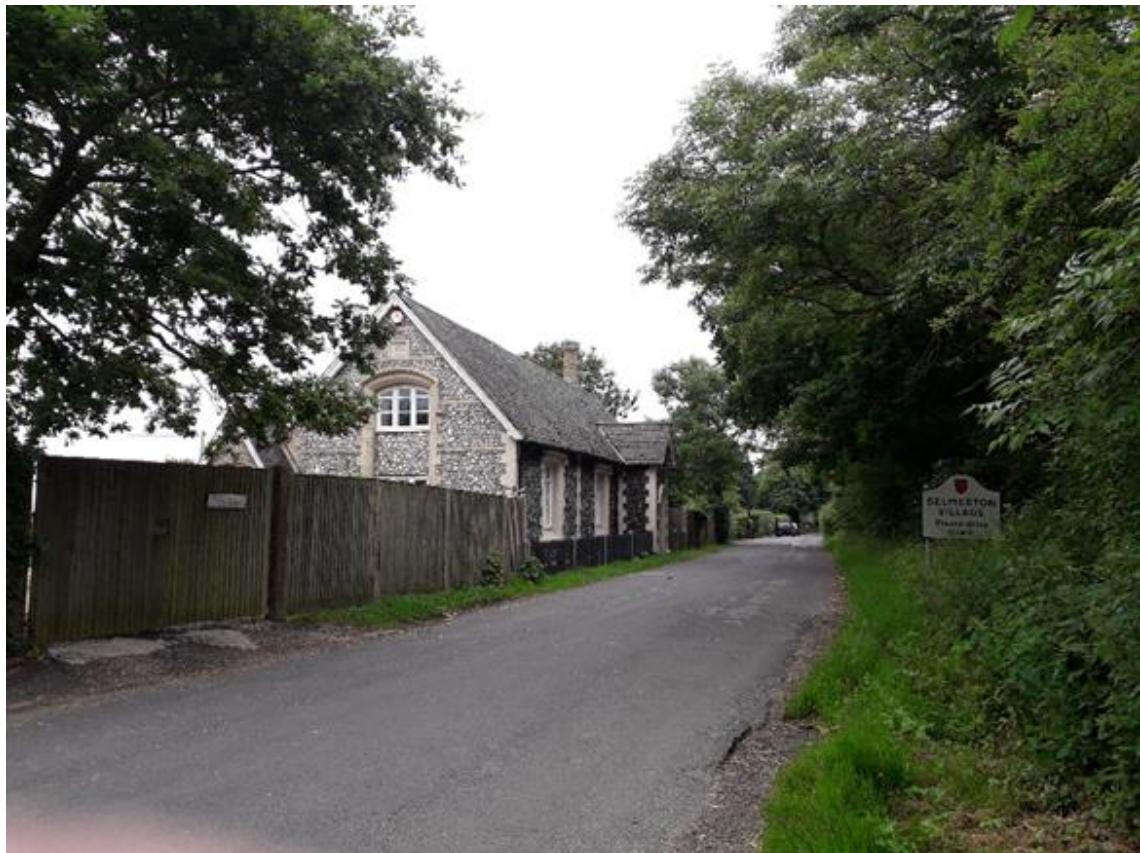
Image 21 – North-west view of the Grade II Flint House (DES5033) situated in immediate boundary comprising fence and grass bank at the roadside of The Street. The asset is constructed of local flints which contributes to the historic character of the asset.

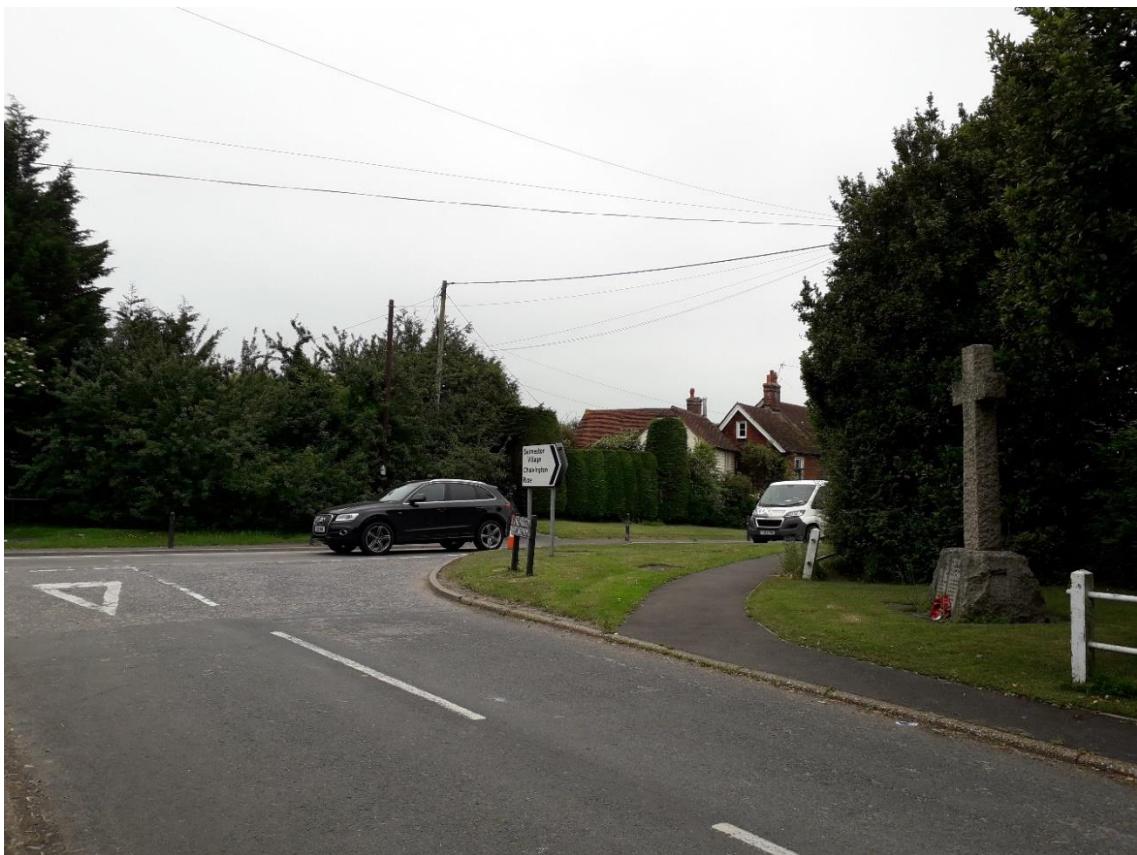
Image 22 – South-west view of the Grade II War Memorial (DES10798) situated on a grass bank off a public footpath on the corner of The Street and A27 at Selmeston. The asset experiences traffic noise, movement and activity due to its proximity to the A27.

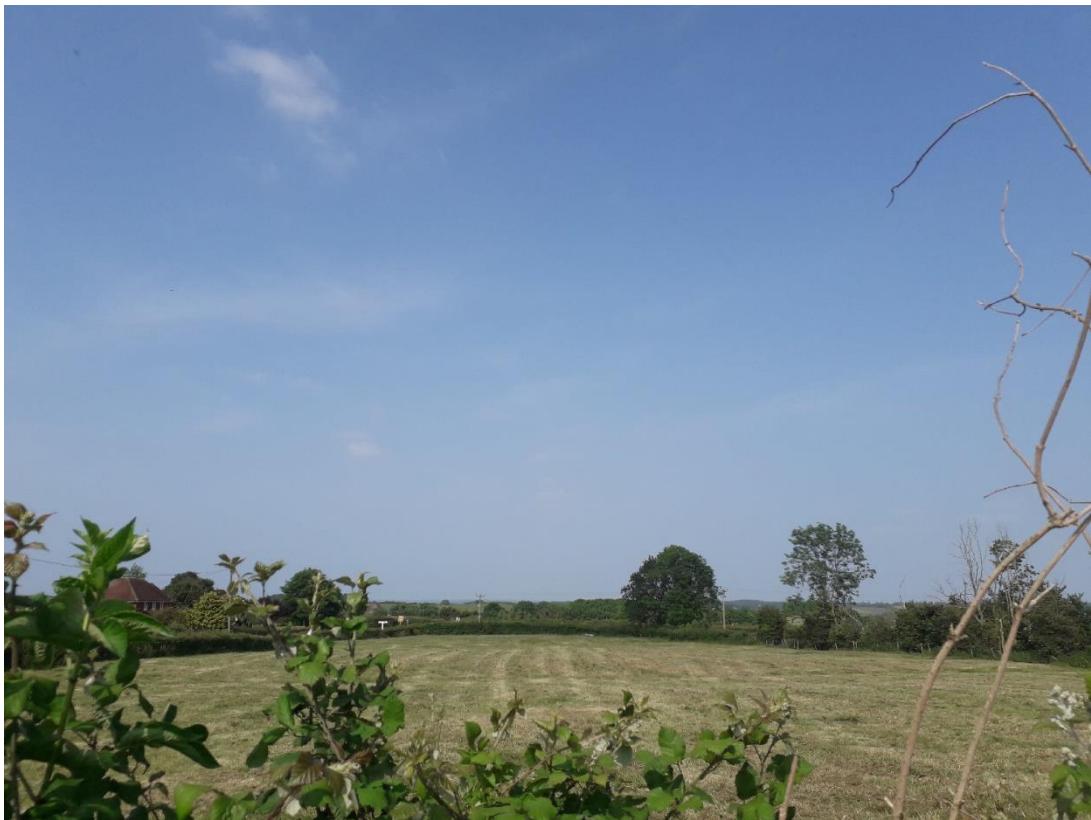
Image 34 – East view of the Scheduled site of the Deserted Medieval Village, north of Church Farm (DES8329) located in an agricultural field in Berwick village and a grass bank on the edge of the A27. The majority of the asset is surrounded by a tall hedgerow with fence.

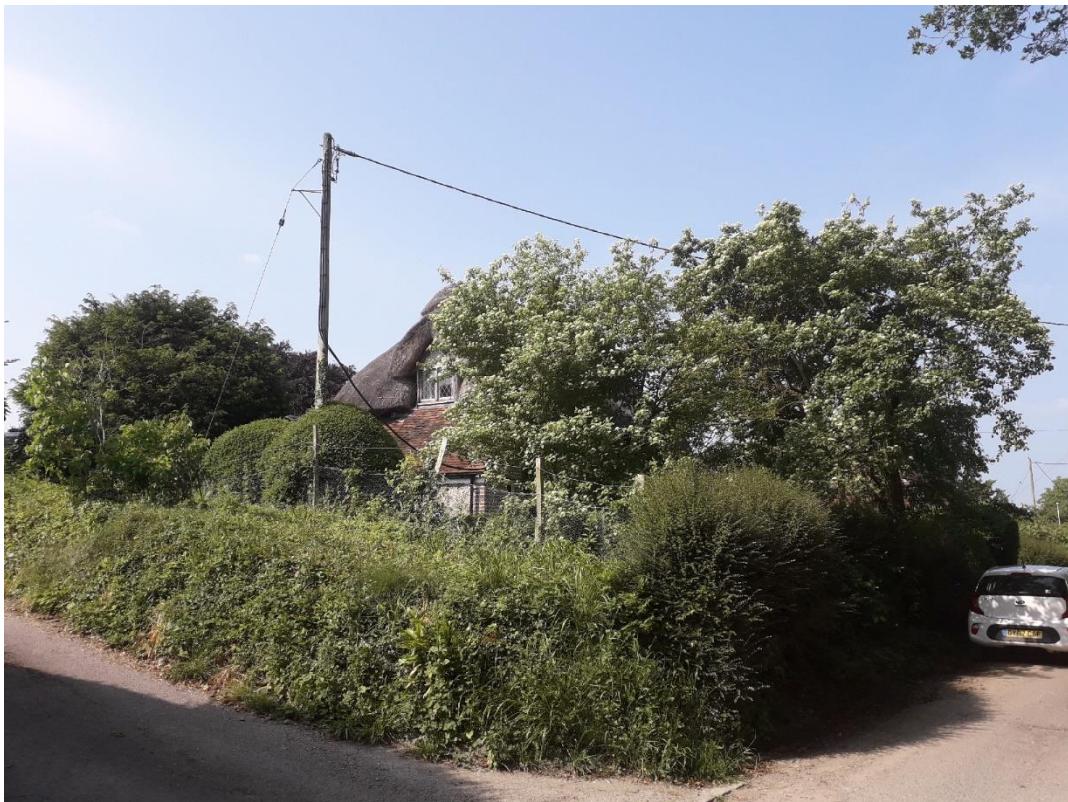
Image 37 – North-east view of the Grade II Thatched Cottage (DES6731) enclosed within its immediate gardens comprising mature trees and hedgerows edging the roadside. The upper floors of the asset are likely to have internalised views of Berwick CA to the north and south.

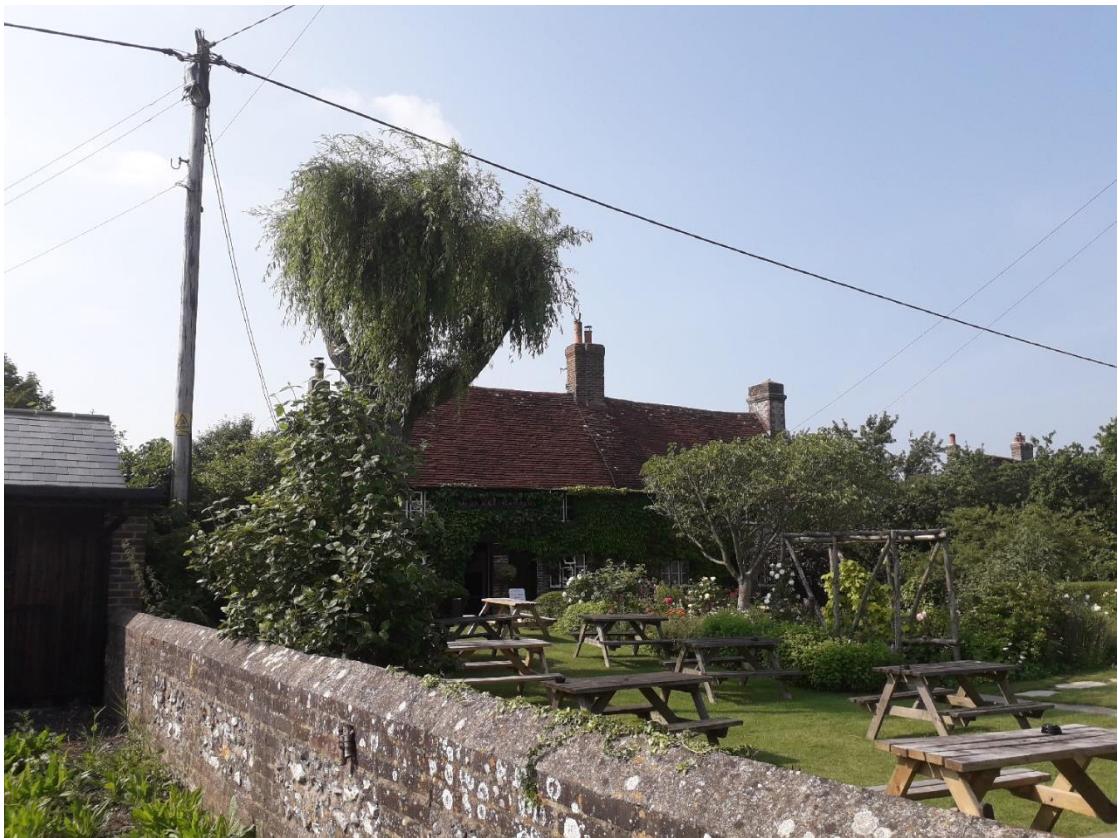
Image 43 – North-west view of the Grade II Cricketer's Arms Inn (DES6414) with beer garden and brick wall. The asset has glimpsed outwards views to the east comprising the wider South Downs landscape.

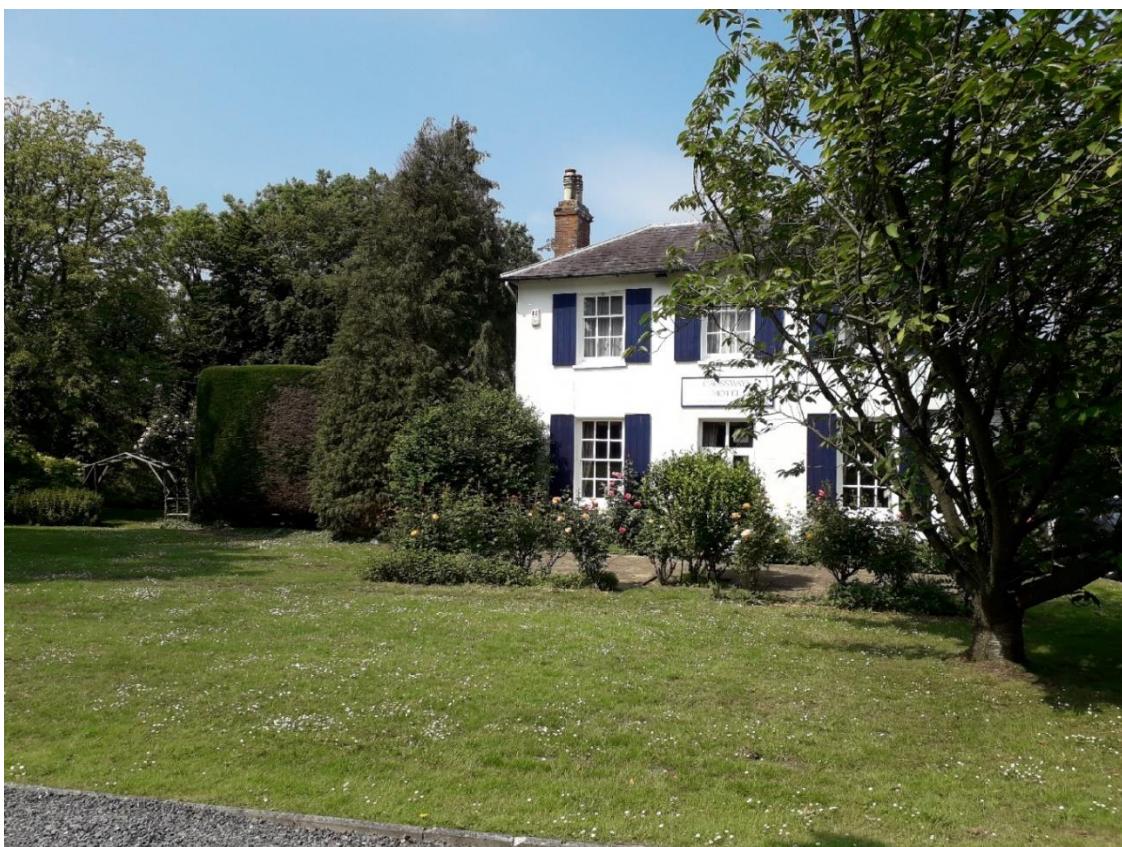
Image 49 – North-east view of the Grade II Crossways Hotel (DES4954) located within tree-lined, landscaped gardens with gravelled access road to the front of the asset, and just off the A27, Wilmington.
