# 6.8 Environmental Statement: Addendum Appendix A

# A303 Sparkford to Ilchester Dualling Scheme

#### **Environmental Statement: Addendum**

Regulation Number:	
Planning Inspectorate Scheme	TR010036
Reference	
Application Document Reference	6.8
Author:	A303 Sparkford to Ilchester Dualling Scheme: Project Team, Highways England

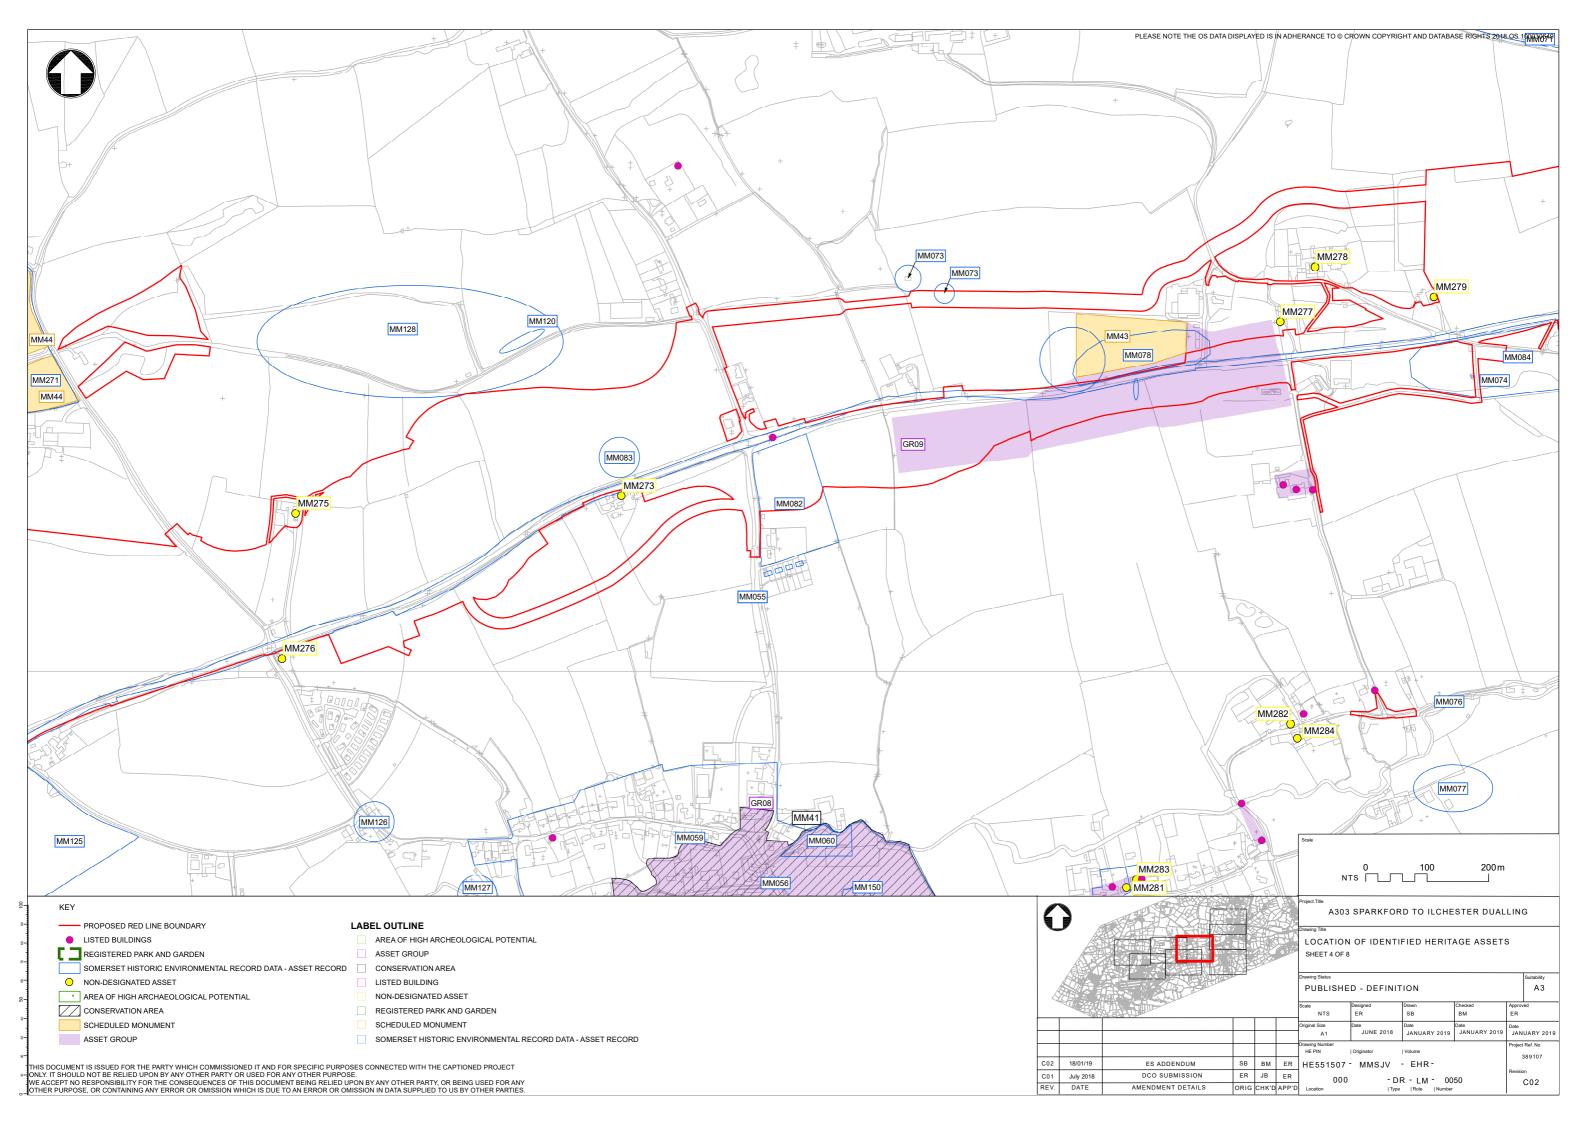
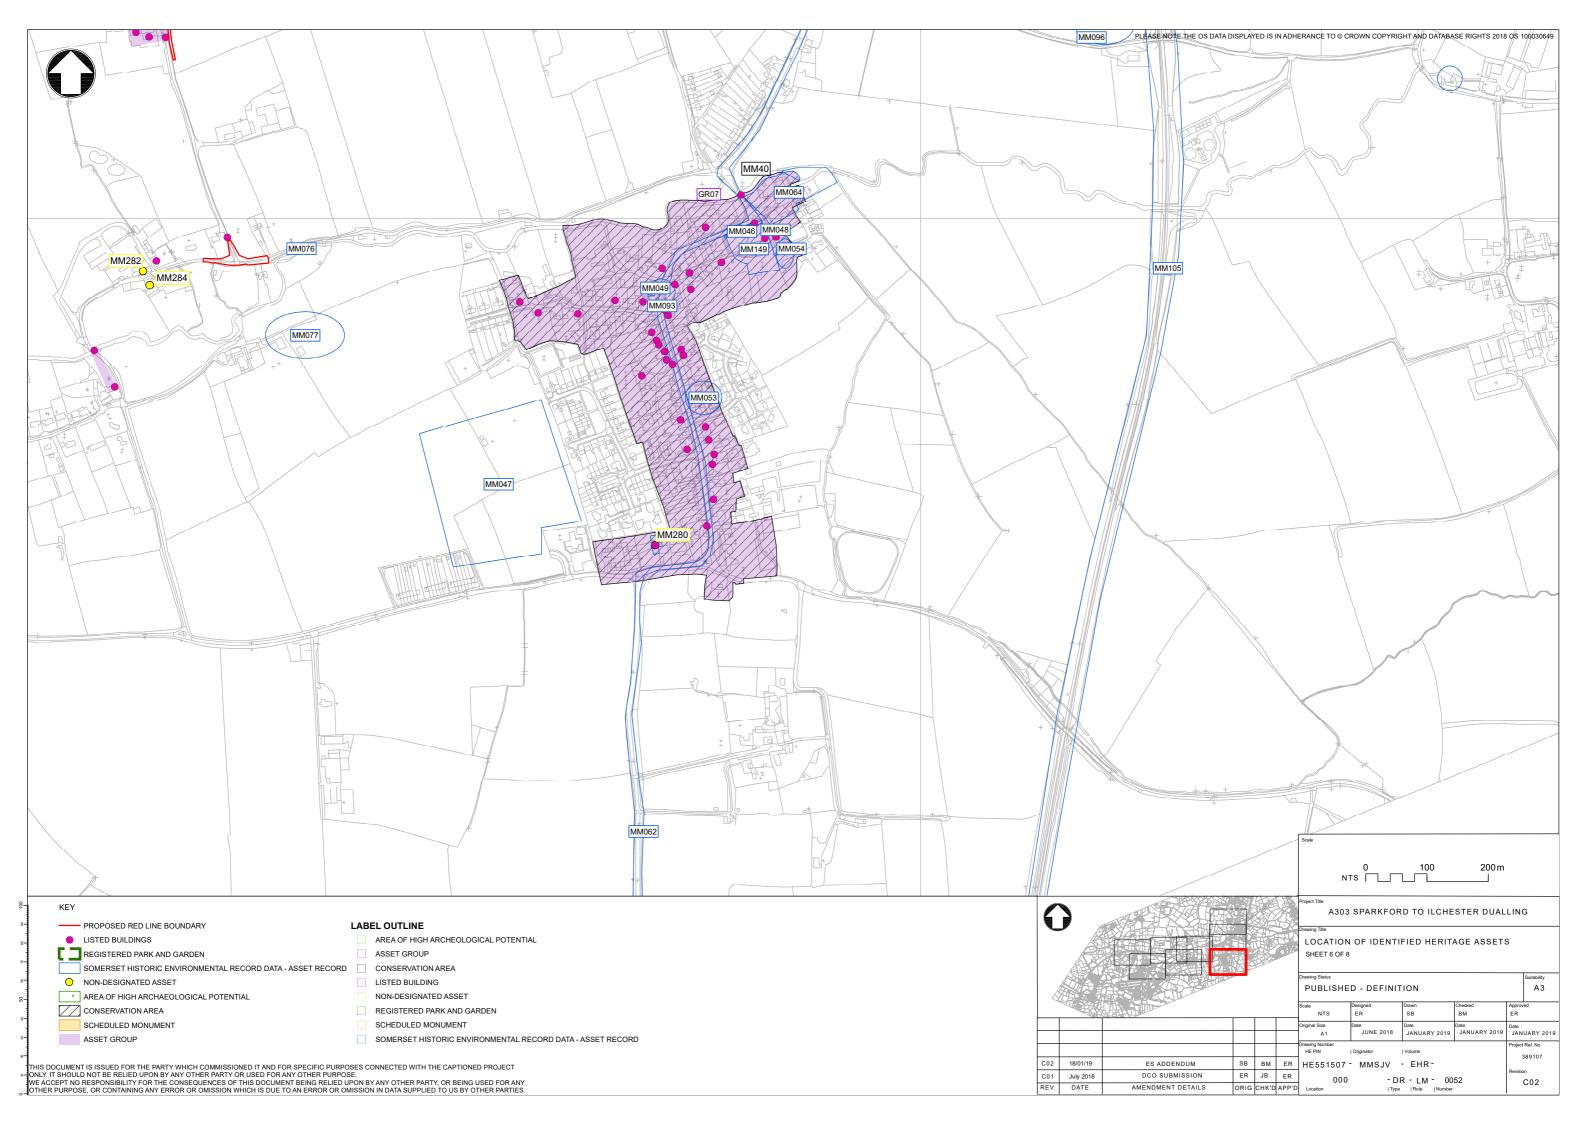
1.1.5 In reference to Appendix C of Appendix 6.1 of Volume 6.3 of the 2018 ES (APP-067), the figures below are the updated versions of the Heritage Data Set Asset Records of the 2018 ES (APP-067). The updates include the addition of receptors newly identified to be within the updated study area.

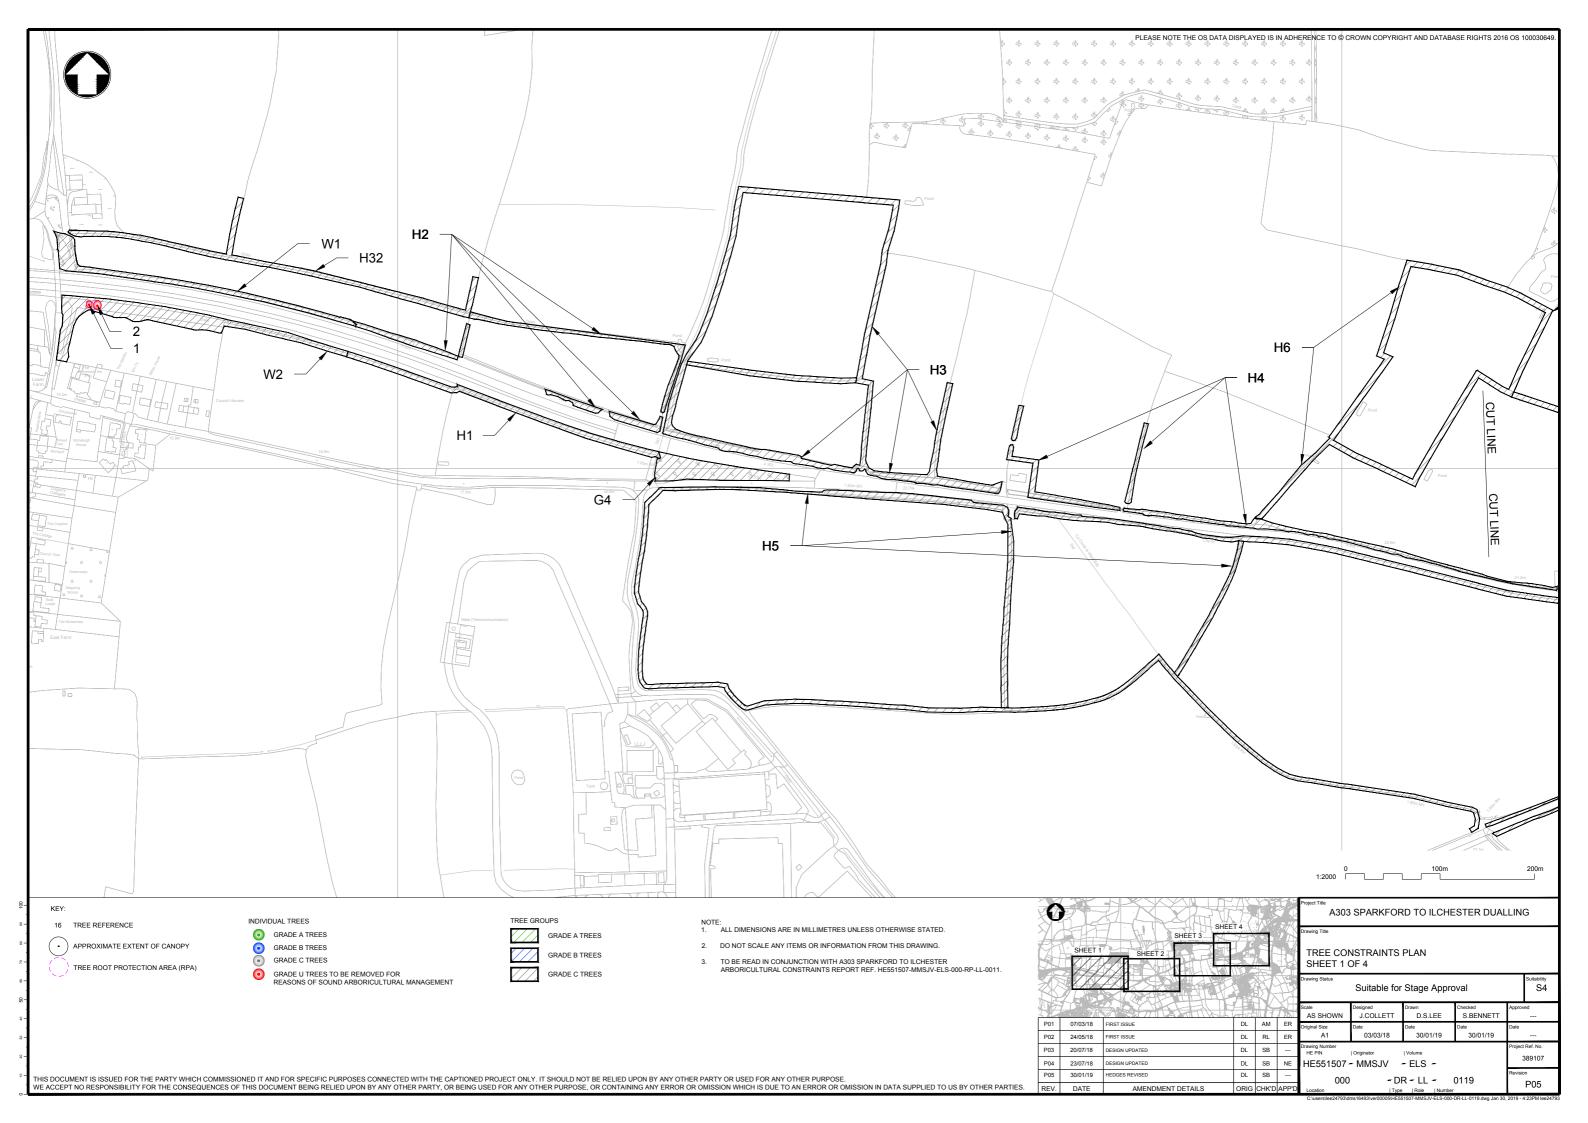
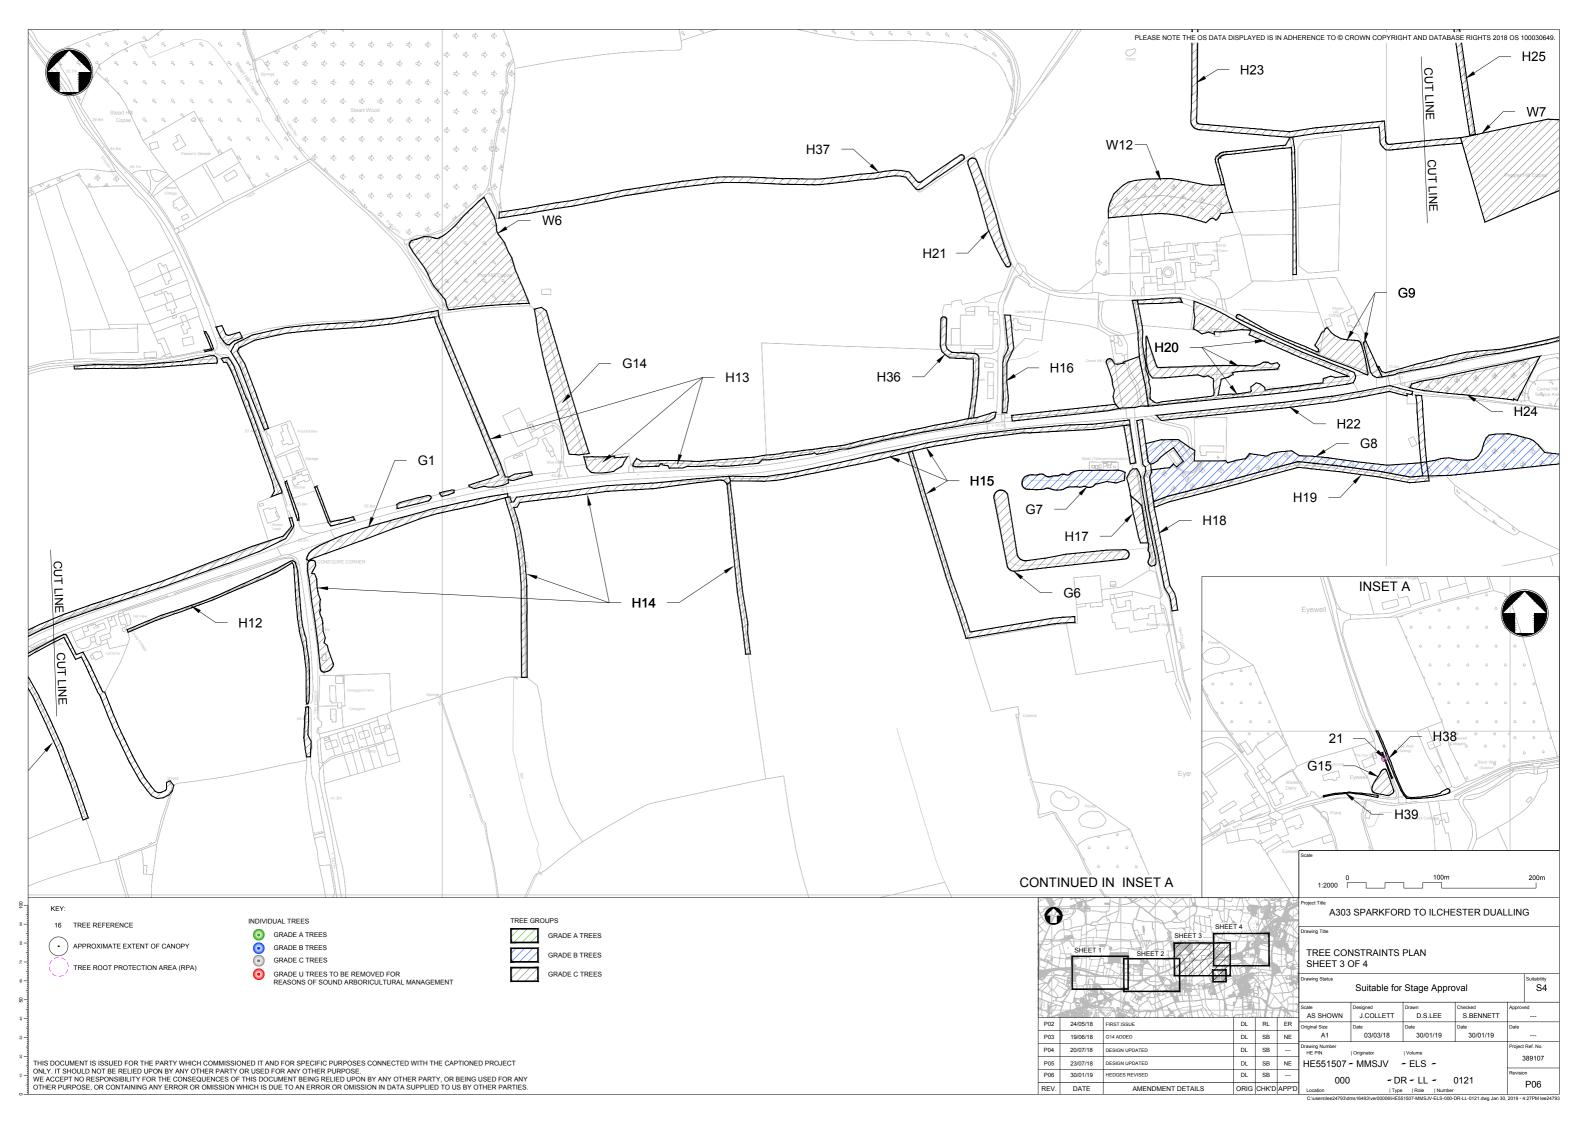
3.1.6 The tree constraints plan drawing Sheet 3 has been updated to include the additional trees, as shown below.
