**Surface properties of longitudinally
diamond ground concrete - Interim
report**

CPR908

CLIENT PROJECT REPORT

Prepared for: Client: Highways Agency, (Mr. D Lee)

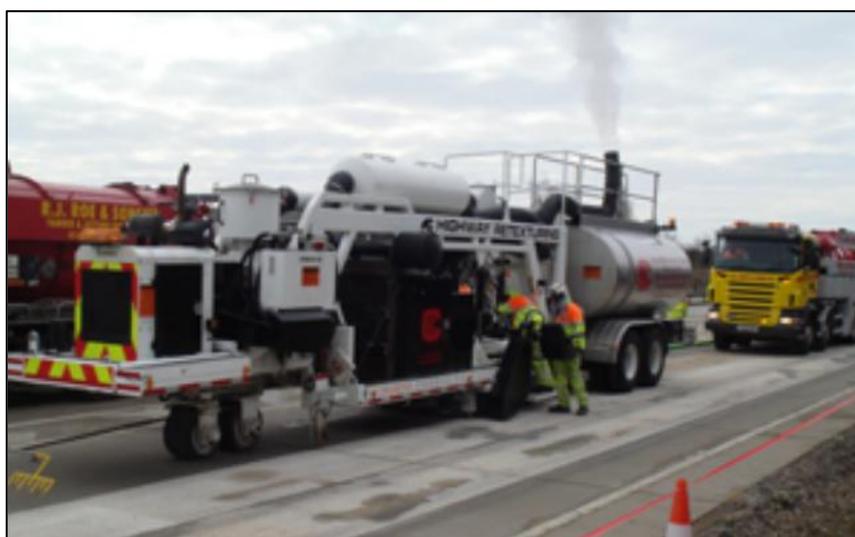
Figure 1-1 The grinding convoy (grinding machine left, and slurry tanker right)

The Highways Agency is investigating the potential of a longitudinal diamond grinding process, similar to that commonly used in America, to provide a cost-effective method of restoring the surface friction characteristics of concrete pavements (Figure 1-1).

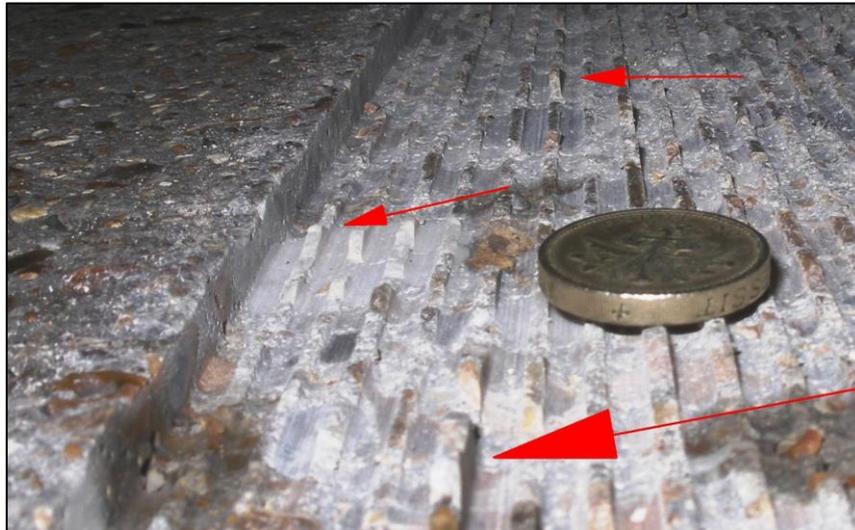
The resulting surface texture consists of longitudinal grooves approximately 2-3mm wide, 3-4mm apart and 0.5-1.5mm deep. Figure 2-2 gives an example of the surface finish that was achieved on the A12 trial site.

Figure 2-2 Surface finished achieved with diamond grinding technique

Figure 2-2 shows an untreated length of concrete surface on the left of the picture and a treated length on the right. As can be seen, a feature of the diamond grinding process is the creation of sharp ridges or fins (highlighted by the red arrows). These fins could contribute to the frictional performance of the surface; however, they could also be removed by the process of trafficking.

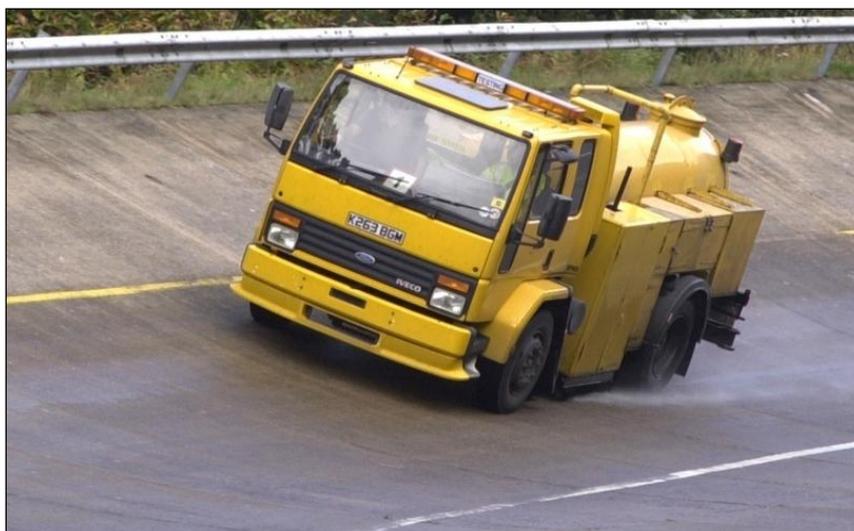
SCRIM is the standard device for monitoring the skid resistance condition of the UK trunk road network and is also used by many local authorities (Figure 3-1). Measurements from this device provide data that can be used to compare the performance of the surfacings with the skidding standards for the sites concerned.

Figure 3-1 SCRIM testing a section of the TRL test track

SCRIM uses an instrumented test wheel angled at 20° to the direction of travel, generating a relative slip ratio. Therefore, the effective speed at which the tyre contact patch moves over the surface (the slip speed) is 17km/h at the normal operating speed of 50km/h. The vertical and horizontal loads acting on the test wheel are recorded, analysed using an on-board system and reported as a SCRIM Reading. On high-speed dual carriageways (which includes the trial sites for this study), for safety reasons a target speed of 80 km/h is used and a correction factor is applied to the results to give values equivalent to measurements made at the standard speed of 50km/h. After some other adjustments, the processed values are known as "SCRIM Coefficient" (SC).

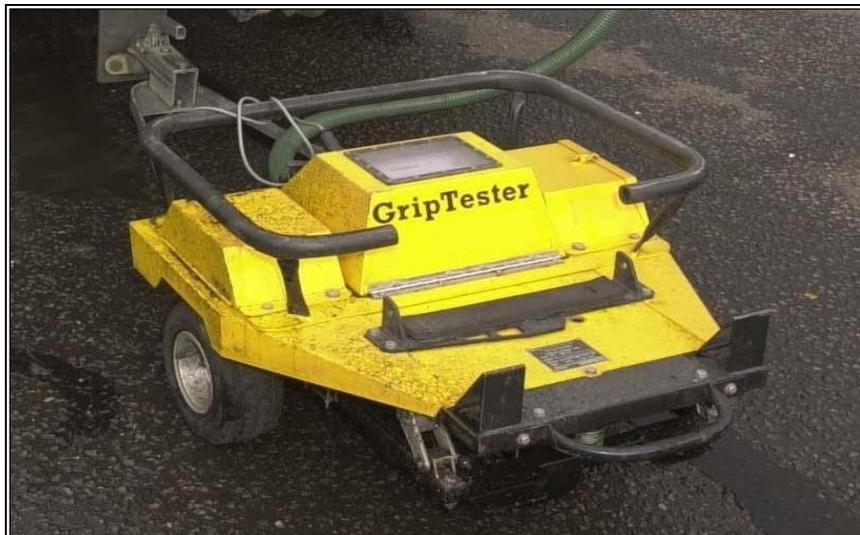
GripTester is a small trailer used by many local authorities for measuring wet low speed skid resistance (Figure 3-2). Like SCRIM, this device operates under the fixed slip principle, but in this case the test wheel is in-line with the direction of travel. The test wheel is mechanically linked via a chain and sprocket to two 'drive wheels', geared so that the test wheel is forced to rotate at a speed slower than that of the drive wheels, thereby generating slip between the test tyre and pavement. Water is applied to the

Figure 3-2 GripTester

Results provided by GripTester from tests at a standard 50km/h test speed can have a conversion factor of 0.85 applied to them so they report values on a similar scale to SCRIM Coefficient. Such values are referred to in this report as Equivalent SCRIM (E.SCRIM) values. GripTester was used as part of this project to provide additional measurements of low speed wet skid resistance at times when SCRIM measurements could not be made.

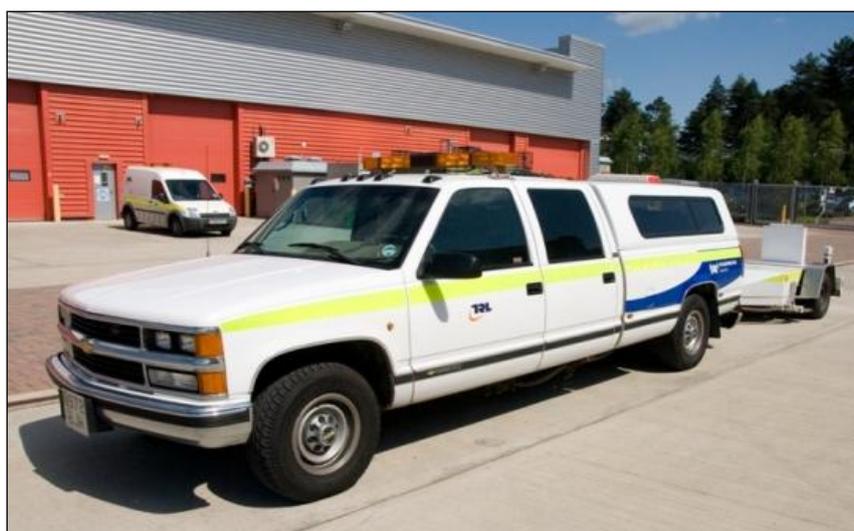
The PFT (Figure 3-3) is a friction testing device, used as a standard measurement technique in the USA. The PFT is owned by the Highways Agency and operated on its behalf by TRL.

Figure 3-3 Pavement Friction Tester

During a test, the towing vehicle maintains a constant test speed while the trailer mounted test wheel is forced to lock, the lock is then held for a short interval before being released. Whilst testing, the load and drag forces on the test wheel are measured every 0.01 seconds throughout the braking cycle. This produces a result that usually follows the form shown in Figure 3-4.

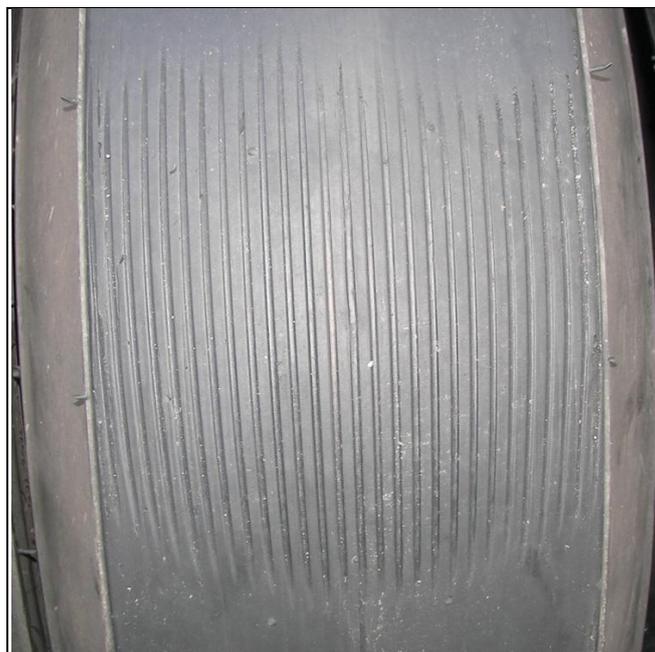
In considering possible reasons why the peak friction data show relatively greater improvement at all speeds as a result of diamond grinding, it is of interest to observe that in making the measurements on the newly-ground surface there was noticeable damage to the surface of the tyre (Figure 3-11).

Figure 3-11 – Photograph of the PFT test tyre after testing.

While tyres used for locked-wheel testing generally suffer some deterioration, the extent of damage observed here during normal wet tests is unusual. It appears that the sharp fins and ridges created by the grinding process (Figure 2-2) have cut into the surface of the test tyre, mirroring the profile of the ground pavement. A consequence of this may be that more kinetic energy than normal is converted during the “peak” phase of the skid profile; giving a higher traction force and therefore a greater peak friction than would normally be observed.

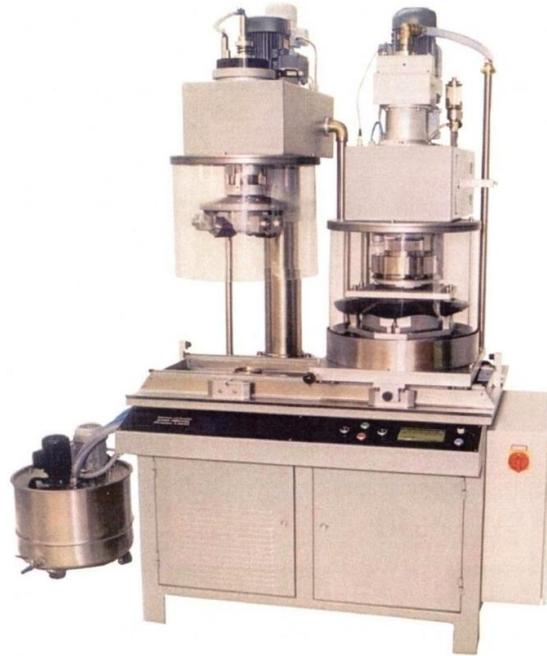
The WS machine illustrated in Figure 4-1 is a development of original devices built during the 1960s in Germany, at the Technical University of Berlin (TUB), as an alternative to the Polished Stone Value test for assessing the polishing of aggregates in road surfacings. It is usually used to assess the effect that the polishing action of traffic on samples of asphalt or aggregate has on skid resistance.

Figure 4-1 – The Wehner Schulze machine

The WS machine comprises two “stations”: one for accelerated polishing of the test specimen and one for testing the friction of the polished surface. The normal procedure is carried out in two stages: a period of polishing to simulate trafficking by heavy goods vehicles is followed by a measurement of friction on the polished surface. The polishing action is generated using a rotary head with loaded rollers that rotate around a circular test specimen.
