The Effects of Inundation on Pavements

Contractors Report

Date: 27 April 2011
Project Sponsor: Donald Burton

Client: Highways Agency
 Project: Inundated Pavements
 Document Title: Contractors Final Report

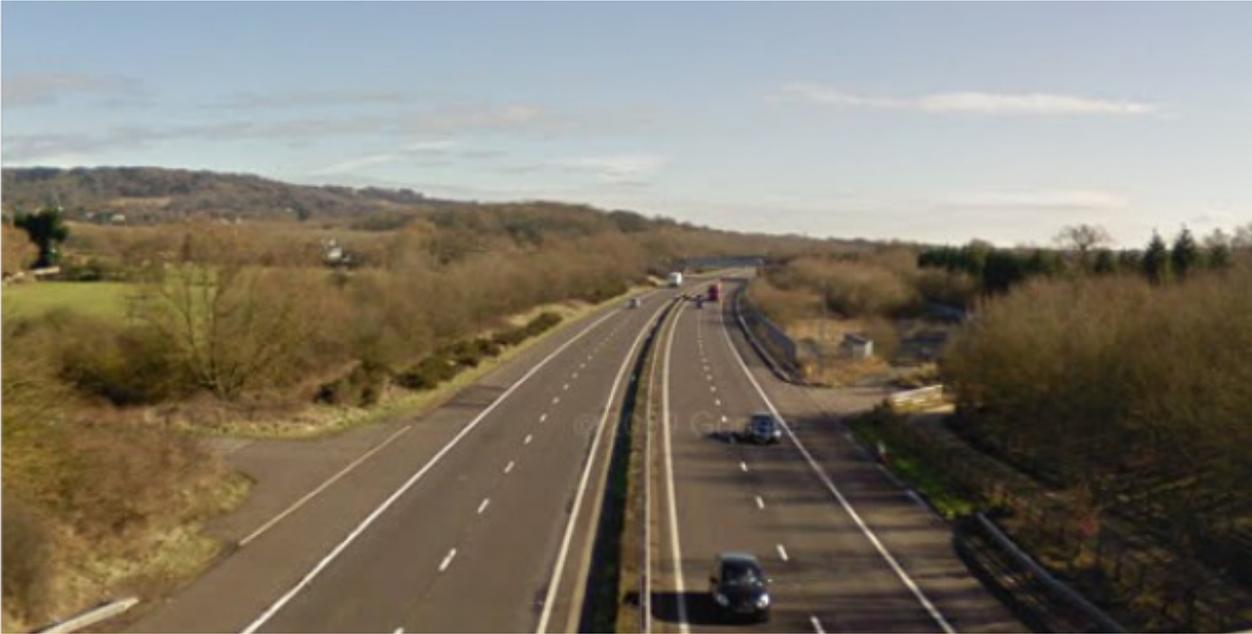
Figure 2.2: M26 Darenth Valley, Kent

An example of where this was carried out is on M26 as it crosses the Darenth Valley, Otford near Sevenoaks, Kent (designed in 1976, opened 1979). The false cutting on the right side of the picture (Figure 2.2), i.e. an embankment formed of unsuitable material between the two bridge embankments, prevents the river flooding the motorway. The drainage lagoon (now surrounded by a high fence) collects the water flowing down from the cutting behind the bridge and stores it until the river flood recedes. In the light of climate change it may be prudent to revisit these calculations wherever such a facility exists, to check they are adequate.

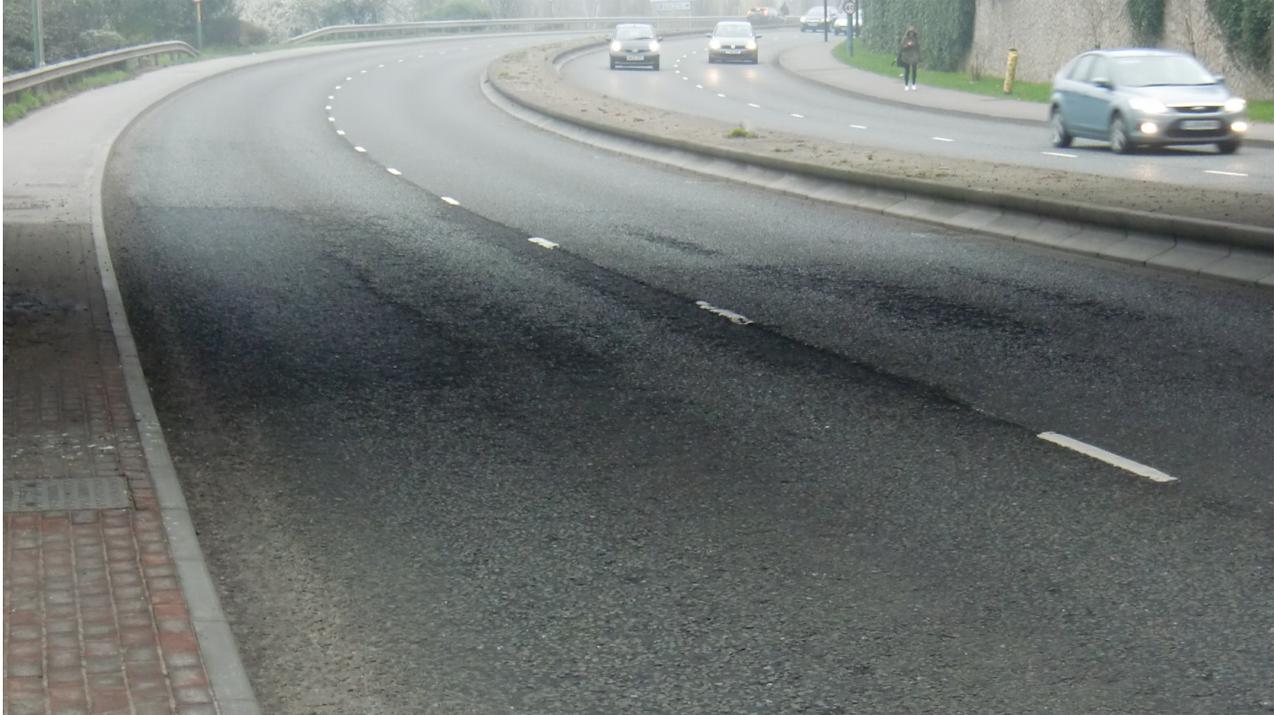
In addition water flowing at high speed over the surface and traffic running on the waterlogged surfaces can scour the asphalt reducing the durability. This is very difficult to simulate in the laboratory. This often occurs where road drainage is not maintained and water ponds in the carriageway after a rainstorm. It also can occur on coastal roads subject to waves and spray as discussed in more detail in Section 3.1.

Figure 2.4: Scour of HRA chippings as a result of almost constant wetting on the carriageway from water dripping from the rail overbridge.

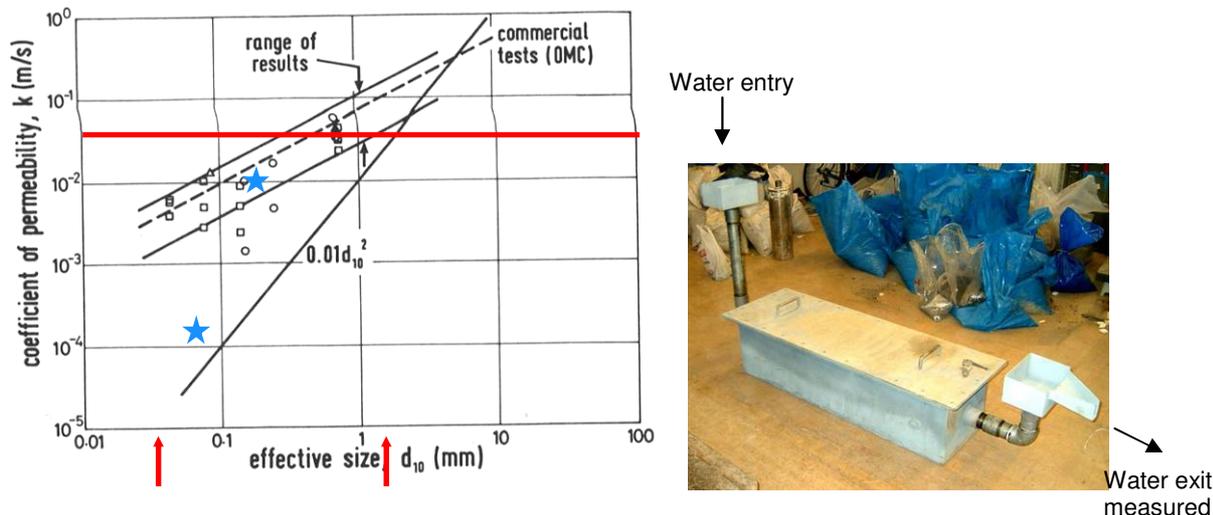
Figure 3.1: Horizontal permeability of sub base

What is also not known is the permeability of typical in-service sub bases. Simple calculations, based for example on the Hazen formula, show that the permitted range of fines (0-10% passing the 63micron sieve) can lead to several orders of magnitude change in permeability. Jones and Jones (1989) and HA 41/90 provided a test method based upon a horizontal permeability device for measuring this property. The results of tests carried out compared to the Hazen formula are given in Figure 3.1.

This test gives the saturated permeability, however there is no specified acceptance value. Experience with this test in Kent CC using crushed limestone and granite Type 1 sub bases, has found that a value of 8×10^{-2} m/sec has been found suitable.

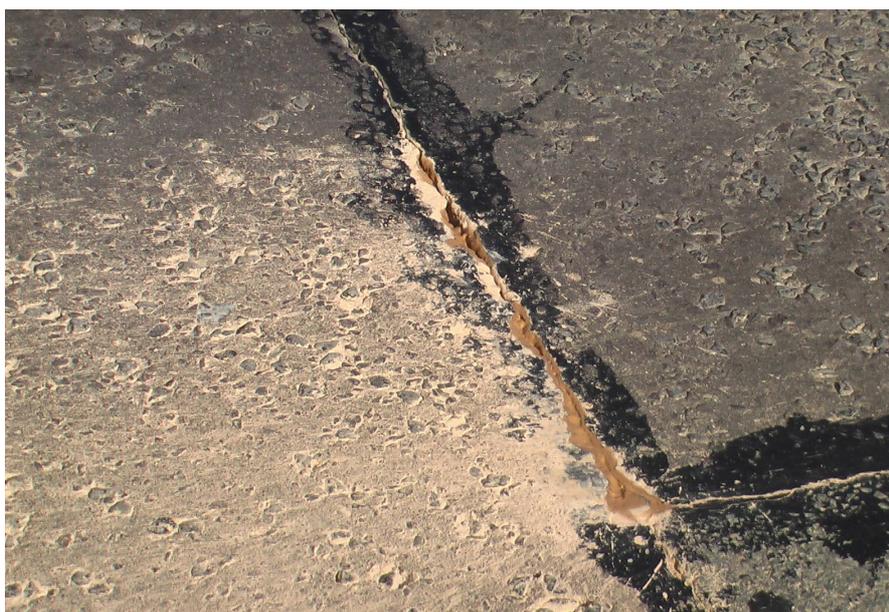
Figure 3.2: Rigid pavement

Where a road is inherently weak, or a concrete carriageway has been laid on a sub base rather than a cement bound material, evidence of sub base piping and fines pumping up to the surface are commonly seen as shown in the photographs below:

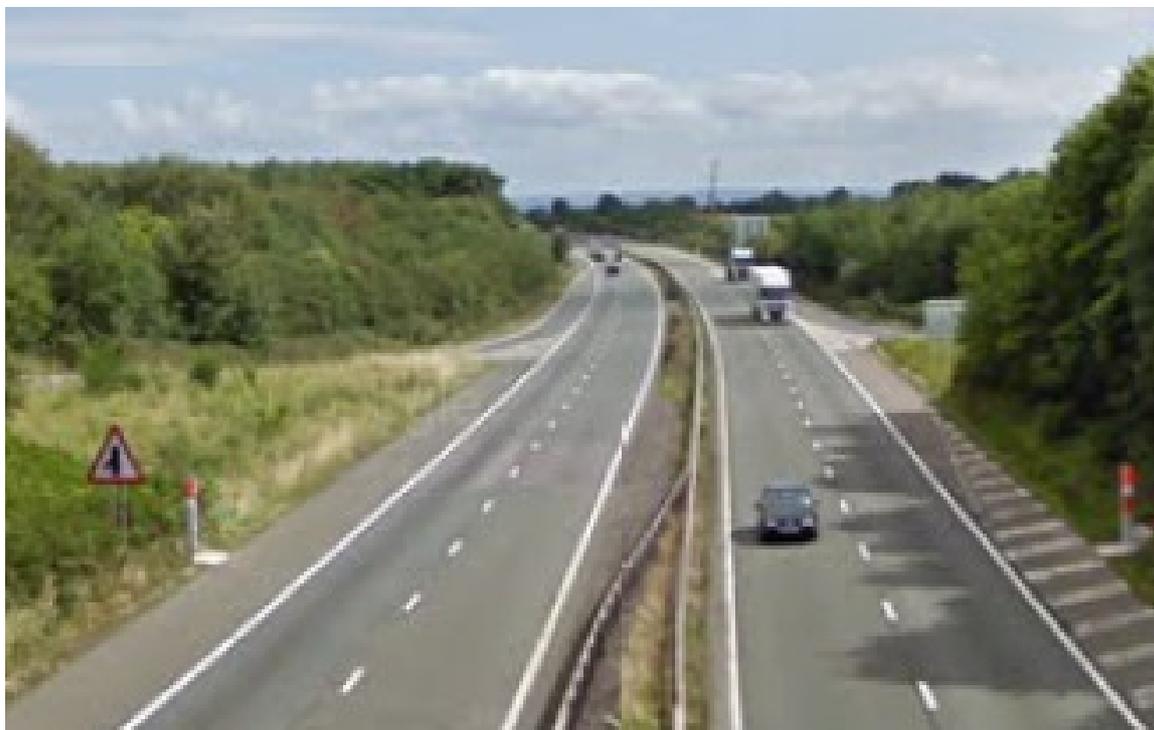
Figure 3.5: M50 J2: Normal conditions

The Highways Agency identified a section of the M50 at Junction 2 (Figure 3.5) that had been the subject of inundation in July 2007 as shown in the photograph (Figure 3.6) below

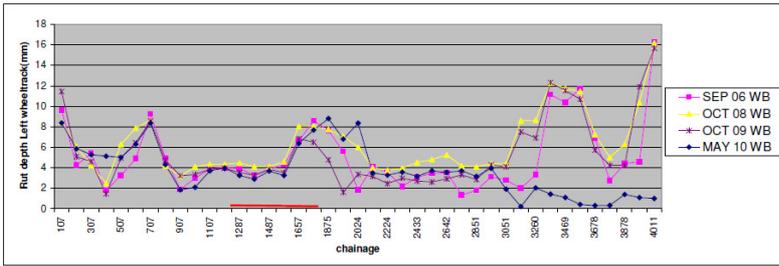
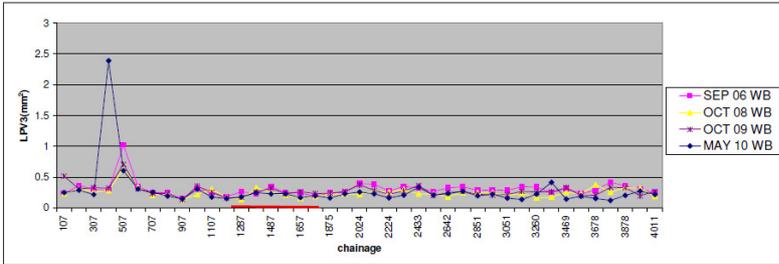
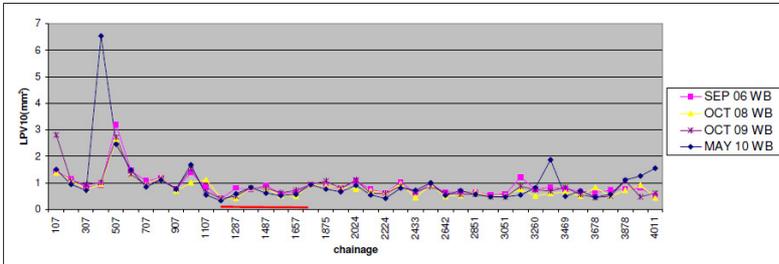
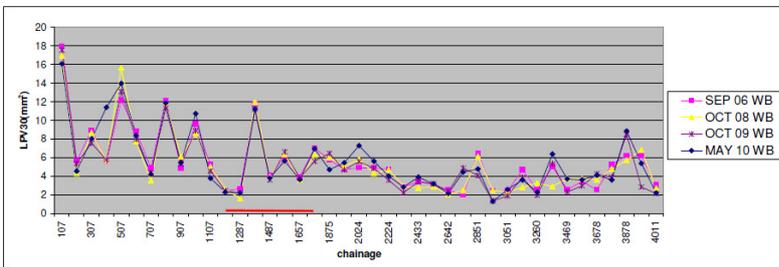
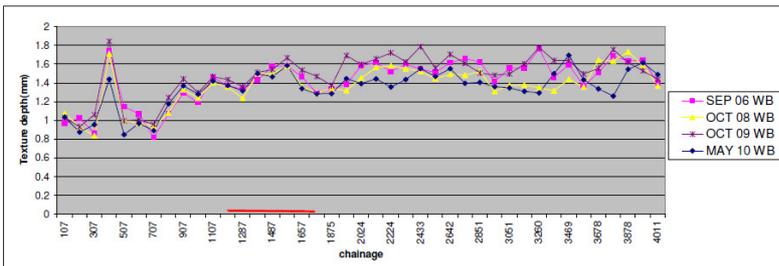
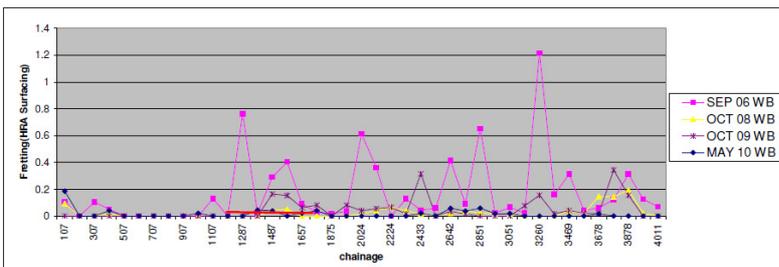
M50 WESTBOUND
 2006 to 2010 TRACS Survey Data

A review of the rate of deterioration between 2006 and 2010 parameters, similarly shows no significant increase in deterioration for the areas of inundation. All parameter values remain within the bounds of variability which could be expected for a typical pavement.

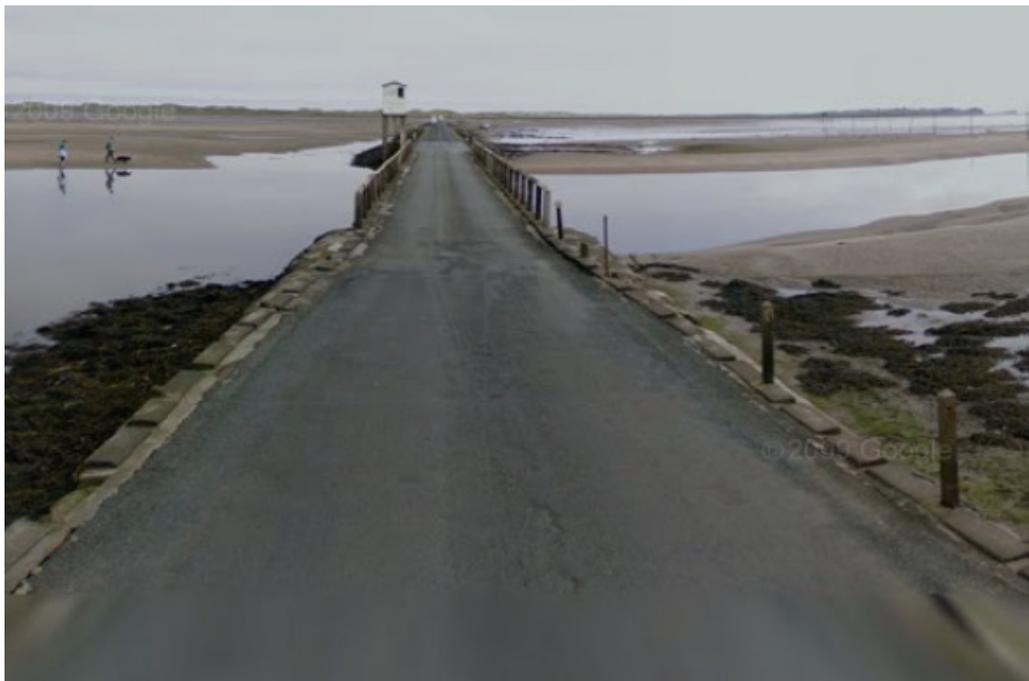
Figure 3.10: Lindisfarne Pavement Surface

It was observed that surface scour occurs from traffic running over a saturated surface, for example at Lindisfarne and Coast Road Antrim, as shown in the photographs. This condition is also

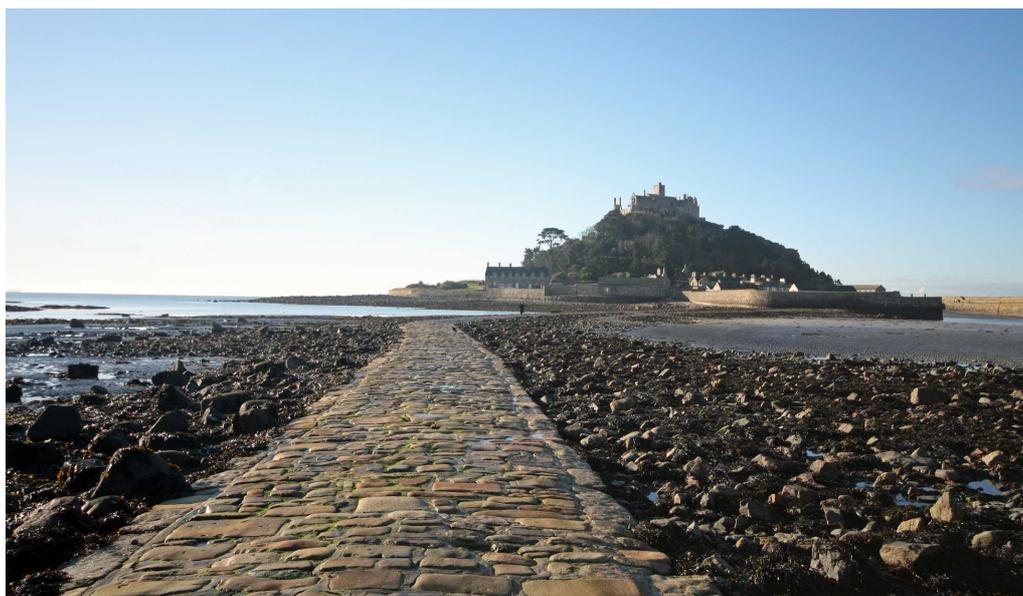
Figure 3.11: St Michaels Mount Causeway

Gaining information from Local Authority staff on the effects of inundation was difficult, as they may know suitable locations but have no maintenance history. No HA staff contributed to the study. The main places where roads are subject to inundation are those coastal roads that are subject to occasional or regular tidal or wave inundation and river fords. In both cases the traffic levels on these roads are very small certainly compared to motorways. In the former case the lack of guaranteed access acts as a constraint on development, in the latter case, if the road was sufficiently important, a bridge has been built. A number of coast roads in N. Ireland, Kent, Devon, Lancashire and North Yorkshire were identified. Additionally there are tidal causeways for example to Lindisfarne (Figure 3.10) and St Michael's Mount (Figure 3.11).

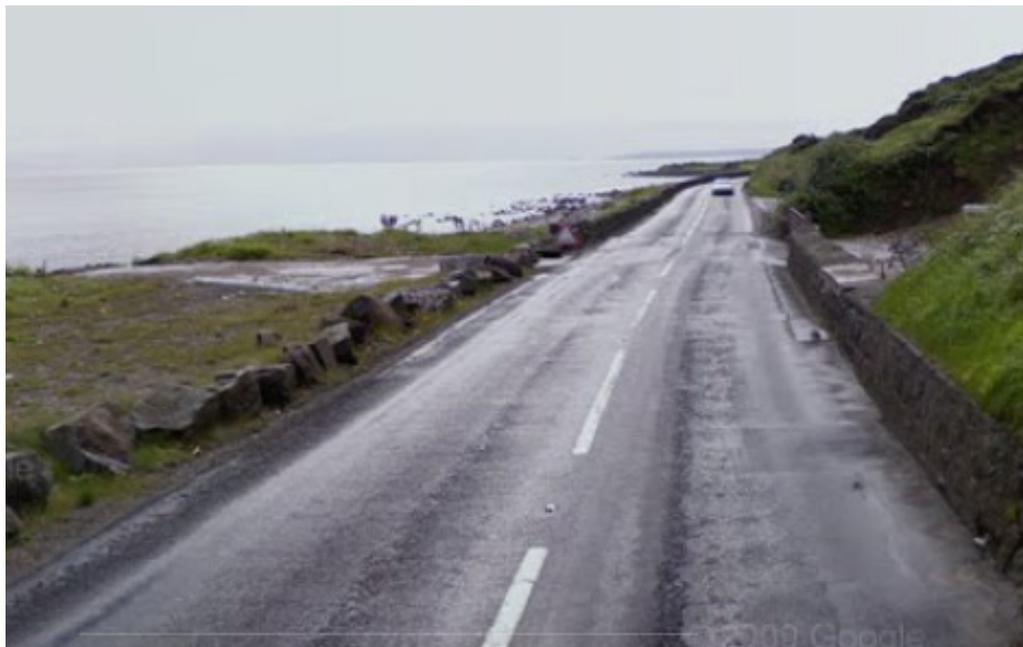
Figure 3.12: Coast Road, Co. Antrim

The NI Roads Service for Coast Road (Figure 3.12) in Ulster has, in the last 10 years, chosen a proprietary SMA with what we would now call ‘low’ texture depth (0.8mm Patch new) as the preferred choice. They tried a BBA HAPAS type Thin Surface Course System (TSCS) about 15 years ago and found that the material was rapidly destroyed by being so frequently saturated that it fretted out. There was also concern about water penetrating down to the lower layers that may have been cracked/oxidised. They have also found that in this environment, they had chip loss from Hot Rolled Asphalt, a phenomenon also found in other places where a road is frequently wet. The denser SMA did not suffer this defect. However the probable reason for using SMA here and in many local authority situations is that the material can be installed within a paver width, unlike HRA, so that work can proceed on relatively narrow roads under one way working. This is a serious matter where diversion routes may be lengthy.

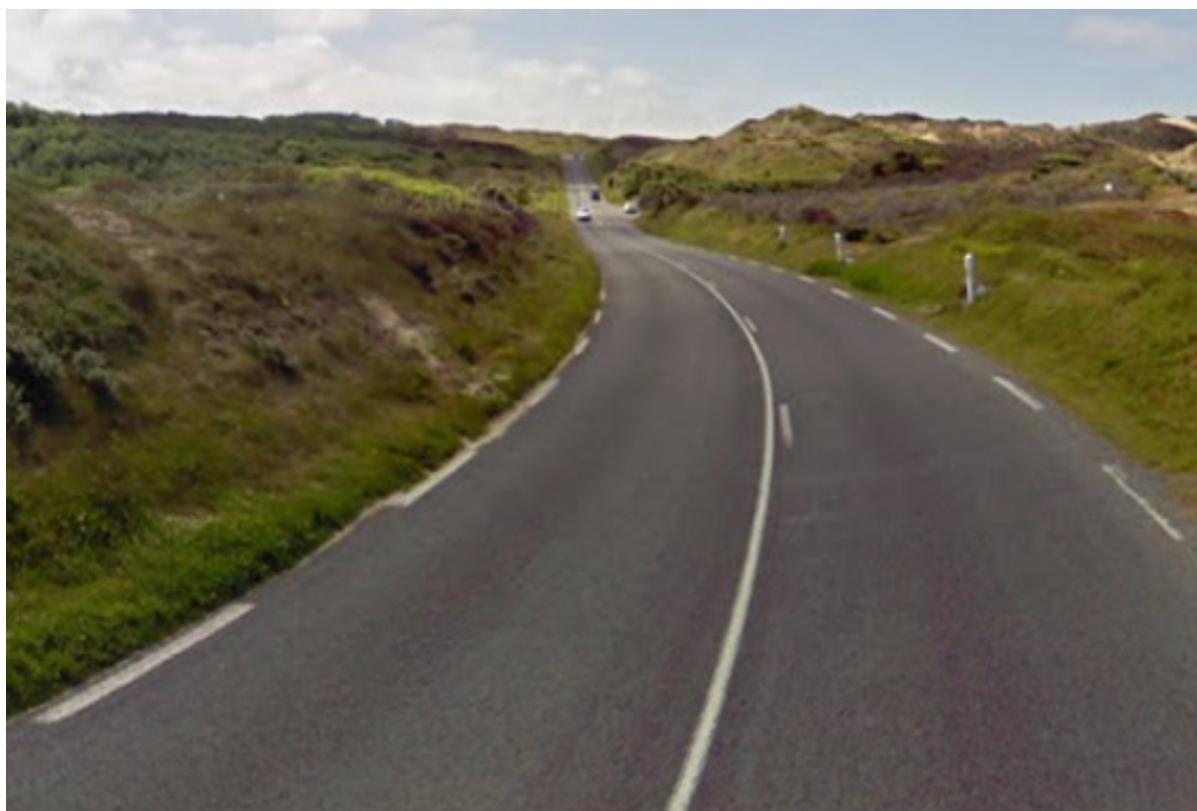
Figure 3.13: Coast road through dunes

Surface scour can also occur where sand is blown onto the carriageway which can act as an abrasive under tyre wheels. Where this type of road also floods at certain stages of the tide, the road surface is then clogged with sand, producing a very smooth potentially slippery surface with a high percentage of rounded sand on the surface. The water is also trapped in the pores of any open textured surfacing exacerbating the effect of water on the bitumen bound material. For these sorts of sites a dense surface of bitumen macadam (asphalt concrete) or hot rolled asphalt could be preferable.

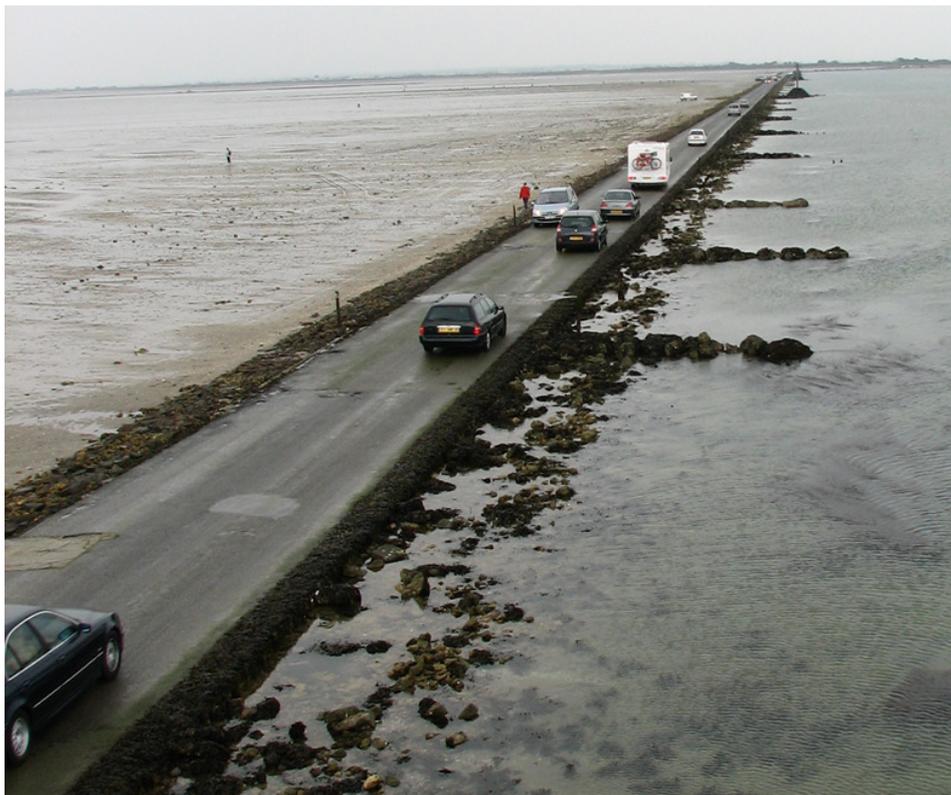
Figure 3.14: Passage de Gois Vendée, France

For the surface to the Passage du Gois, Ile de Noirmoutiers, France, the Highway Authority has tried concrete slabs, small pavers and dense surfacing. However, the dense asphalt suffers from the ingress of water and needs regular patching as shown on the photograph below (Figure 3.14). The mix design is not known.

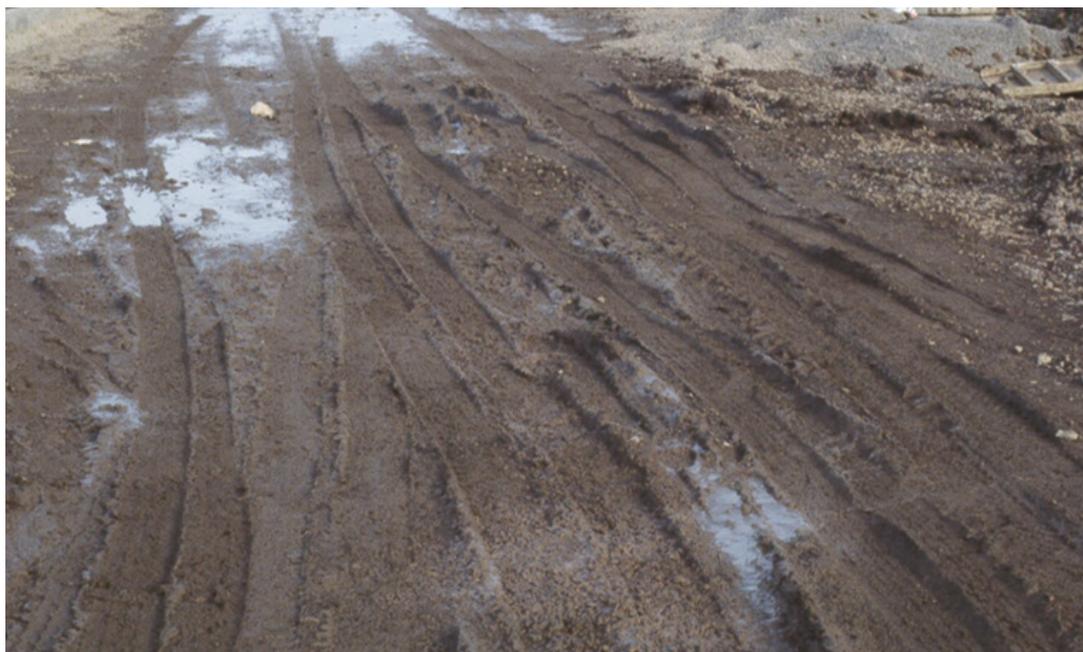
Figure 3.16: A gritstone aggregate sub-base badly contaminated by site traffic

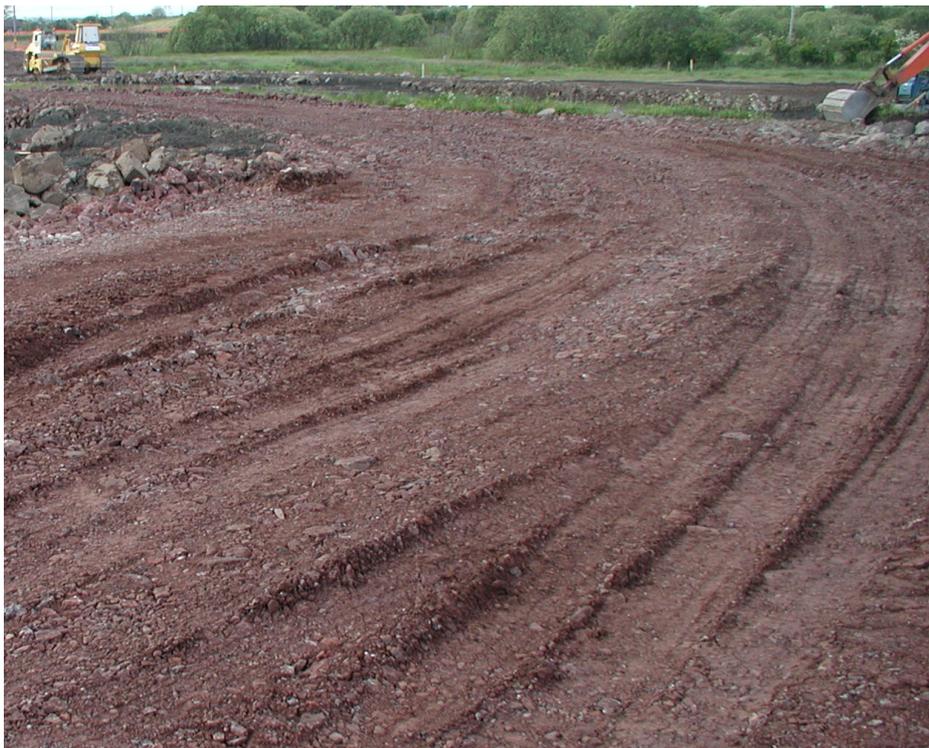
Figure 3.18: Sub base rutting under construction traffic

Another example is a heavily weathered basic igneous rock with very high expansive clay minerals being used as a capping / sub-base layer. As the picture below (Figure 3.18) shows, the material is rutting under construction traffic. This material will breakdown in the presence of water. In an inundated situation this layer will have very little stability or supporting structure.

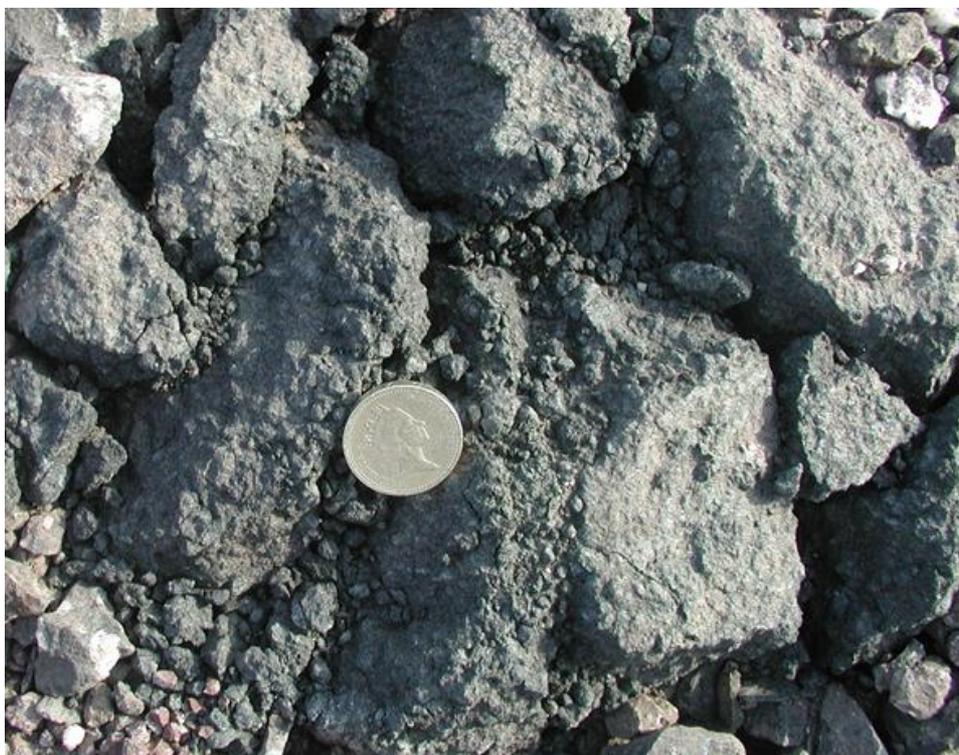
Figure 3.19: Example of Sonnenbrand type failure

An even more unusual case is a Sonnenbrand type failure of a basic igneous rock being used in the UK as sub-base, illustrated in the picture below (Figure 3.19). The crushed aggregate reacts with the air and water and starts to decompose. This aggregate was quarried less than 2 weeks before this image was taken. Sonnenbrand type failure is claimed not to occur in the UK.

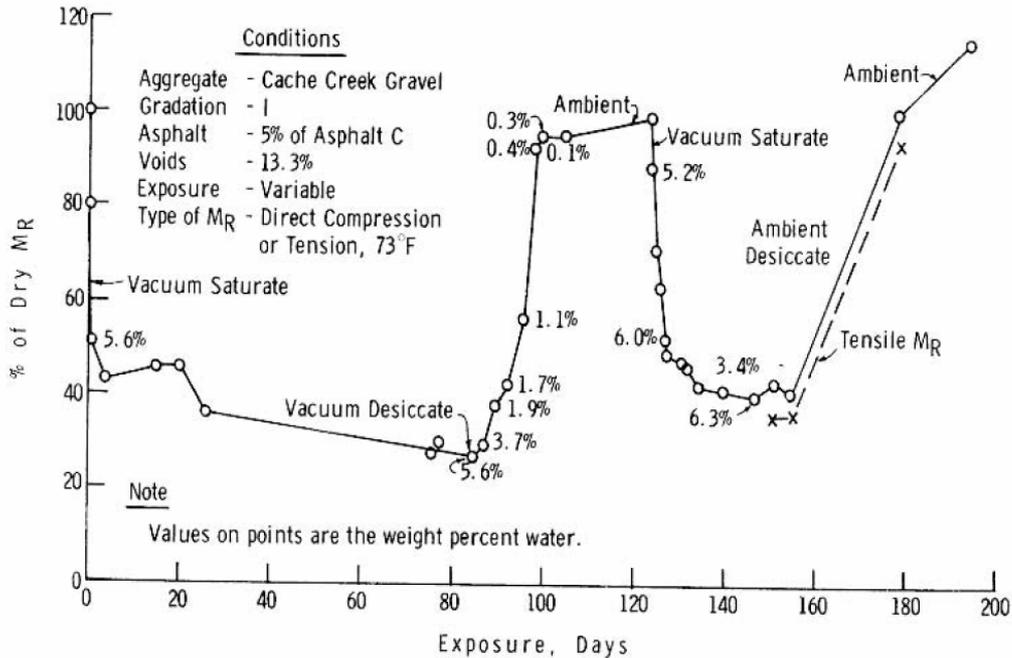
Figure 3.26: Effect of moisture on resilient modulus may be reversible (after Schmidt and Graf, 1972)

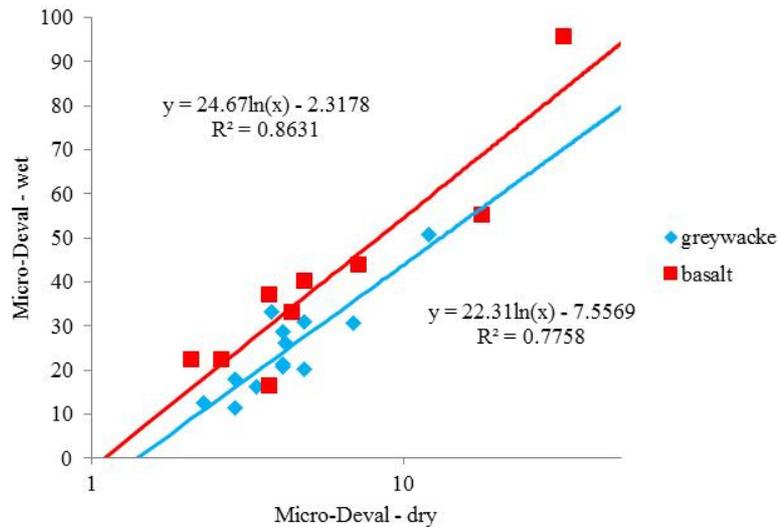
The investigation found many issues relating to the inadequacies of predicting aggregate performance in the UK. For example, Figure 3.27 shows the difference between wet and dry micro-Deval testing, i.e. water during testing causes considerably greater amounts of wet wear.

Figure 3.27: Plot of dry and wet micro-Deval data for a range of aggregates (after Woodward, 1995)

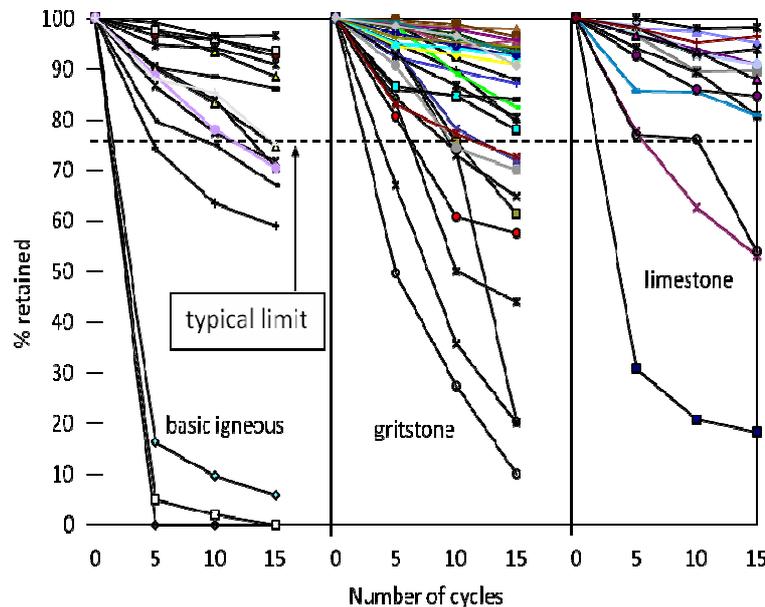
Woodward (1995) extended the number of soaking cycles in the magnesium sulfate soundness test from 5 to 10 and 15 as shown in Figure 3.28. This found that the majority of the 75 aggregates assessed would have been classified as sound using a value of >75% retained after the standard 5 cycles. However, with an increase in the number of test cycles, a significant number of aggregates continued to break-up. Given the excessive frost and salt used in the last two winters this is worrying.

Figure 3.28: The effect of extended test cycles on aggregate durability using modified magnesium sulphate soundness testing (Woodward, 1995)

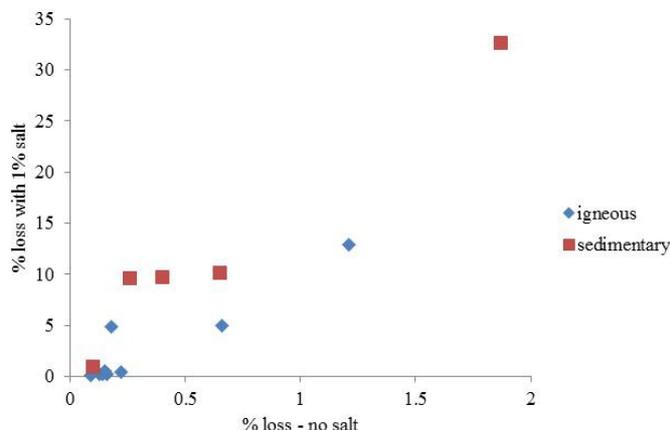
These simple examples show how aggregates that may be considered as durable based on standard test methods used in the UK may be susceptible to premature failure when the asphalt surface gets wet, has salt applied as a de-icer or subjected to freeze/thaw cycles.

Figure 3.29: Plot of FRAS data showing effect of 1% salt addition to water during freeze/thaw testing (after Petersen and Schouenborg, 2004)

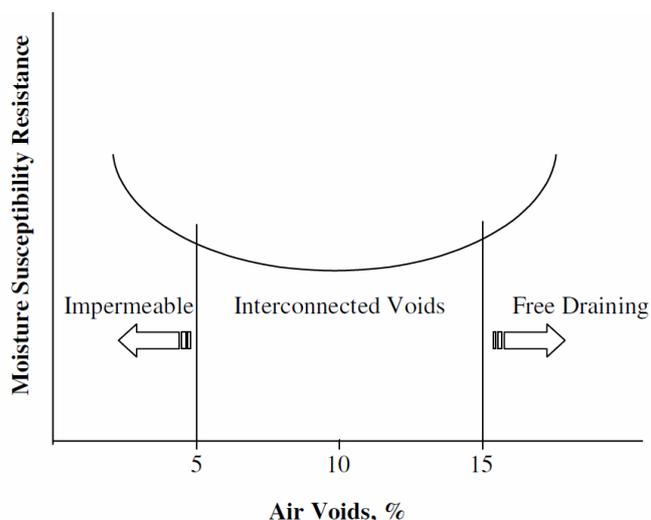
Figure 3.30: Concept of pessimum air voids (Terrel and Al-Swailmi (1994)).

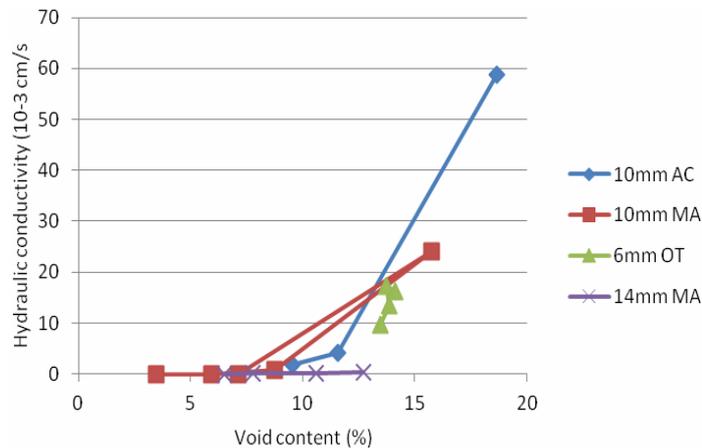
The hydraulic conductivity of the 100mm diameter test specimens was assessed using the University of Ulster in-house falling head method. The hydraulic conductivity data is plotted in Figure 3.31. This shows a ranking in the permeability of the materials used in relation to void content i.e. the 14mm MA was impermeable with the 10mm AC being most permeable.

Figure 3.31: Void content v. hydraulic conductivity using falling head apparatus for 100mm diameter specimens (Nursetiawan, 2009)

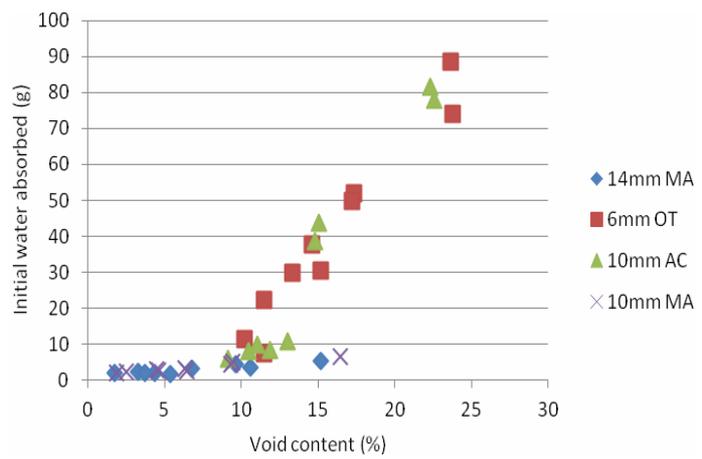
The base and sides of each test specimen was sealed using wax and then submerged in water for 48 hours. Each test specimen was then removed, dried with a towel and weighed. The wax ensured that any moisture loss during drying occurred from the top. The weight of each specimen was determined. The effect of air void content on mass of initial absorbed water for the four types of mix is shown in Figure 3.32.

Figure 3.32: Initial water absorbed v. air void content (Nursetiawan, 2009)

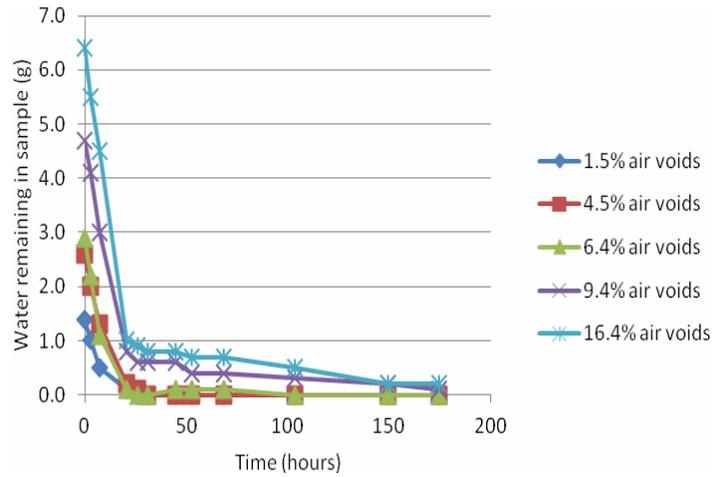
Moisture loss due to drying at 20°C was measured periodically over a 170 hour period. This was determined by weighing each specimen in the temperature controlled room. As the base and sides of each test specimen was sealed with wax any change in specimen mass was due to evaporation. Figure 3.33 and Figure 3.34 show the data during the drying process for the dense 10mm MA and open 6mm OT at 20°C. It was found that the greatest amount of water loss occurred within the first 20 hours. Comparison of drying out rate at 10 and 20°C found no significant difference

Figure 3.33: Water remaining in 10mm MA samples at 20°C (Nursetiawan, 2009)

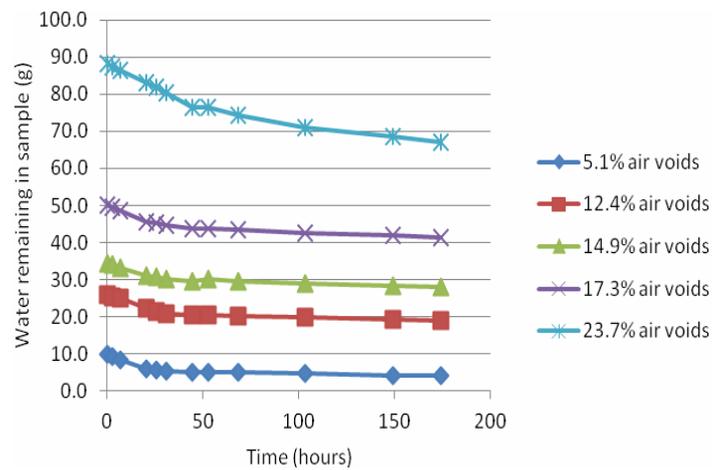
Figure 3.34: Water remaining in 6mm OT specimens at 20°C (Nursetiawan, 2009)

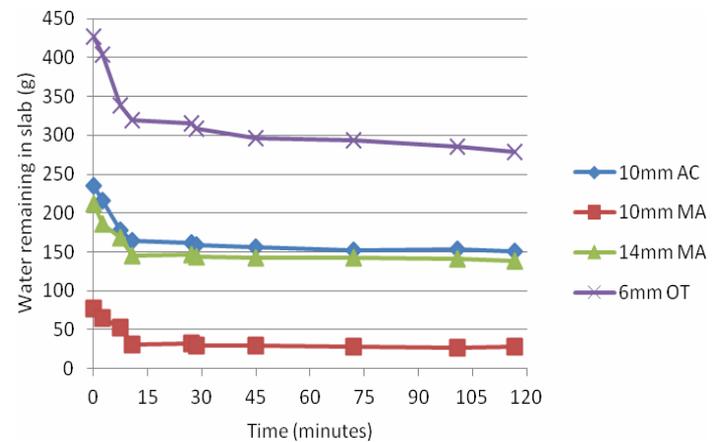
The drying out test was repeated using 305mm x 305mm slabs at 20°C. The method was similar to the 100mm diameter test specimen test. Figure 3.35 shows the amount of water retained for the 305mm square slabs tested at a room temperature of 20°C.

Figure 3.35: Water mass loss with time for 305mm slabs at 20°C (Nursetiawan, 2009)

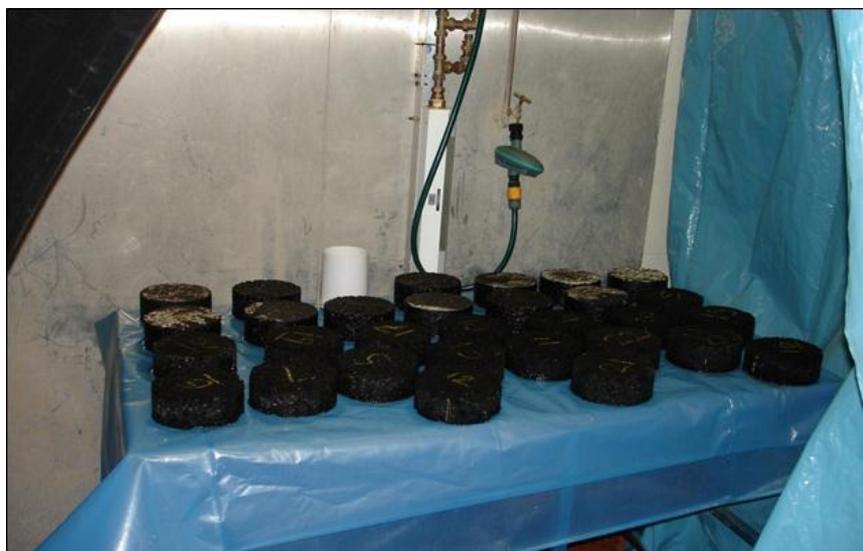
The Ulster Rainfall Simulator (URS) was used to simulate 4 rainfall events over a 24 hour period (see Figure 3.36). A rainfall event consisted of 30 minutes rainfall and 5.5 hours drying at room temperature.

Figure 3.36: Test specimens in the URS being subject to simulate rainfall (Nursetiawan, 2009)

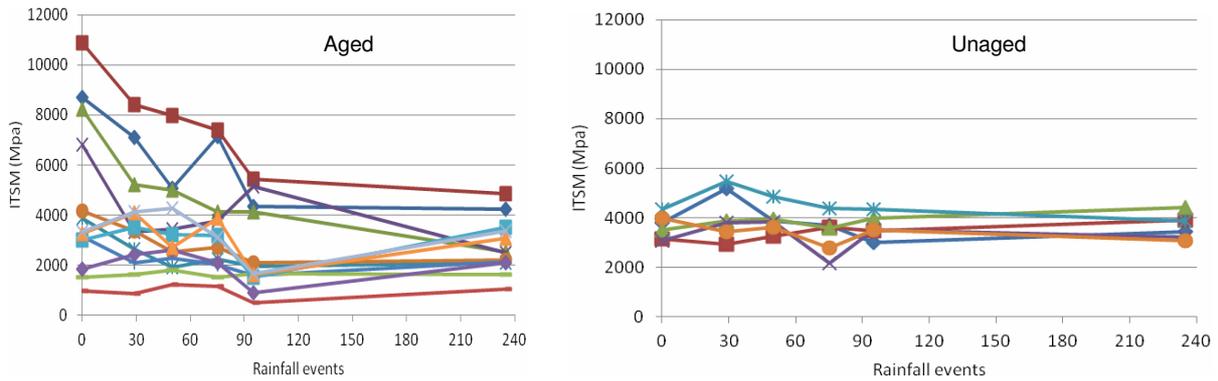
The Indirect Tensile Stiffness Modulus (ITSM) was used to assess the effect of repeated for a total of 235 rainfall and drying events. The data plotted in Figure 3.37 for the Test Condition 1 aged asphalt shows that Stiffness Modulus decreases with increasing number of rainfall cycles. In contrast, there is little change in the ITSM data for the test specimens made with the Test Condition 2 un-aged asphalt as can be seen in Figure 3.37.

Figure 3.37: Change in ITSM for aged and unaged asphalt test specimens due to increasing number of rainfall events (Nursetiawan, 2009)

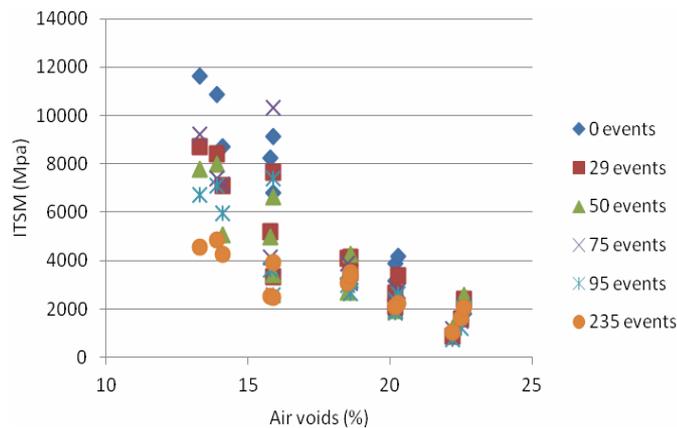
Figure 3.38 plots void content for the aged specimens against Stiffness Modulus for increasing number of rainfall cycles. The graph shows that Stiffness Modulus decreases with increasing void content. The plot shows that the greatest decrease in ITSM occurred for the lowest air void content test specimens. Although the higher void content mixes did not have as high ITSM, their relative loss due to simulated rainfall was considerably less.

Figure 3.38: Relationship between Stiffness Modulus and void content for increasing number of rainfall cycles (Nursetiawan, 2009)

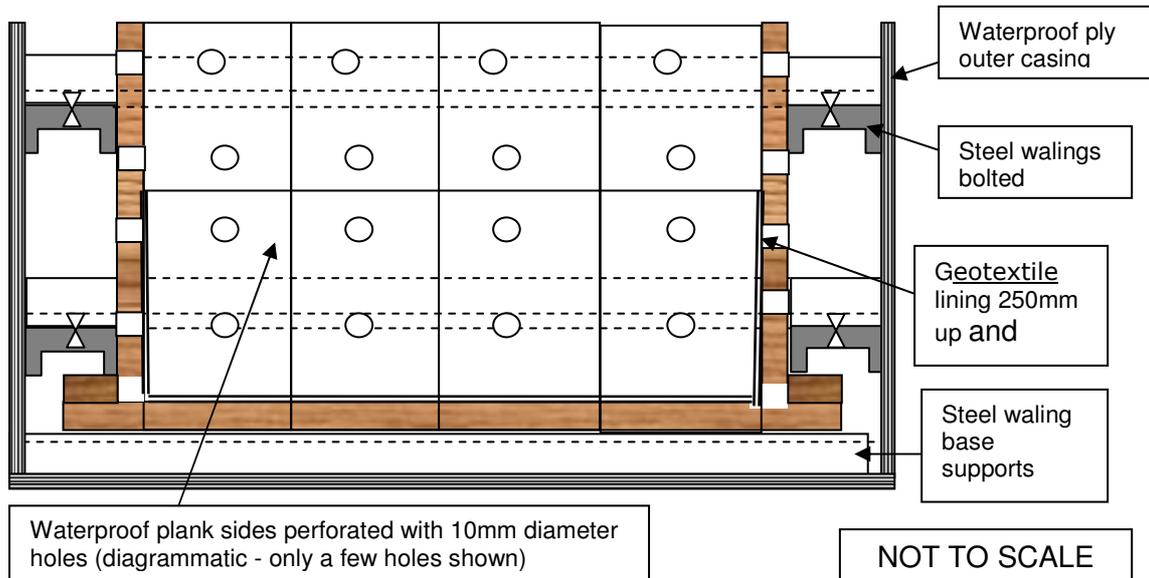
Figure 3.39: Permeable test box

The box design is as shown in Figure 3.39 and Figure 3.40 below.

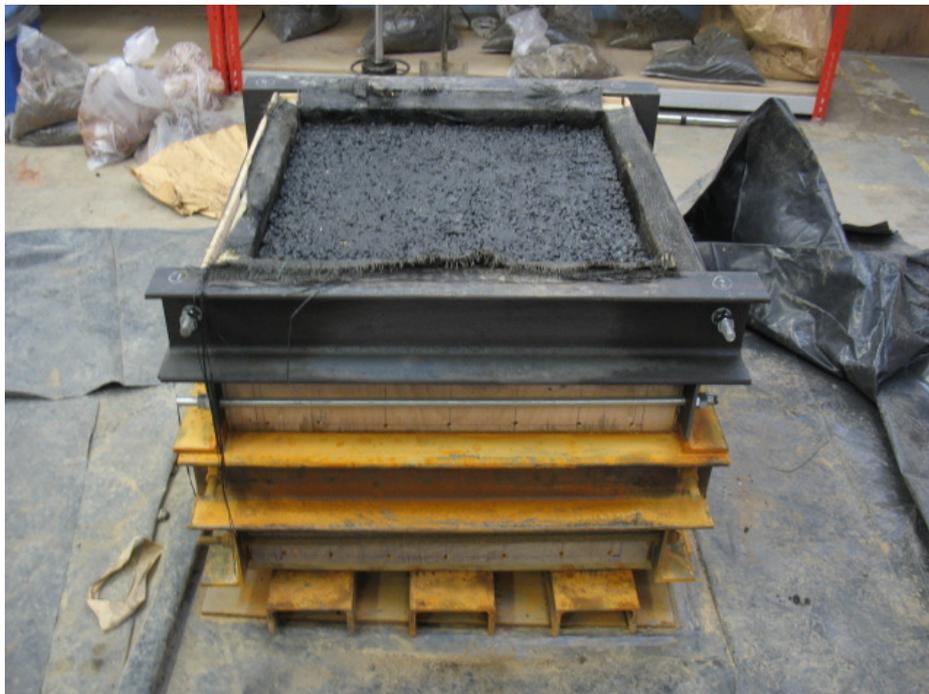
Figure 3.40: Permeable test box (outer casing removed for transport)

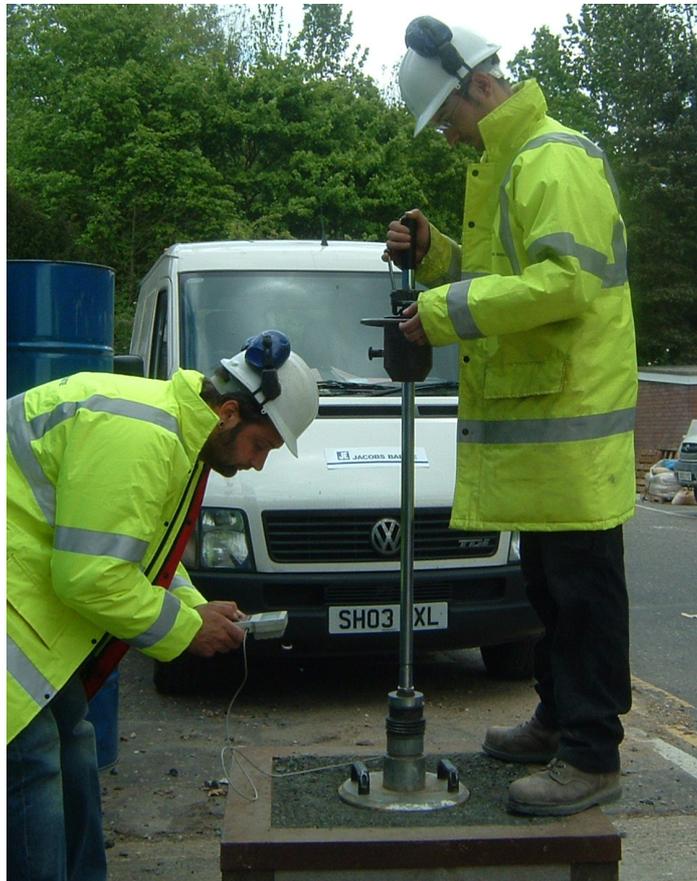
The SHW Type 1 limestone sub base was compacted in the box close at close to optimum moisture content (4.6%) in layers with a commercial plate vibratory compactor then tested without saturation, after saturating and after draining, using a lightweight Falling Weight Deflectometer, [the German Dynamic Plate] operated in accordance with the procedure in *Appendix A*. The device is shown in the photograph (Figure 3.41) testing sub base on a similar box.

Figure 3.41: Lightweight Falling Weight Deflectometer (LWFWD)

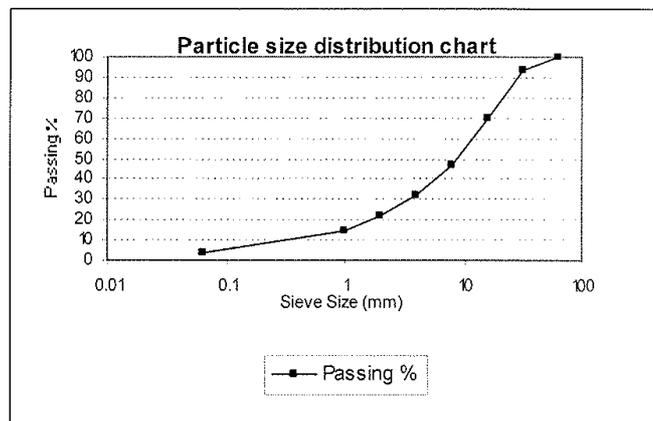
Figure 3.42: Sub base grading

The sub base had a grading curve as shown in Figure 3.42 with 4.1% passing the 63micron sieve. The dry density moisture content relationship is given in Figure 3.43.

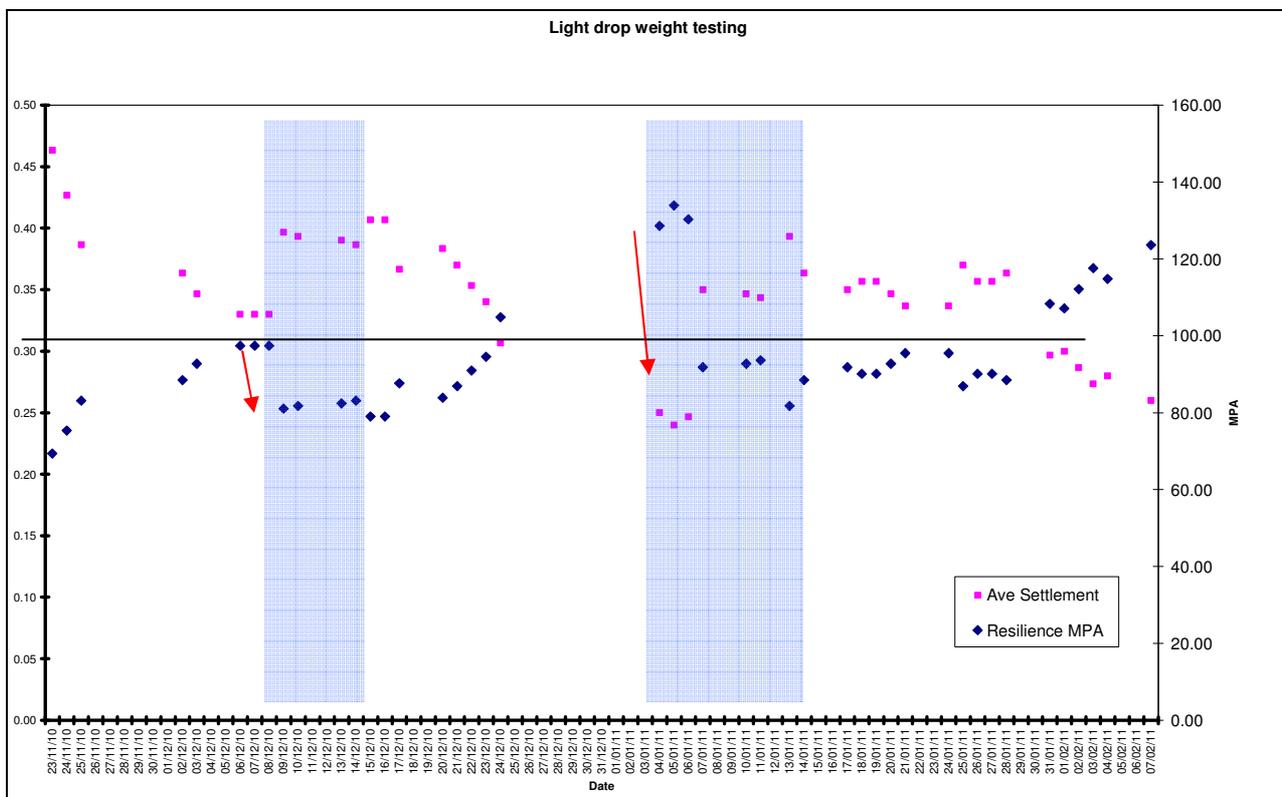
Figure 3.44: Layer stiffness modulus for sub base

In Figure 3.44 the two soaking cycles are shown in blue. Between soaking the box was allowed to drain naturally. The relevant figures are those as blue diamonds and the right hand scale. The soaking periods are in pale blue. Base axis data is days.
