The Effects of Inundation on Pavements

Contractors Report

Date: 27 April 2011
Project Sponsor: Donald Burton

Client: Highways Agency
 Project: Inundated Pavements
 Document Title: Contractors Final Report

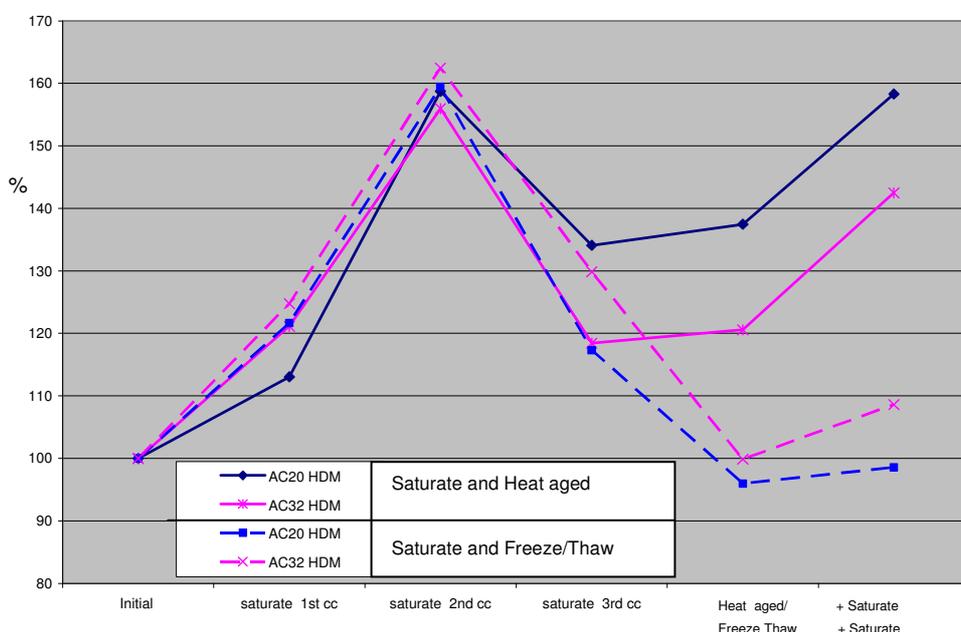
The results from the tests are presented graphically in Figure 3.45 and tabulated in Figure 3.46.

Figure 3.45: Effect of saturation, heat aging and freeze thaw cycling on binder course and base

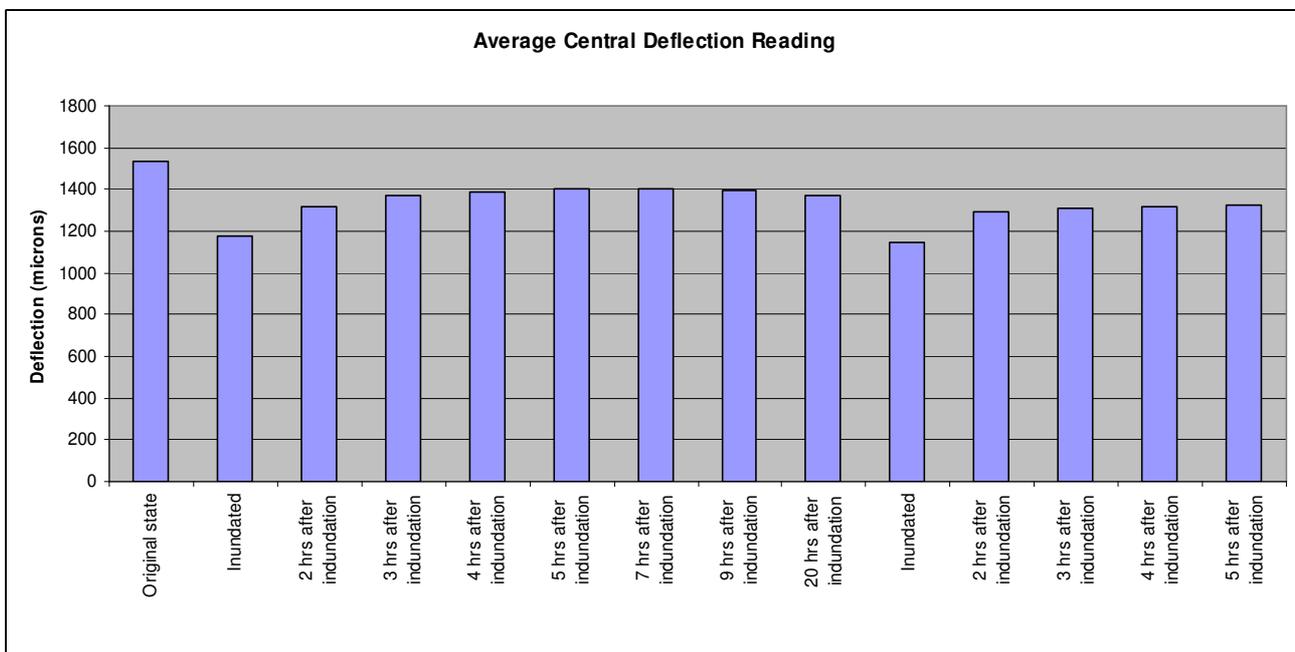
Figure 3.47: Deflection data and graph of average central deflections

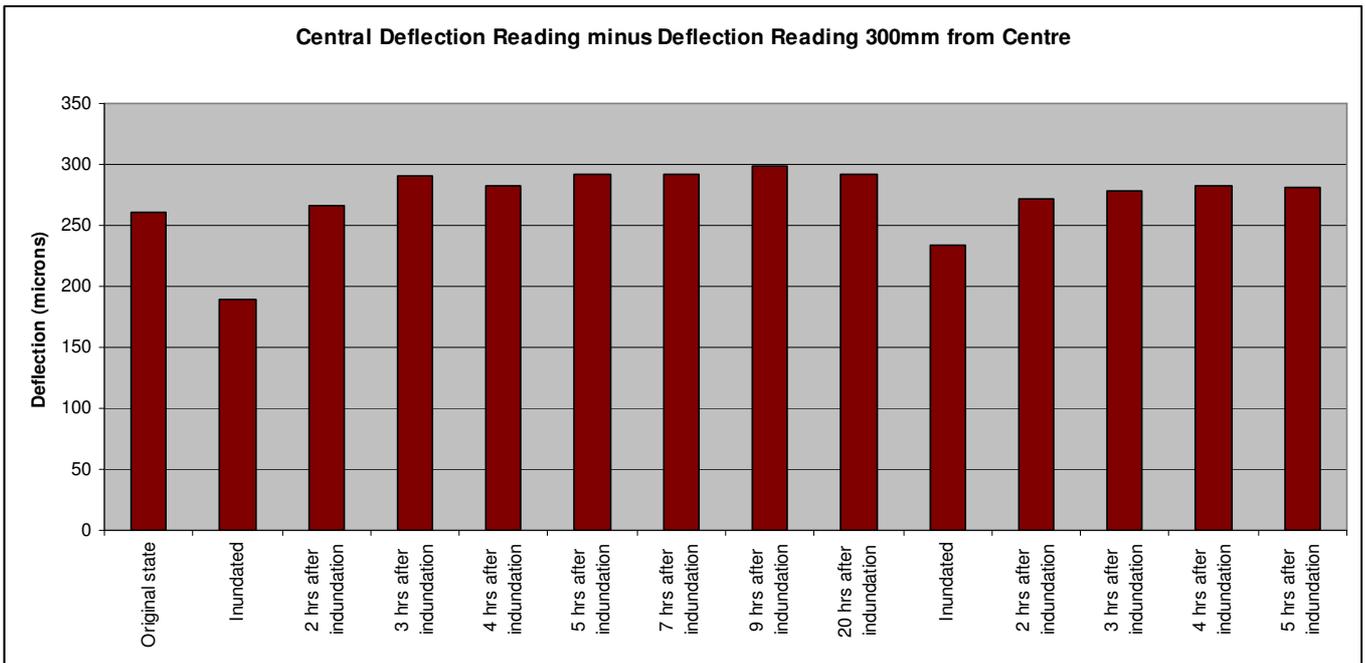
Figure 3.49: Central Deflection Reading minus Deflection Reading 300mm from Centre

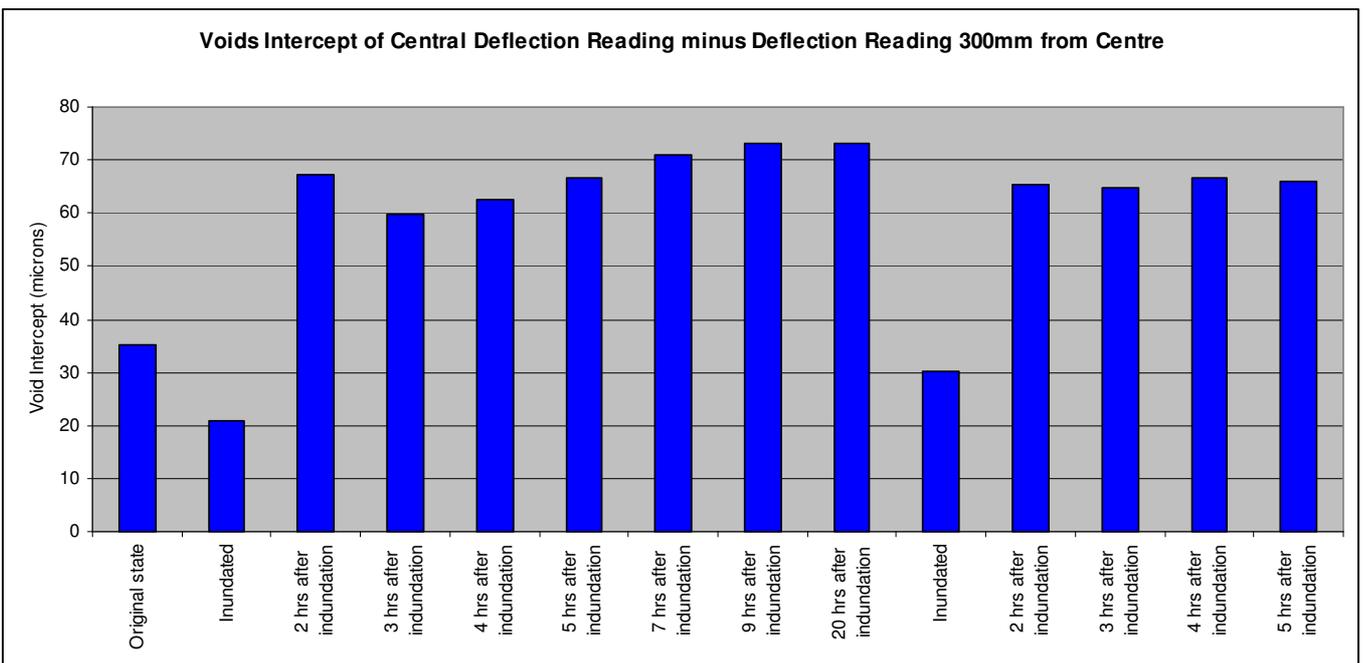
Figure 3.50: Voids Intercept of Central Deflection Reading minus Deflection Reading 300mm from Centre
