Werrington Brook Improvements: Aubretia Avenue Reach Post- enhancement Survey

Lincolnshire & Northamptonshire Analysis & Reporting Team

January 2020

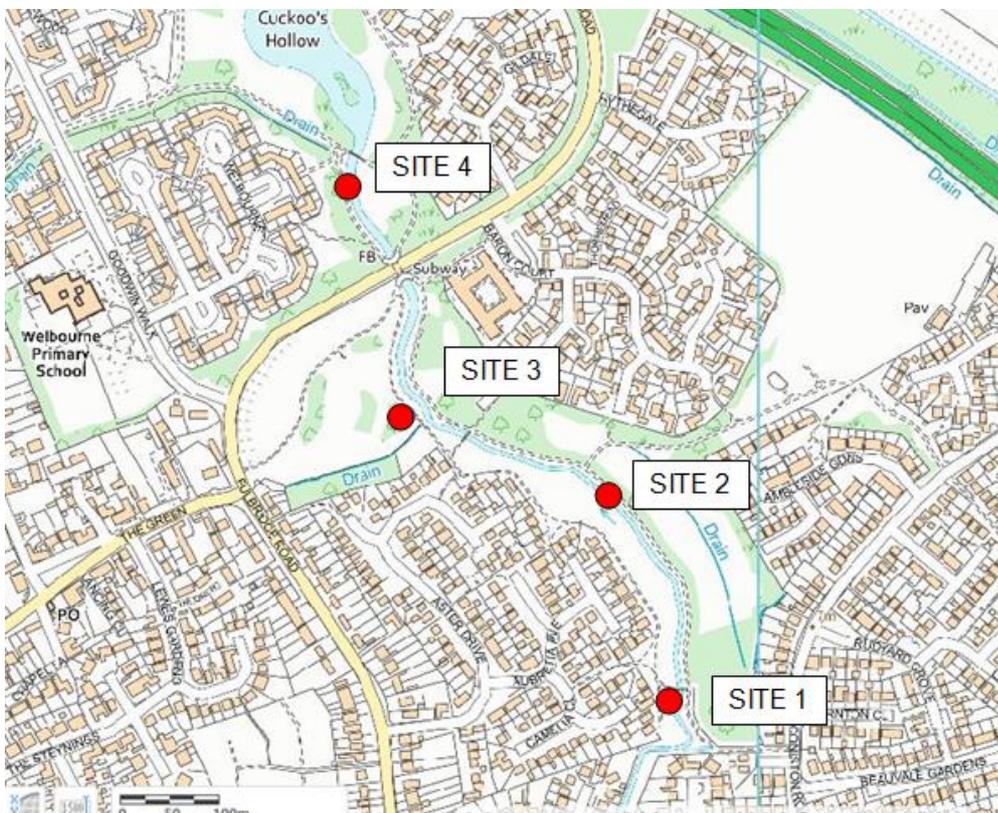
Figure 1: Map showing the Werrington Brook Survey site locations. Site 1 is the control upstream of the 2018 improvement works.

Four sites were surveyed for macro-invertebrates in September 2019 to assess the success of the project; Upstream Larkspur Bridge (Site 1; TF1790903185), Wysteria Way Green (Site 2; TF1784503398), Welbourne Outflow (Site 3; TF1763503486) and Upstream Cuckoo's Hollow Footbridge (Site 4; TF1757703726). The locations of these sites are shown in Figure 1. Site 1 is a control site and located in an area upstream of the 2018 improvement works. Macrophyte (plant) data was again collected at each site as per the pre-enhancement survey and fish presence also noted. Photographs both upstream and downstream were taken at each site (see Appendix 2).

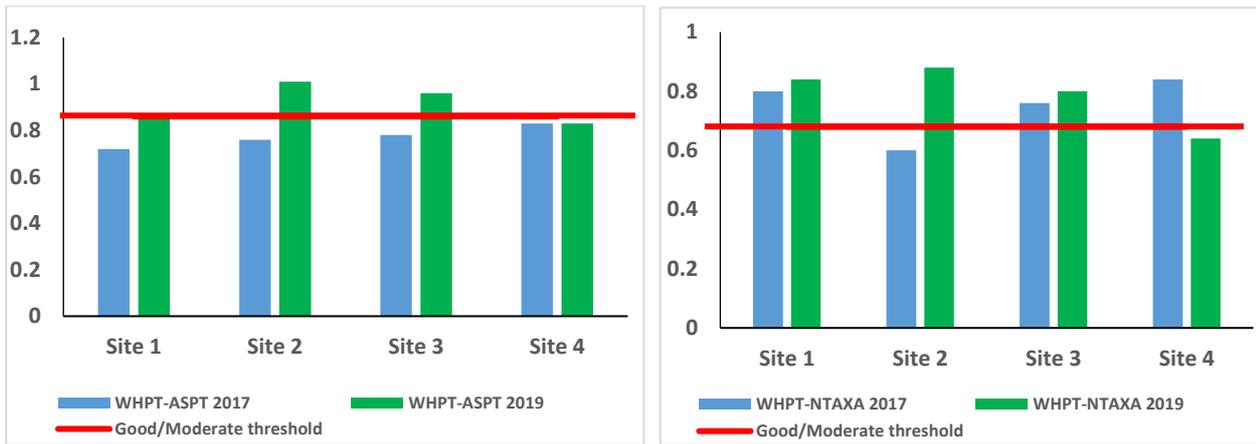
Water and habitat quality at Sites 1, 2 and 3 increased after the 2018 improvement works. The O/E ratios for these sites are now above the Good/Moderate threshold for both WHPT-ASPT and WHPT-NTAXA, with improvements most apparent at Site 2 (see Figure 2). At Site 4 WHPT-ASPT O/E ratios remain the same, at just below the Good/Moderate threshold (Figure 2), however this site showed a decrease in WHPT-NTAXA to below the threshold values compared with 2017 results indicating water/habitat issues. Overall Site 4 still remains below the Good/moderate threshold for water/habitat quality after the enhancement works. This may be due in part to the recent weed cutting (see Plate 2) at Site 3 and 4 that would have reduced habitat quality and affected the WHPT-NTAXA and WHPT-ASPT scores. Additionally three recent pollution events in Werrington Brook may have affected the water quality and coincidentally, on the day of survey, pollution was noted flowing downstream of Site 2.

Figure 2: Comparison of Werrington Brook profiles for water quality (WHPT-ASPT O/E and WHPT-NTAXA O/E) before (2017) and after improvement works (2019).

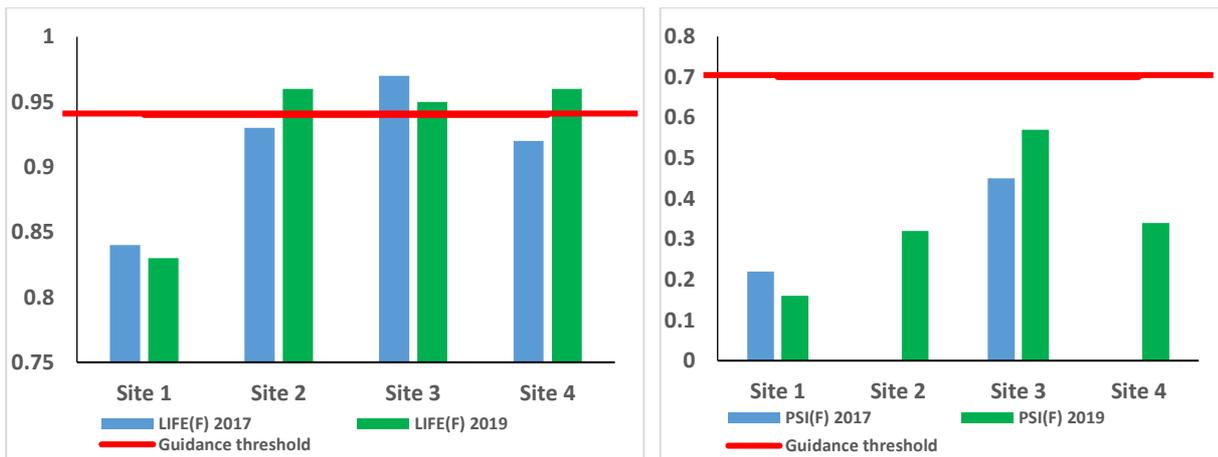
The O/E LIFE ratios from Figure 3 below indicate low flow pressure was still impacting the control site (Site 1), however, the ratios are now above the guidance threshold for all other sites indicating general improvements in flow downstream of Site 1 after the enhancement works. PSI O/E ratios also improved since the enhancement works although they remained below the guidance threshold and indicated a continued fine sedimentation pressure at all sites.

Figure 3: Comparison of Werrington Brook profiles for flow velocity (LIFE O/E) and fine sedimentation accumulation (PSI O/E) before (2017) and after improvement works (2019).

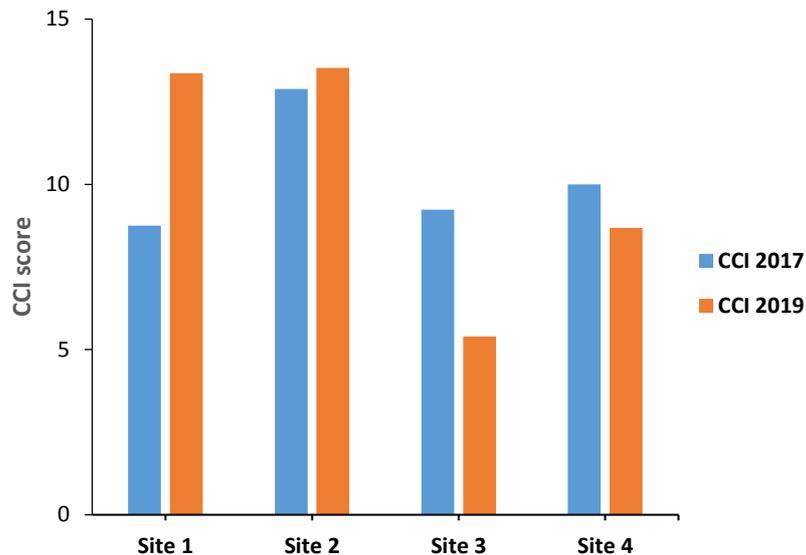
Figure 4: Comparison of Werrington Brook Community Conservation Index (CCI) profiles before (2017) and after restoration (2019).

The CCI increased at Site 1 and 2 (from 8.8 to 13.4 and 12.9 to 13.5 respectively; see Figure 4) and are both now classified as having “Fairly High” Conservation Value. The large increase at Site 1 may be due to ongoing habitat improvement after the completion of enhancement works in 2015 upstream of this site. The CCI values decreased at Site 3 and 4 after the enhancement works, which may be due to the weed cutting.

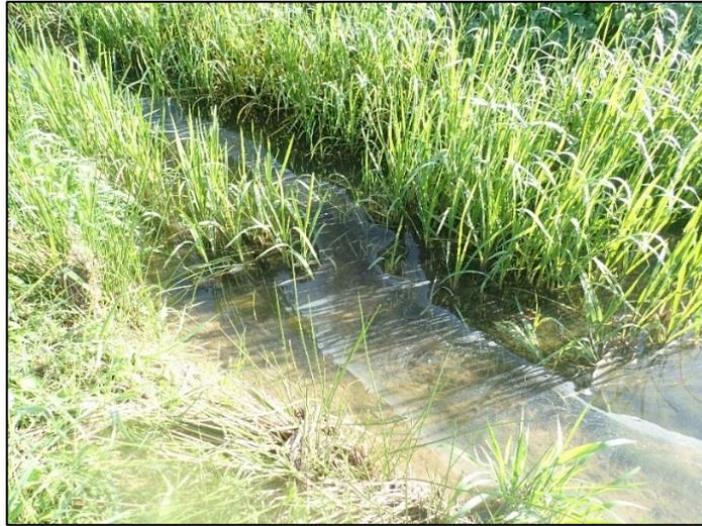
No *Haliplus* species were found at site 4 during the 2019 survey, whereas *Haliplus sibiricus* and *Haliplus linneatocollis* were found before in 2017. This could be an indication of the reduction in water and/or habitat quality at this site. There are six known rainwater drain outfalls into this stretch of Werrington Brook and on the day of survey (18 September 2019) a white ‘oily’ substance was observed on the surface flowing downstream of Site 2 (see Plate 1). Additionally, two pollution events along this stretch of Werrington Brook were recorded in 2019 before the survey was conducted the 3rd May 2019 (NIRS ref: 1699445) and 9th July 2019 (NIRS ref: 1717105). It is therefore possible that this could have affected the water quality.

Plate 1: Pollution event observed on day of survey (18th September 2019) flowing downstream of Site 2.

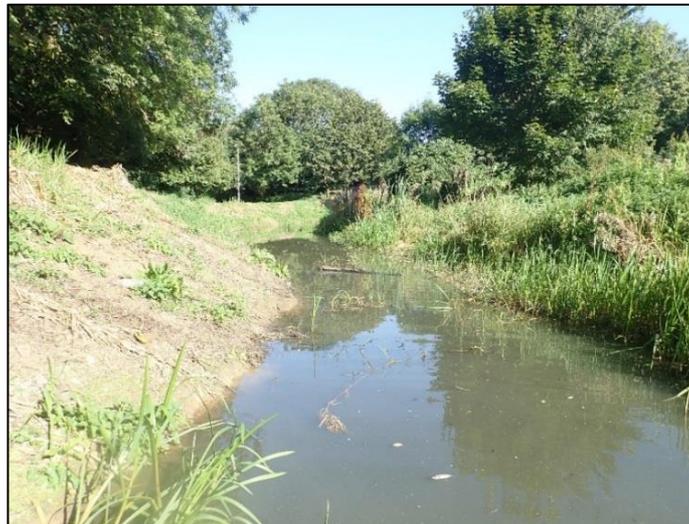
Plate 2: indicating weed cutting had taken place on one side of Werrington Brook just upstream of Site 4.

The apparent decrease in water/habitat quality at Site 4 is likely to be a combination of factors. Recent weed cutting at this site and multiple pollution events upstream may have affected the habitat quality and therefore the aquatic invertebrates at this site. It should be also noted that this is always going to be a marginal site as it's located just upstream of Cuckoo's Hollow lake so there is limited gradient and energy in this section so naturally would be the slowest to show improvement.

Only one site (Site 4) furthest downstream of the works was found to have decreased in water and/or habitat quality which could be due to multiple factors such as its location in close proximity to Cuckoo's Hollow Lake, recent weed cutting and pollution events compared with sites further upstream. It is therefore recommended that another survey is completed in September 2020 to allow for these compounding factors.

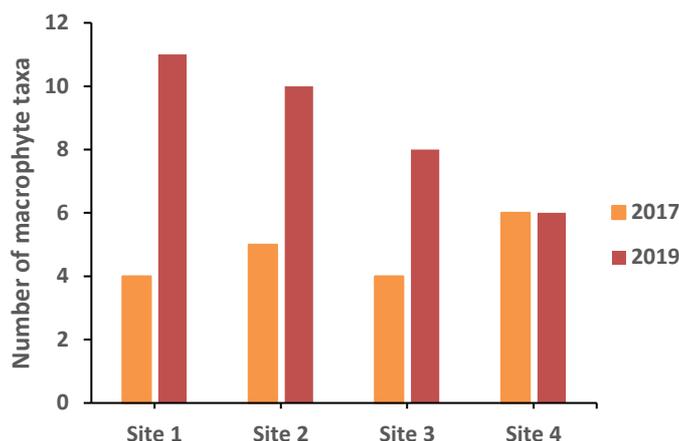
A previous macrophyte survey completed in 2018 along this stretch of Werrington Brook found the aquatic plant species diversity had doubled since the improvement works therefore increasing habitat quality and amenity value of the waterbody. The survey in 2019 confirms increases in aquatic plant diversity at all sites after the enhancement works (see Figure 7 below) with the exception of Site 4 which had been visibly affected by the recent weed cutting. Site 1 and 2 had the highest diversity with species such as starwort (*Callitriche*), water plantain (*Alisma Plantago-aquatica*) (Plate 3), Fool's watercress (*Apium nodiflorum*) (Plate 4) and Brooklime (*Veronica beccabunga*) and Softrush (*Juncus effusus*) (Plate 5).

Figure 7: Comparison of the number of plant and algae species per site before (2017) and after (2019) improvement works.

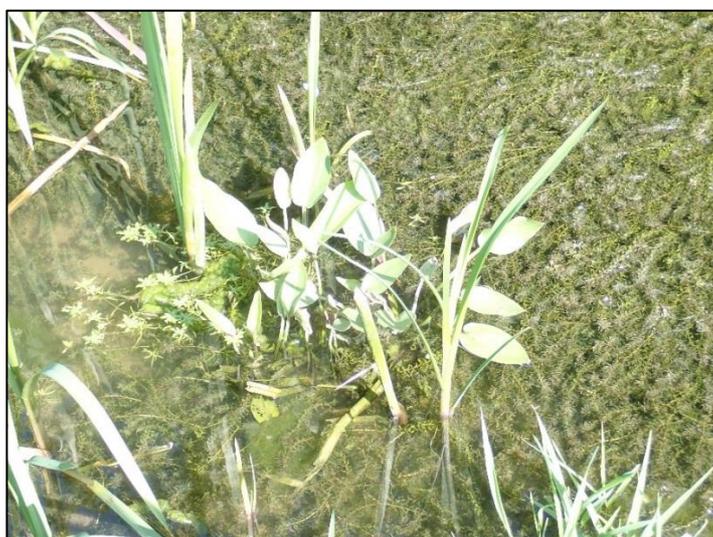
Plate 3: Water starwort (*Callitriche*), Nuttall's pond weed, (*Elodea nuttallii*) water plantain (*Alisma plantago-aquatica*), reed sweet-grass (*Glyceria maxima*) along Werrington Brook between Site 1 and 2.

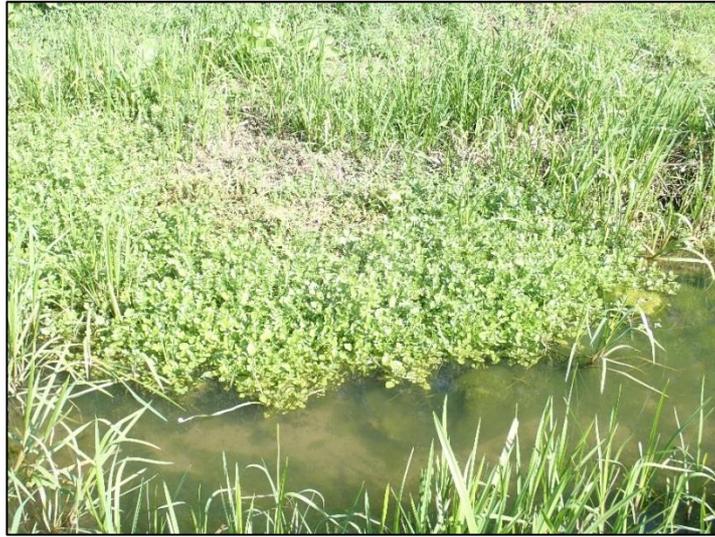
Plate 4: Large stands of fool's watercress (*Apium nodiflorum*).

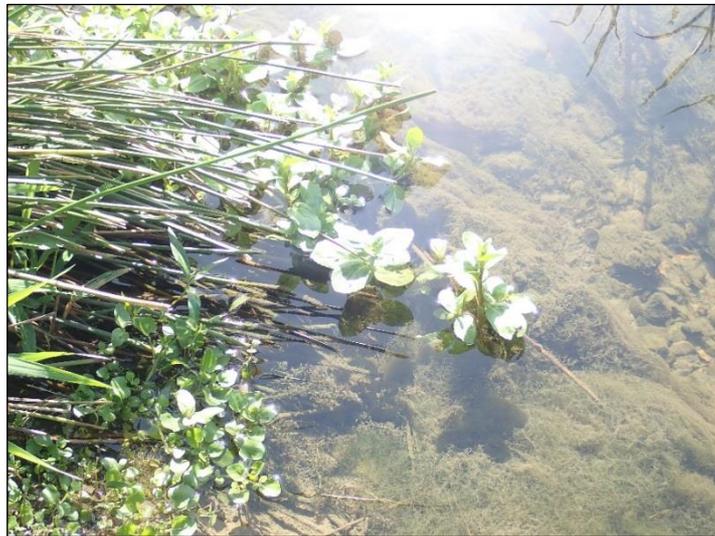
Plate 5: Brooklime (*Veronica beccabunga*) and soft rush (*Juncus effusus*).

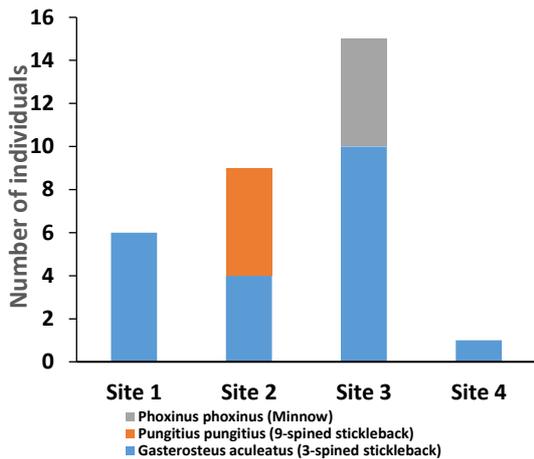
The highest numbers of small fish were found at Site 3 where *Phoxinus phoxinus* (Minnow) were found (Figure 5). An increase in small fish was observed at Site 1 (Figure 6) compared to 2017 but there were decreases in the number of fish found at Site 3 and 4 compared to the 2017 data (Figure 6); this could again be due to reductions in habitat quality after weed cutting and pollution events. However, on the day of survey several large very active schools of roach were observed along the reach between Site 3 and 4 and also in Cuckoo's Hollow Lake and a kingfisher was also observed between Site 3 and 4.

Figure 5: Number and species of fish at each site during the 2019 survey.

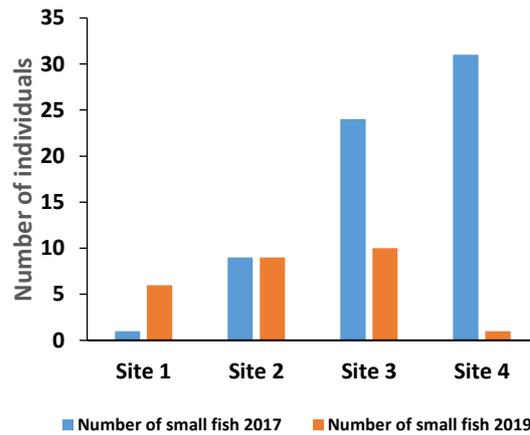
Figure 6: Comparison of fish numbers between 2017 and 2019.
