## HRE major work review template

### Proforma for SAF consideration

Structure name	Asset ID	NH Priority Rank
Paisley Road West, Glasgow	GTB/78	P3

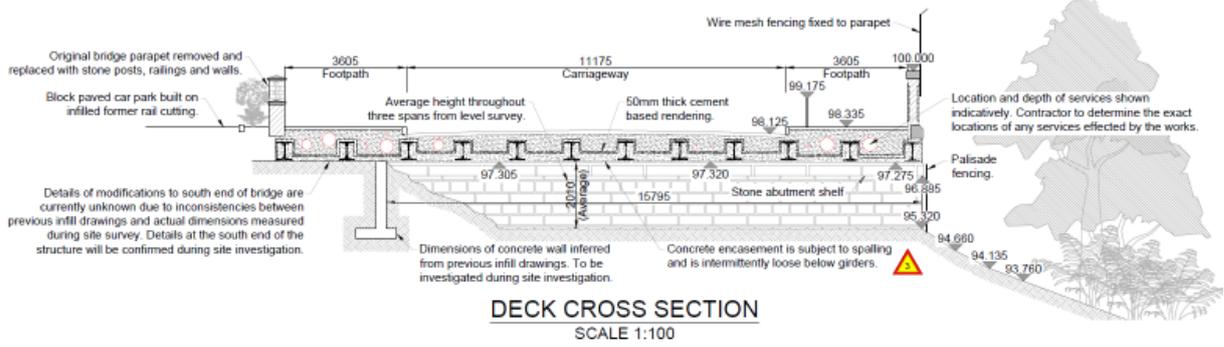
Figure 13 -Existing deck cross section (extract from Drg. B38380DE-DH-0001).

The four-span bridge comprises of 12 no. rivetted steel plate deck girders encased in concrete with a concrete slab at bottom flange level. The four service bays are located, two below each footway and seven are under the carriageway. The service bays have been formed using transverse steel joists encased within mass concrete slabs, spanning between the plate girders. The deck has zero skew and has three spans of 7.6 metres and one span varying from 7.6 metres to 5.0 metres. Masonry stone abutments and intermediate piers support the deck.
