A27 East of Lewes Improvements

PCF Stage 3 – Preliminary Bat Roost Assessment Report

March 2019

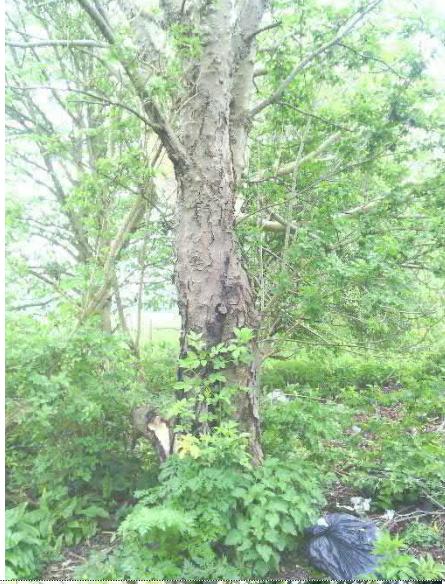
| TREE/GROUP NUMBER | OVERALL SUITABILITY CATEGORY | PHOTOGRAPHS |
|---|---|---|
| T4 | Low | |

| Identification number | Tree/ Group | Species | Approx. Height (m) | Age (OM/M/SM/I) | Description of features with potential to support bats | Brief description of surrounding habitats | Grid reference | Distance from scheme extent (m) | Orientation to A27 | Overall Suitability Category |
|---|---|---|---|---|--|--|---|---|---|---|
| T4 | T | Horse Chestnut | 8 | SM | Split from butt-rot 1m long NE stem. In a disturbed area. | In woodland strip adjacent to A27, road lay-by and pasture field. | TQ4715708070 | 0 | S | Low |

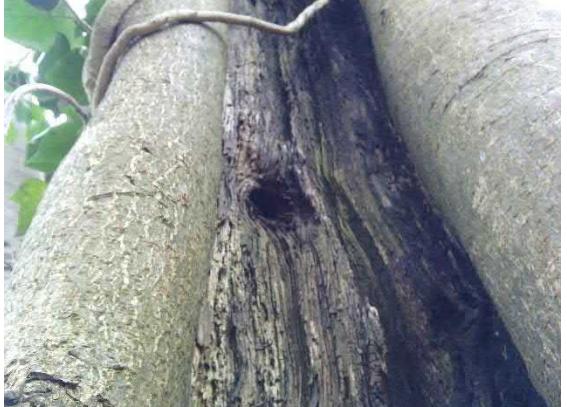
| TREE/GROUP NUMBER | OVERALL SUITABILITY CATEGORY | PHOTOGRAPHS |
|---|---|--|
| T20 | Moderate | |

| Identification number | Tree/ Group | Species | Approx. Height (m) | Age (OM/M/SM/I) | Description of features with potential to support bats | Brief description of surrounding habitats | Grid reference | Distance from scheme extent (m) | Orientation to A27 | Overall Suitability Category |
|---|---|---|---|---|--|--|---|---|---|---|
| T20 | T | Horse Chestnut | 11 | SM | Frost crack with cavity 2m S stem. | In woodland adjacent to pasture field between local road and A27. Nearby hedgerows. | TQ4771308133 | 61 | N | Moderate |

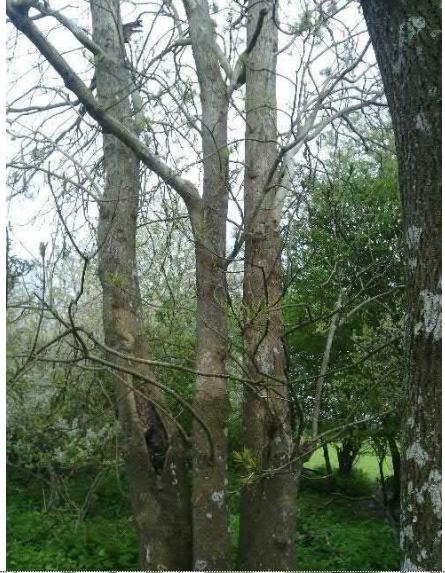
| TREE/GROUP NUMBER | OVERALL SUITABILITY CATEGORY | PHOTOGRAPHS |
|---|---|--|
| T21 | Moderate | |

| T21 | T | Ash | 8 | SM | Multi-stem tree with features on each stem. Tear out with rot leading to internal cavity going up 1m stem. Wound with cavity possible cavity going up major limb. Tear out 6m E major limb. | In woodland between pasture field and improved grassland. | TQ4774007984 | 55 | S | Moderate |

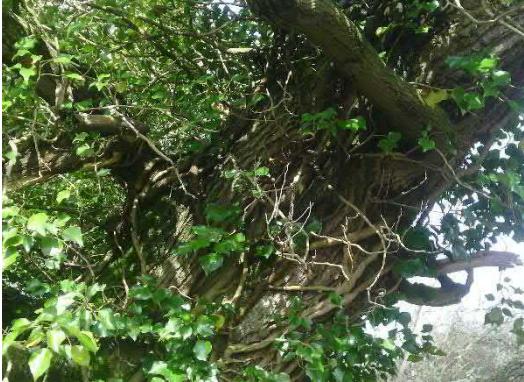
| TREE/GROUP NUMBER | OVERALL SUITABILITY CATEGORY | PHOTOGRAPHS |
|---|---|--|
| T100 | Low | |

| T100 | T | Oak | 10 | M | Frost crack 1m long 2-3m E main limb. | In woodland adjacent to arable field and stream. Nearby hedgerows. | TQ5091206605 | 183 | N | Low |

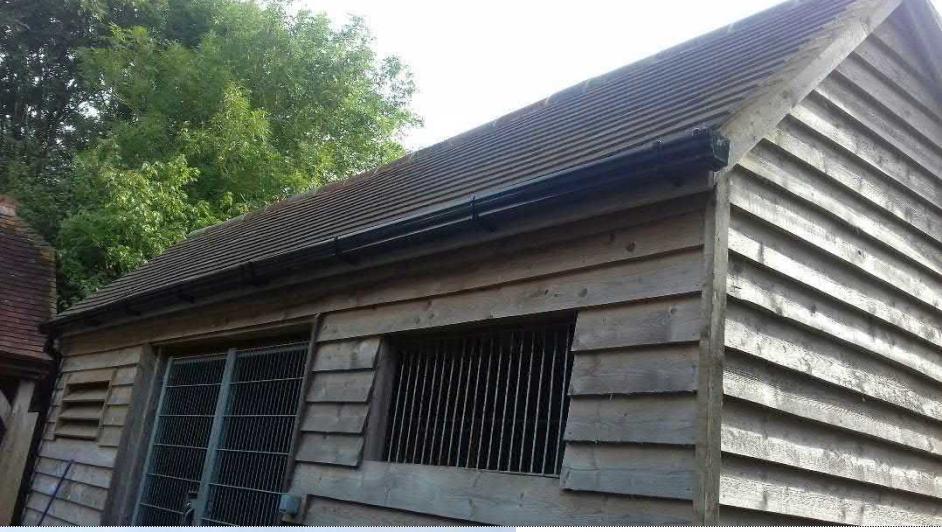
| B11 | Low | |

| Identification number | Structure type | Approx. Height (m) | Description of features with potential to support bats | Brief description of surrounding habitats | Grid reference | Distance from scheme extent (m) | Orientation to A27 | Overall Suitability Category |
|---|---|---|---|---|---|---|---|---|
| B11 | Building | 3 | Loose roof tiles E aspect | Adjacent to residential house, arable field and pasture field. Nearby pond, hedgerows and woodland. | TQ5226605487 | 52 | N/W | Low |

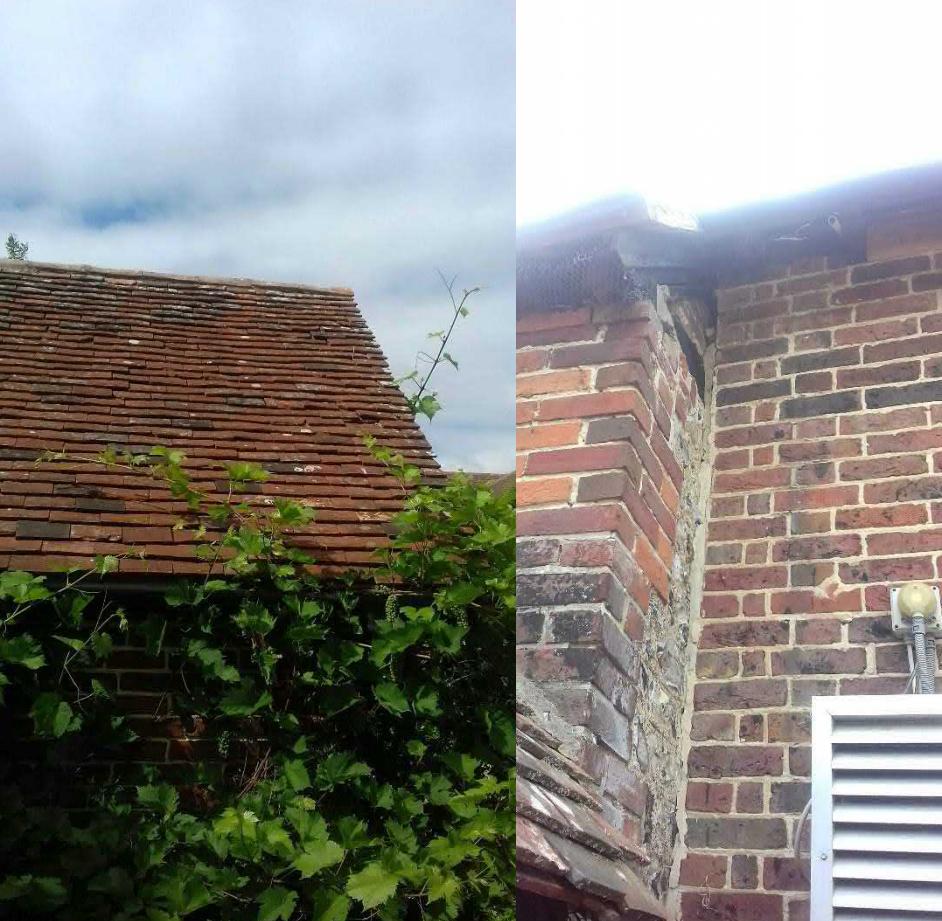
| B12 | Moderate | |

| Identification number | Structure type | Approx. Height (m) | Description of features with potential to support bats | Brief description of surrounding habitats | Grid reference | Distance from scheme extent (m) | Orientation to A27 | Overall Suitability Category |
|---|---|---|---|---|---|---|---|---|
| B12 | Building | 4 | Multiple loose roof tiles on S single storey annex. Gaps under eves E aspect, gaps behind wooden cladding E. Gap between brickwork 5cm x 10cm E aspect. | Adjacent to car park and garden. Nearby barns, amenity grassland and hedgerows. | TQ5244005153 | 21 | S | Moderate |

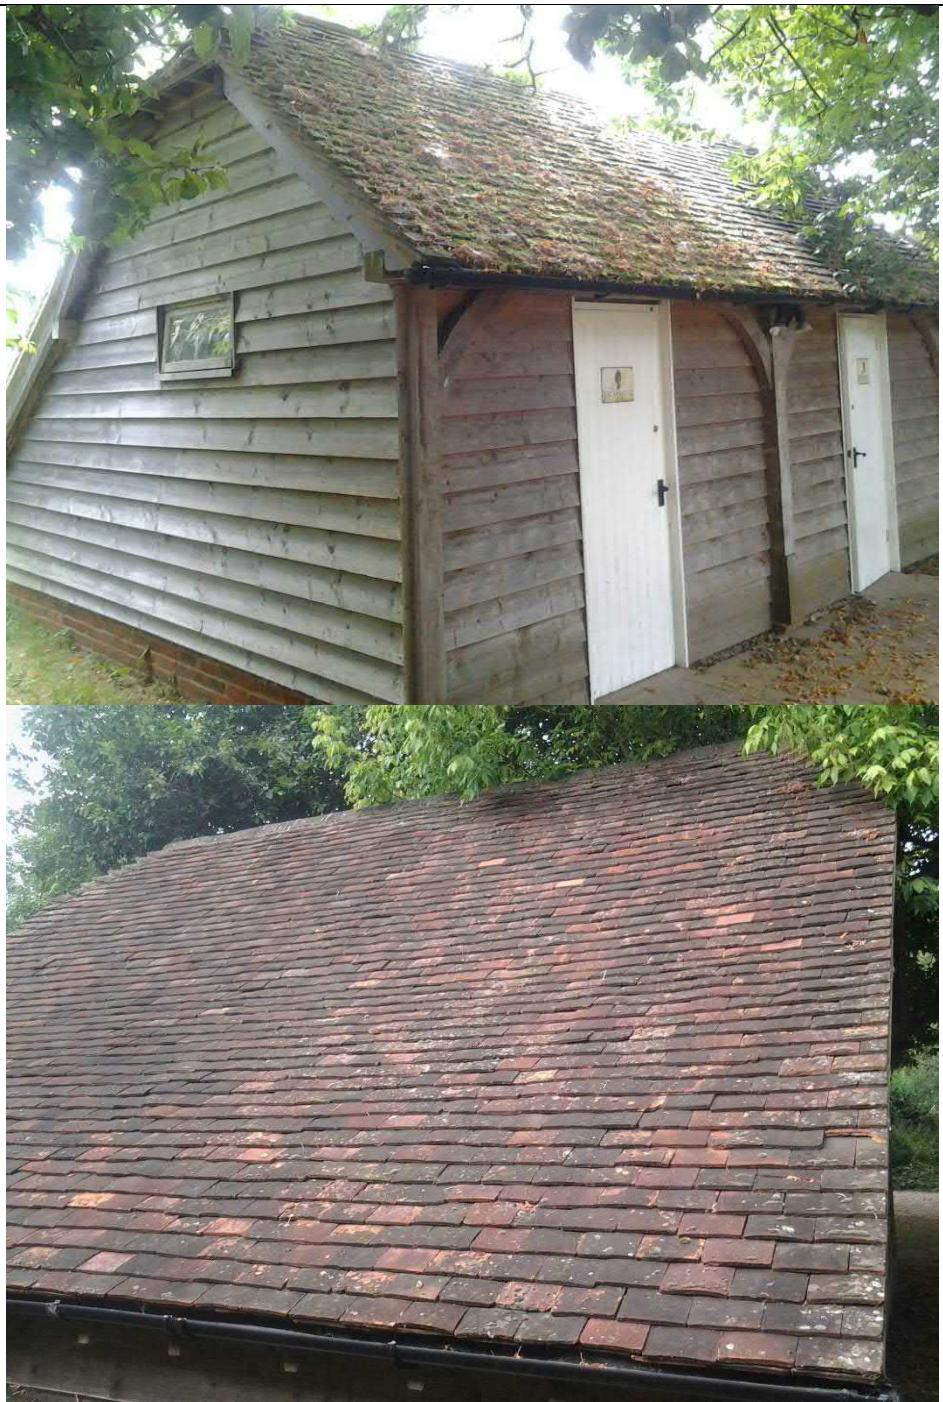
| Identification number | Structure type | Approx. Height (m) | Description of features with potential to support bats | Brief description of surrounding habitats | Grid reference | Distance from scheme extent (m) | Orientation to A27 | Overall Suitability Category |
|---|---|---|---|---|---|---|---|---|
| B13 | Building | 3.5 | Loose roof tiles with gaps underneath S. | Adjacent to car park and garden. Nearby barns, amenity grassland and hedgerows. | TQ5247805133 | 61 | S | Low |

Low

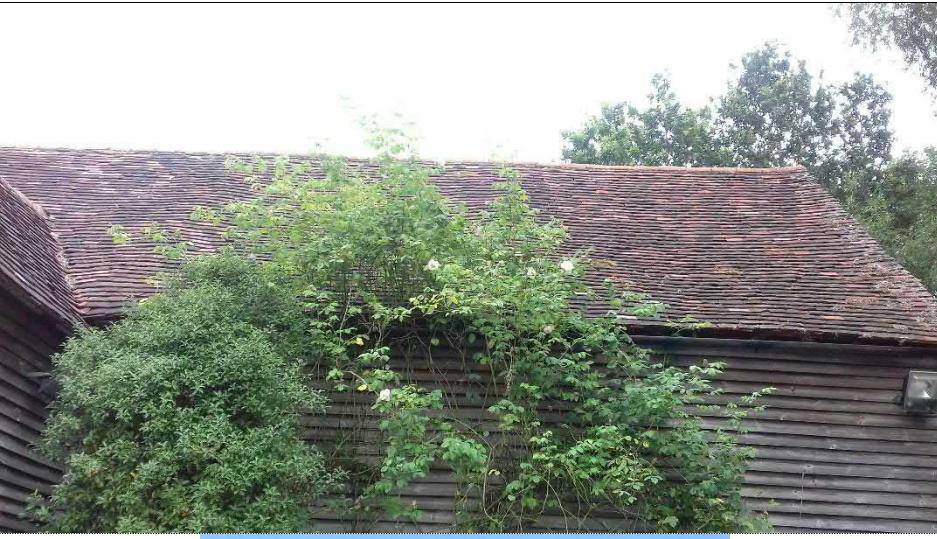
| B14 | Moderate | |

| Identification number | Structure type | Approx. Height (m) | Description of features with potential to support bats | Brief description of surrounding habitats | Grid reference | Distance from scheme extent (m) | Orientation to A27 | Overall Suitability Category |
|---|---|---|---|---|---|---|---|---|
| B14 | Building | 8 | Loose roof tiles E & W aspect, gaps under soffit W, mesh under eves coming away E, wooden cladding coming away SE corner. | Adjacent to car park and garden. Nearby barns, amenity grassland and hedgerows. | TQ5250805146 | 44 | S | Moderate |

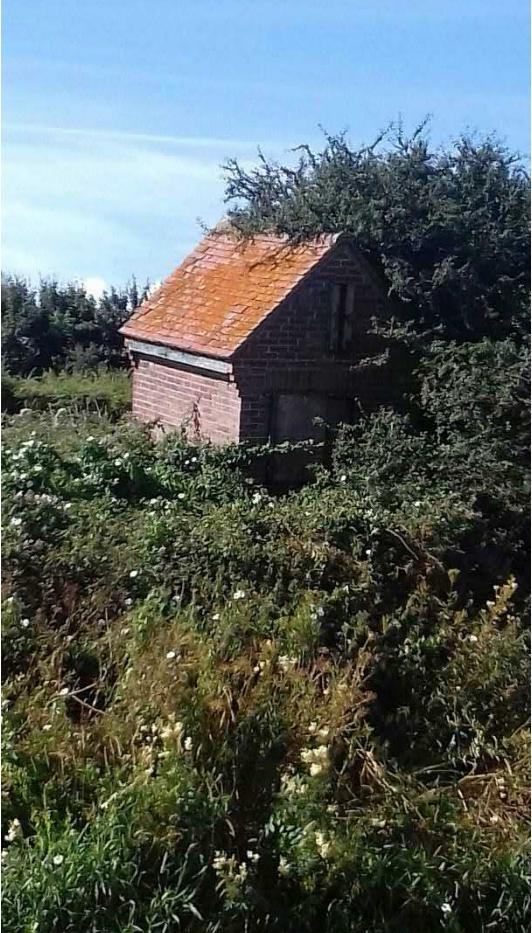
| B15 | Moderate | |

| Identification number | Structure type | Approx. Height (m) | Description of features with potential to support bats | Brief description of surrounding habitats | Grid reference | Distance from scheme extent (m) | Orientation to A27 | Overall Suitability Category |
|---|---|---|---|---|---|---|---|---|
| B15 | Building | 3 | Undisturbed building with vertical slit open window W and open window SE. Loose and missing roof tiles N. | Within pasture field adjacent to river Cuckmere. Nearby hedgerows and arable fields. | TQ5324205094 | 46 | N | Moderate |

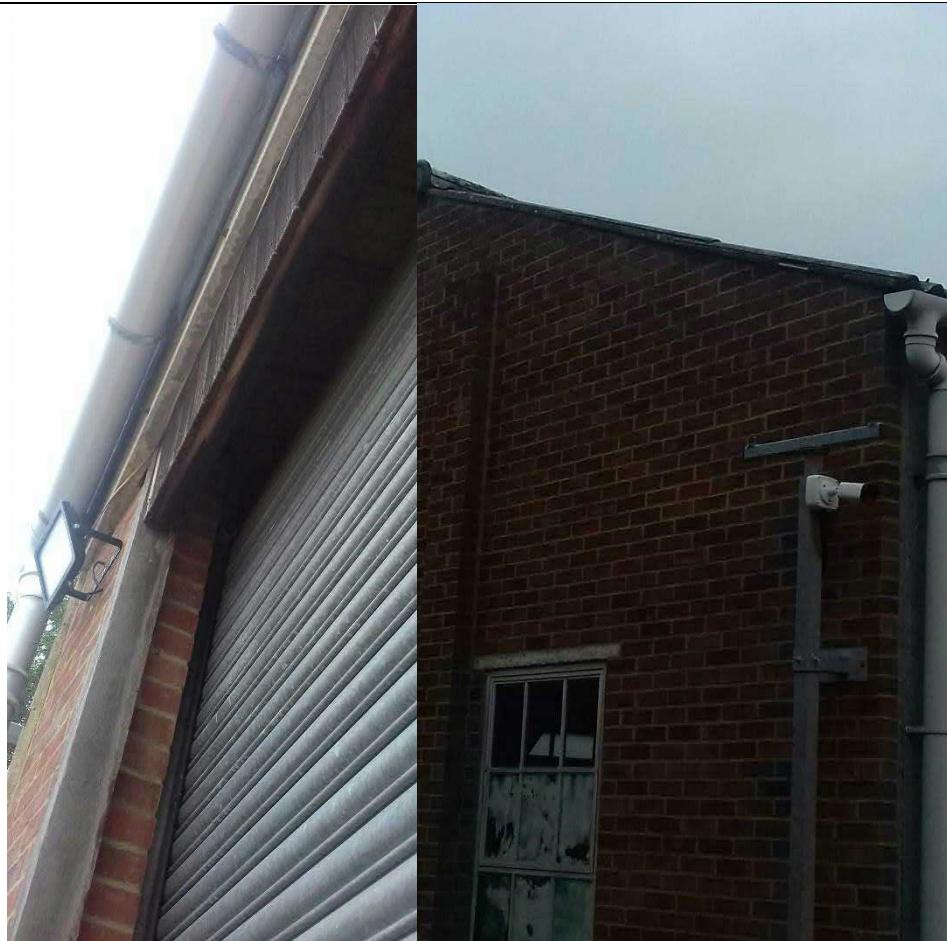
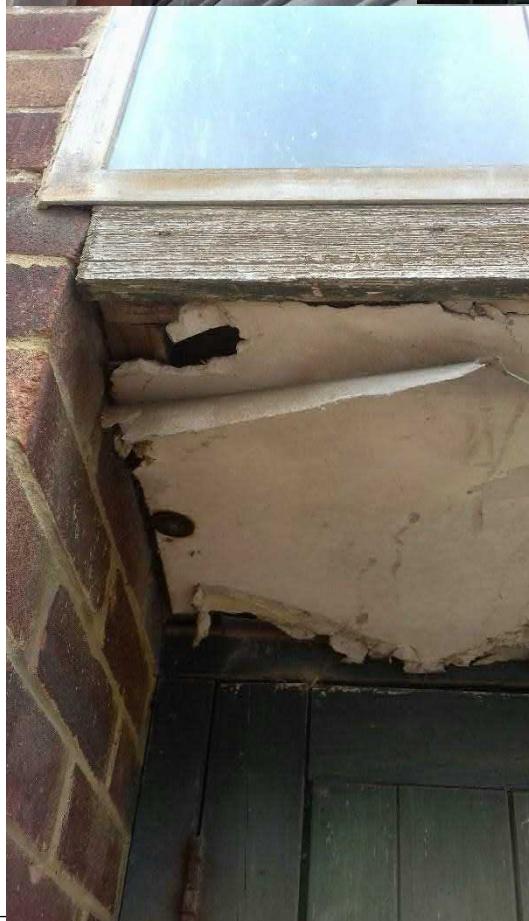
| B20 | Building | 4 | Missing tile on concrete roof edge 2m S. Gaps over the top of rolling service doors leading to inside of building. Damage to soffit box above door. | Adjacent to A27 and railway line. Nearby bridge, hedgerows, pasture fields and woodland. | TQ5769404764 | 19 | N | Moderate |

Moderate
