Improving Stability of Emergency Traffic Management Signs

CPR1003

CLIENT PROJECT REPORT

Client: Highways Agency, National Health and Safety Team

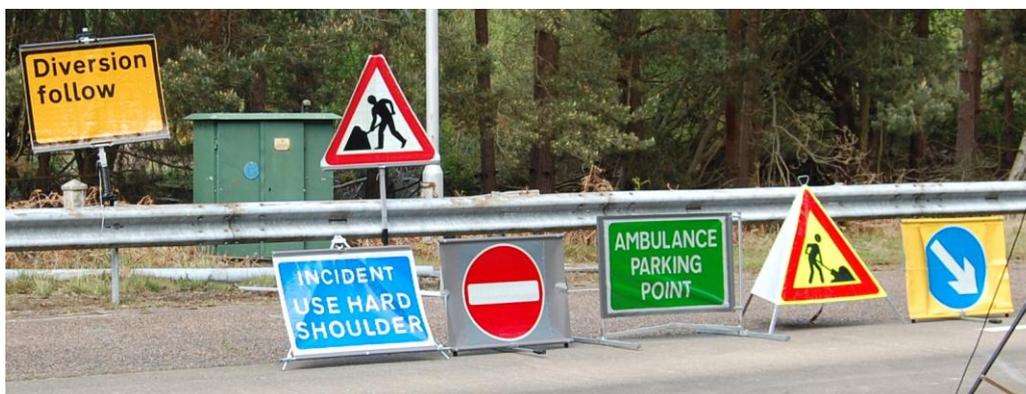
Figure 4: First set of signs, before and during wind testing

During the testing of first set of signs, peak wind speed reached 58mph. The pyramid sign with additional square sign face blew over at about 40mph.
