Notes from the DAC site visit held on Friday 15th of September 2021 at St Peter's, Poulshot.

Purpose of the meeting:

This is a report of an inspection of the bells and fittings at St Peter's, Poulshot which was carried out on Friday 15th of September 2021 at the request of, and in company of, the Church Warden, Dankay Cleverly. The inspection was requested as the PCC are considering restoration of the church bells and improvements to tower access.

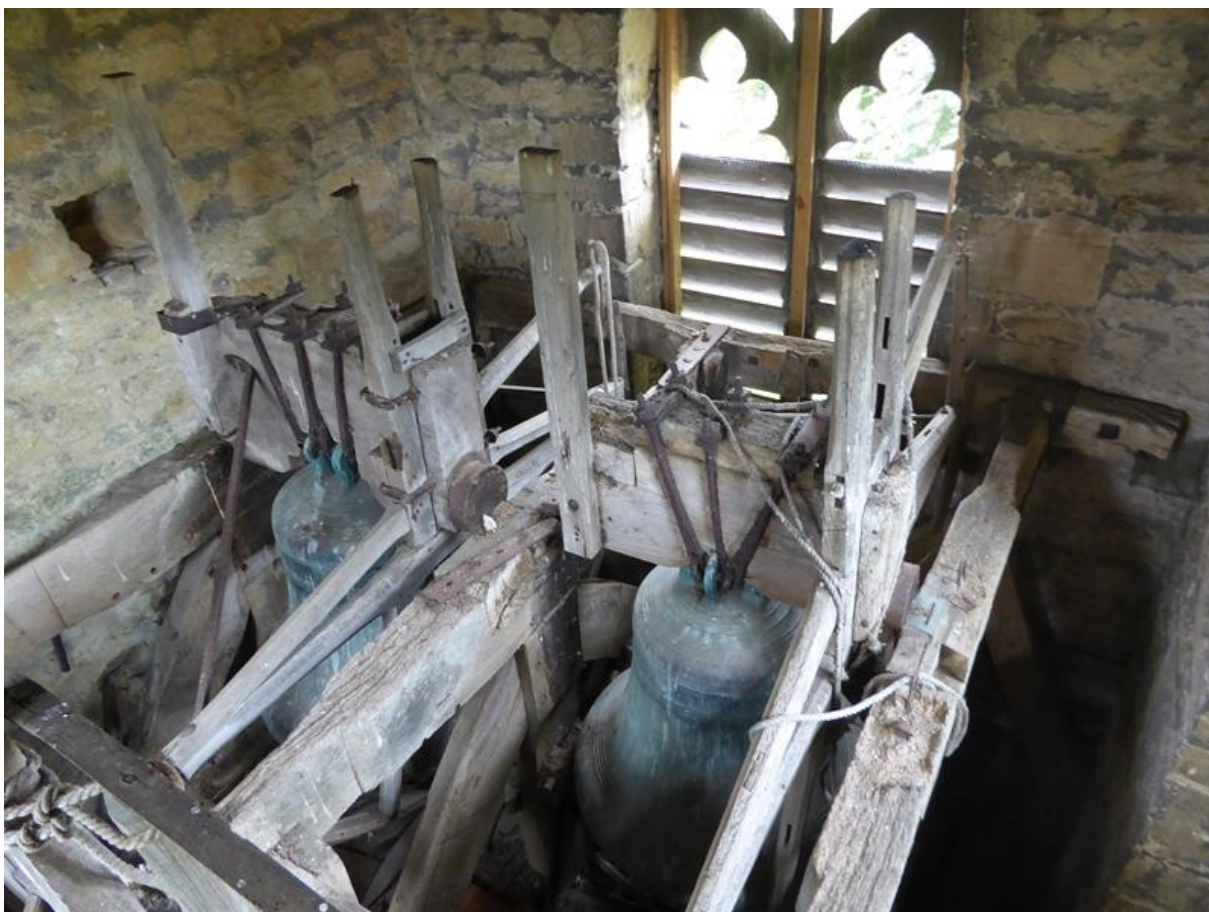
1) Headstocks and Bearings

All bells have Elm Headstocks and are mounted on plain bearings with strap gudgeons. None of the bells are loose on their headstocks, but the headstocks are in poor condition, especially the treble, which is exposed to the driving rain from the north louvre, which is close by.
