PUBLISHED PROJECT REPORT PPR662

Package Order 001/4/45/12 - Traffic Officer Vehicle Conspicuity

Prepared for: Highways Agency,
Project Ref: Package Order 001/4/45/12

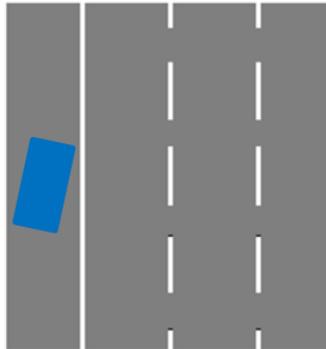
The TOV is parked in 'fend off' when the nose of the vehicle is directed towards the live lane (Figure 1).

Figure 1: TOV parked 'fend off' within the hard shoulder

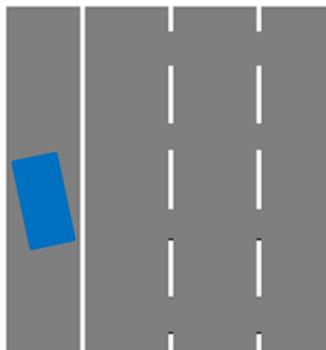
The TOV is parked in 'fend in' when the nose of the vehicle is directed away from the live lane (Figure 2).

Figure 2: TOV parked 'fend in' within the hard shoulder

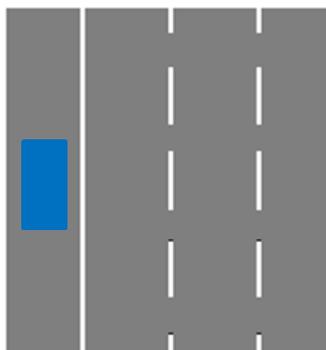
Figure 3 shows the TOV parked 'parallel' within the hard shoulder: the vehicle is positioned such that it is parallel to approaching traffic.

Figure 3: TOV parked 'parallel' within the hard shoulder

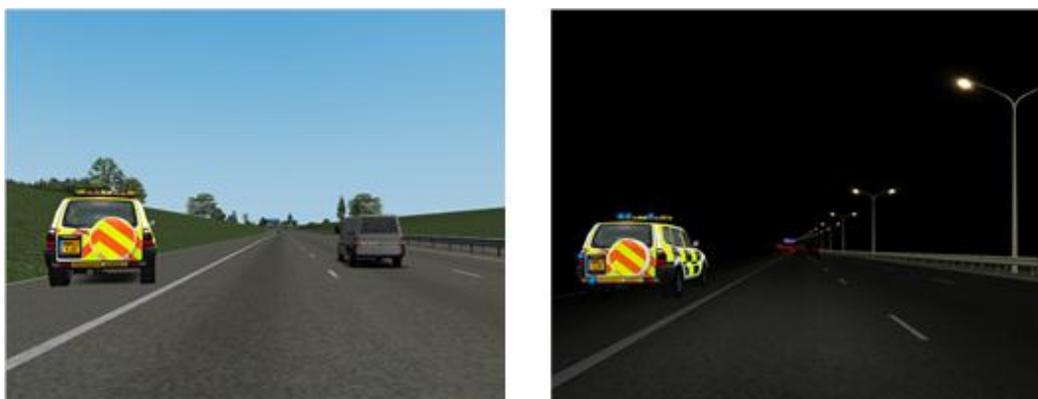
Figure 4: Screenshot from the simulator database, showing the TOV parked fend in (left), and parallel parked, displaying blue flashing lights (right)

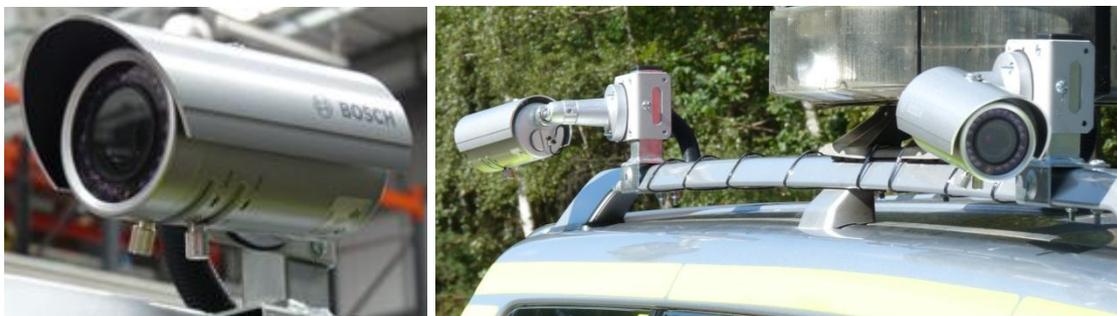
Figure 5: Roof-mounted video cameras

Several suitable manufacturers were provided with the specification; subsequently CSS Group was awarded the task of design, manufacture and fitting of the measurement and logging system. Fitting was undertaken within TRL's vehicle workshops. Figure 5 shows the roof-mounted video cameras; Figure 6 shows the laser distance sensor, mounted on the TOV's spare wheel cover, directed horizontally to the right side of the vehicle at a level where it was expected to measure the widest selection of passing vehicles.

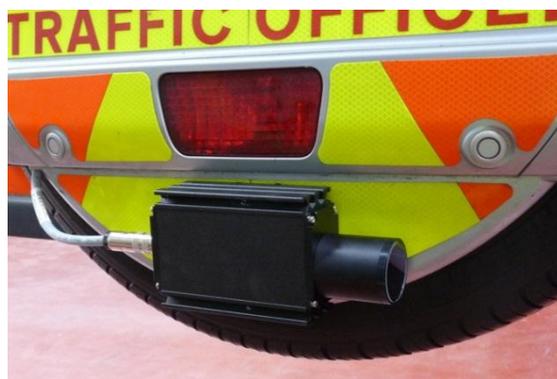
Figure 6: Laser distance measurement sensor, fitted to spare wheel cover on rear of TOV

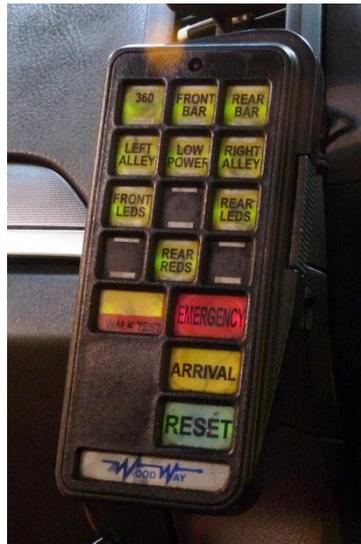
Figure 7: Lighting control panel

The system was powered from the vehicle's 12V system, and operated via the main lighting control switching system already installed in the TOV. When the TOV was arriving at an incident scene one of the crew would select the 'Arrival' button (while the vehicle was still travelling in a live lane), which operated both amber and red beacons. Connections made within the roof-mounted light bar were used to identify which beacons were in use.

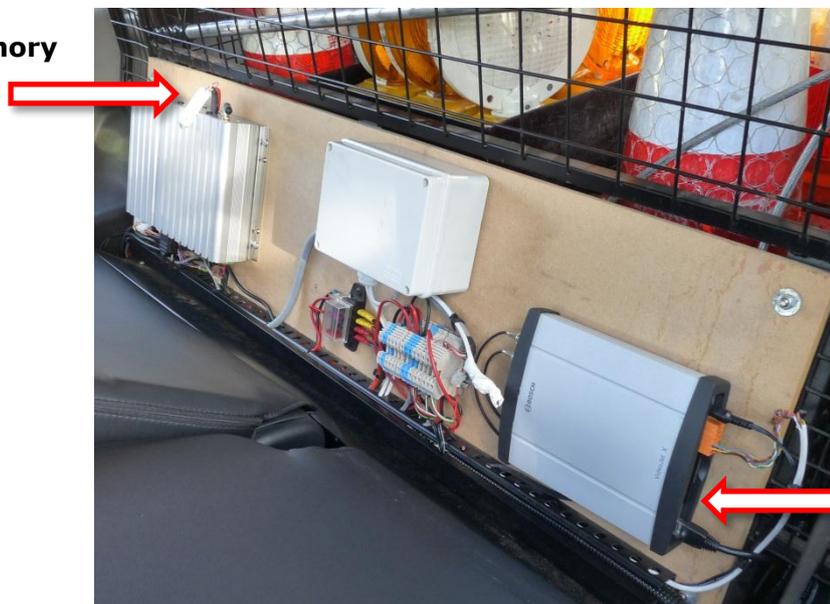
The mobile PC and video recorder were mounted in the TOV's passenger compartment, behind the rear seat back (see Figure 8). Video was recorded onto a CompactFlash card; distance measurements and beacon trigger information were recorded onto USB memory.

Figure 8: Mobile PC (left) and video logger (right) installed into TOV

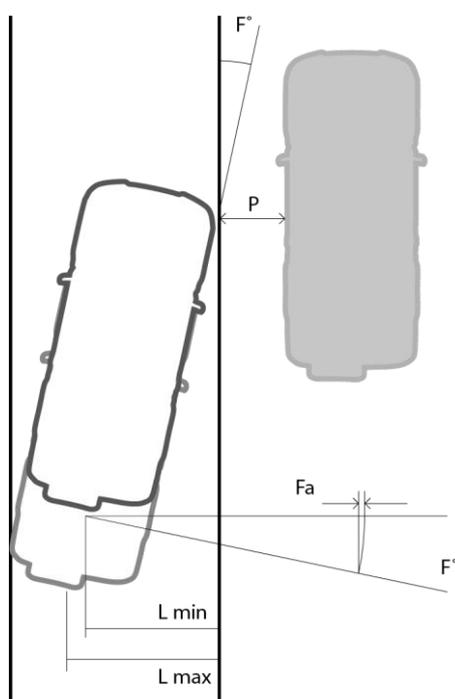
In order to allow for those two inaccuracies, it was necessary to first identify the fend angle at which the TOV was parked and its lateral offset, then adjust the data recorded and supplied for analysis. The variables of fend angle and lateral offset are shown in Figure 9.

Figure 9: Adjustment variables for distances recorded

Lmin and Lmax show the range of lateral offsets possible when the vehicle is parked within the hard shoulder, measured from the laser lens to the edge of the lane marking. The two extreme conditions used during test track calibration when determining the likely ranges of lateral offsets were:

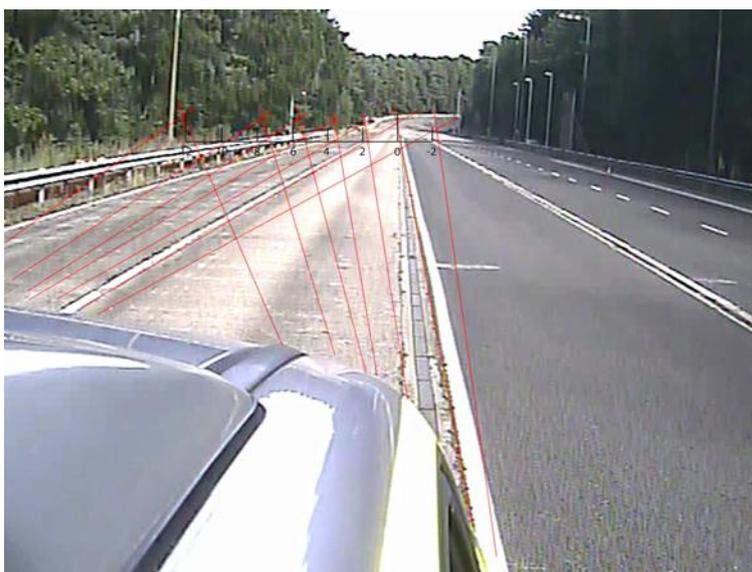
Figure 10 shows a screen image from video taken during calibration on the TRL test track. The horizontal (red) scale was used to identify the angle in degrees (from straight ahead) at which the vehicle was parked. The lines drawn along the carriageway identify, from the white line markings along the track, the 'vanishing point'; a vertical line from that vanishing point to the horizontal scale shows the fend angle (in this example, 0° , i.e. straight ahead).

Figure 10: On-track calibration for fend parking angle

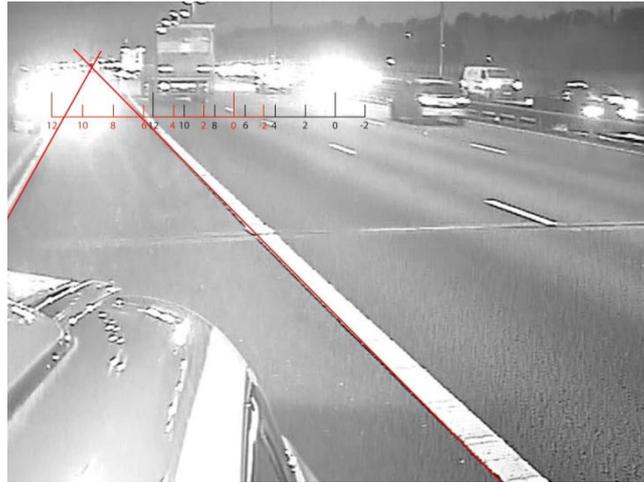
Figure 11 demonstrates how a screen grab from the TOV's forward-facing video can be used to identify the vehicle's fend angle while attending an incident.

Figure 11: Identifying fender angle from incident video

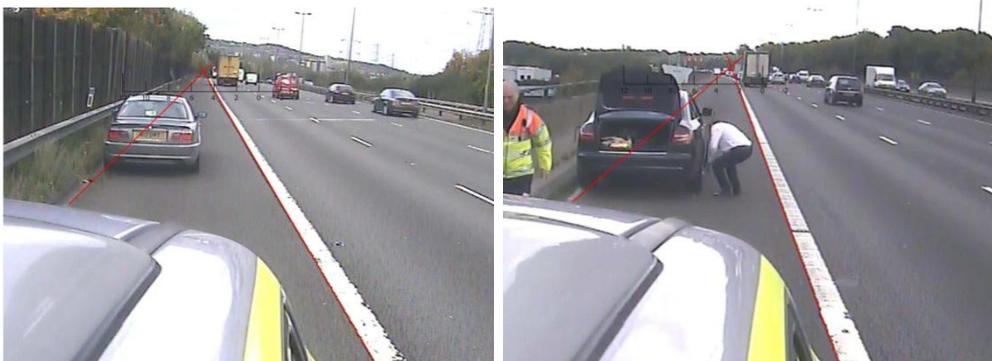
Figure 12 shows how the white line adjacent to the right side of the vehicle appears further away from the TOV in the left image, showing that the TOV is further left within the hard shoulder. It is likely that the TOV is further towards the right of the hard shoulder in the right hand image so that the driver performing the wheel change is afforded some protection from passing traffic.

Figure 12: Determination of fender angle and lateral offset

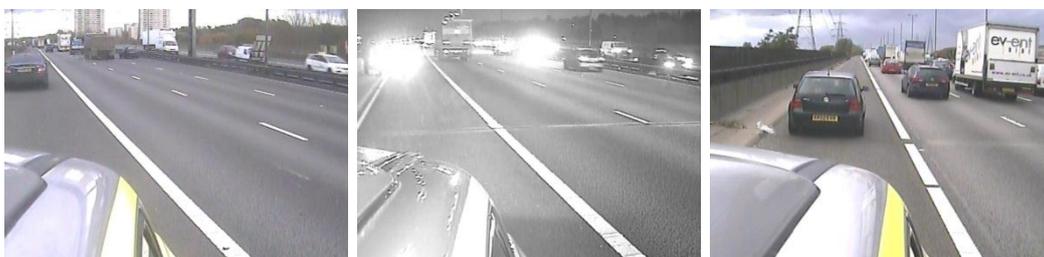
Figure 13 gives further examples of TOV attendance at incidents, showing a variety of fender angles and range of lateral positions within the hard shoulder.

Figure 13: Examples of incidents attended, showing the variety of fender angles and range of lateral positions used

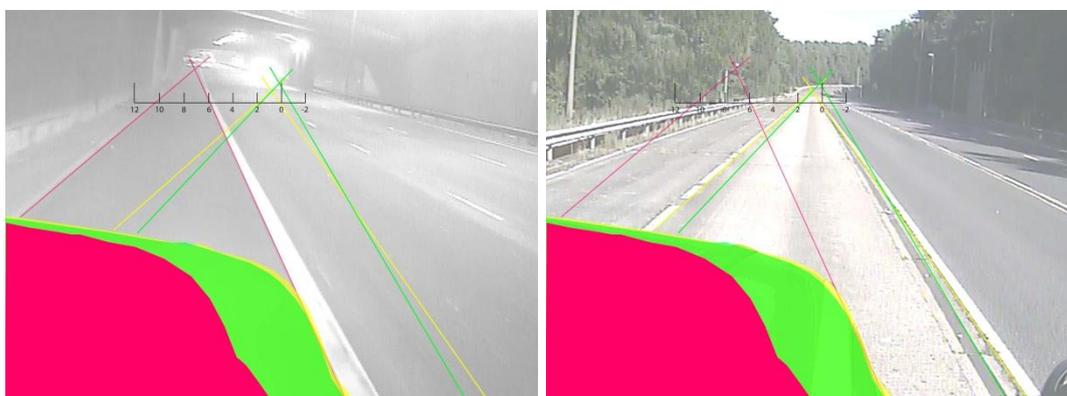
It was found during analysis that, on two occasions between incidents during the on-road trial, the position of the camera had changed, invalidating the pre-calibrated scale. In Figure 14 the bodywork of the TOV, as visible in the camera view, is shown in colour. The green lines and vehicle outline show the original camera view as at system installation; the yellow and red lines and outline show the camera view after the first and second time on which the camera position had changed.

Figure 14: Camera movement. Green (right image) shows original calibration

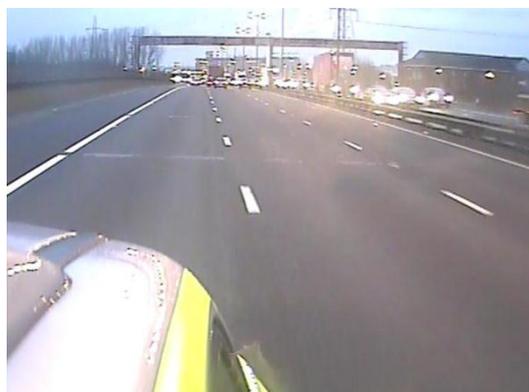
It was possible to re-orientate the 'straight ahead' (i.e. 0° parking orientation) from the video obtained whilst the vehicle was being driven forwards (Figure 15), though this approach did mean that the pre-calibrated scale was not as accurate as it had been previously for angles other than 0° . It was intended that a visit would be undertaken to re-measure and re-calibrate the scale in full, but the collision involving the TOV led to it being written off and so this was not possible. Therefore, accurate measurements could not be obtained from the laser measurement system, and the distances and angles used are therefore approximations only.

Figure 15: Live lane with TOV travelling forward; image as used to reorient the fend angle scale after camera movement

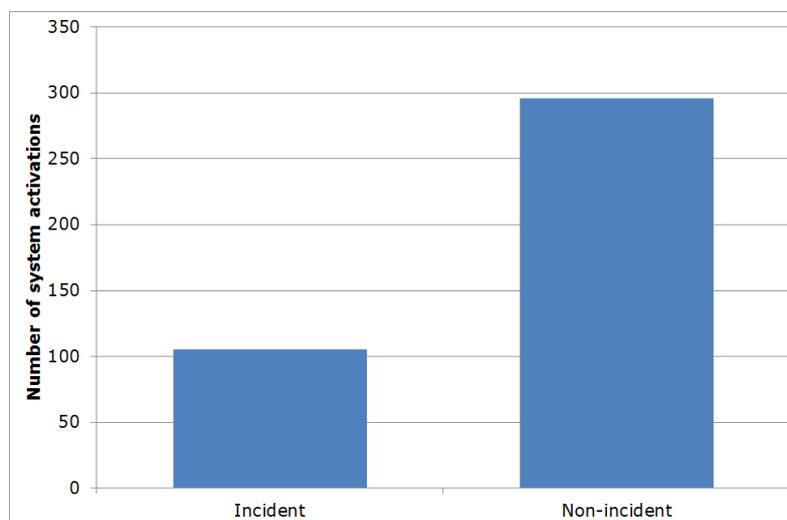
Using the available camera footage, the location of the TOV during each incident was identified. Figure 16 shows the number of system activations recorded split by type.

Figure 16: Number of system activations by type

The majority of the non-incidents occurred when the vehicle was undergoing daily checks (so the beacons were activated) or travelling on link roads accessed via the hard shoulder, hence these were not of interest. There were 105 incidents; of these, incidents were excluded where:

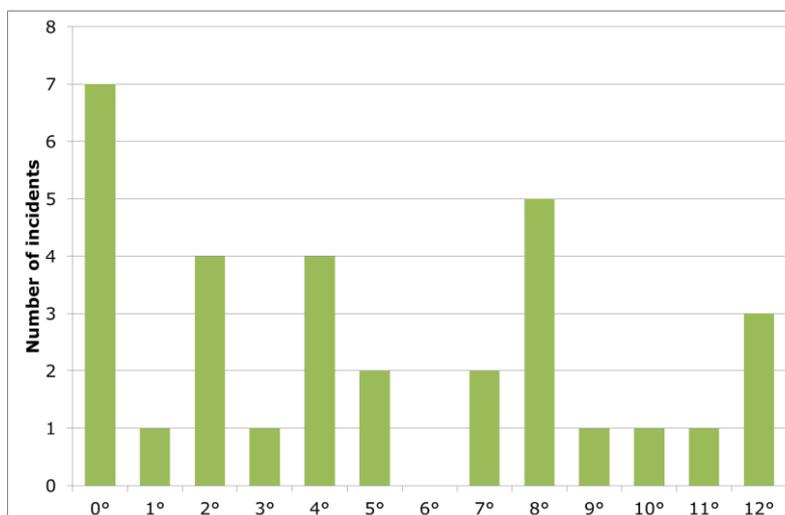
It was possible to analyse estimated fend angles used, although the data available represent only a small sample of the incidents attended by TOVs. Figure 17 provides an indication of the range of fend angles used by TOs when attending an incident. The methods used by TOs to place the vehicle into fend when attending incidents is considered in section 5.1.

Figure 17: Variety of fender angles (degrees) identified (not to scale), and quantities of each orientation recorded

This range shows that 12° is the maximum angle at which the TOVs were parked. Certain road conditions such as an adjacent lane closure, however, may allow the TOV to be parked at greater angles and not encroach on the lane containing passing traffic.

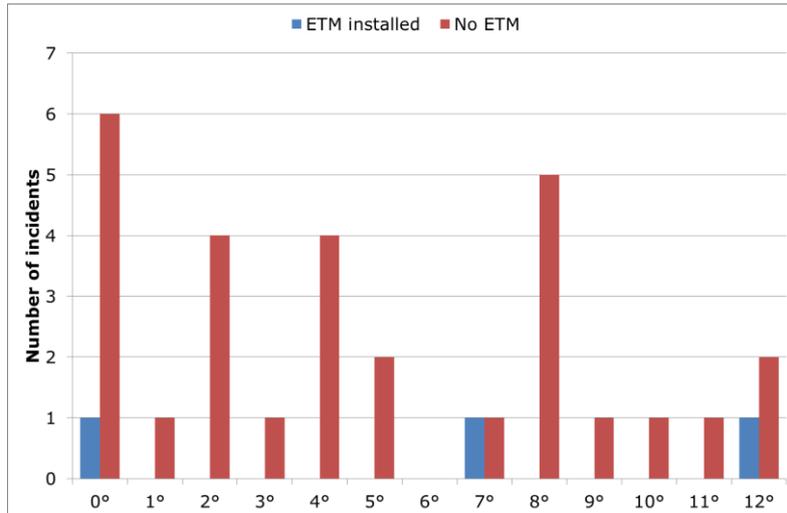
Figure 18: Fend angle selected according to ETM use: ETM deployed (left), no ETM (right)

Given the wide range of fender angles identified, comparisons were made to determine whether these choices were related to factors concerning the incident, such as the vehicles involved or time of day. These comparisons are shown below in Figure 18 to Figure 20.

Figure 18 to Figure 20 suggests that selection of fend angle does not seem to be related to any aspect of the incidents attended.

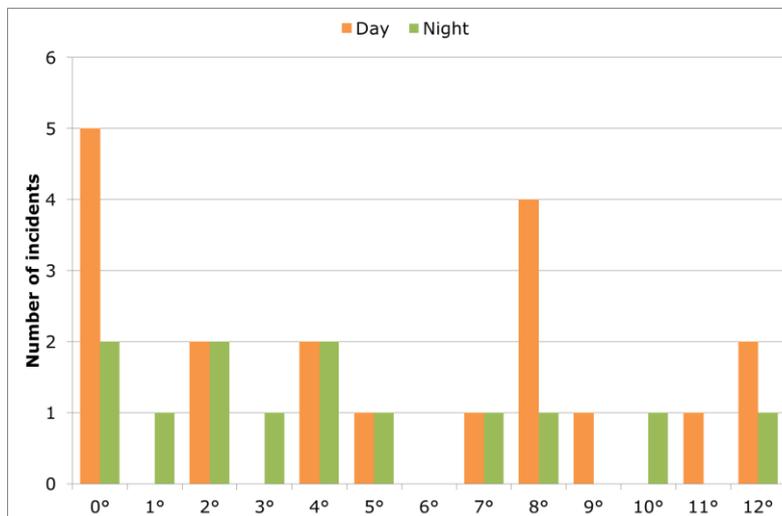
Figure 19: Fend angle selected according to time of day: daytime (left), night time (right)

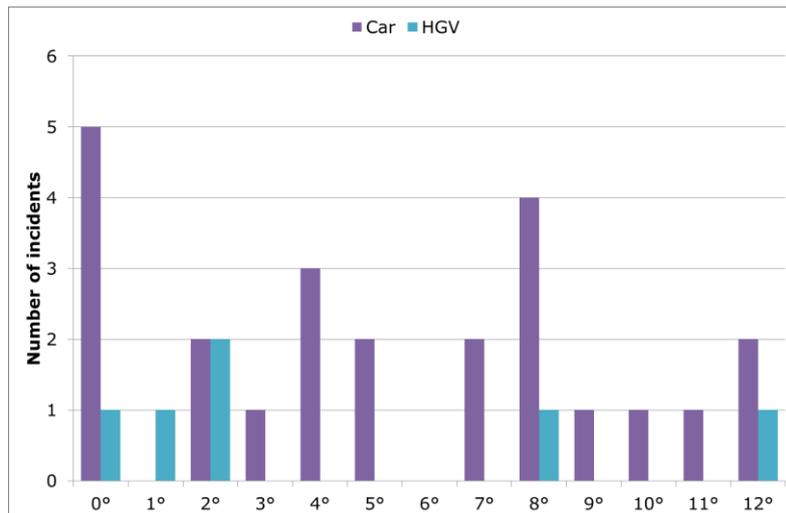
Figure 20: Fend angle selected according to incident vehicle: car (left), HGV (right)

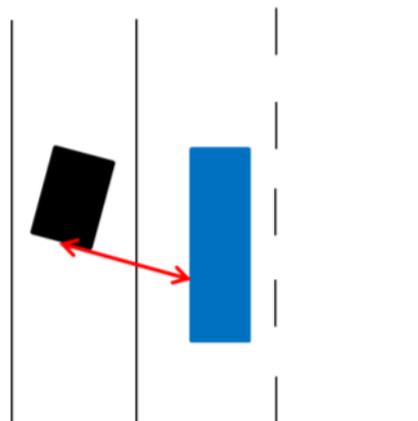
When the vehicle was parked fend off, the distances measured by the laser were as shown in Figure 21.

Figure 21: Laser measurement when parked at fend

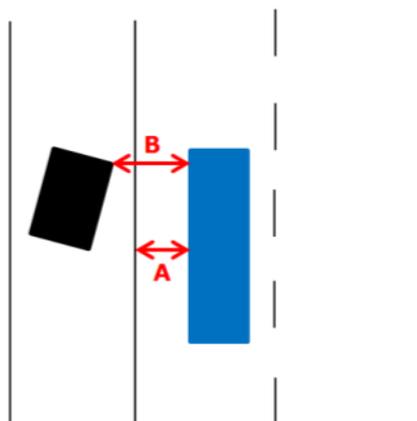
Using trigonometry, the measurements recorded by the laser in each of these incidents were therefore converted into the two measurements shown in Figure 22.

Figure 22: Converted measurements

Distance A is the distance from the rib line to the passing vehicle. Distance B is the distance from the nearest point of the TOV to passing traffic.

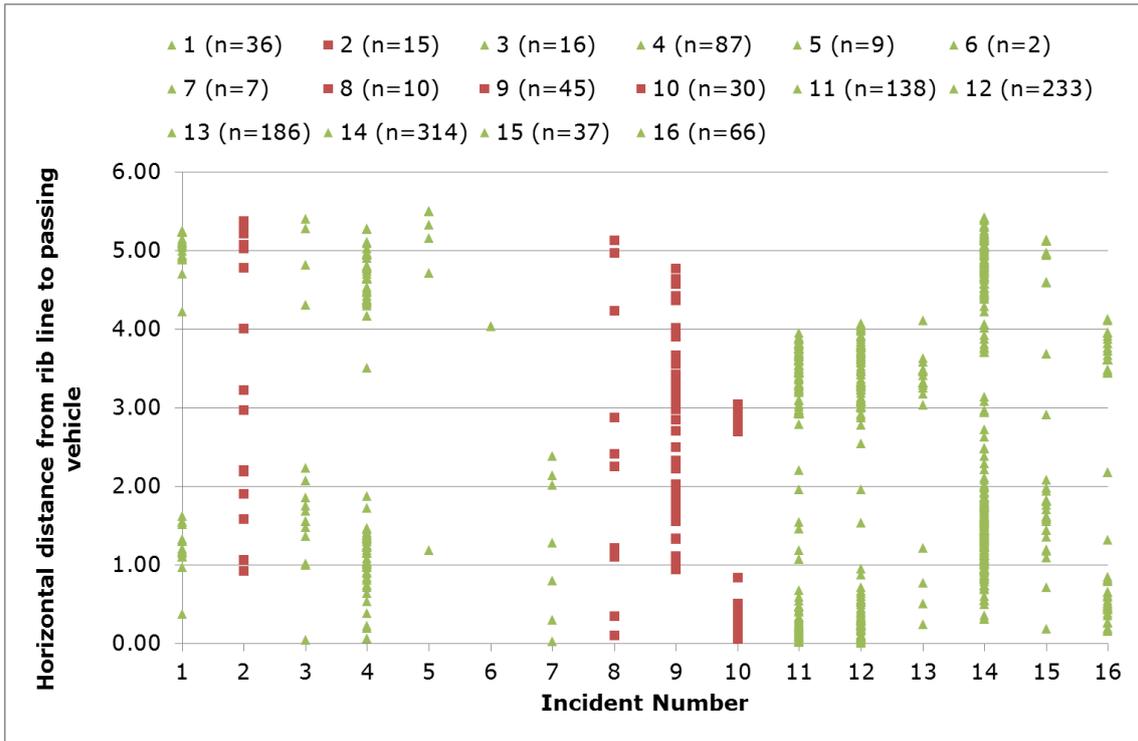
Figure 23 shows the range of distances from the 'rib' line (the line between the hard shoulder and lane 1) to passing vehicles recorded in each incident (distance A). Figure 24 shows the range of distances from the TOV to the passing vehicle (distance B). The legend shows the number of passing vehicles (n) for which measurements were obtained in each incident.

Figure 23: Distance A - horizontal distance from rib line to passing vehicle [parallel = green, fend = red]

A number of the incidents show two distinct groups of distances; these represent the vehicles in the closest two lanes to the TOV.

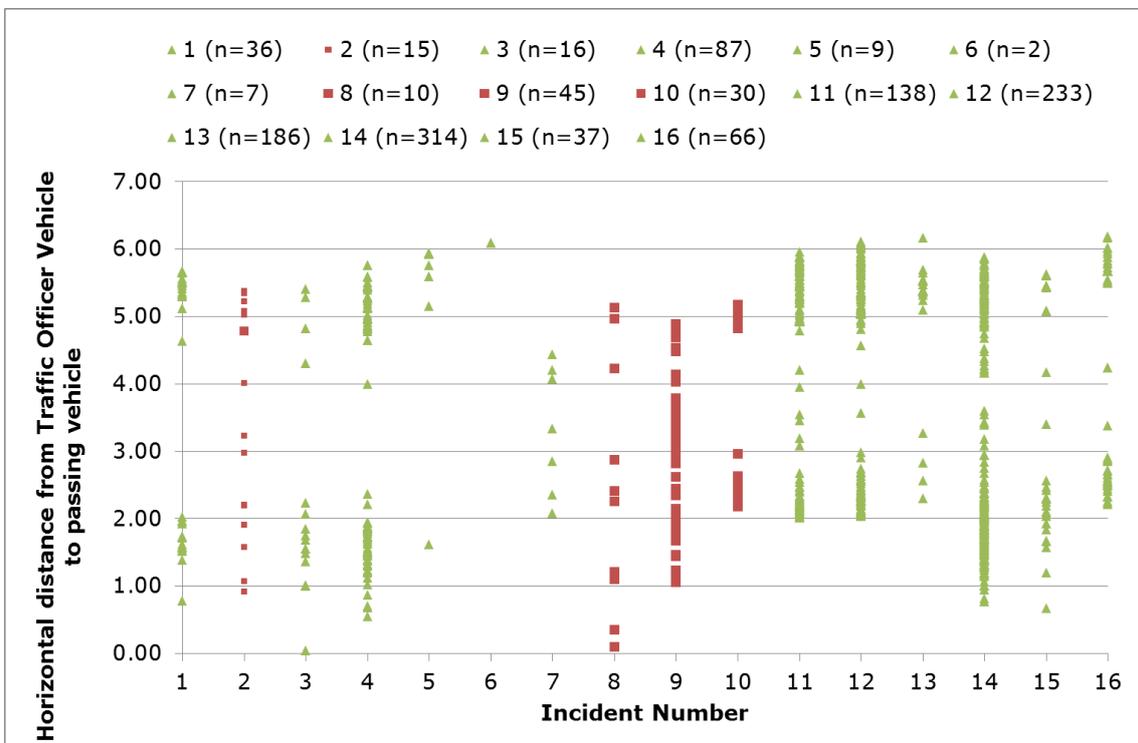
Figure 24: Distance B - horizontal distance from TOV to passing vehicle [parallel = green, fend = red]

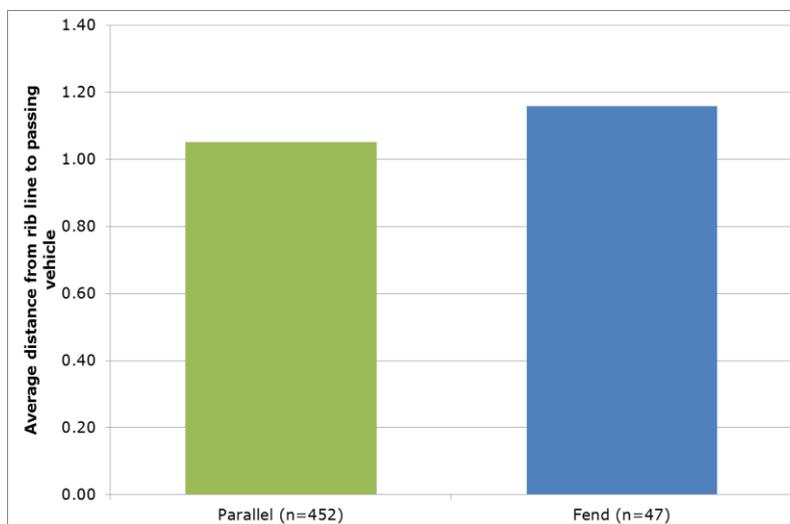
Given that lane widths are typically 3.6m, it was possible to identify those vehicles which were travelling in the lane 1 to the TOV and examine their average distance from the TOV for each of the two fend types. Figure 25 displays the average distance from the rib line to the vehicle passing in lane 1 by fend type. Figure 26 displays the average distance from the TOV to the vehicle passing in the lane 1 by fend type.

Figure 25: Average distance from the rib line to the vehicle passing in the lane 1 by fend type (average distance A)

Figure 25 shows that when the TOV is parked in fend, vehicles in lane 1 were on average further from the rib line separating the TOV from the passing vehicle. Figure 26 demonstrates that when the additional distance to the nearest point of the TOV was incorporated, the average distance was very similar when the TOV was in fend and when it was in parallel. However, given the small sample size, these data are not suitable for statistical analysis.

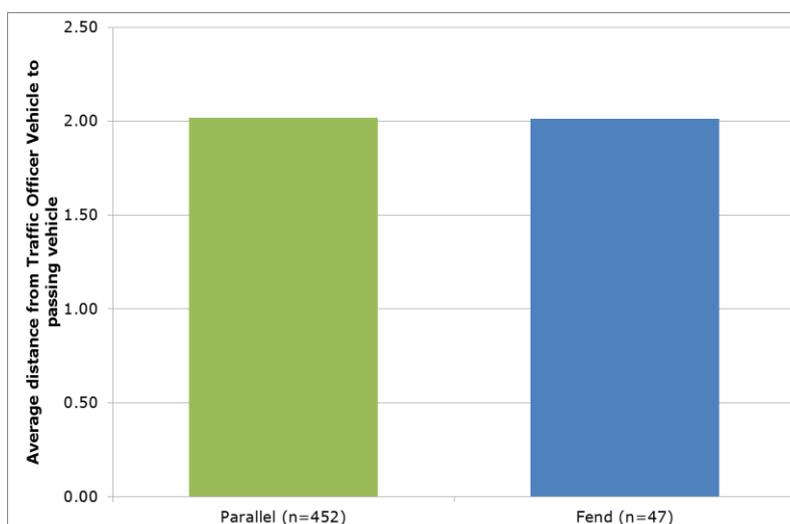
Figure 26: Average distance from the TOV to the vehicle passing in the lane 1 by fend type (average distance B)

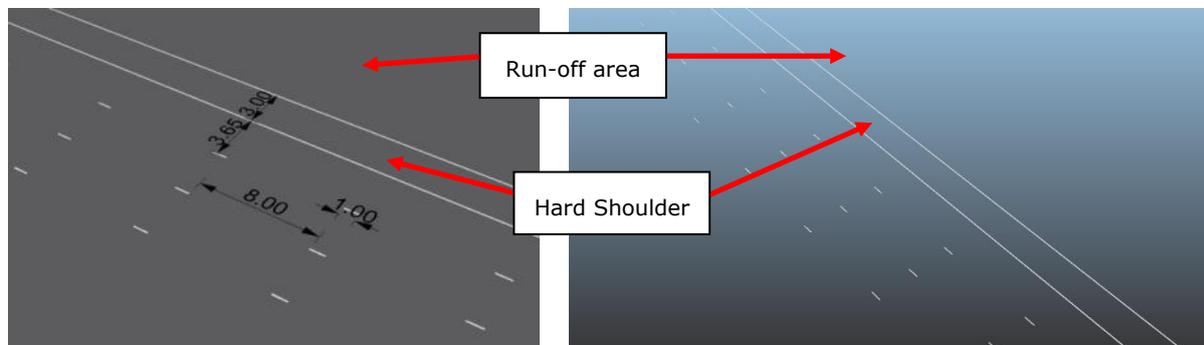
Figure 27: The three-lane motorway with hard shoulder and flat run-off area environment model

The environment model for this project was created to represent a typical three-lane motorway with a hard shoulder. The model was created within the Rhinoceros 3D modelling software. Lanes 1-3 of the motorway were created with widths of 3.65m and the hard shoulder was 3.00m wide. Dashed white lines were used to separate the 'live' traffic lanes. The line lengths were 1.0 metres and the separation was 8.0 metres. Between the hard shoulder and lane 1 a solid white line was used, with a similar solid white line used to highlight the extents of the hard shoulder (Figure 27).

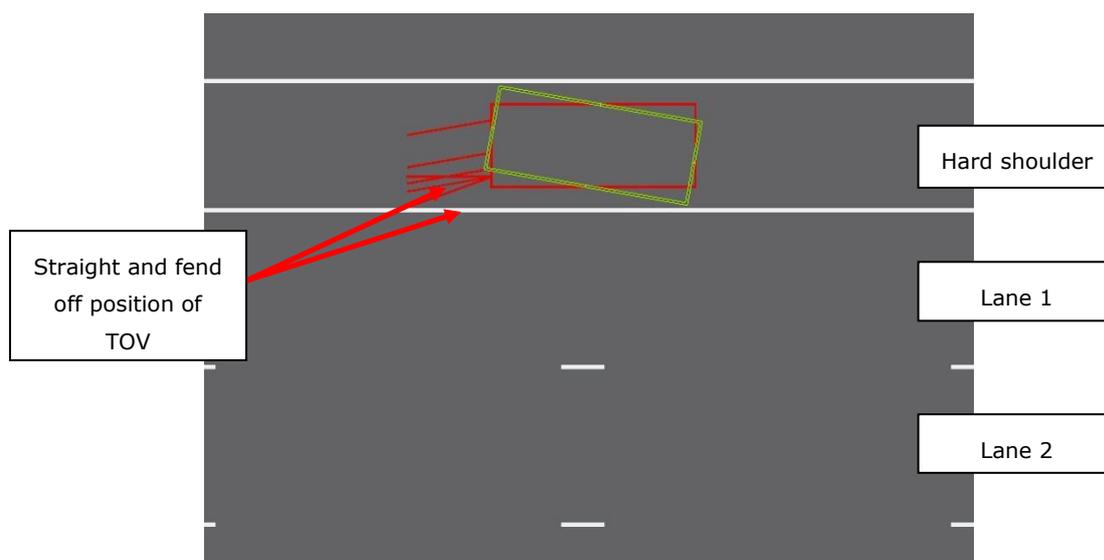
Figure 28: Lines laid onto the surface of the hard shoulder to show the position of the stationary TOV

To help with the alignment of the vehicle models within the HVE environment, lines were added to the surface model to show the orientation and position of the impacting vehicle and the position and orientation of the TOV (see Figure 28). The angle of impact, overlap and angle of the TOV on the hard shoulder will be discussed later.

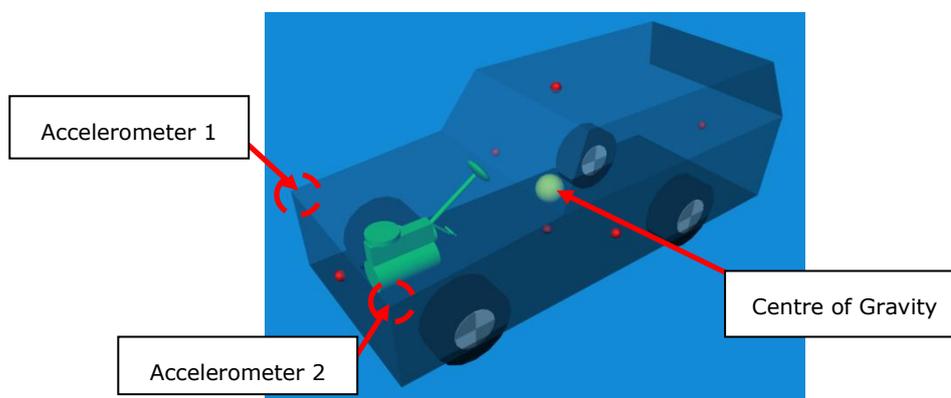
Figure 29: Location of the accelerometers on the TOV model to determine the displacement and orientation of the vehicle post-collision

The deflection and the route of the TOV after the collision formed part of the analysis. To provide a 'map' of the deflection, it was necessary to identify the location of specific points of the vehicle and be able to track these. The X, Y and Z position of the centre of gravity and two further points are required to enable not only the location but the specific orientation of the vehicle to be known. Within HVE it is possible to 'place' virtual accelerometers at specific coordinate locations on the vehicle. Due to the vehicle being impacted at the rear and thus the rear of the vehicle sustaining deformation the accelerometers are placed on the front nearside and offside corners (Figure 29). From these accelerometers it is possible to obtain their location at a specific instant in time.

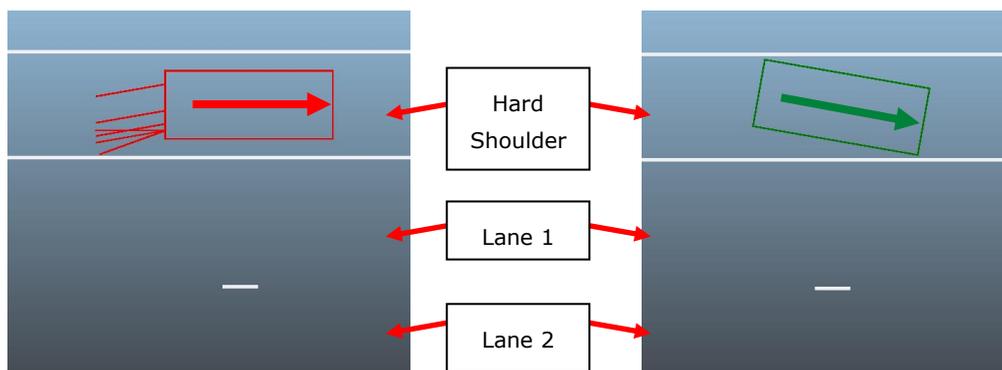
Figure 30: The orientation of the TOV in the straight and fend off position within the hard shoulder

The first orientation of the TOV was such that it was straight within the hard shoulder lane (i.e. parallel to the line of the road) and central (laterally) within its lane. The second orientation was such that the vehicle was angled at 10 degrees to the straight ahead direction in a fend off position (Figure 30). The wheels of the TOV were straight (in the line of the vehicle) with zero steering angle in both vehicle orientations.

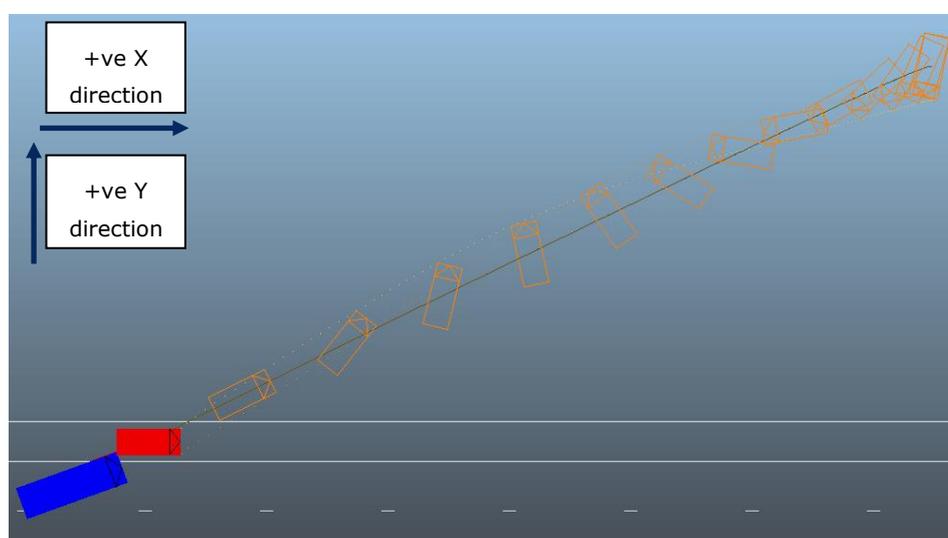
Figure 31: The displacement and track of the TOV following the impact from the lorry when the TOV was straight and the lorry was overlapping by 10% and approaching at an angle of 20 degrees (Run 3)

An example of the output from the simulation is shown in Figure 31. This shows Run 3, where the TOV was positioned straight in the hard shoulder lane, the collision overlap was 10% and the lorry approach angle was 20 degrees. The centre of gravity point of the TOV in Run 3 was displaced approximately 58 metres in the X direction (longitudinal movement along the road) and 28 metres in the Y direction (lateral movement, perpendicular to the road). The total (vector) distance travelled by the centre of gravity of the TOV in Run 3 was approximately 64 metres.

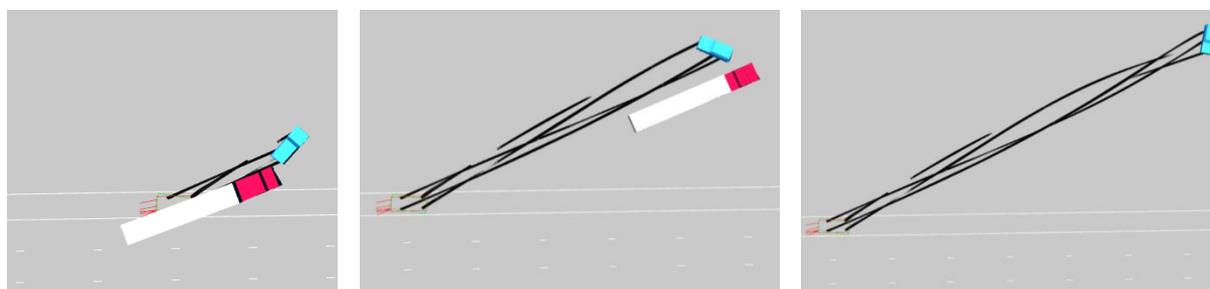
Figure 32: Images of Run 3 from the HVE software, the TOV was stationary and straight in the hard shoulder pre impact

Figure 32 shows the position of the vehicle at various stages of the Run 3 simulation, taken from the HVE software. These can be compared with the vehicle position analysis shown above.

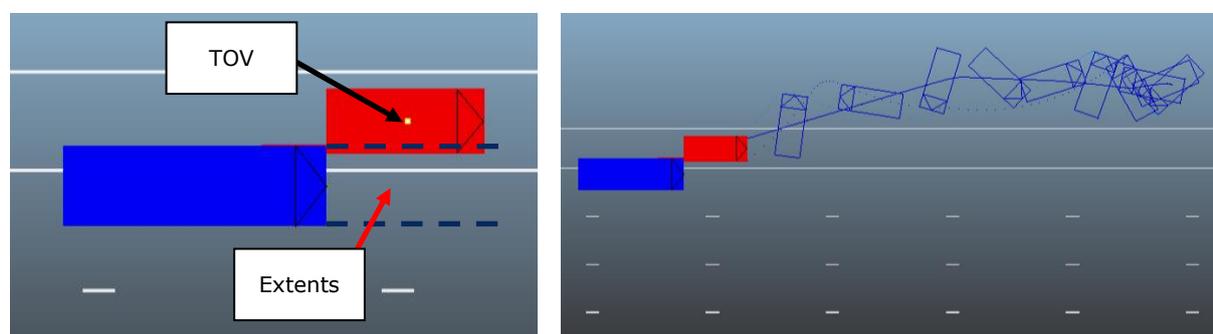
Figure 33: Run 1 simulation configuration showing the alignment of the extents of the lorry and the TOV centre of gravity position

The point of impact on the TOV with respect to its centre of gravity position determines how the vehicle will rotate or displace after the collision. For example if the point of collision is such that the extents of the front of the lorry (thus the direction of force) are not aligned with the centre of gravity of the TOV then it will cause the vehicle to rotate (Figure 33).

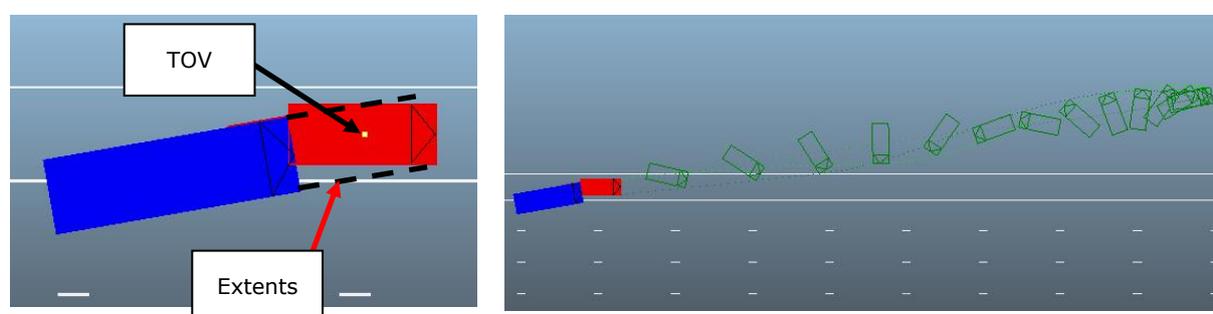
Figure 34: Run 6 simulation configuration showing the alignment of the extents of the lorry and the TOV centre of gravity position

If, however the centre of gravity of the TOV lies within the width of the lorry at impact then the TOV will effectively be 'pushed' in the direction of the lorry (Figure 34). The reason for this is due to how the principle direction of force acts about the centre of gravity of the TOV. When the percentage overlap is low (i.e. Run 1), the exchange of momentum is lower and a larger proportion of the energy from the collision that is transferred to the TOV is then dissipated in its rotation and thus the displacement of the vehicle is lower. Vice versa, when the interaction overlap is larger (i.e. Run 6) a lower proportion of the energy from the collision will be dissipated through rotation, thus the displacement of the TOV will be larger.

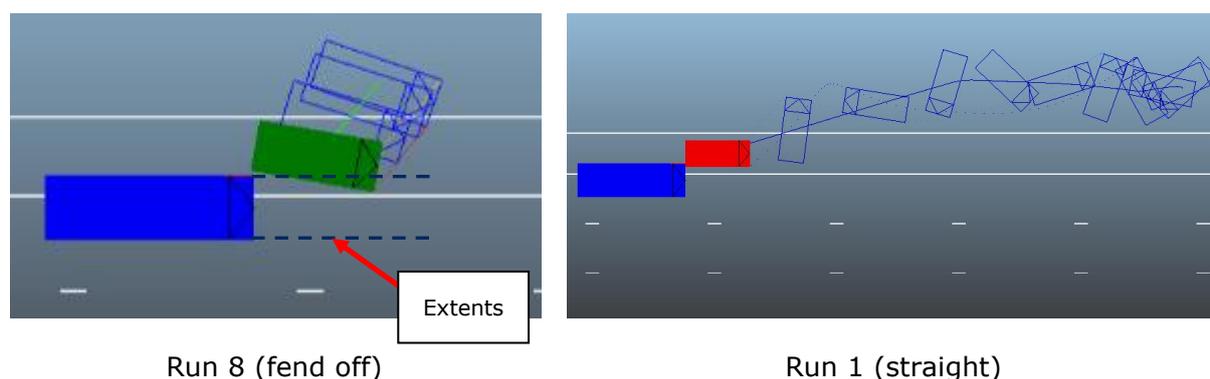
Figure 35: The displacement route of the TOV following the collision with the lorry in Run 8 (fend off) and Run 1 (straight) showing the difference due to the differing impact points

With regard to the simulations when the TOV was parked on the hard shoulder in a fend off position the displacement of the vehicle was found to alter. This was predominantly due to the effect of the point of impact changing. For example Run 1 (straight) and Run 8 (fend off) consisted of the same approach angle and overlap, however, due to the orientation of the TOV the point of impact on the vehicle changed and thus it changed how the TOV was displaced (Figure 35).

In Run 8, it is effectively a glancing contact between the lorry and the TOV, hence the reason for the vehicle appearing to travel sideways post impact. The two dimensional plan of the track and rotation of the fend off TOV post impact are shown in Appendix B. Table 12 shows a summary of the displacement of the centre of gravity of the TOV when it was parked in a fend off position in the hard shoulder for each of the simulation runs.

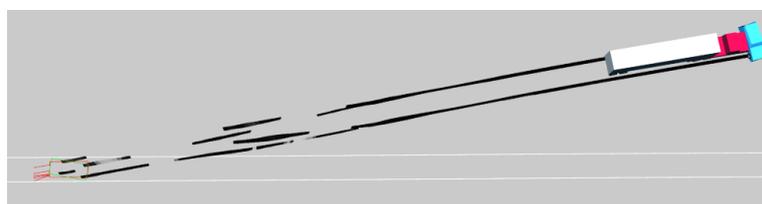
Run 13 (Lorry unbraked)

Figure 36: Comparison of Run 13 where the lorry is unbraked and braked

Run 13 was the impact configuration where it was found that the unbraked impacting lorry continued to push the TOV after the collision. Whilst this is possible, it is more likely that the driver of the impacting vehicle would react to the collision and apply the brakes or at minimum remove any application to the throttle. Consequently, Run 13 was re-run with the brakes of the tractor unit being applied immediately after the collision to remove the secondary contact and the pushing of the TOV by the lorry. This simulation has been termed Run 13A (Figure 36).

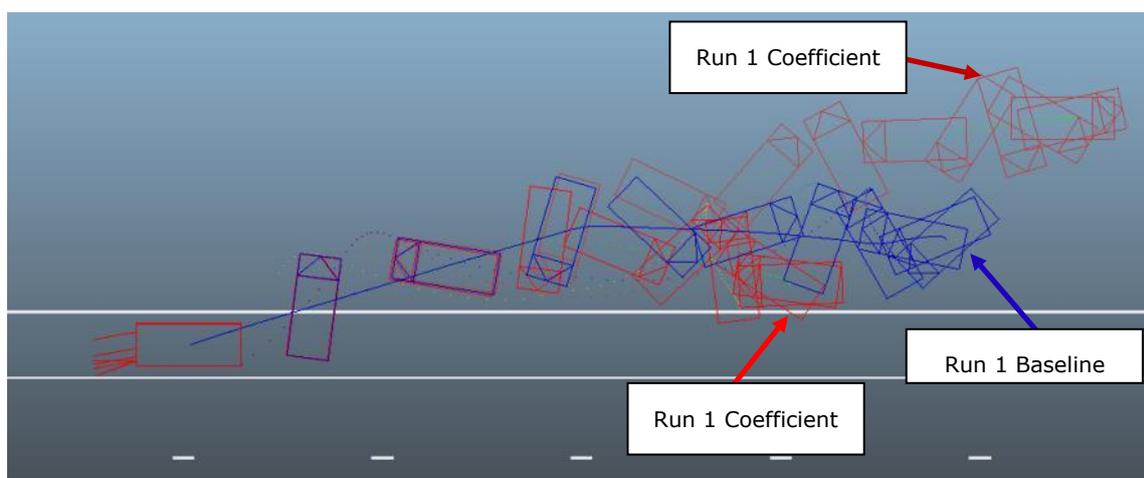
Figure 37: The track and displacement of the TOV in the HVE Simulation in Run 1 showing the effect of a change in coefficient of friction between the tyres and the road surface

The effect of the friction was such that, if the coefficient of friction between the tyres and road surface was increased (i.e. higher level of 'grip') then the TOV would not be displaced as far due to the increased resistance to the locked tyres travelling over the surface. With the coefficient of friction between the tyres and road surface reduced (i.e. lower level of 'grip') then the resistance to the tyres sliding across the road surface is lower and the TOV travels further post-collision (Figure 37). As mentioned earlier in the report a road surface does not have a particular coefficient of friction, as it is a function of the interaction between the vehicle tyres and the road surface. In addition the environmental conditions at the time of the collision are also likely to affect the coefficient of friction between the vehicle tyres and the road surface. If the road surface is dry, wet or icy it will affect the coefficient and thus potentially affect the displacement of the vehicle.

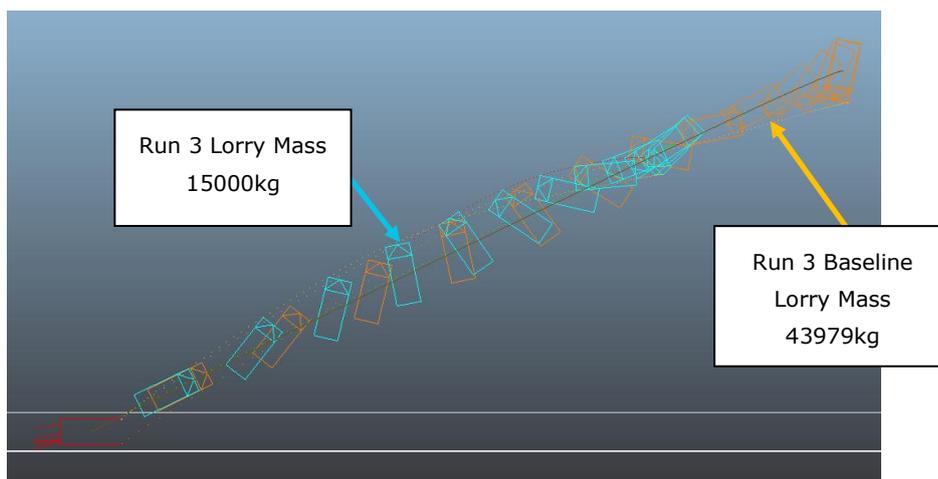
Figure 38: The track and displacement of the TOV in the HVE Simulation in Run 3 showing the effect of a change in mass of the impacting vehicle

The HVE sensitivity analysis simulations showed that when the TOV was stationary on the hard shoulder, reducing the mass of the impacting vehicle resulted in the overall displacement being reduced. This is due to the energy involved in the collision. For example for the baseline tests, the kinetic energy of the lorry immediately prior to the point of collision (approximately 44,000kg and 96km/h) was approximately 15,644kJ. Comparing this with the kinetic energy of the lorry when its mass has been reduced by approximately two thirds to 15,000kg (at 96km/h) the energy of the collision reduces to approximately 5,333kJ. Therefore due to the law of conservation of energy (energy cannot be created nor destroyed, only transferred one form to another), the higher mass lorry has a greater impact energy to impart upon and transfer to the TOV during the collision and thus the TOV will travel further post-collision (Figure 38).

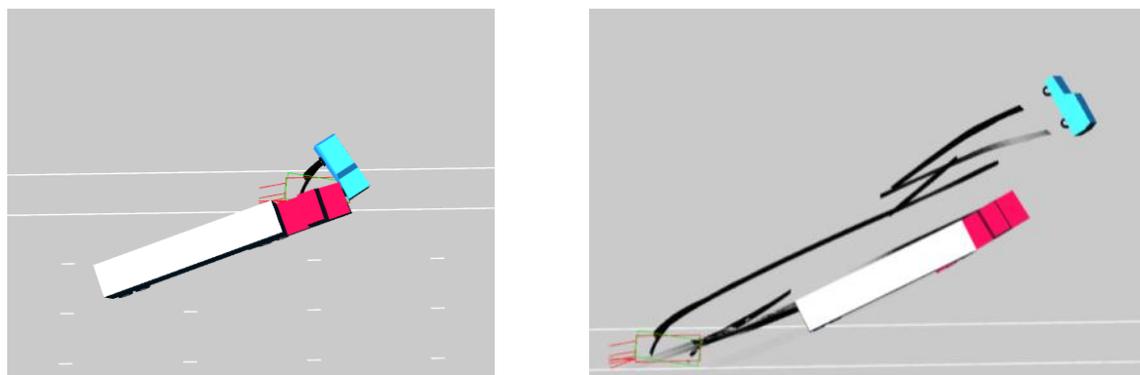
Figure 39: Run 10 with the yaw inertia reduced by 10% showing the vehicle rolling in the HVE simulations

For the Run 10 impact configuration it was found during the simulation that if the yaw moment of inertia (which is a measure of the vehicle's resistance to rotation – in this instance, turning) about the vertical (Z) axis was lowered, the vehicle rolled. For a given amount of angular momentum (i.e. due to the alignment of and collision with the impacting lorry) a reduction in the moment of inertia (yaw inertia) will result in the increase of the angular velocity of the vehicle and thus the speed at which the vehicle spins. In this instance, the vehicle was noted to spin and the unsettling of the vehicle caused the offside wheels to trip and the vehicle to roll. Further work would be needed to consider if this effect is likely to occur with a TOV, as the inclusion of embankments and road side restraints in the 'real world' that would potentially limit this would cause the vehicle to travel along the hard shoulder or be deflected into the live lanes.

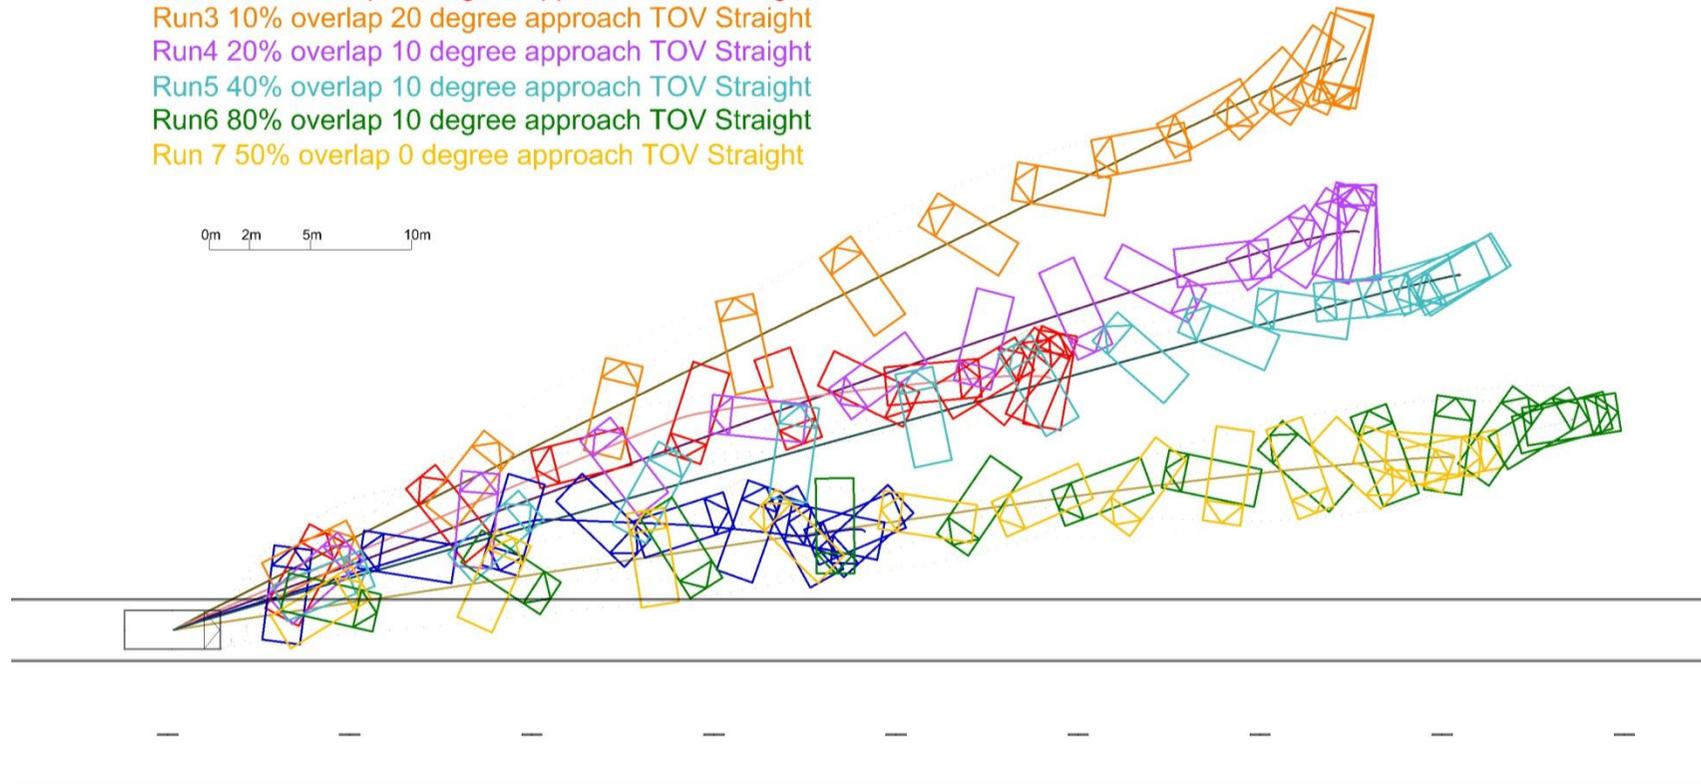
Run1 10% overlap 0 degree approach TOV Straight
Run2 10% overlap 10 degree approach TOV Straight
Run3 10% overlap 20 degree approach TOV Straight
Run4 20% overlap 10 degree approach TOV Straight
Run5 40% overlap 10 degree approach TOV Straight
Run6 80% overlap 10 degree approach TOV Straight
Run 7 50% overlap 0 degree approach TOV Straight

Figure 40: Overlay of the displacements of the TOV in the HVE simulations when the TOV is initially stationary and straight within the hard shoulder

Figure 40 below shows the seven baseline simulation runs performed when the TOV was initially stationary and aligned straight in the hard shoulder. In the HVE simulations in the X direction (i.e. along the carriageway) the maximum displacement of the TOV is approximately 70 metres measured from the front offside corner of the HA vehicle in its pre-impact position to the furthest extent of the vehicle in Run 6. The largest displacement in the HVE simulation of the TOV in the Y direction is approximately 32
