PUBLISHED PROJECT REPORT PPR662

Package Order 001/4/45/12 - Traffic Officer Vehicle Conspicuity

Prepared for: Highways Agency,
Project Ref: Package Order 001/4/45/12

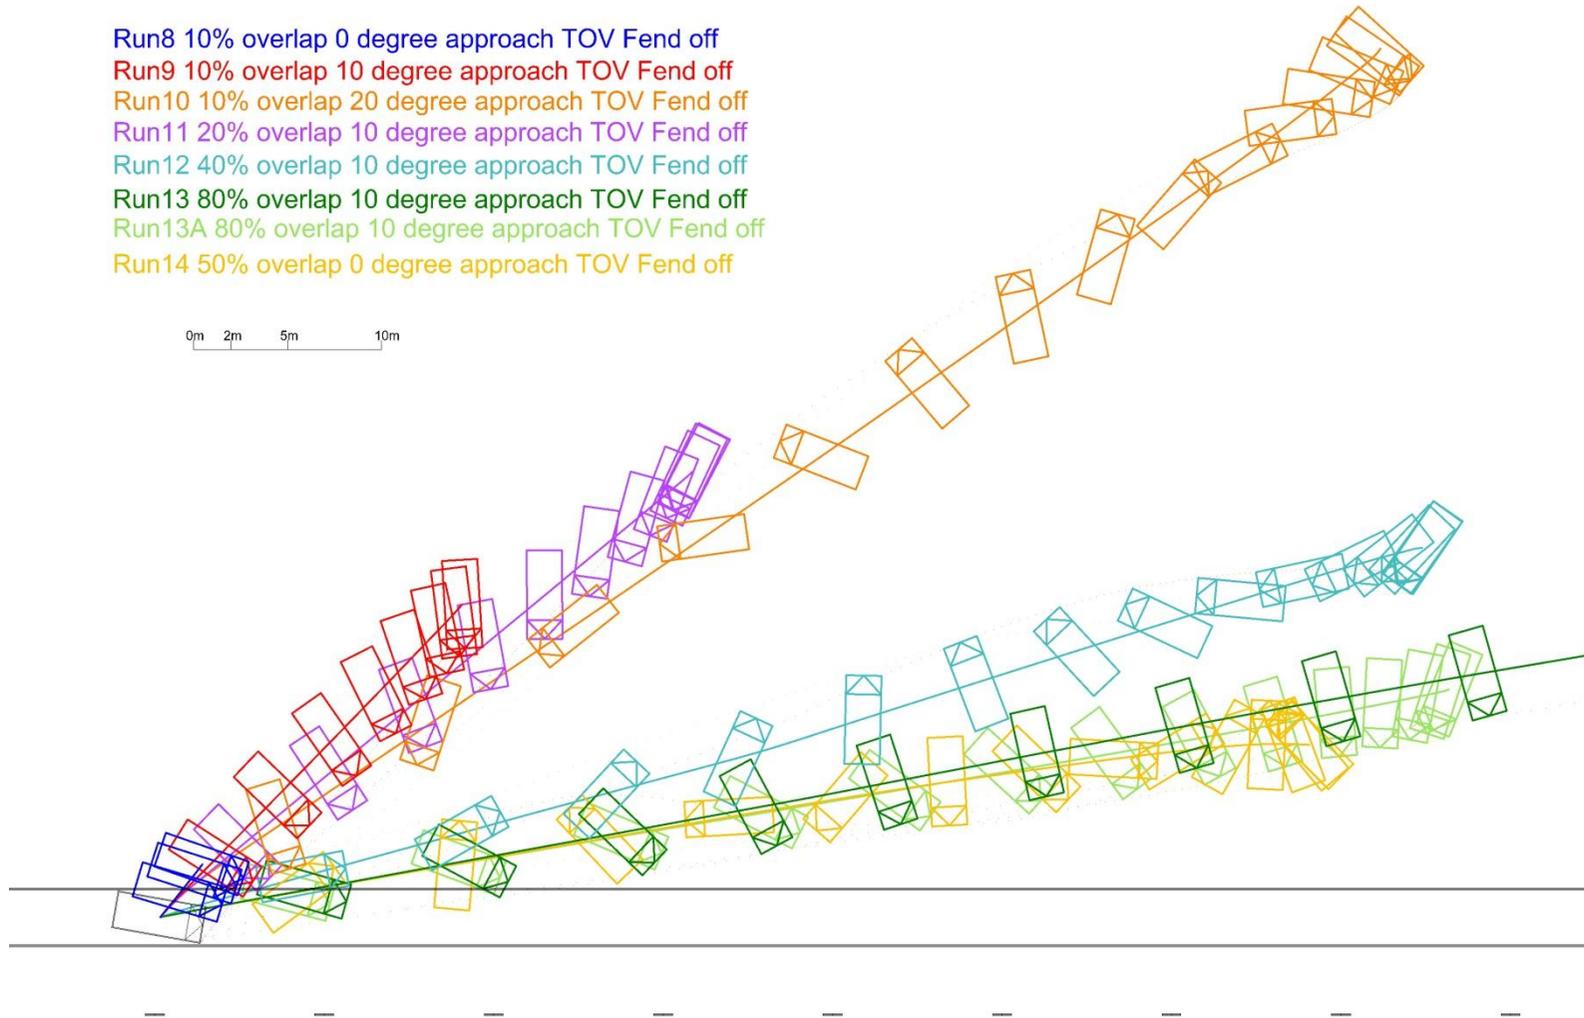
Figure 41: Overlay of the displacements of the TOV in the HVE simulations when the TOV is initially stationary and in a fend off position within the hard shoulder

Figure 41 shows the eight baseline simulation runs performed when the TOV was initially stationary and in the fend off position. The additional run (Run 13A) is included and shows the displacement of the TOV when the lorry is braked and does not have a secondary impact as is the case in Run 13. In the HVE simulation the maximum deflection in the X direction when the TOV is initially in the fend off position was approximately 70 metres (not including the Run 13 where the TOV was 'pushed' by the unbraked lorry) measured from the front offside corner of the HA vehicle in its pre-impact position to the furthest extent of the vehicle in Run 13A. The largest displacement based upon the results from the HVE simulation of the TOV in the Y direction was approximately 50 metres measured from the front offside corner of the TOV in its pre-impact position to the furthest extent of the vehicle in Run 10.

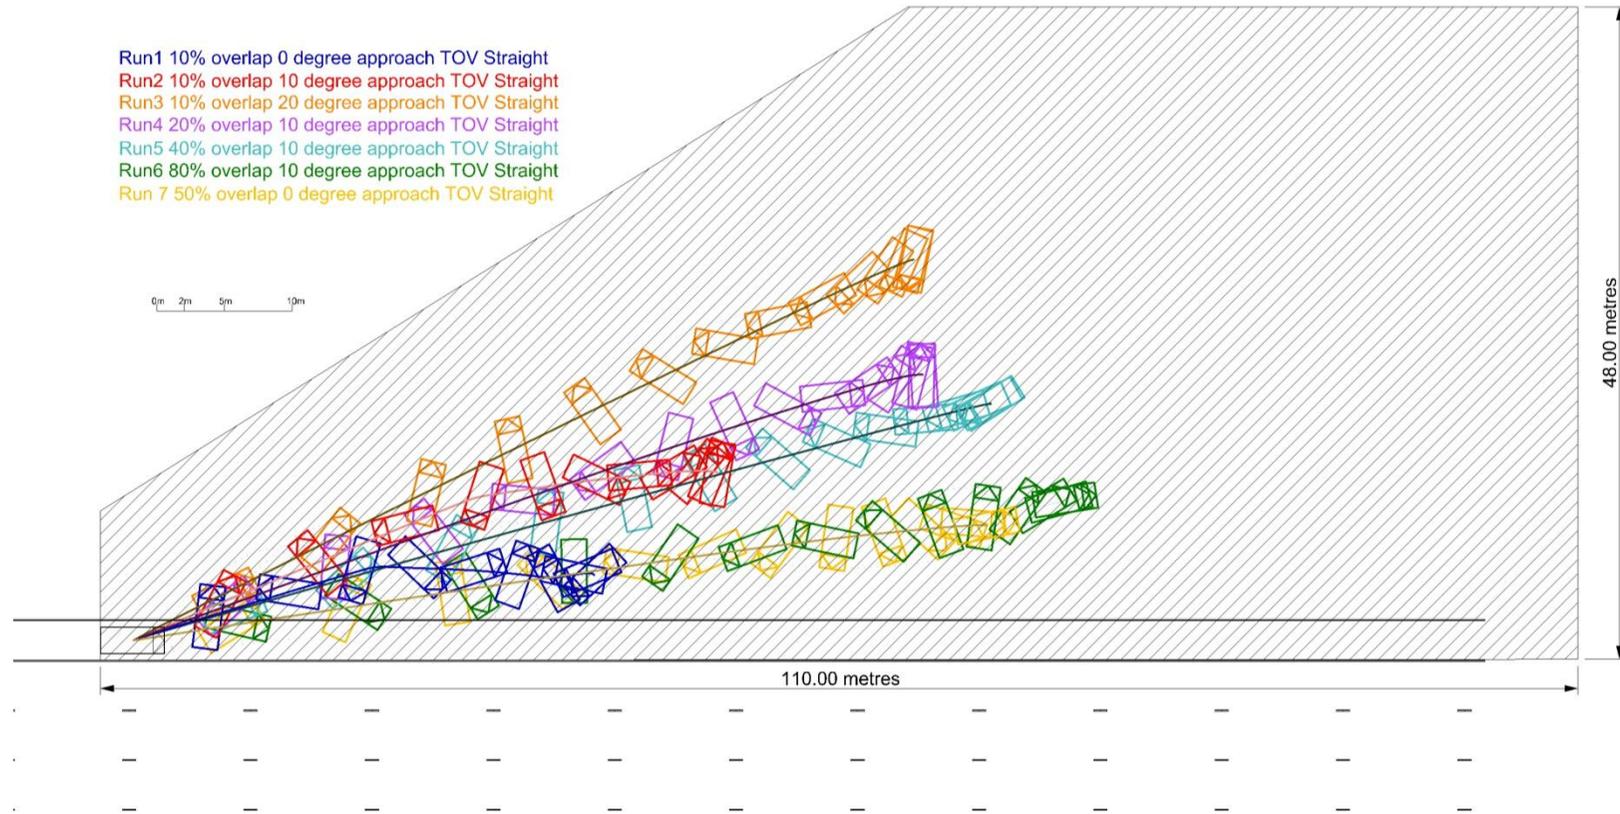
Figure 42: The area including a margin of safety believed from the simulation analysis to be unsafe for a person to stand within when the TOV is stationary in a straight orientation.

As mentioned previously, in the simulations with the TOV in the fend off position if the collision configuration is such that the impact is glancing (i.e. Run 8) then the TOV is displaced in a sideways direction. Consequently it is not recommended that any person stand forwards of the rear of the vehicle, irrespective of how the TOV is orientated. Therefore, any zones believed to be unsafe for a person to stand within should also include the length of the vehicle. This increases the X direction of the zone to approximately 110 metres (Figure 42 and Figure 43).

- From the analysis and based upon the HVE simulations it was possible to create an area that would not be advisable for people to stand in when the TOV is stationary. Incorporating a margin of safety, this area extended from the rear of the vehicle forwards approximately 110 metres and to approximately 75 metres to the side of the vehicle. Therefore, it is recommended that a 100m zone should be established whenever possible.
- The effect of the steered wheels made little difference to the overall travel distance of the TOV and was within the range of the values shown in the sensitivity analysis, so guidance on wheel orientation should be removed from TOS procedures.

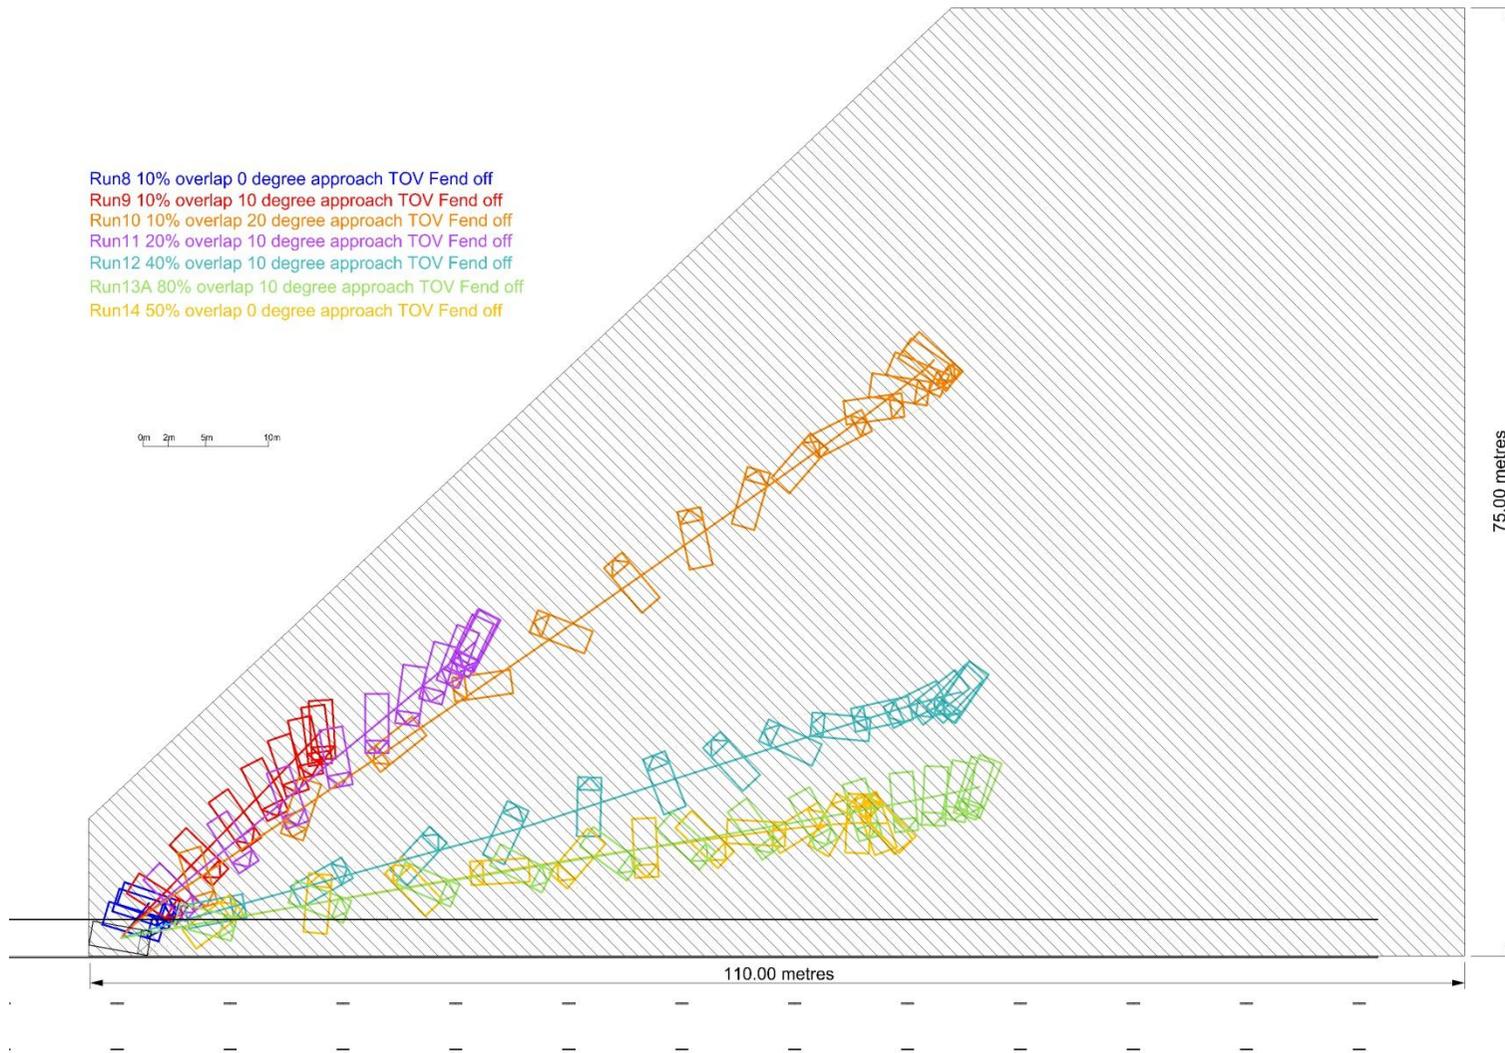
Figure 43: The area including a margin of safety believed from the simulation analysis to be unsafe for a person to stand within when the TOV is stationary in the fend off position.

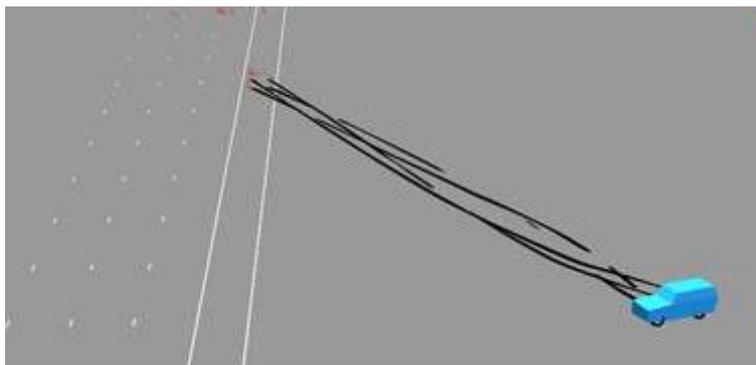
Figure 44: Steered wheels angled towards the live lanes (offside of the vehicle)

It is known that when parked it is possible for the steered wheels of the TOV to be at angles other than straight ahead (i.e. steering wheel angle not zero). As part of the HVE modelling, Run 3 (where the TOV was straight in the hard shoulder) was re-run with both a positive and negative steering angle on the front axle of the TOV. The angle of the front wheels was changed so that it represented a wheel angle of approximately 16 degrees which, in the 3D model, represented approximately 280 degrees of steering wheel angle. The images below show the trajectory and travel path of the TOV with and without the steering angles applied.

It was found that, at the simulated collision speed of approximately 60mph and where it was impacted with a model of a 44t lorry, the effect of the steered wheels made little difference to the overall travel distance of the vehicle and was within the range of the values previously shown in the sensitivity analysis.

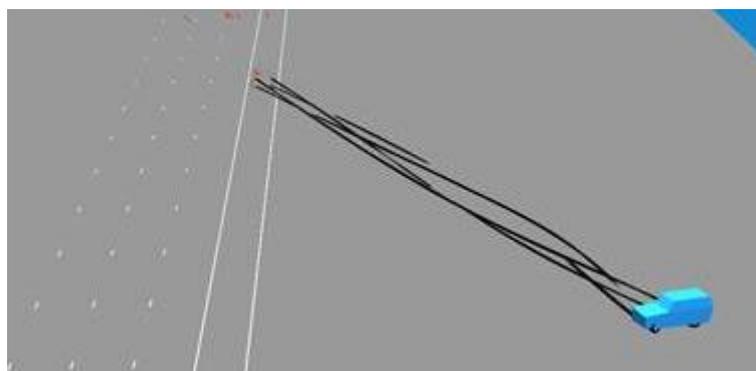
Figure 45: Steered wheels angled towards the nearside of the vehicle

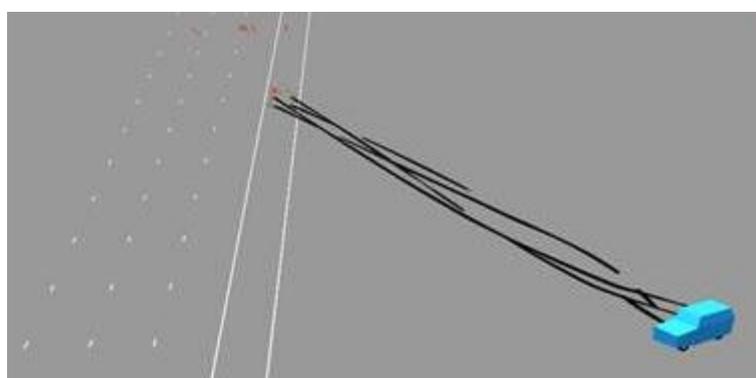
Figure 46: Zero steering applied (i.e. steered wheels in-line with the vehicle)

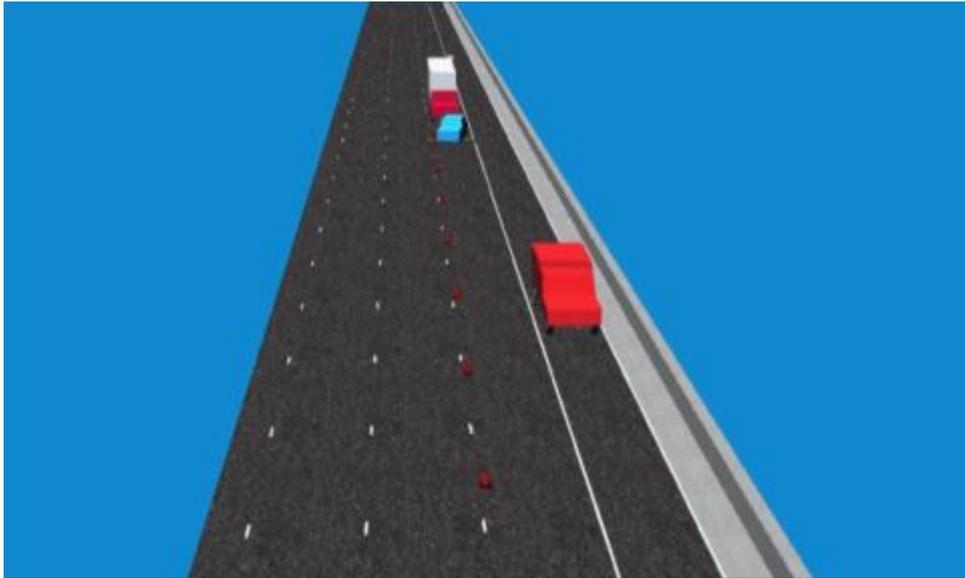
Figure 49: Simulation 1; HGV continues straight ahead, 1s braking prior to impact

Both of these simulations graphically demonstrate how far both the errant (impacting) and impacted (TOV and recovery) vehicles might travel along the carriageway as a result of the collision, with implications for any pedestrians present at the scene.

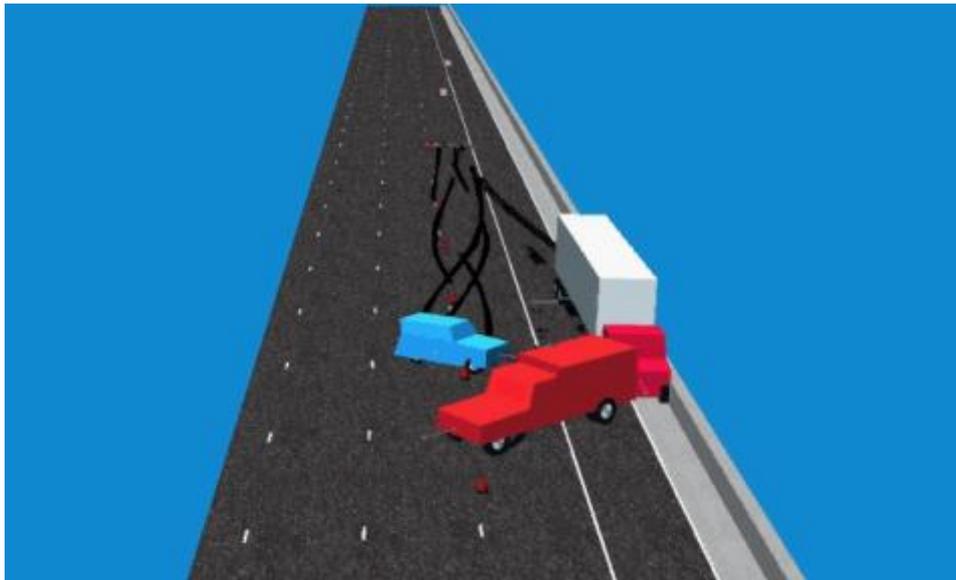
Figure 50: Simulation 1; final positions of vehicles

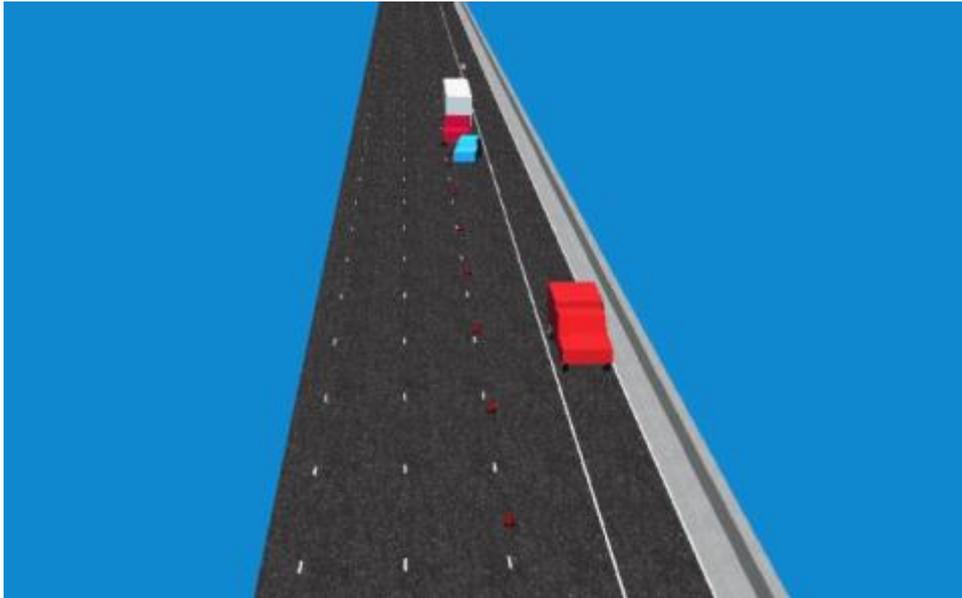
Figure 51: Simulation 2; no braking, HGV swerves

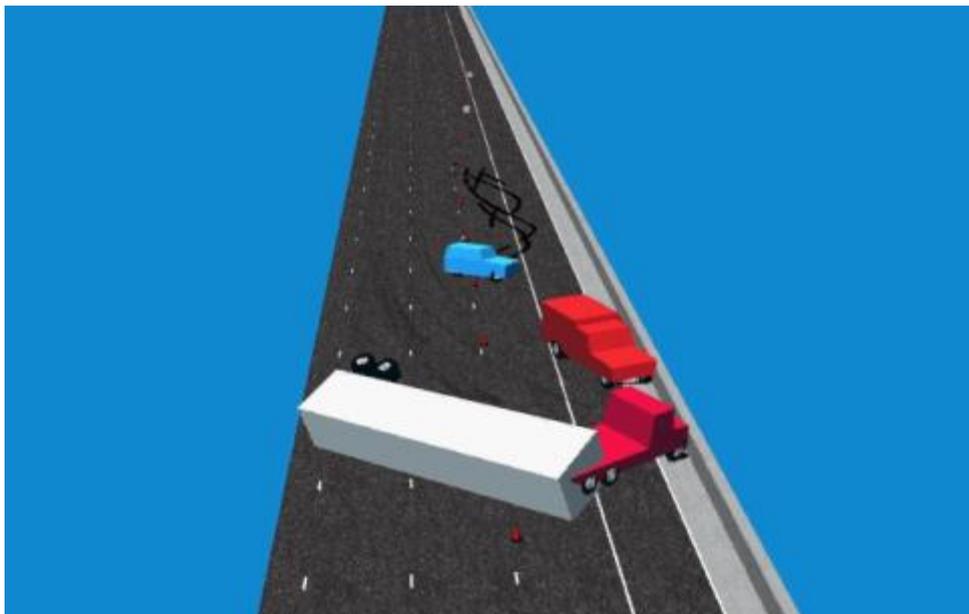
Figure 52: Simulation 2; final positions of vehicles

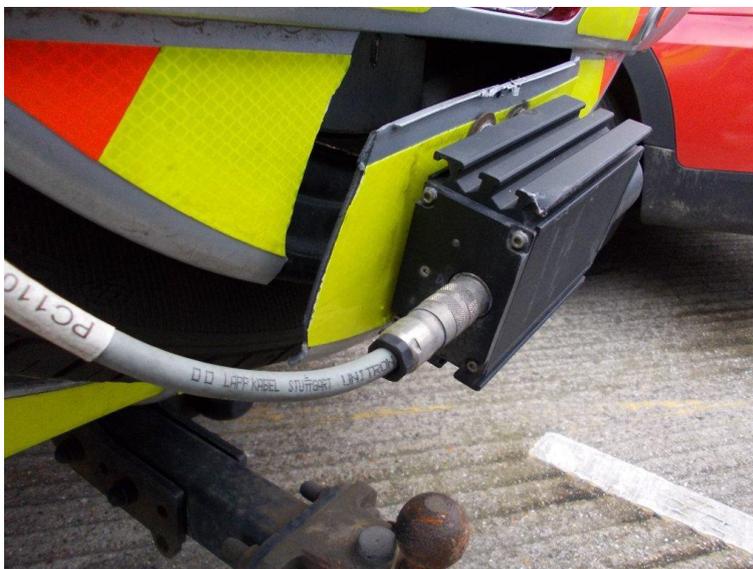
Figure 53: Laser distance measurement equipment, post-impact

In January 2013 the instrumented TOV was involved in a further event while in attendance at an incident, also on the M6, but on this occasion the vehicle was impacted and suffered extensive damage. The damage was deemed beyond economic repair, leading to the TOV being written off (meaning the system could not be recalibrated). The main contact point was the laser distance sensor mounted to the rear of the vehicle. This incident occurred after the project trials had ended data collection and so, unfortunately, no video was obtained.

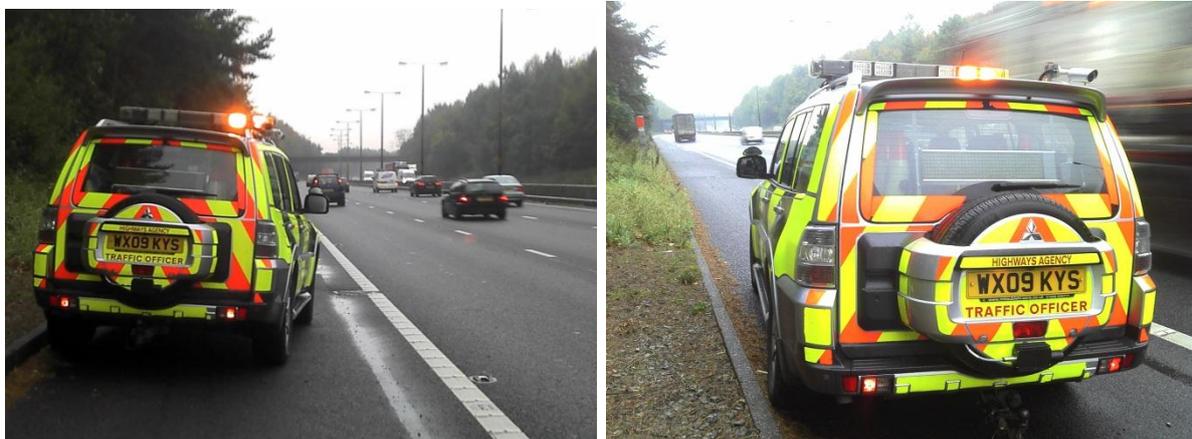
Figure 54: TOV parked in fend off orientation; note proximity of front offside wing to live lane and front wheels steered to left (TOV was reversed into fend)

In both these cases, the limited space available within the hard shoulder restricts the driver's ability to return the TOV's front wheels to be in line with the vehicle unless this is done with the vehicle stationary, potentially damaging the vehicle or roadway. Also, if those wheels are placed in line with the vehicle, unless they are steered back toward the hard shoulder then the vehicle will have to leave the hard shoulder directly into the live lane.

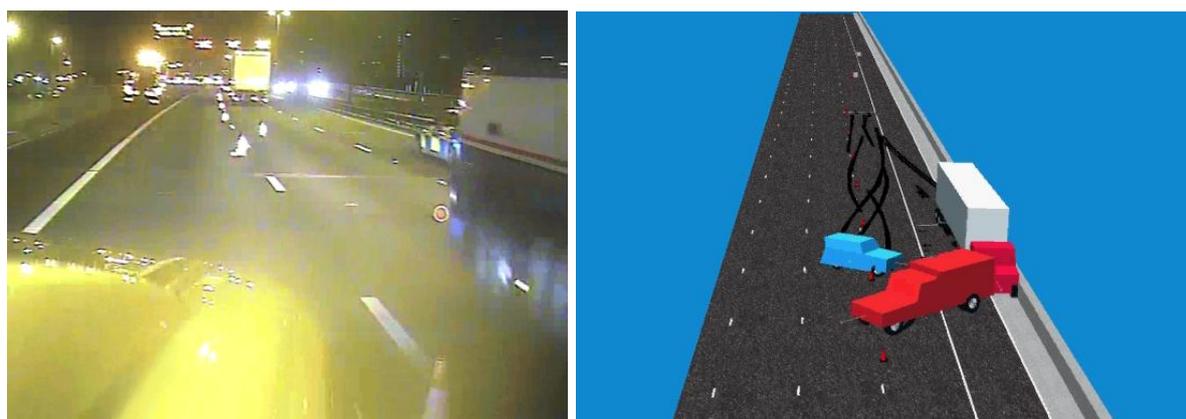
Figure 55: Left: M6 near miss incident ETM, with 50m safety zone; right: simulation 1 post-impact vehicle locations

Workstream 2 has identified that a TOV positioned in conformance with TOS procedures 50m upstream of an incident may, if subjected to a high-energy impact, be propelled through the current 50m 'safe' zone and into the incident and working space.

Furthermore, having identified that a parked TOV could be propelled over 70m, Workstream 2 suggests that, after applying a 50% safety factor, the 'at risk' zone extends up to 110m from the TOV's location (rounded to 100m).

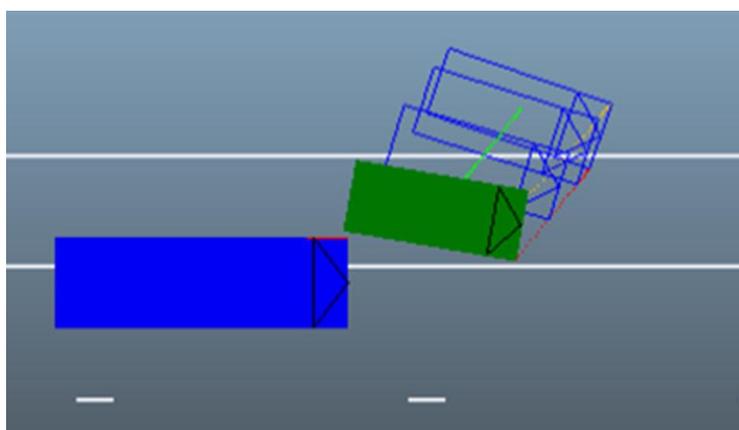
Figure 56: Simulation Run 8 (fend off), displacement route of the TOV following the collision

The displacement diagrams generated from the impact simulations clearly show the areas in which pedestrians are at risk of being hit by a displaced TOV. Perhaps unexpectedly, these areas extend back alongside the parked TOV (it is known that the TOs attending the M6 incident were both stood adjacent to their TOV).

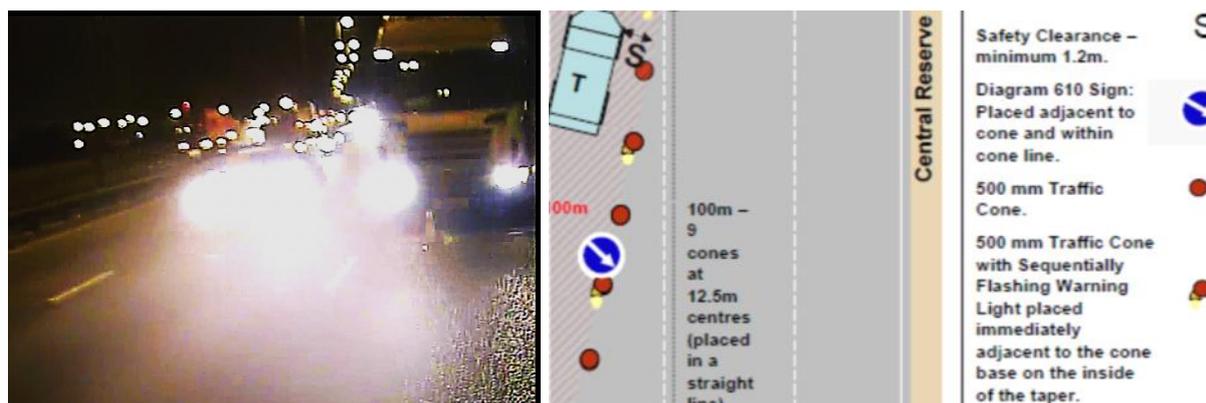
**Figure 58: Left: near miss video screenshot, - ETM cone impact
Right: extract from TOS procedures for ETM layouts, - 1.2m safety clearance**

For live lane parking fend parking, there may be distinct advantages beyond those described in the previous interim report (Palmer et al., 2012). This is shown from careful examination of the near miss incident video, which shows how close the HGV approached the TOV. As can be seen in the image below, the ETM cone is impacted over half way across the HGV's width. These cones are placed in a straight line to pass 1.2m from the parked TOV (the full ETM layout diagram is given in Appendix B). In this incident, the use of the fend off orientation may have provided just enough additional clearance to allow the HGV to pass without impacting the parked TOV.

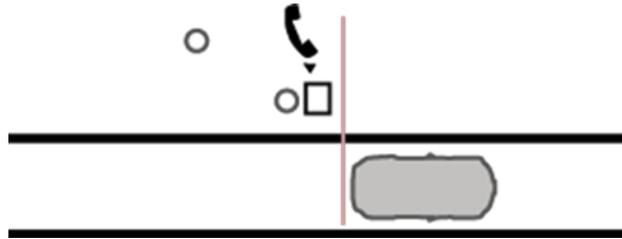
Figure 61: Parking relative to emergency telephones and safer pedestrian locations when stopped on the hard shoulder or in a live lane

This project, particularly from the extensive impact simulations, has identified that substantial revisions of the TOS procedures may be required, and that the same simple advice ("stand in a place where you are off the carriageway and can see the rear of your vehicle") is equally applicable to all people, whether professionals such as the TOS, road workers, etc. who are on the roadside as part of their work, or road users who find themselves on the hard shoulder with their broken-down vehicle.

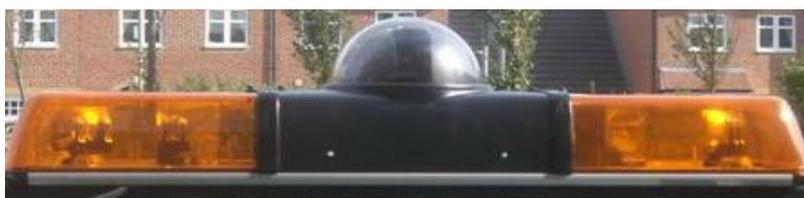
Figure 62: CCTV camera 'dome' integrated into Premier Hazard light bar

Premier Hazard supply a range of in-vehicle CCTV systems, including the option of a remotely-controlled camera integrated into the vehicle's roof-mounted lighting bar (Figure 62). Their multi-camera systems are able to provide live streaming of video, whilst within the vehicle a hard disk recorder and mirror recording to SD cards provide data security.

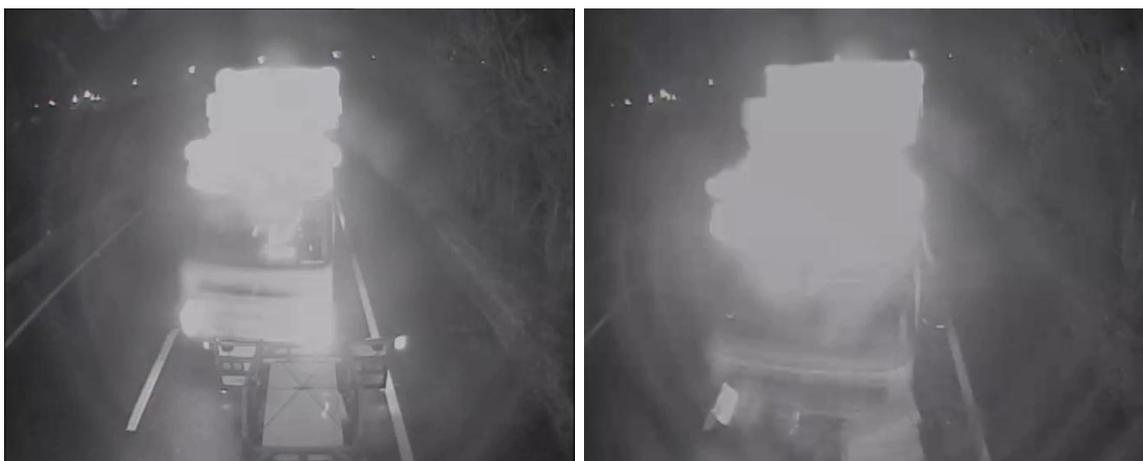
Figure 66: Rear view from a camera installed above the crash cushion, views immediately prior to and after impact

Colas is involved with the traffic management industry and wished to increase the safety of their crews while they are engaged in deployment and retrieval of traffic management signs etc. They have been involved with the development of a multi-camera system with live streaming ability, but with the recent enhancement of a two-stage warning system which utilises Bosch video analysis software to identify vehicles encroaching into predetermined 'at risk' zones behind the Traffic Management Impact Protection Vehicle (TMIPV). If the system identifies approaching vehicles within those zones, additional warning beacons are displayed to the rear and the TM crew are given warnings of imminent impact. An early version of this camera system, prior to the development of the driver and crew warning element, captured several video sequences documenting a high-speed impact from an HGV while the TMIPV was stationary in a live lane during the retrieval of road works advanced warning signs (see Figure 65 and Figure 66).

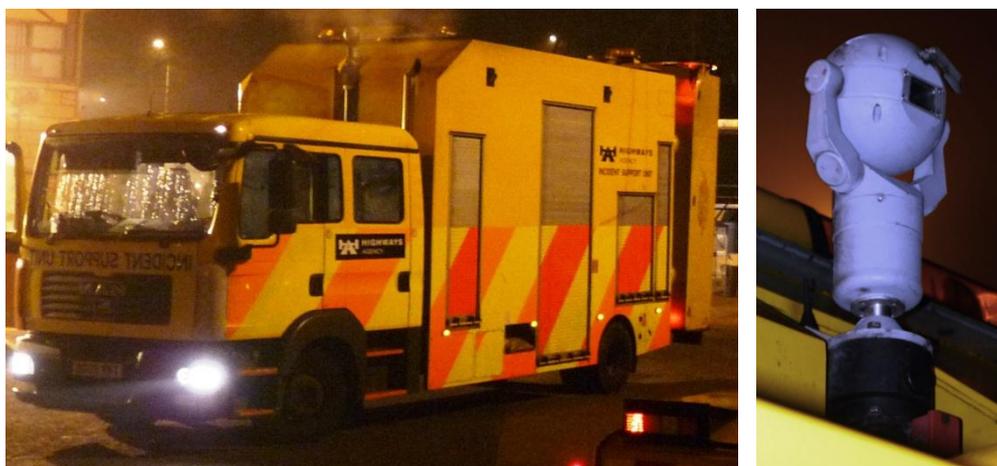
The HA has installed CCTV on a number of Incident Support Units (ISUs), but it is not known whether this equipment has been used at incidents.

Figure 68: Incident Support Unit, with CCTV camera mast installed behind the cab

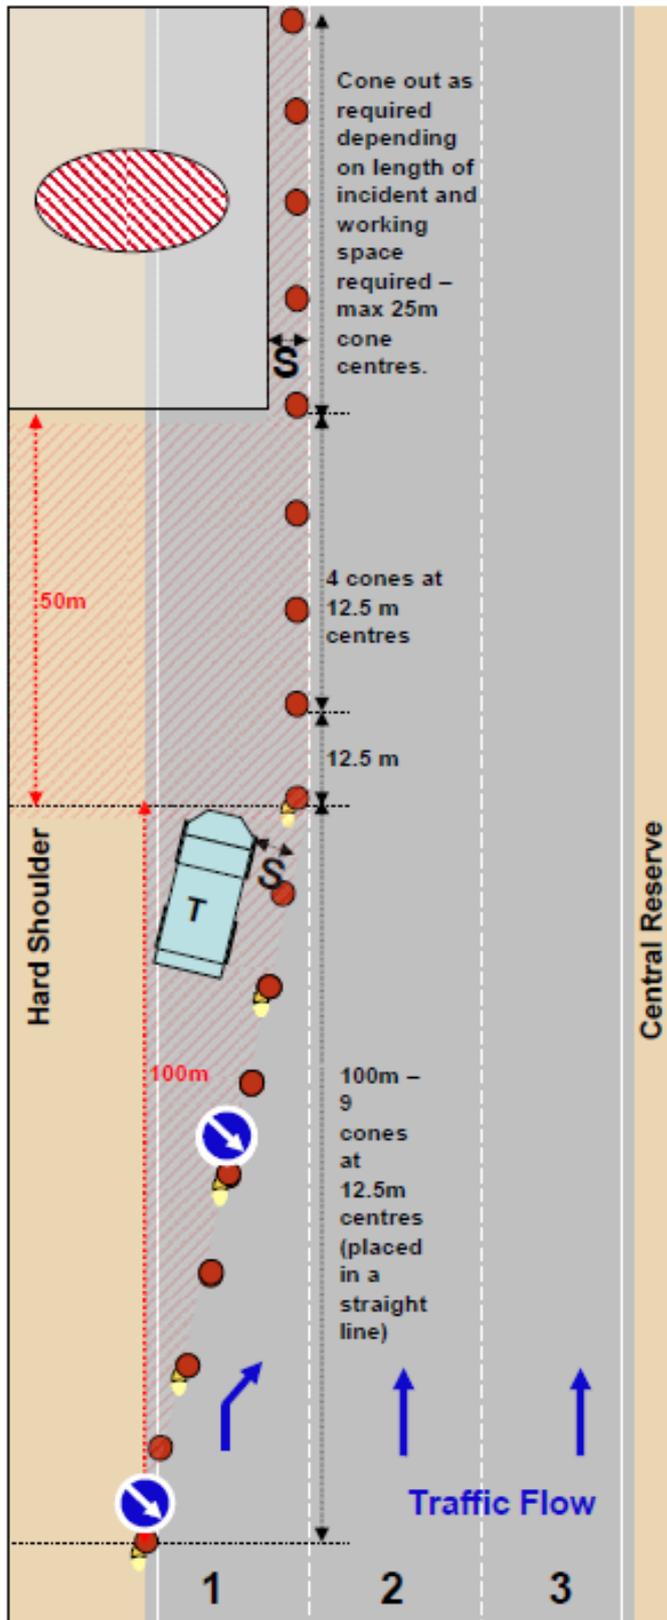
Appendix B Traffic Officer Manual Version 3.2. Extract: ETM Diagram 2 (V10) Lane 1 Closure
