DrainFix

**INVESTIGATION
REPORT**

EXAMPLE SUMMARY

Drainage investigation summary

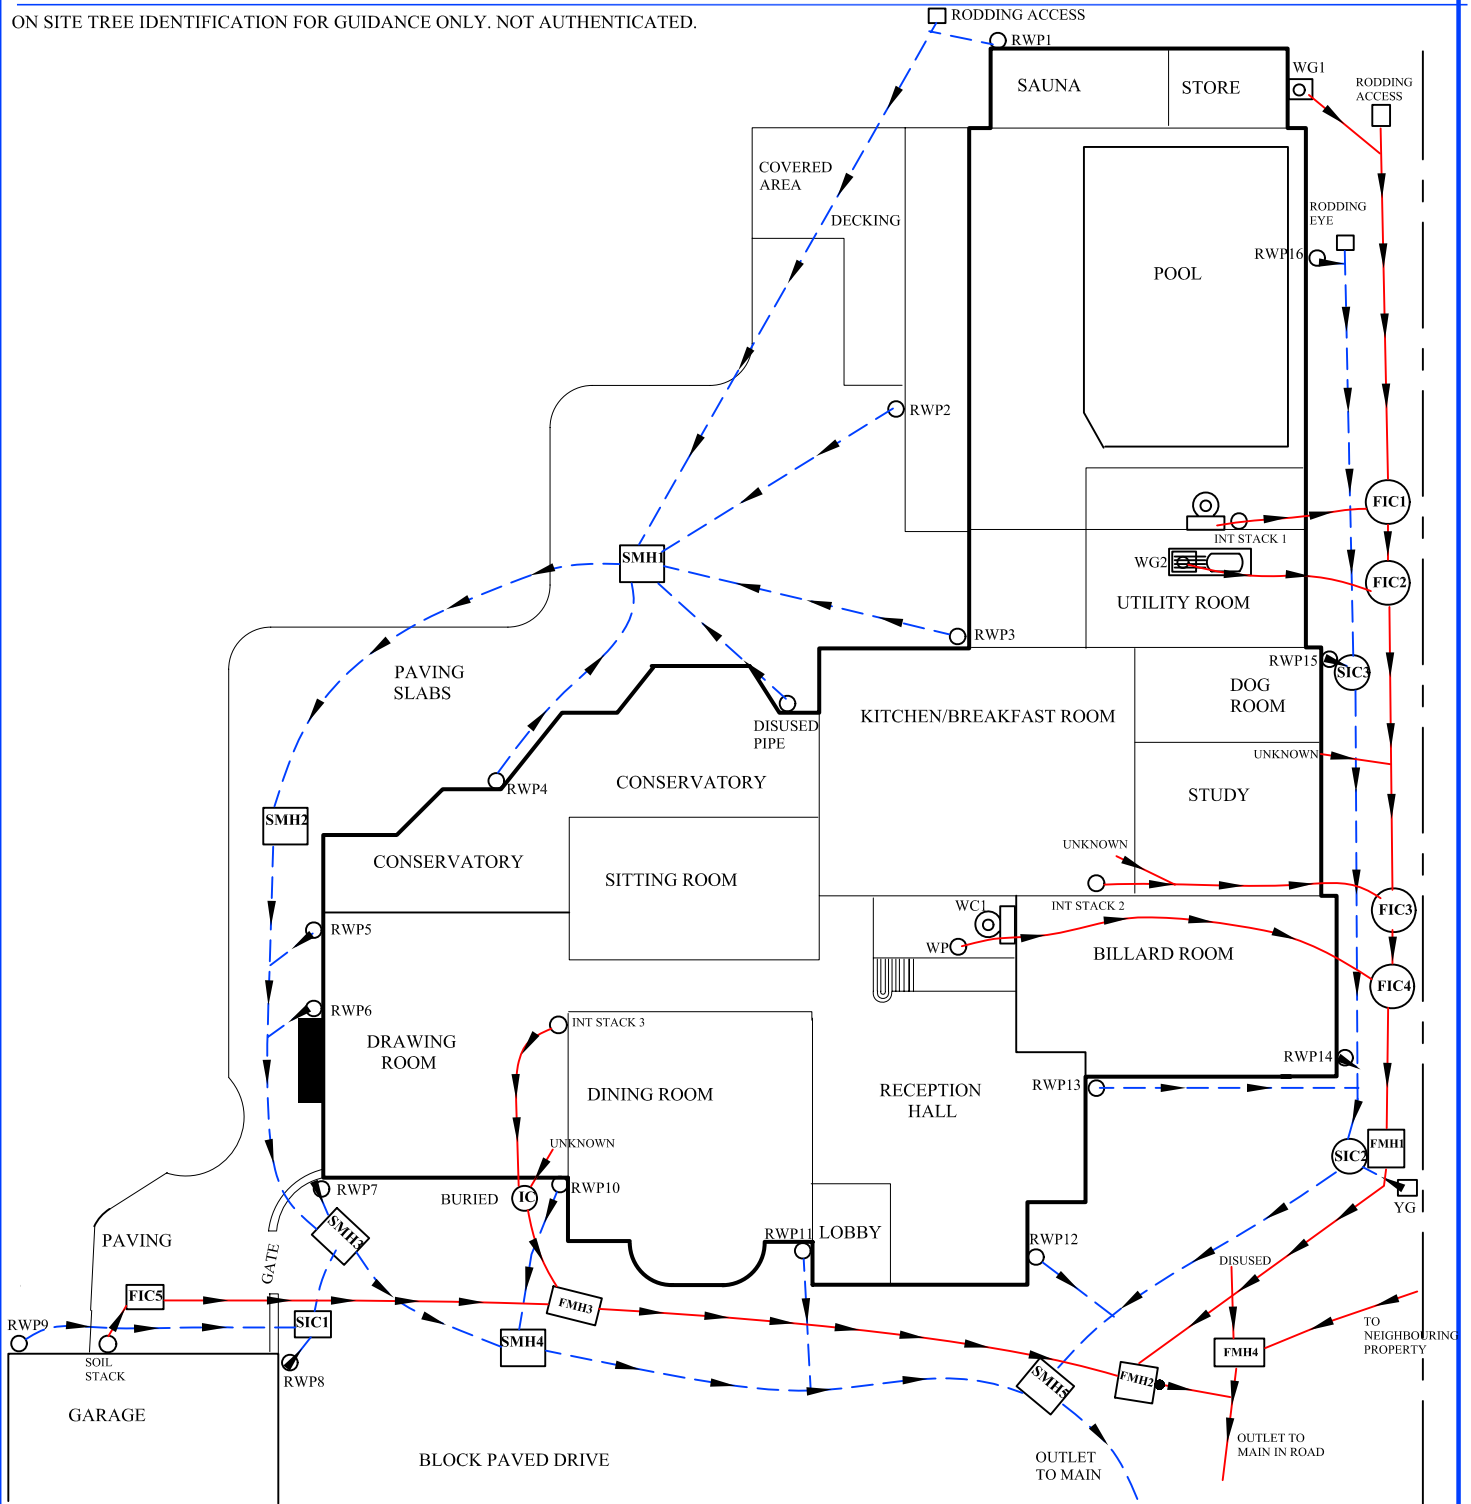
From our survey we have detailed the drainage layout on the enclosed site plan.

Survey type: Full Drainage Survey

Scale: N.T.S.
