4 ½" Slimline Tubing Perforator in 4 ½" 12.75 lb/ft GRE Tubing

450DTITP-S

DTI SO: 001908

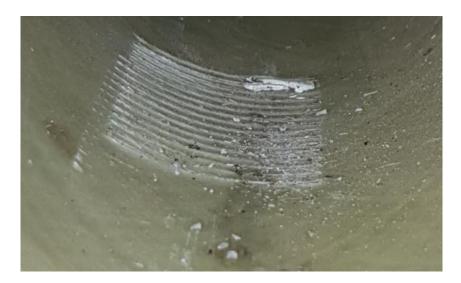
A clean hole was punched in the 4 ½" GRE lined tubing. The damage caused to the lining on the tubing by the tubing perforator slips is minor as seen on the image below.

Figure 1 - Impression of tubing perforator slips on GRE after perforating

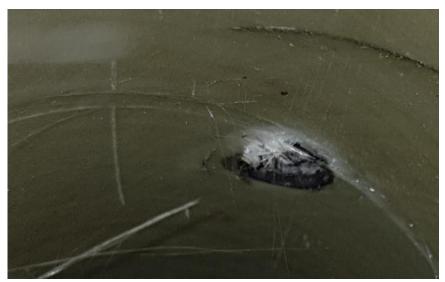
The tubing punch punched a clean hole through the lining and the tubing as can be seen on the following two images. It was noticed that in withdrawing the tubing punch by jarring upwards the punch caught on some of the GRE causing it to unravel.

Figure 2 - Punched hole from inside of GRE lined tubing. The groove where some of the lining has unraveled can be seen.

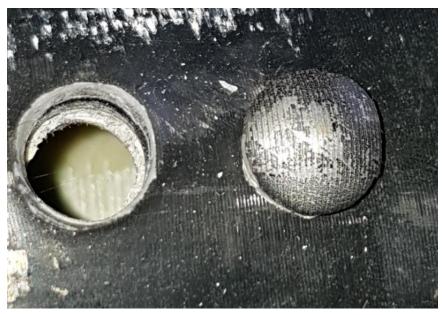
Figure 3 - Punched hole in the tubing from the outside with the punched section.

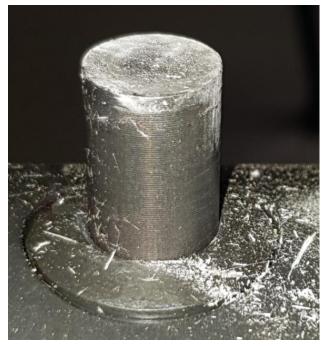
On disassembly it was observed that the tubing punch retainer pin (item 15-SPS19-188) was slightly bent. All other components were found to be in good condition.

Figure 4 - Tubing Punch after use.
