**Reduced Energy Lighting – White Light Sources**

**Initial Site Deployment Lessons Learnt Report (Product ID 3)**

This document details the lessons learnt from the Initial Site Deployment (ISD) of Reduced Energy White Lighting on the M4 between Junctions 5 and 6.

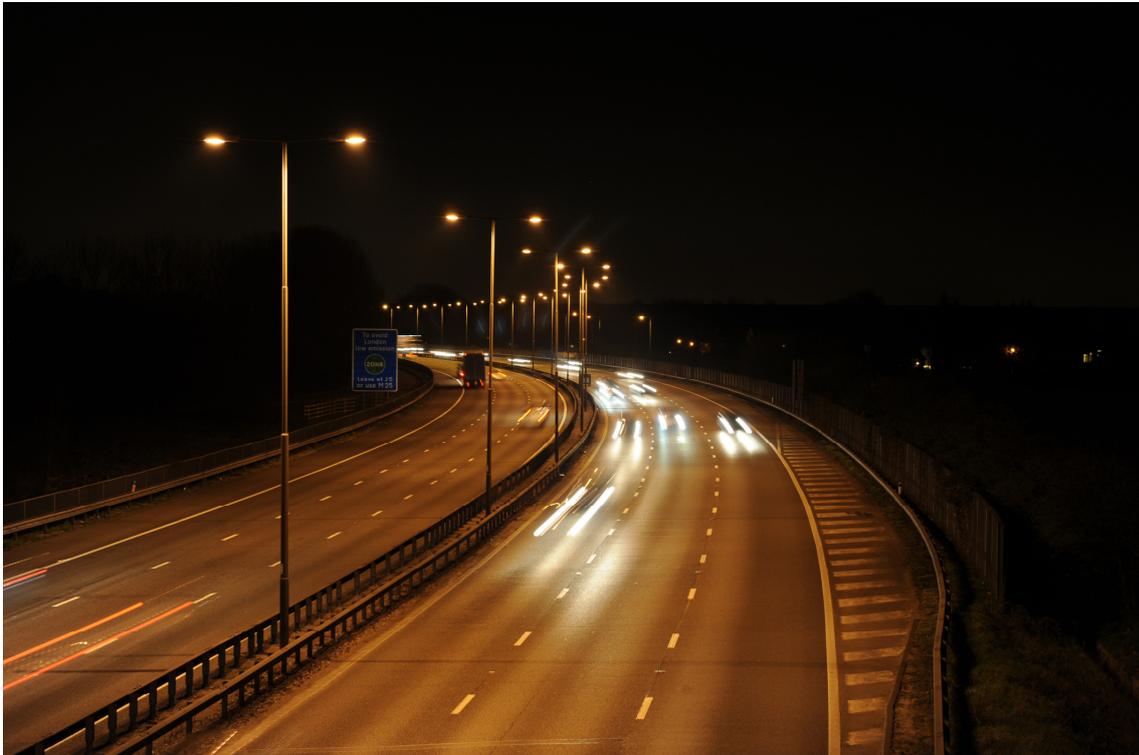
Figure 1.3.1 – Existing 250W SON installation (before ISD)

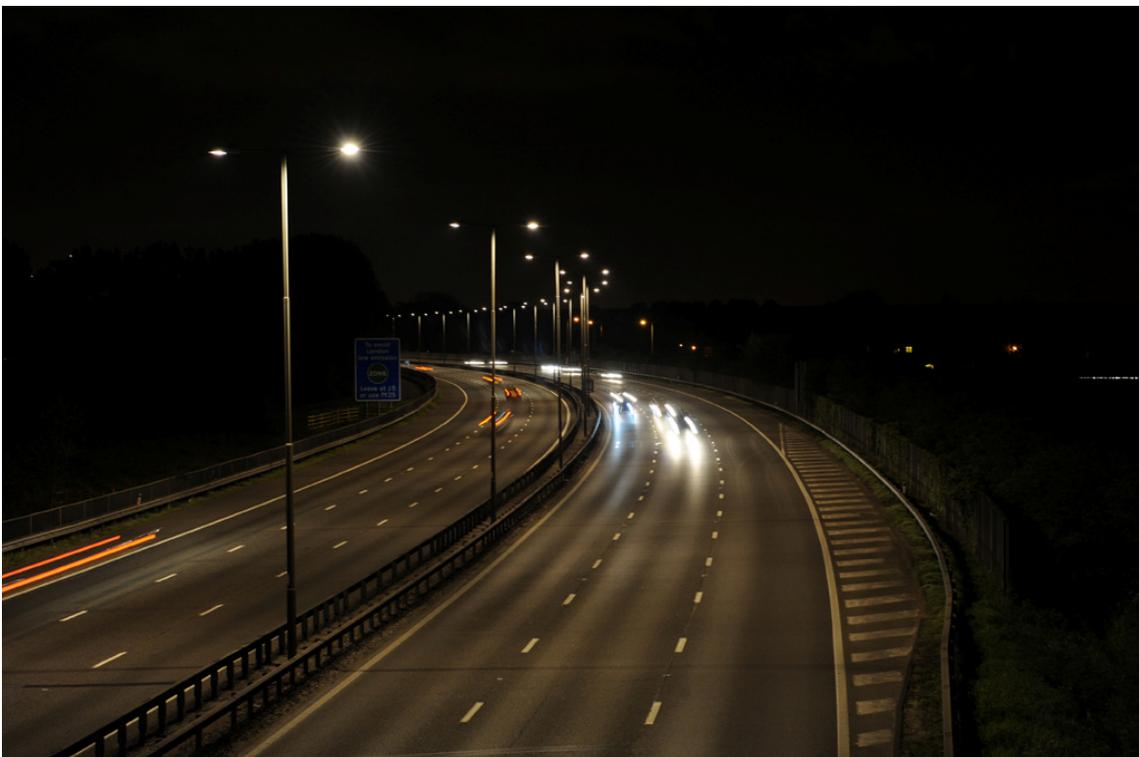
Figure 1.3.2 – New 140W Cosmo installation (after ISD)
