## Case Study

### Compact Intervention Technology Enables Rapid Plug Setting and Tree Repair on a High Producing North Sea Gas Well.

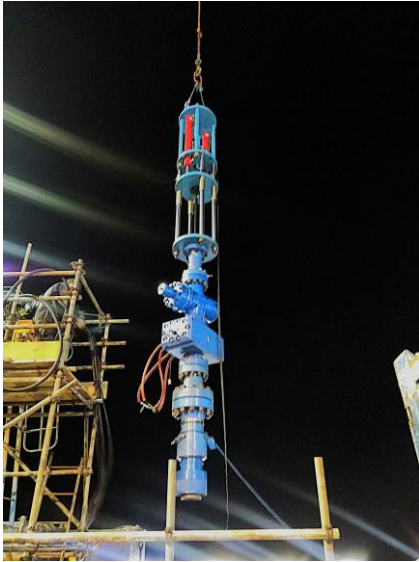
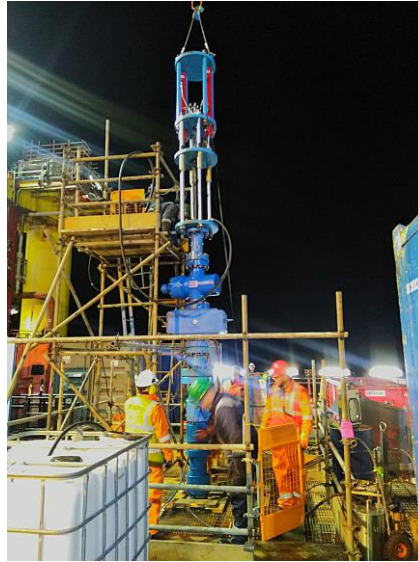
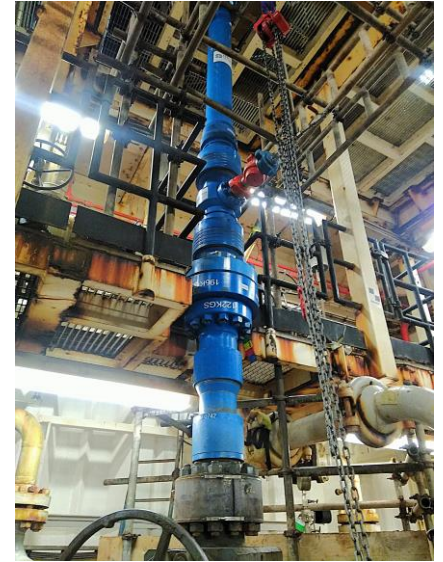
Unity mobilised its Surface Intervention System and Compact Shear-Seal BOP (shown above), plus XMT spare parts, pressure control equipment and four technicians, within a week of the initial call.

Part of our compact suite of tools, Unity's Surface Intervention System (SIS) is the only multi-functional lightweight system designed for shallow operations. It combines heavy-weight capability with rigless efficiency for near-surface isolation and intervention. This makes it ideally suited to congested wellbays, remote satellite platforms and rapid response services.

For plug setting we use a range of bridge plugs and our Compact Shear-Seal BOP (CSS) with pressure control equipment. Simple operation and offline deployment will quickly repair, prepare, upgrade or verify wells for production or abandonment.
