Water Mains trench October 25 - November 15^{th} 2012 A new water main was laid across Park 3 at Lackham in late October, early November 2012 The course of this pipe took it just to the east of the old Lackham House and then across the northern part of the Playing Fields.

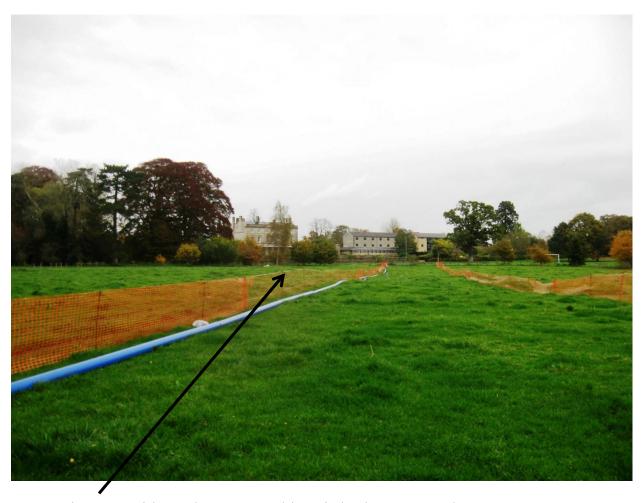
Approx location old Lackham House (demolished 1793-1795)

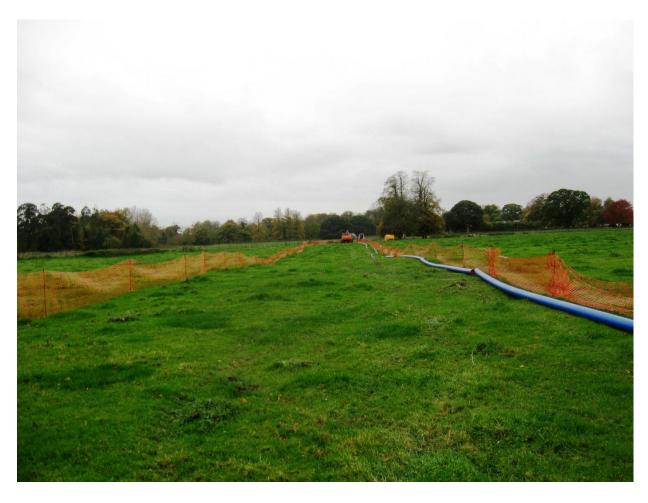
Looking south west along the line of the pipeline before operations commenced

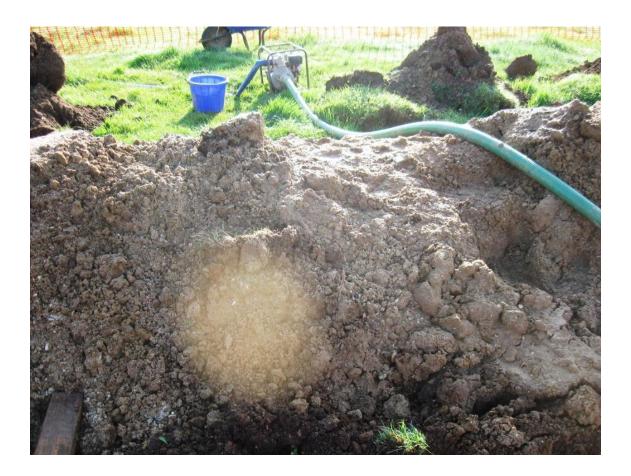
Nothing except alluvial deposits of sand, gravel and clay were found along the entire length of the trench from the corner of the field next to the entrance to Home Farm until the base of the slope in the north east corner of the field Park 3.

Measurements for the trench do not, however, run from this location but from the gate at the north east corner of Park3

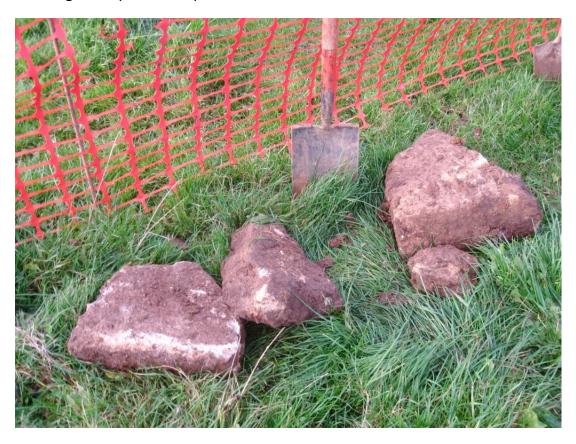
Three dressed ashlar blocks were dug out "at a depth of about 30cm" at ST 92219 70022,. These were located 89.1 from the northeast end of the trench at the gateway to the Sports Field.

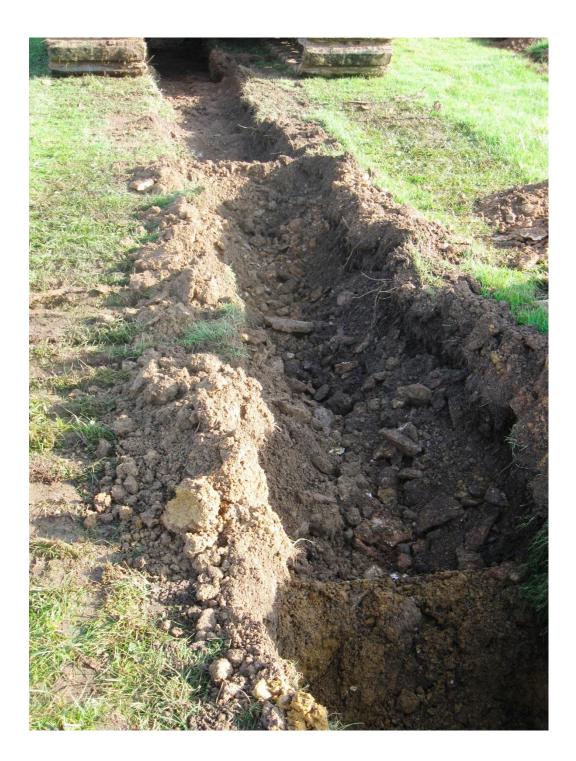
As progress was made up the slope, identified from illustrations and Andrews and Dury's map as the boundary of the western garden, cobbling material was found at ST92226 70036 this was located 10 cm below the soil surface and was approximately 30cm in depth. (Fig 2). This material was around 85m from the northeast end of the trench in the gateway into the Sports Field

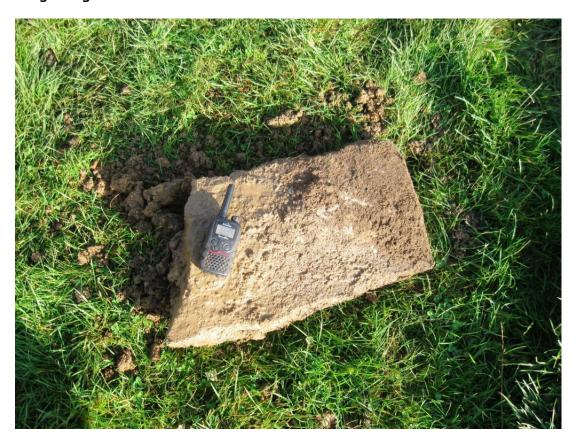
Large flags were found at ST 92239 70041

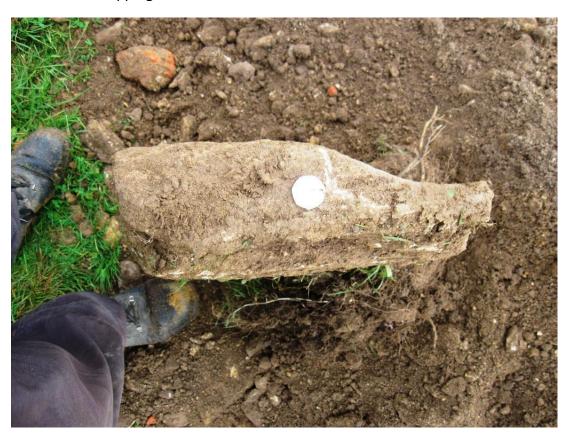
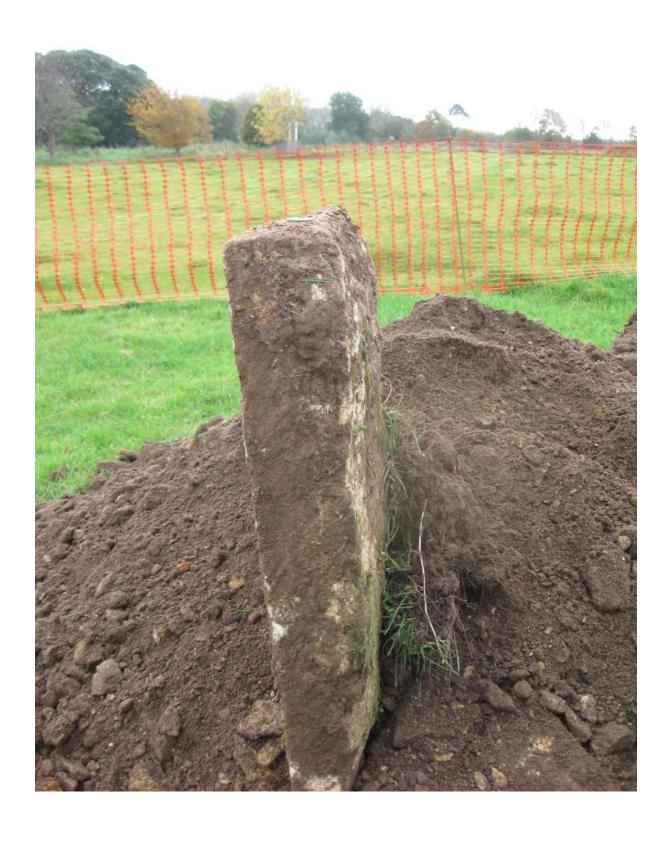
Carved wall capping stones? were found at ST 92235 70052

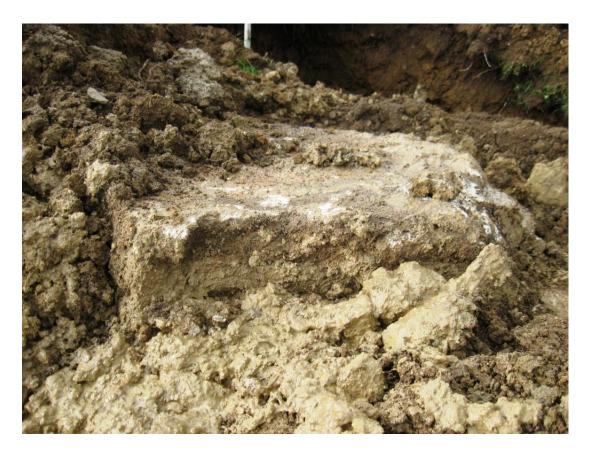
Large blocks were found at ST92239 70046 these were located 55.4m from the north east end of the trench at the gateway into the Sports Field

and these were found in both side walls of the trench. They were over 15cm in thickness and two were found in situ on top of each other

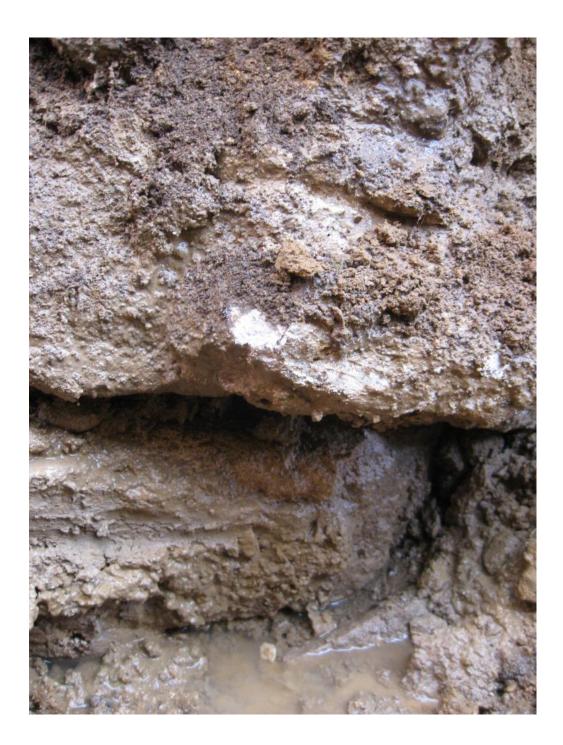
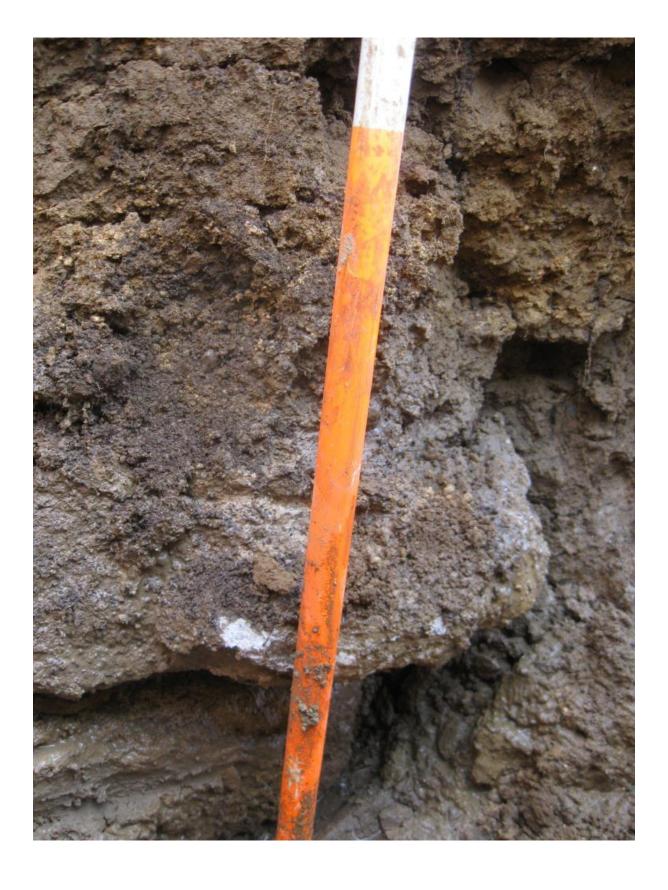
The trench cut the line of these stones at an angle as they were orientated almost exactly north-south. From excavations of the old house it is known that the walls of that house were orientated on the same alignment.

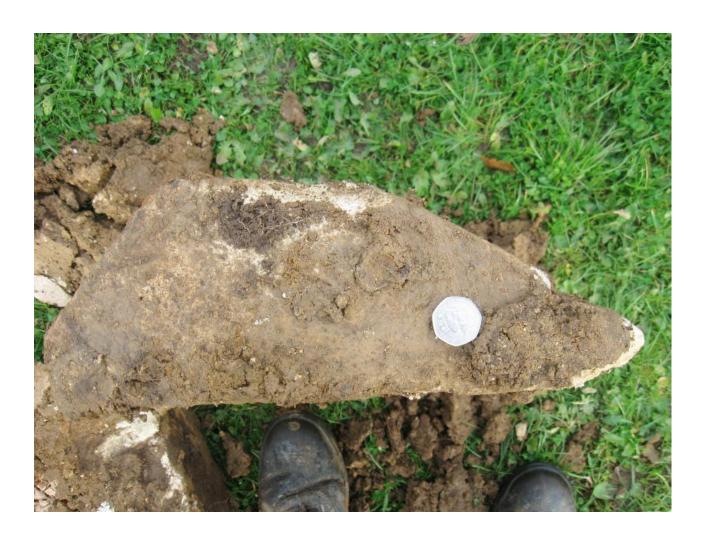
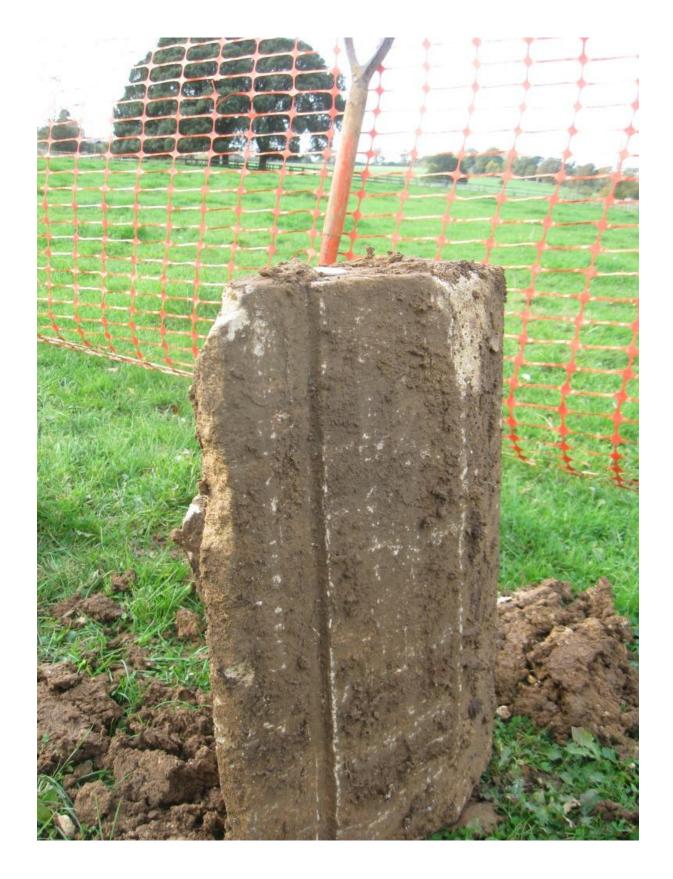
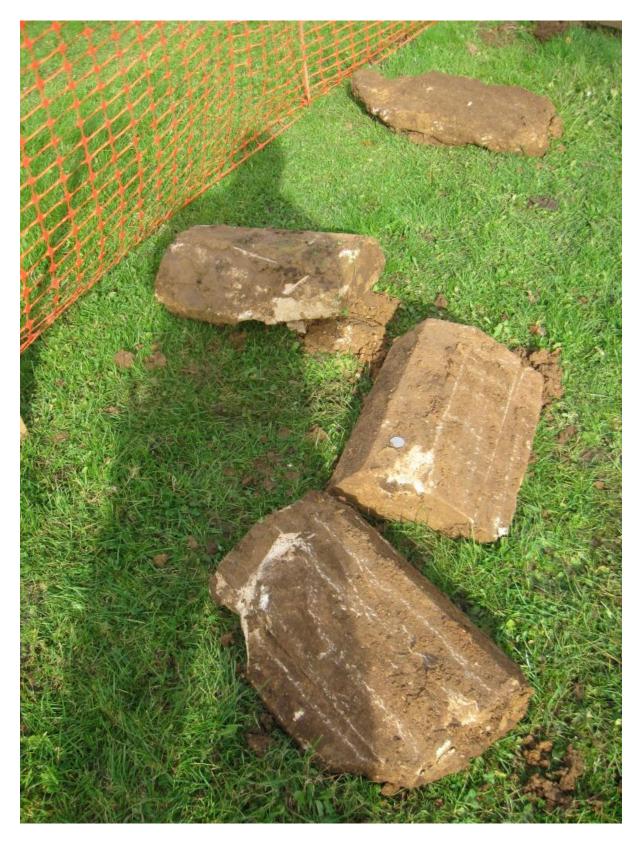
At ST242240 70046 carved stone work was found. These were located 50.3 m from the northeast end of the trench at the gateway into the Sports field.

At the base of the trench more were seen in the side walls. When this was investigated it was found that they had been pushed together to form a triangular space which went back a full arms length plus that of a shovel (aprox. 2.5m).

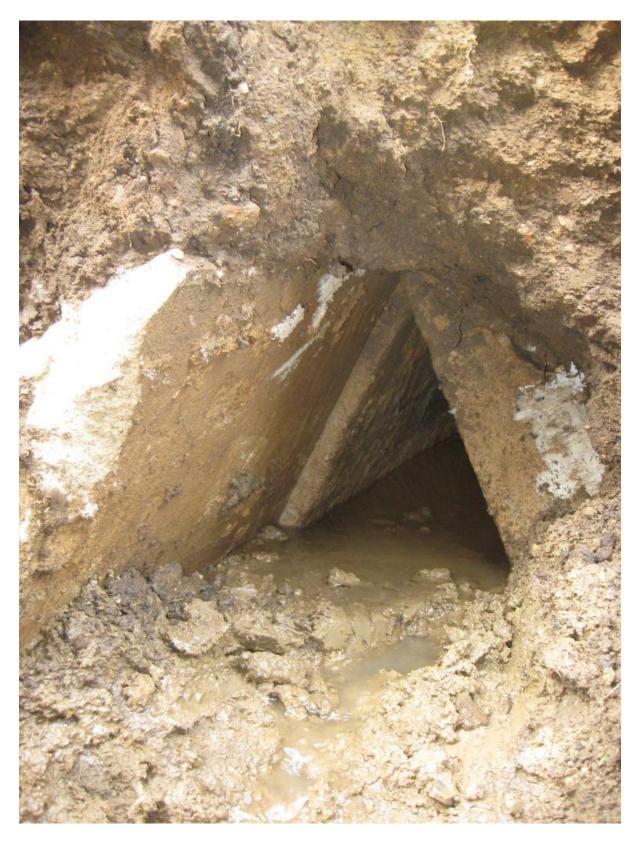
Following overnight collapse of part of the trench side adjacent to the stonework amounts of wall plaster was found. Unfortunately these carved blocks were replaced in the trench before filling.

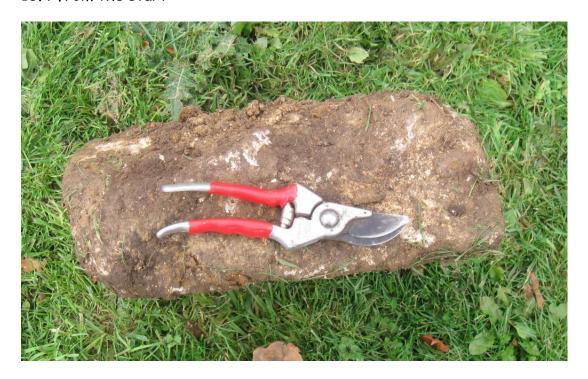
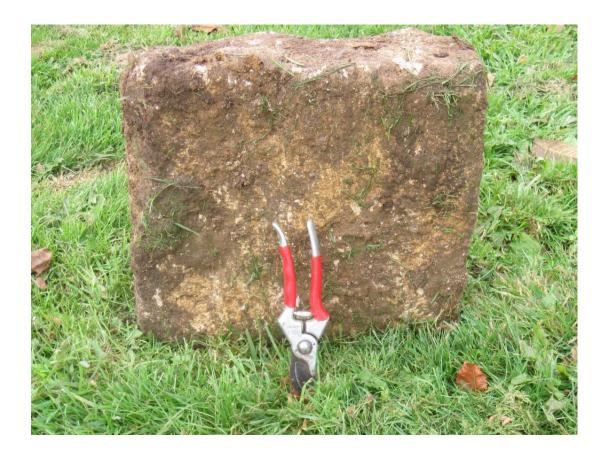
Blocks of dressed stone were found at depth (approx. 1.5m) at ST 92285 70084 13.4 from the start

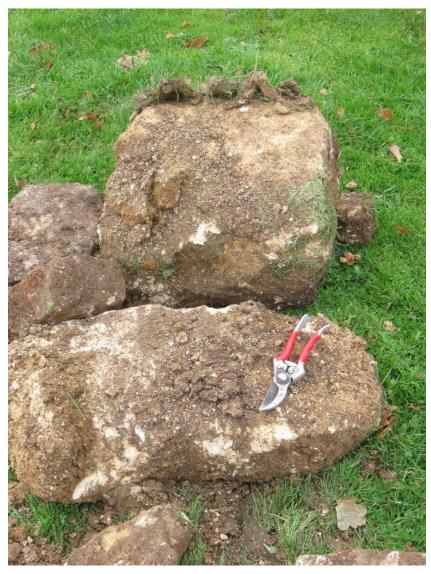
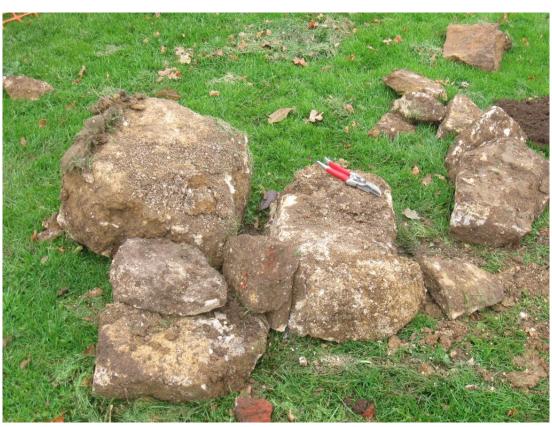
Substantial amounts of dressed stone were found at 21.2 m ST92249 70084

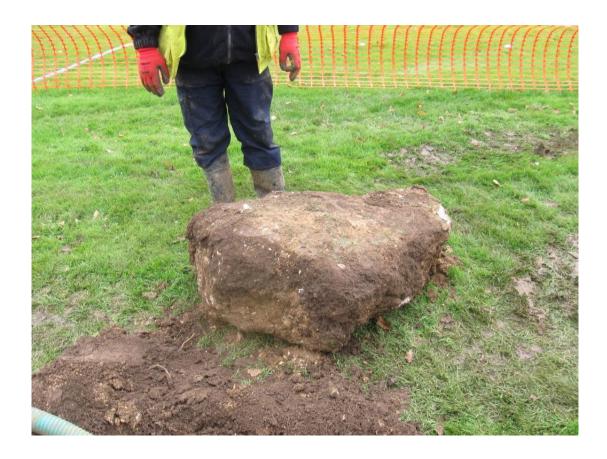
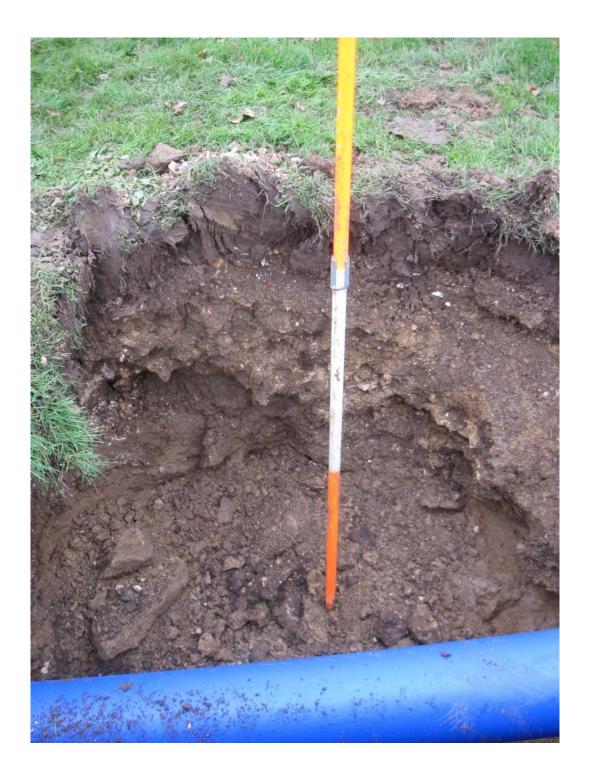
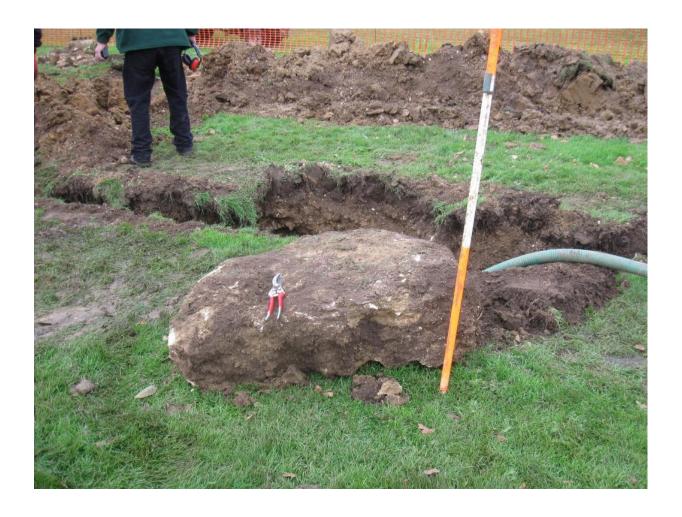
And large blocks were found at 26.3m. Loose plaster debris was found sitting directly on top of these blocks when removed

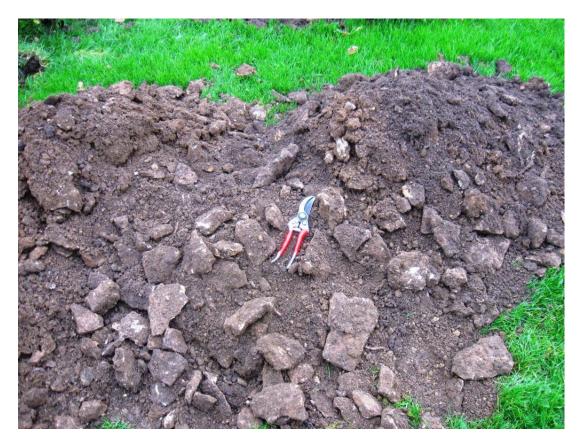
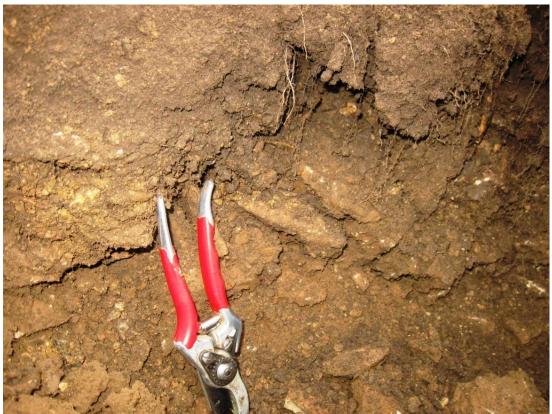
A layer of small stones and "cobbling" similar to that seen in the north-south section of the trench, was located at a depth of 15cm at 72 eats fo the start point at $ST92341\ 70084$

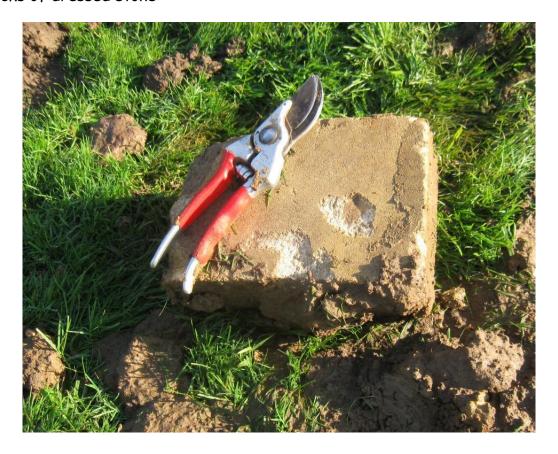
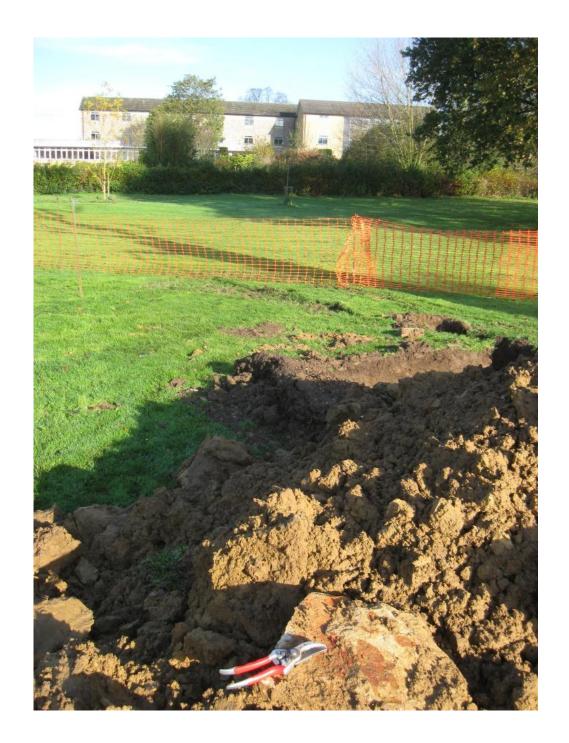
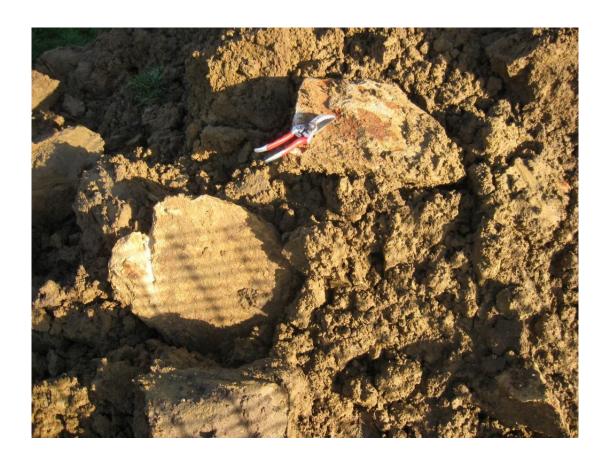
The east end of the trench, at 84.3m ST92368 70084 uncovered more small blocks of dressed stone
